**Via E-Mail RE: Variance Request  
Zeus SWD Line  
OCD Incident #NRM2026231125  
Lea County, New Mexico**

**Zeus SWD Line Release, NMOCD Incident #NRM2026231125**  
**Liner Installation Construction Map**

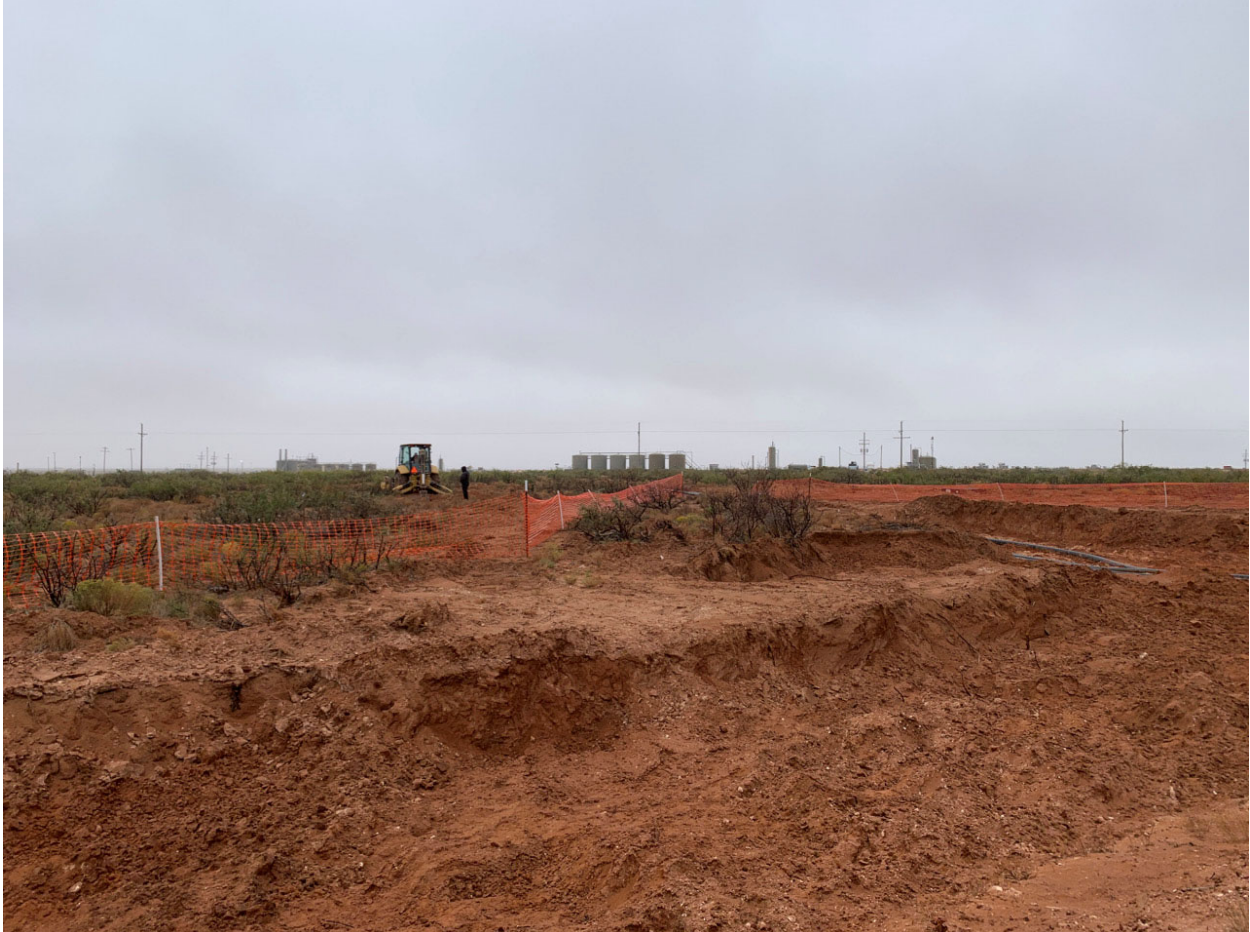
From September 5 through September 12, 2020, approximately 900 cubic yards of impacted soil were excavated and transported to Northern Delaware Basin Landfill, a licensed disposal facility. The initial excavation reached depths of 2 feet bgs at the extreme northern and extreme southwestern extents of the excavation, getting progressively deeper to 4.7 feet bgs where the north-south portion of the excavation meets the east-west portion of the excavation. The field excavation crew visually inspected the impacted area to determine the extent of the release. CDH staff arrived on site September 23, 2020 to collect confirmation soil samples demonstrating that impacted soil has been removed. Field analysis utilizing a photoionization detector (PID) initially indicated that the impacted soils had been removed as all readings were within the range of the background readings. Field-screening PID results are included in Table 1. Photographs of the site taken during initial excavation and sampling activities are included as Attachment 5.

**Excavation Facing North**

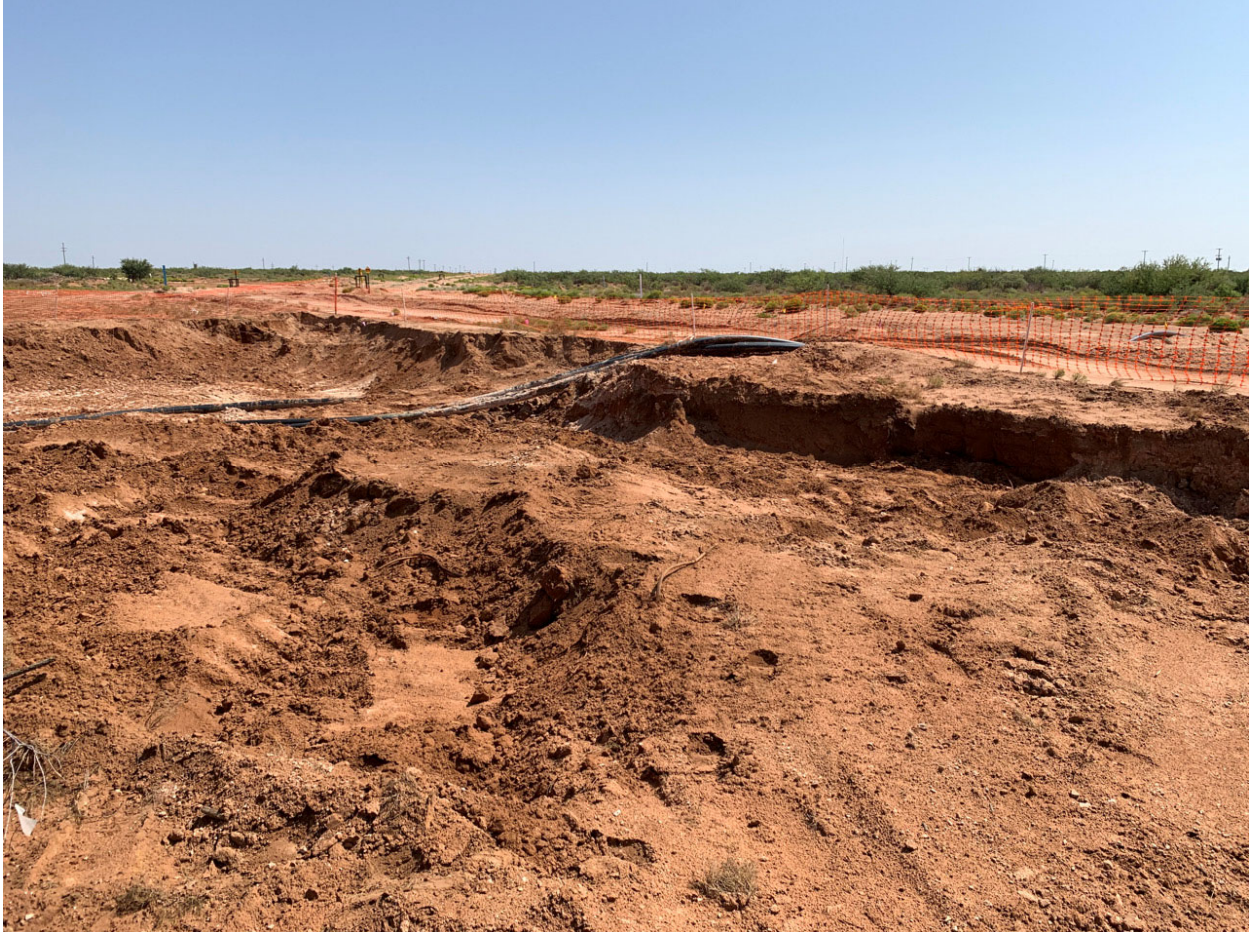
**Excavation Facing South**

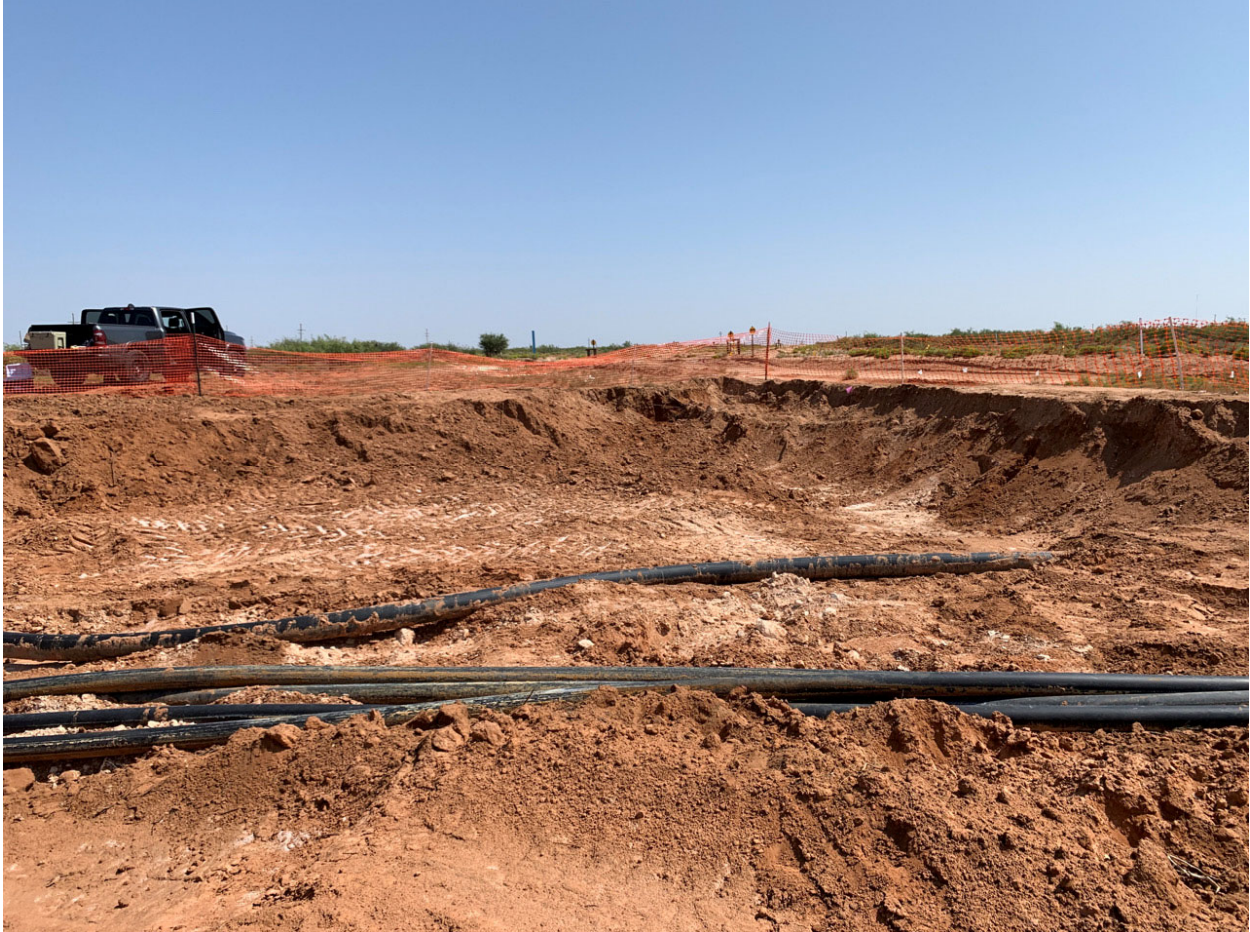
**Excavation Facing East**

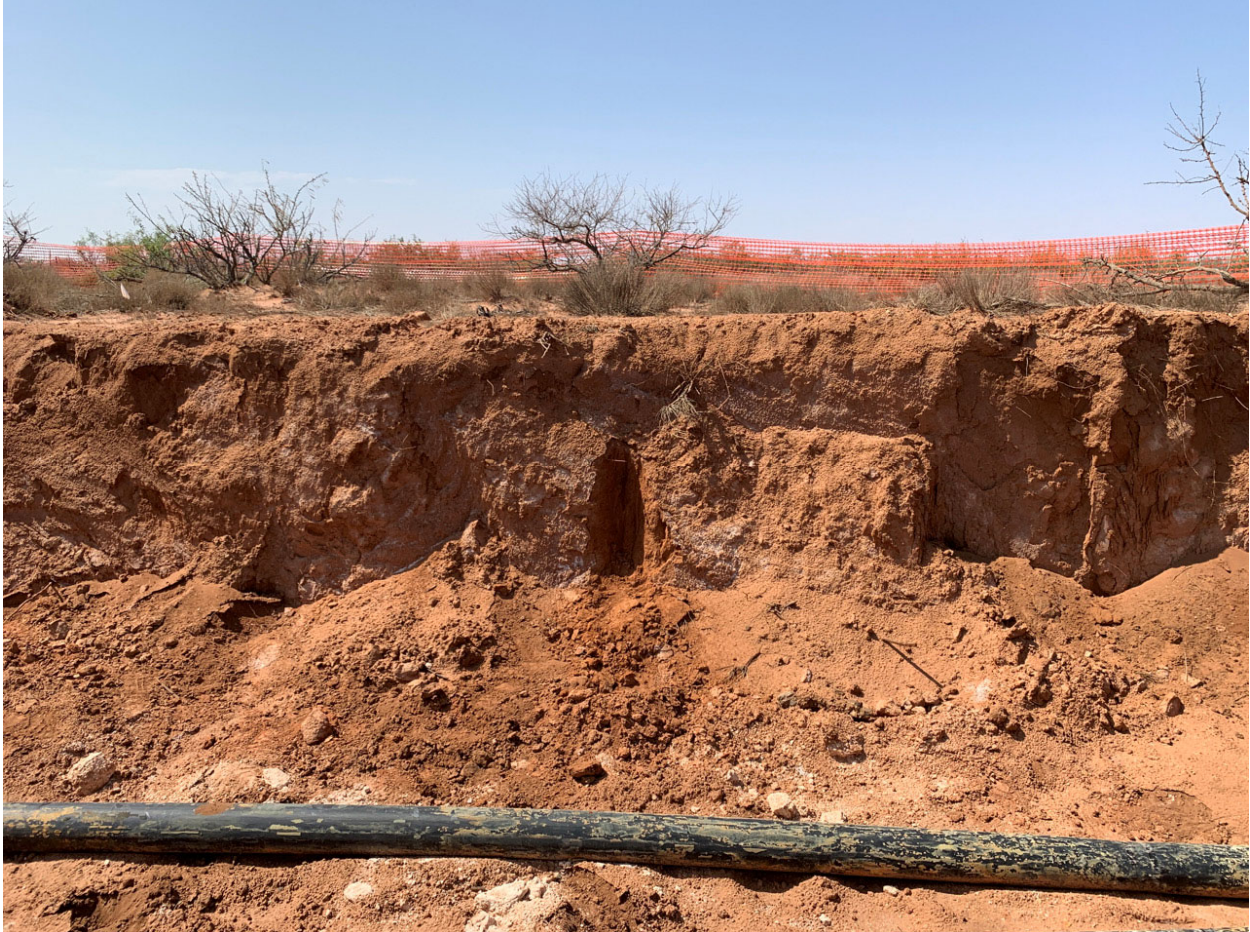
**Excavation Facing West**

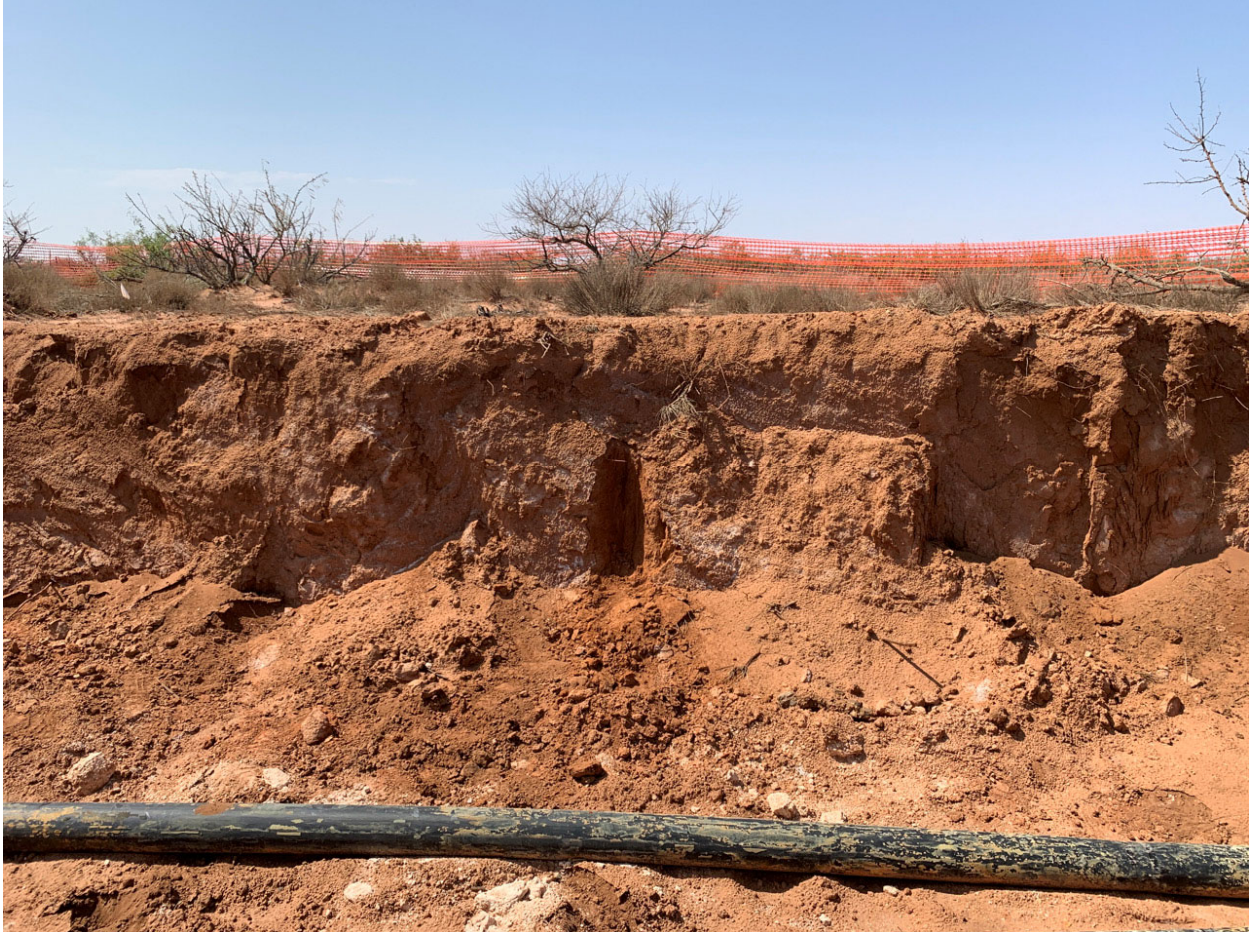
**Liner Instillation**

In order to address the remaining chlorides exceedances, while addressing safety concerns associated with excavating near or beneath existing buried pipelines in the area, on December 2, 2020, CDH submitted an updated Form C-141 to NMOCD as a deferral request and remediation plan, included as Attachment 3. CDH also prepared and submitted a Soil Assessment & Remediation Work Plan document to the NMOCD.

On February 8, 2021, Ms. Eads communicated via phone call to CDH that additional excavation would be required, to which CDH responded that on behalf of Tap Rock, installation of a liner was being considered in accordance with NMOCD June 19, 2020 Draft Part 29 Releases Liner Installation as Part of Spill Remediation Guidance. Ms. Eads agreed to this approach in principle, however stated that the liner was required to be buried at 8 feet bgs. CDH noted that this would be problematic given both aboveground and buried pipelines in the impacted area. Ms. Eads stated that in areas where the total depth of excavation was less than 4 feet bgs and soil exceeded NMOCD reclamation standards and areas where confirmation and pothole samples collected from depths greater than 4 feet bgs exceeded the applicable chlorides standard, a liner would need to be installed. Ms. Eads also stated that she would agree to shallower placement of the liner.

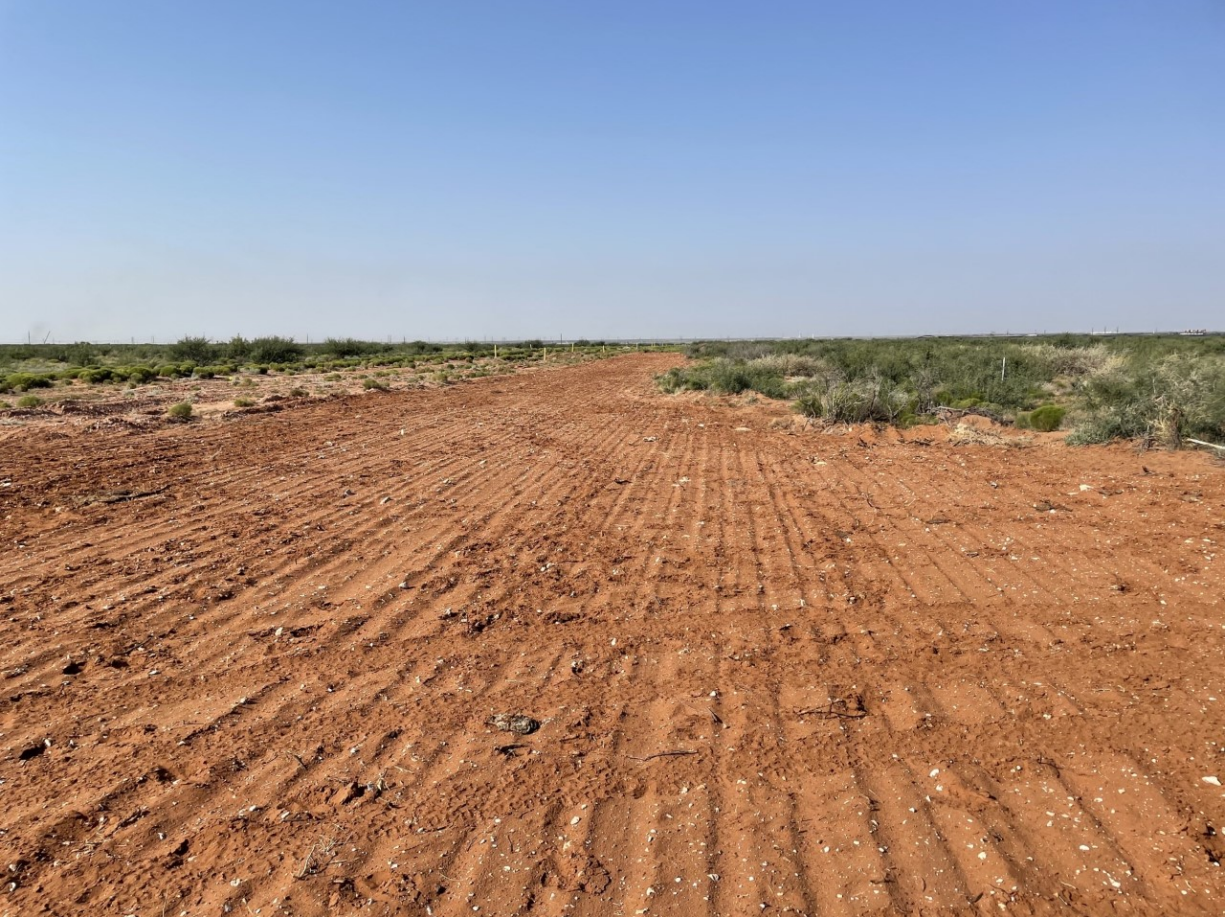
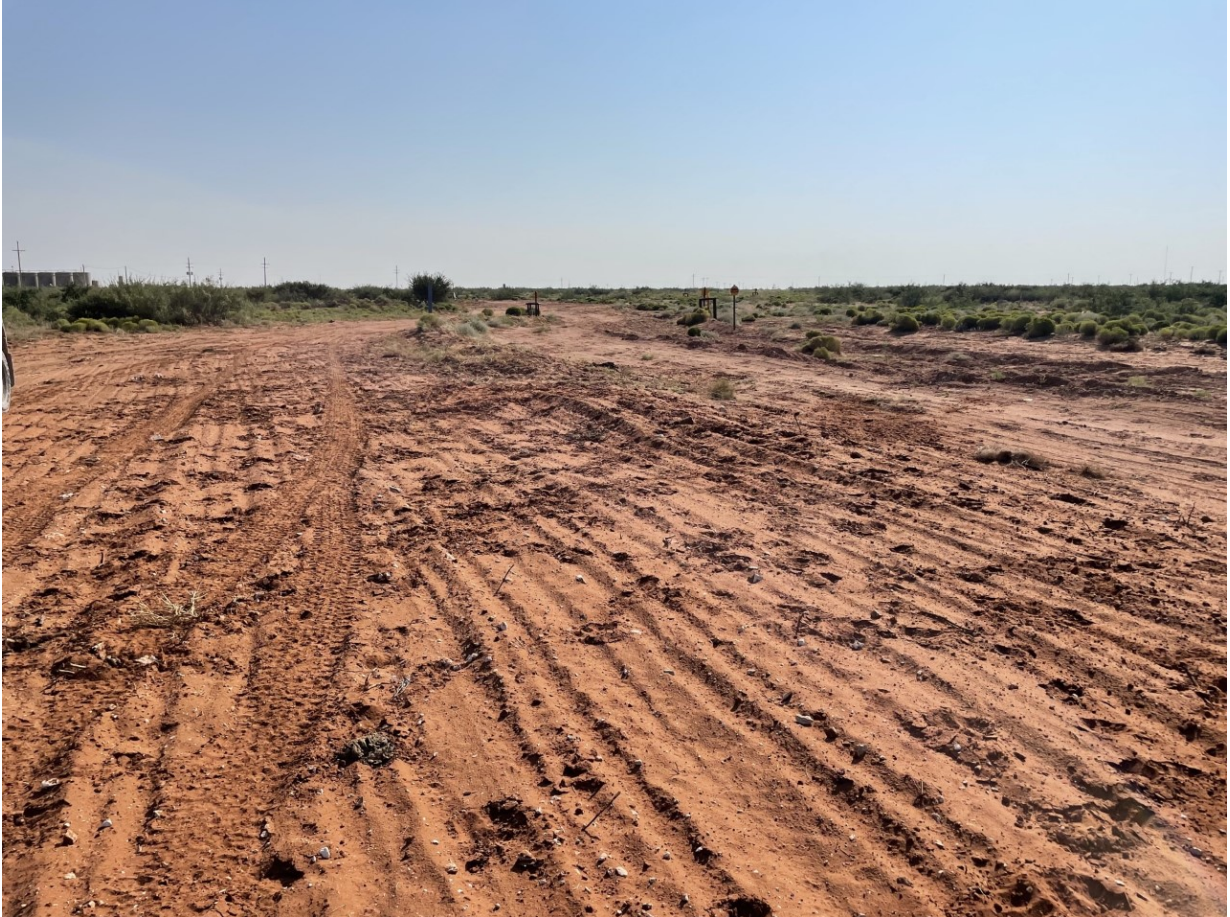
**Backfill on Location**
