# R. T. HICKS CONSULTANTS, LTD.

RE: Temporary Pit Closure Report  
Jackson Jackson Unit #19H, API #30-025-41138, Pit Permit #P1-06107  
Unit N, Section 21, T24S, R33E, Lea County

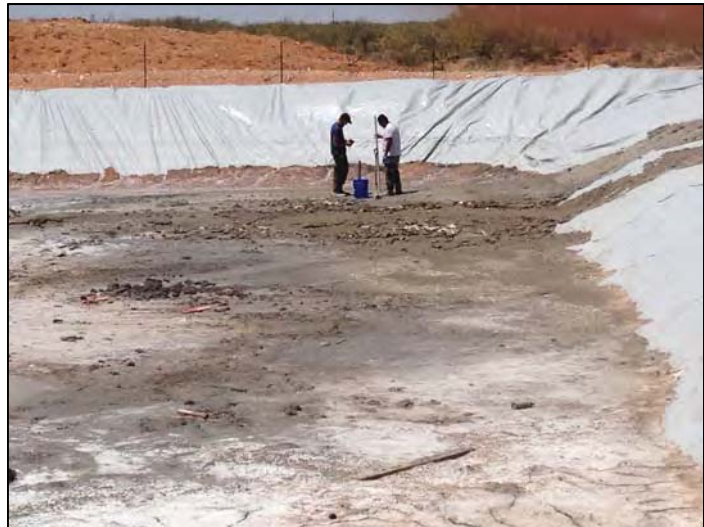
On June 4, 2014, four-point composite samples of the pit solids from the inner and outer cells respectively and from the berms of the pit (below the liner) were collected in accordance with the Pit Rule and were representative of the cuttings from both the #19H and #28H wells. Hall Environmental Analysis Laboratory of Albuquerque was instructed to compose a “3:1 Stabilized Cuttings” sample in the laboratory consisting of 3 parts available mixing soil and 1 part pit contents. The pit composite consisted of 1 part inner cell cuttings and 2.4 parts outer cell cuttings, reflective of the volume of material in each cell of the pit. Preparation of this sample was delayed and resulted in a lab report that exceeded

Sampling Pit Contents 6/4/2014

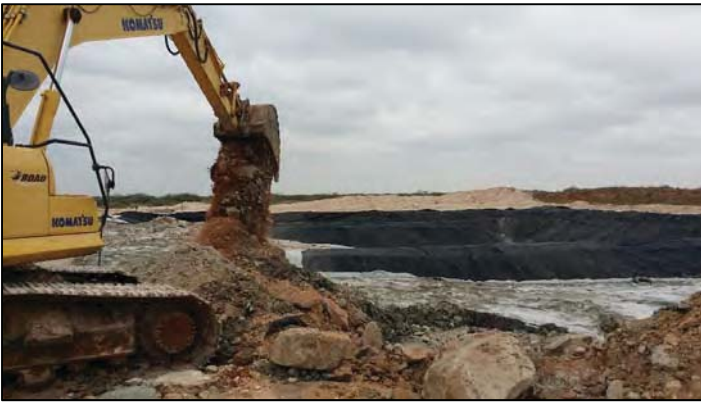
Beginning closure mixing 10/20/2014

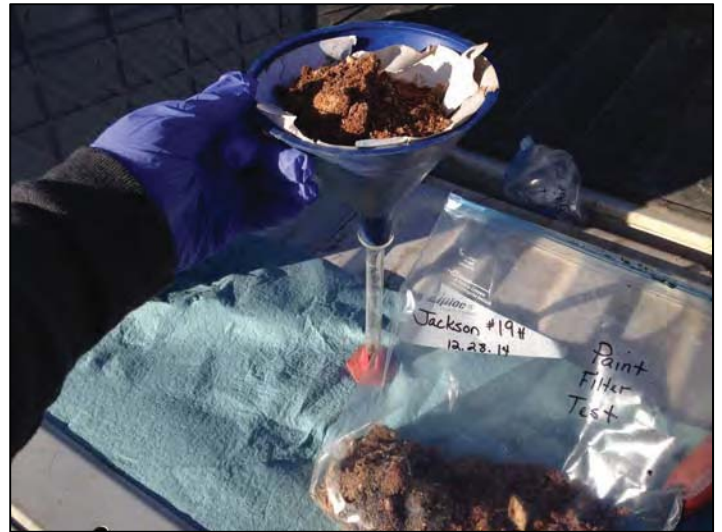
Paint filter test on stabilized cuttings 12/28/2014

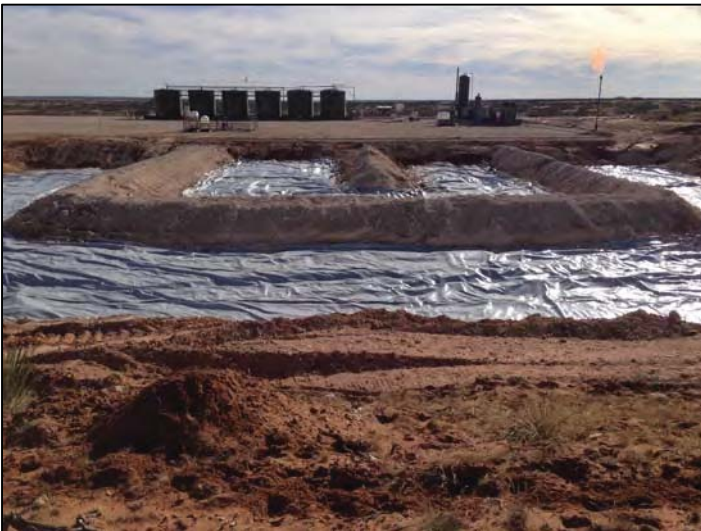
Geomembrane cover over stabilized cuttings  
12/29/2014

7. Having achieved all applicable stabilization requirements associated with in-place burial, a geomembrane liner was installed to cover the stabilized cuttings on December 29, 2014. The pit contents and liner were shaped to shed infiltrating water, slightly higher in the center.

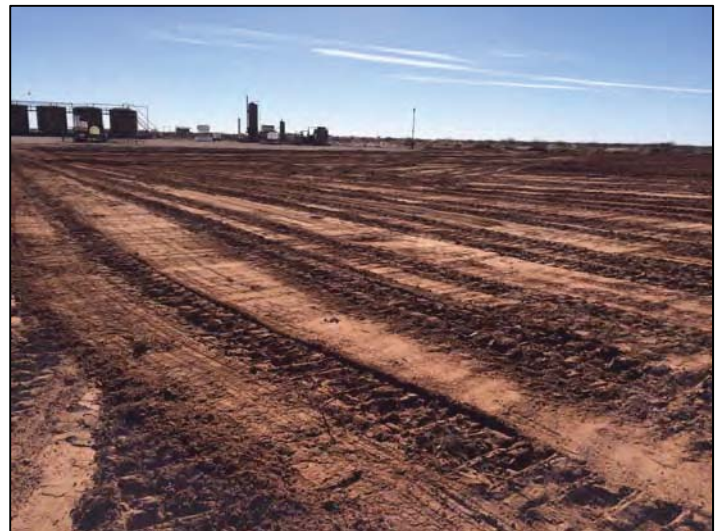
Backfill complete (facing southwest) 1/20/2015

8. Once the geomembrane cover was in place, approximately 4 feet or more of non-waste containing, uncontaminated, earthen material and the reserved topsoil were replaced to their relative positions in accordance with Subsection (3) of Paragraph H of 19.15.17.13 NMAC. The soil cover consists of at least four feet of compacted, non-waste containing, earthen material. The uppermost topsoil is equal to the background thickness at least one foot. The surface was contoured to blend with the surrounding topography and to prevent erosion and the ponding of water over the on-site closure. Inclement winter weather delayed closure activities but this work was completed on January 20, 2015.

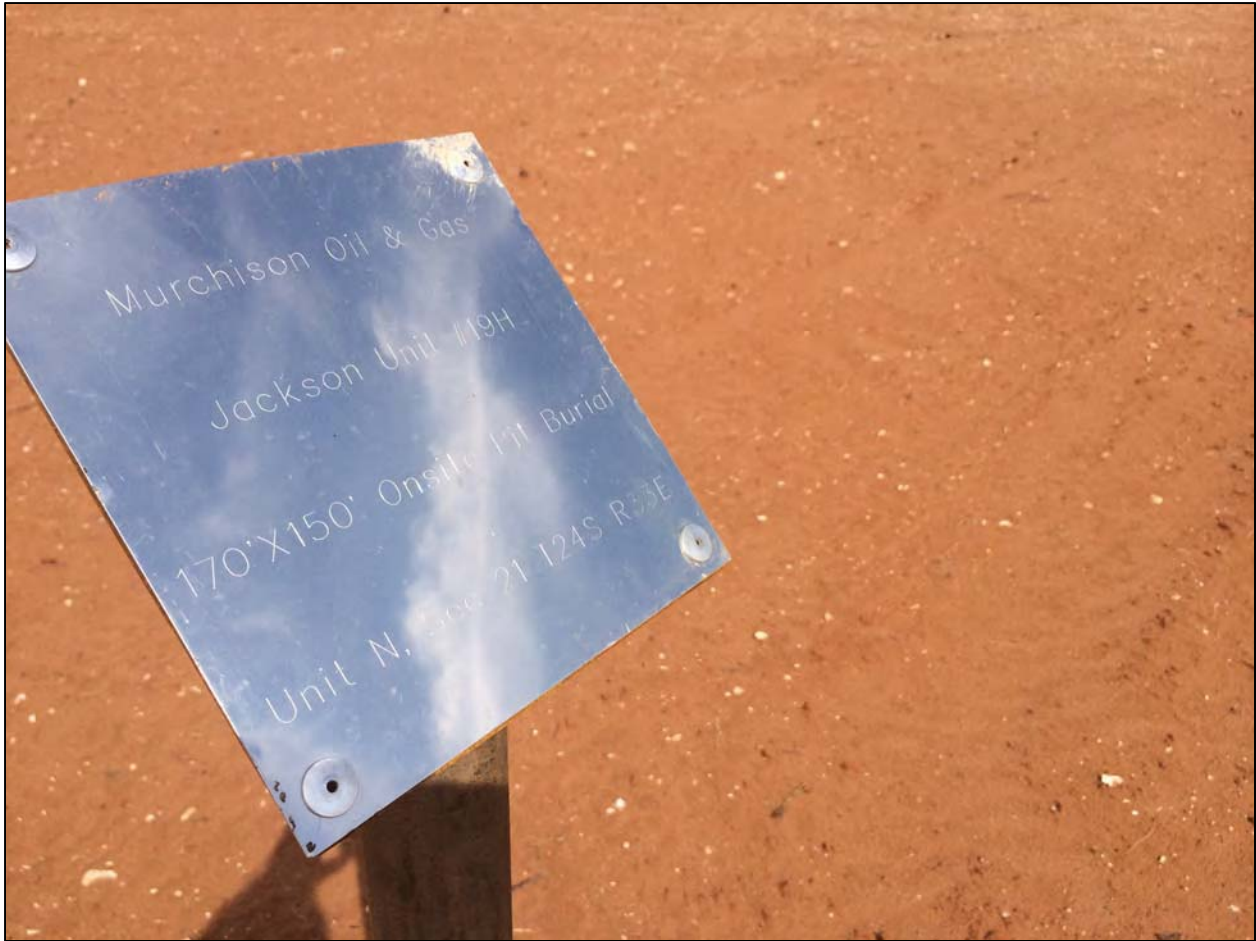
Steel marker plate identifying pit burial site

3. After seeding, a steel plate marking the site as an in-place pit closure has been placed on the surface at the center of the former pit location in accordance with Subsection (3) of Paragraph F of 19.15.17.13 NMAC.
4. The seeded area will be monitored for growth and the operator will repeat seeding until a successful vegetative cover is achieved as outlined in Subsection (5) of Paragraph H of 19.15.17.13 NMAC.
5. If conditions are not favorable for the establishment of vegetation, such as periods of drought, the operator may request that the division allow a delay in additional seeding until soil moisture conditions become favorable. The operator will notify the division and provide photo-documentation when it successful re-vegetation is achieved.
