RE: Temporary Pit Closure Report, Jackson Unit #25H
API #30-025-41230, Pit Permit #P1-06388
Unit O, Section 22, T24S, R33E, Lea County

ATTACHMENT 1

Waste Material Sampling Analytical Results

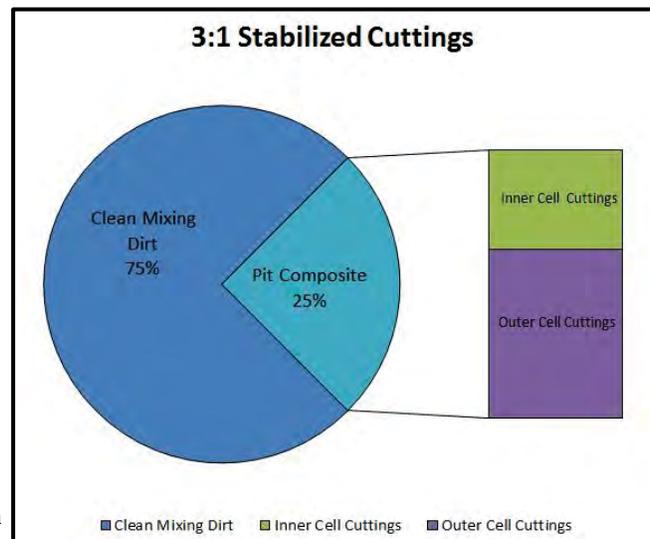
After hydraulic fracturing and flow-back were completed, 4-point composite samples were collected from the inner horseshoe cell, outer horseshoe cell, and from the clean soil of the berms (beneath the liner) of the pit on July 17, 2014 for laboratory analyses. The table on page 2 of this notice demonstrates the calculated concentration for "3:1 stabilized" material that results when the pit contents are combined with available mixing soil during the closure process. The calculated value mathematically mixes 3 parts clean soil (mixing dirt) with 1 part of the weighted pit composite calculation, as depicted in the adjacent chart. The pit composite consists of 37% solids from the inner cell of the drilling pit and 63% of the solids from the outer cell (1:1.7 ratio), representative of the volume of cuttings in each cell.

Jackson Unit #25H: closure composition

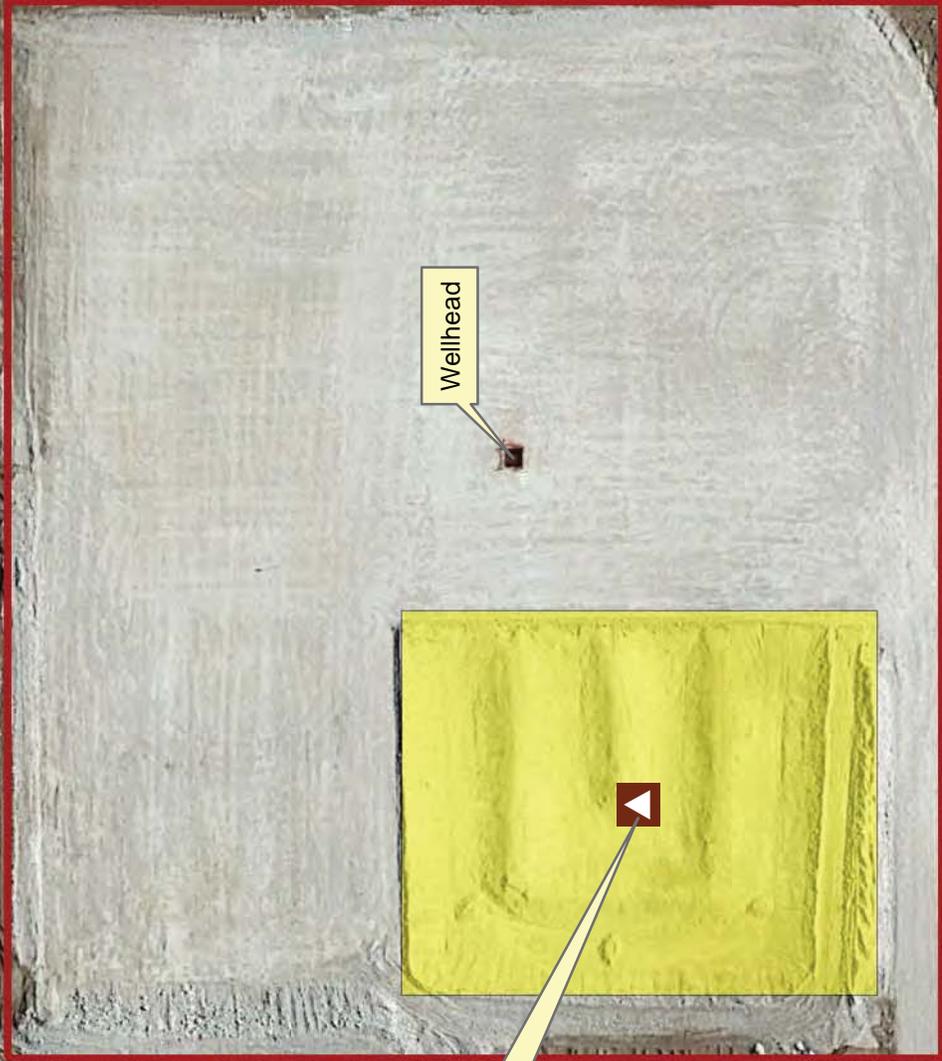
<p>R.T. Hicks Consultants, Ltd 901 Rio Grande Blvd NW Suite F-142 Albuquerque, NM 87104 Ph: 505.266.5004</p>	<p>On-Site Burial Location of Temporary Pit Murchison Oil and Gas, Inc. Jackson Unit #25H</p>	<p>Plate 1 form C-105 February 2015</p>
---	---	--

On-site Burial Center
Lat: 32.196269
Long: -103.556751
Datum: NAD83

32. If a temporary pit was used at the well, attach a plat with the location of the temporary pit.
 PLATE I ATTACHED

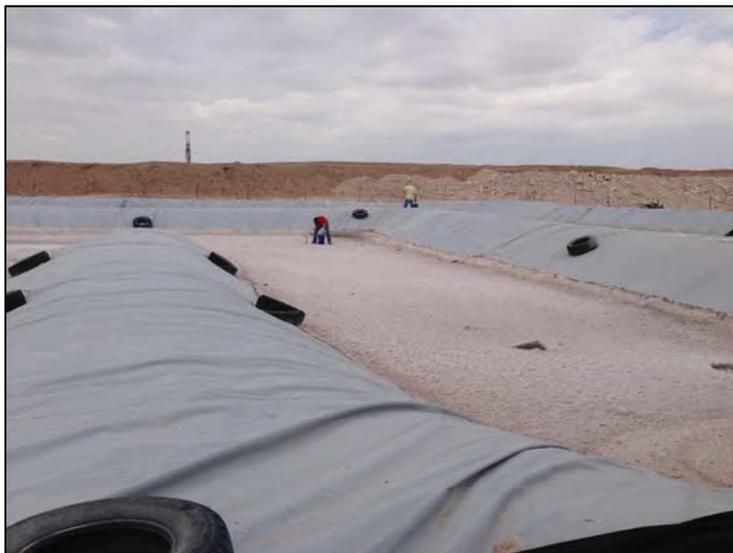
Sampling cuttings of inner and outer cells 7/17/2014

On July 17, 2014, 4-point composite samples were collected from the contents of the outer and inner cells of the temporary pit. A 5-point composite sample was also collected from the clean soil of the berms beneath the liner. The composite samples were submitted to Hall Environmental Analysis Laboratory in Albuquerque for BTEX (8260B), GRO+DRO (8015D), TPH (418.1), and Chloride (SM4500) analyses. These component samples were used to determine a calculated concentration for the “3:1 stabilized cuttings” by mathematically

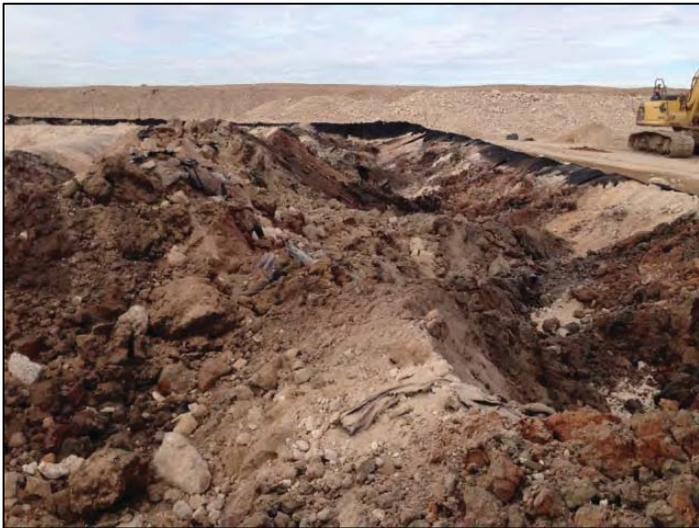
Mixing pit contents with trackhoe 12/3/2014

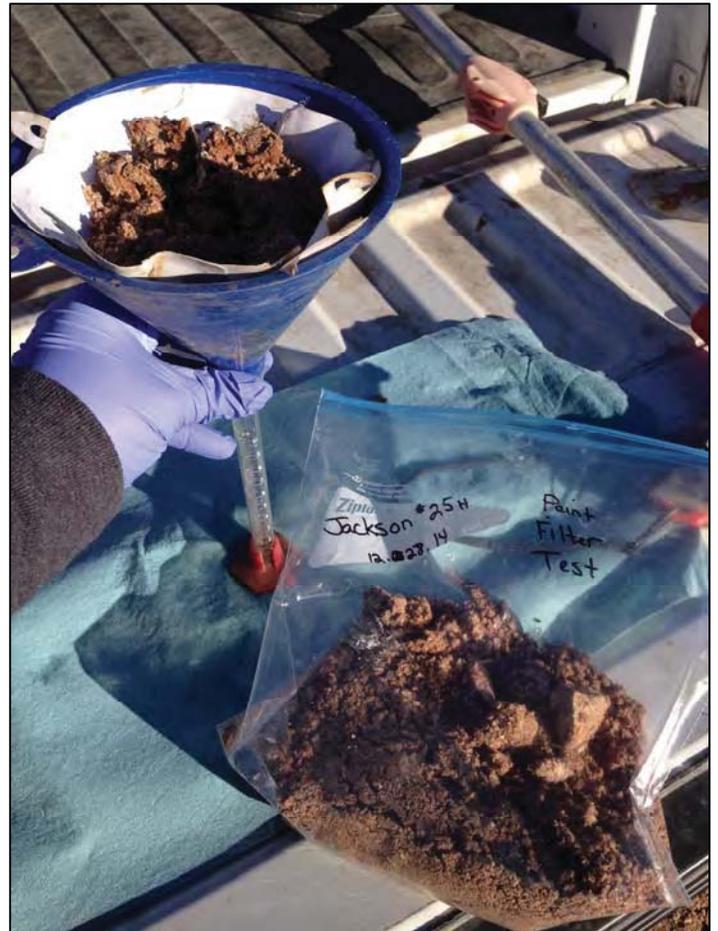
Paint filter test of stabilized cuttings 12/28/2014

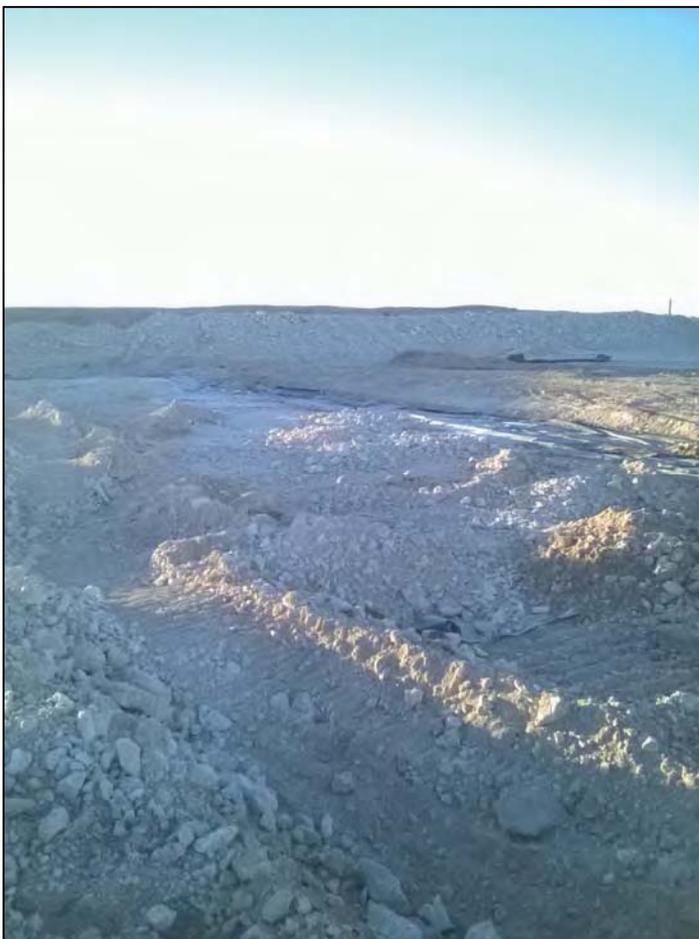
Backfilling over geomembrane cover
12/30/2014

5. Having achieved all applicable stabilization requirements associated with in-place burial, a geomembrane liner was installed to cover the stabilized cuttings on December 29, 2014. The pit contents and liner were shaped to shed infiltrating water, slightly higher in the center.

6. Once the geomembrane cover was in place, approximately 4 feet or more of non-waste containing, uncontaminated, earthen material and the reserved topsoil were replaced to their relative positions in accordance with Subsection (3) of Paragraph H of 19.15.17.13 NMAC. The soil cover consists of at least four feet of compacted, non-waste containing, earthen material. The uppermost topsoil is equal to the background thickness at least one

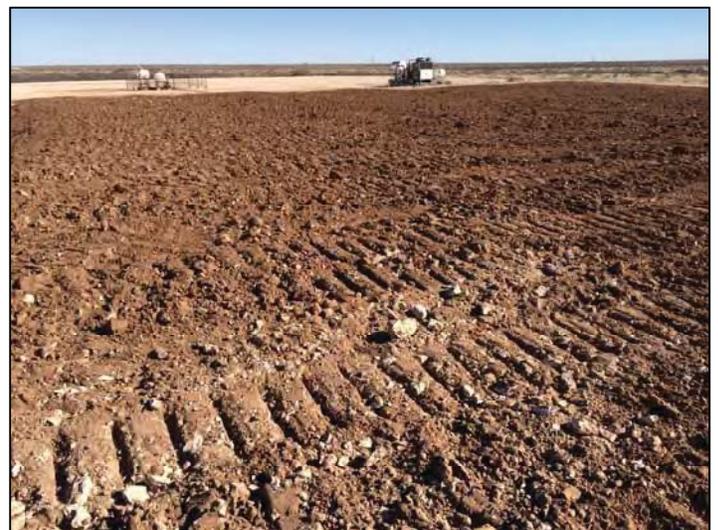
Backfill complete 1/20/2015

foot. The surface was contoured to blend with the surrounding topography and to prevent erosion and the ponding of water over the on-site closure. This work was completed on January 20, 2015.

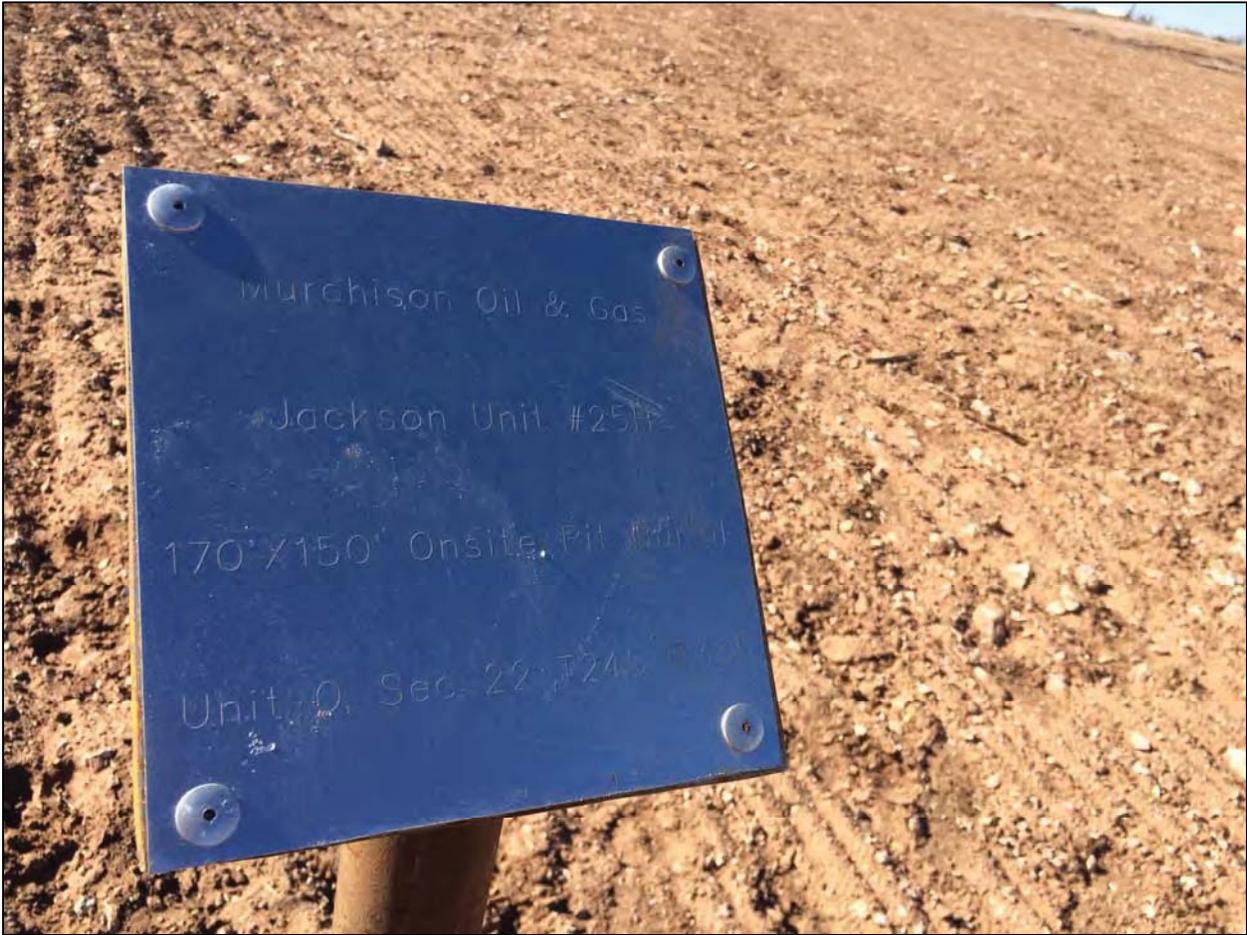
Steel marker plate identifying pit burial site

3. After seeding, a steel plate marking the site as an in-place pit closure has been placed on the surface at the center of the former pit location in accordance with Subsection (3) of Paragraph F of 19.15.17.13 NMAC.
4. The seeded area will be monitored for growth and the operator will repeat seeding until a successful vegetative cover is achieved as outlined in Subsection (5) of Paragraph H of 19.15.17.13 NMAC.
5. If conditions are not favorable for the establishment of vegetation, such as periods of drought, the operator may request that the division allow a delay in additional seeding until soil moisture conditions become favorable. The operator will notify the division and provide photo-documentation when it successful re-vegetation is achieved.
