R. T. HICKS CONSULTANTS, LTD.

RE: Temporary Pit Closure Report
Convoy "BUC" State No. 2H
API 30-025-41642 Ut O, Section 28, T24 R33E
Lea County

ATTACHMENT 1

ATTACHMENT 2

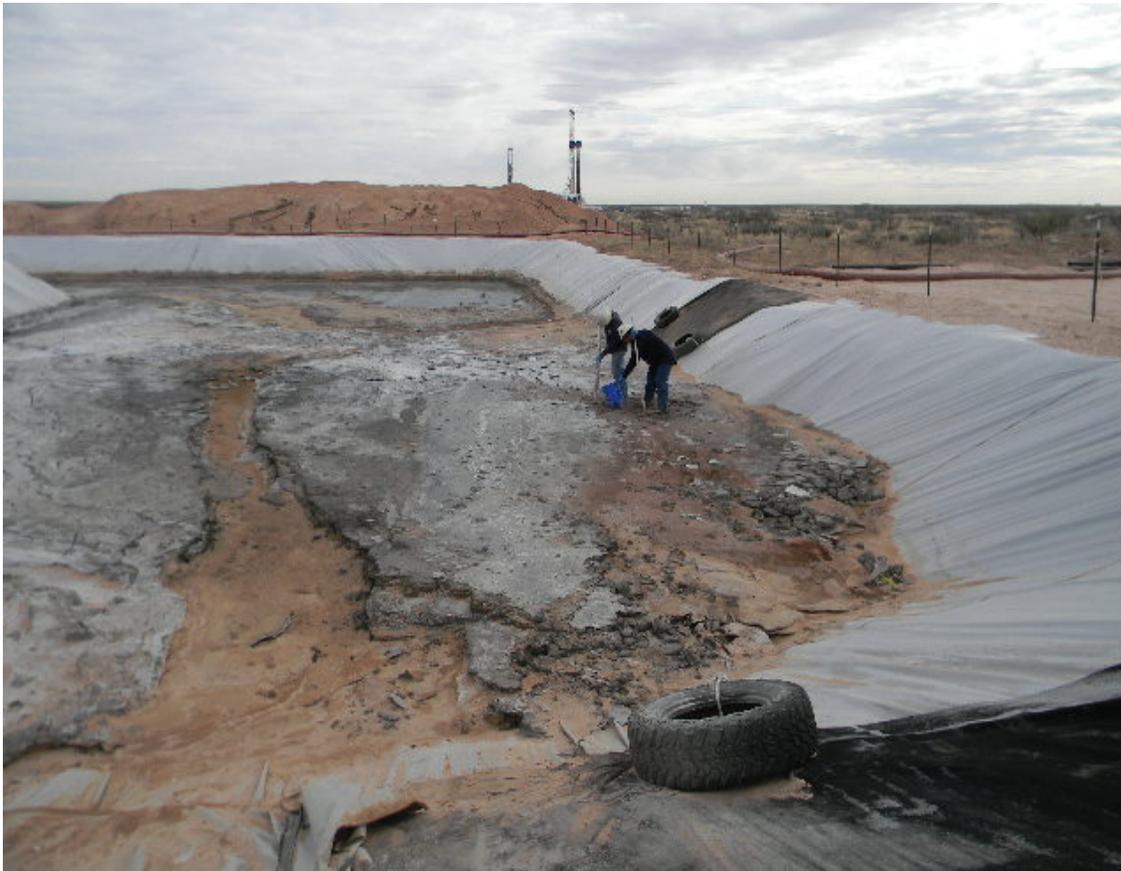
Waste Material Sampling Analytical Results

On December 3, 2014, eight-point composite samples were collected from the temporary pit. Clean mixing soil was collected from under the liner. The composite samples was submitted to Hall Environmental Analysis Laboratory in Albuquerque, New Mexico for BTEX (8260B), GRO/GRO (8015M), TPH (418.1), and Chloride (SM4500) analyses.

The table below depicts the samples collected from the cuttings in this pit and their concentrations of the parameters listed in Table II of 19.15.17.13 NMAC (June 2013 Pit Rule). These analyses demonstrate that this site meets the criteria for in-place closure.

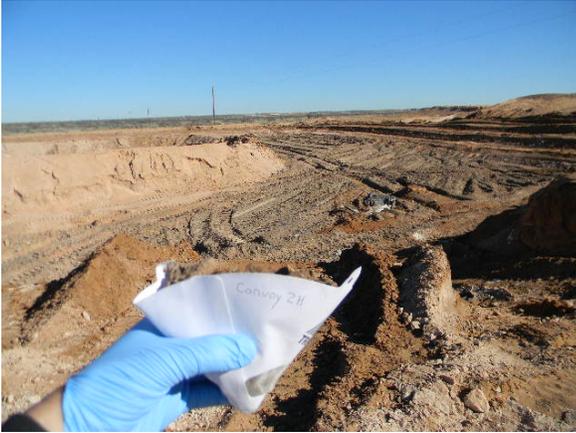
Paint filter test on 2/10/2015

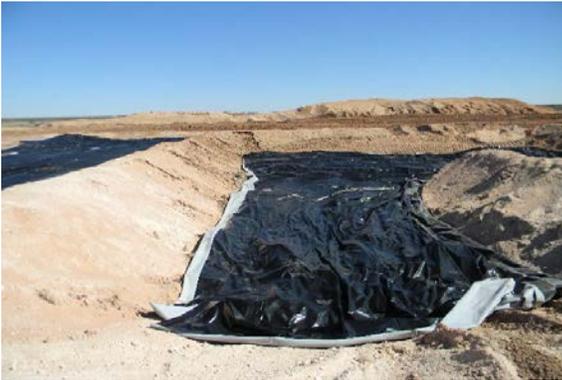
Liner Installation completed on 2/10/2015.
Viewing to North.

5. Following the February 10, 2015 inspection, having achieved all applicable stabilization requirements associated with in-place burial, a 20 Mil. geomembrane liner was installed to completely cover the stabilized cuttings on February 10, 2015. The pit contents and liner were shaped to shed infiltrating water, sloping from East to West.

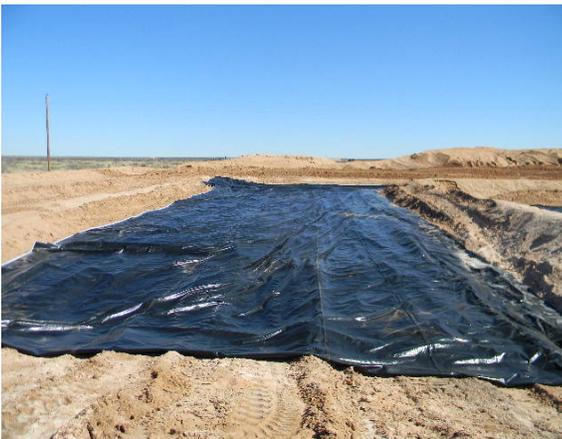
Liner Installation completed on 2/10/2015.
Viewing to North.

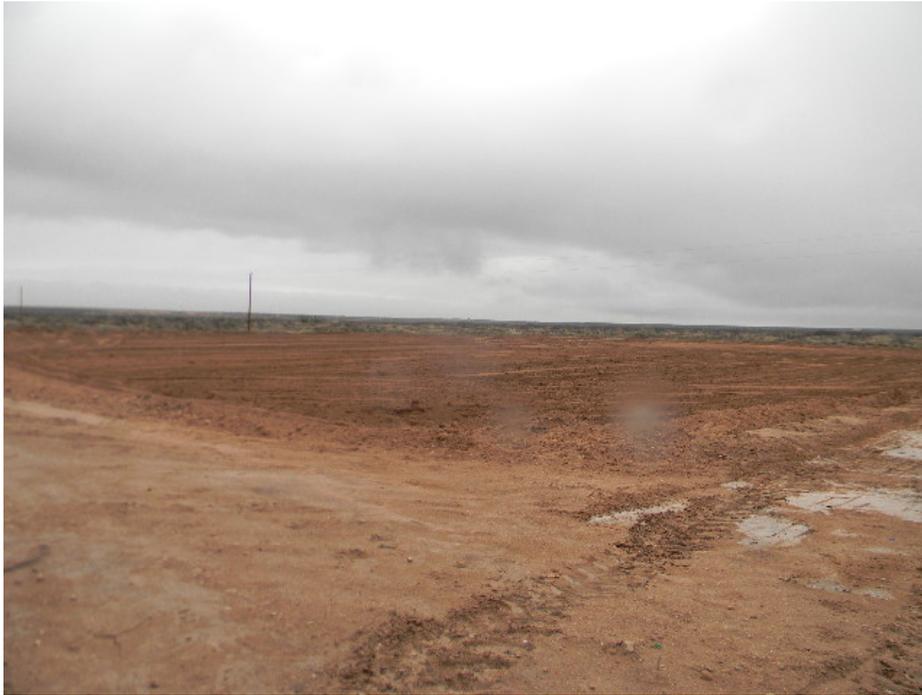
Completed drilling pit – viewing to North..

7. The surface was contoured to blend with the surrounding topography and to prevent erosion and the ponding of water over the on-site closure. This work was completed on February 16, 2015.
