BOPCO

PLU -409H

CLOSURE REPORT

2RP-2135

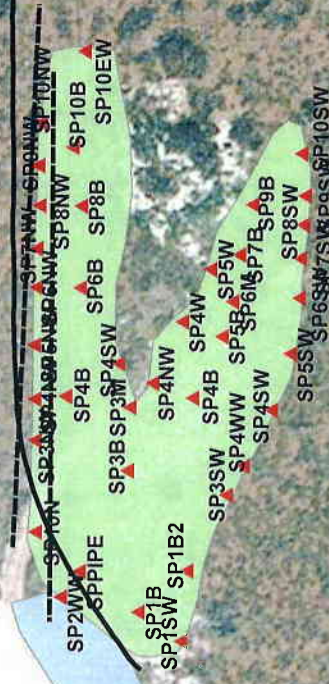
At source, excavation was completed to 3' bgs. Buck Jackson Rd. was scraped 1' bgs until clean.

Spill Area:
48,633 sq. ft.

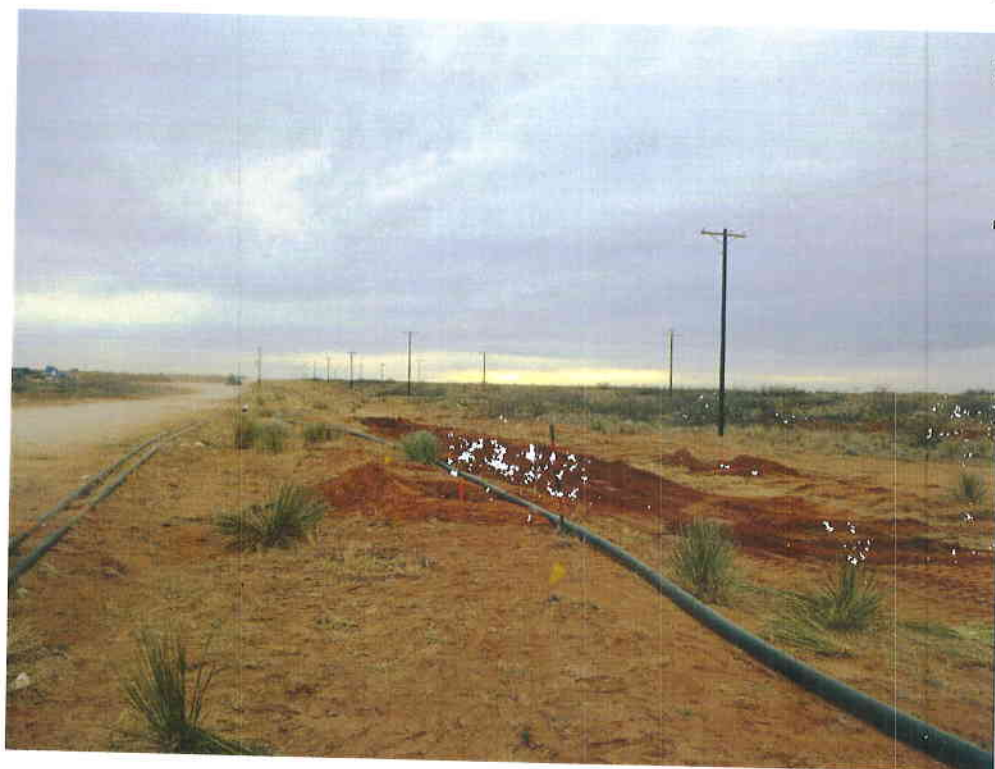
Sample points in pasture area east of lease road 12/30/13

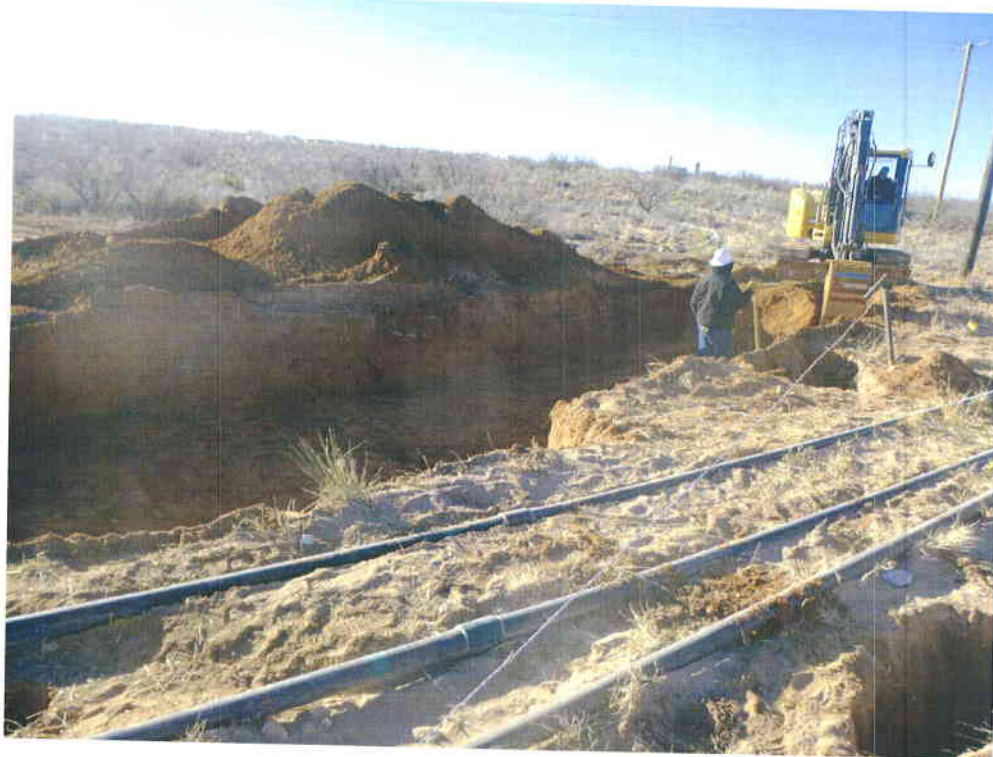
Excavation of impacted area north leg of the flowline

1/14/14

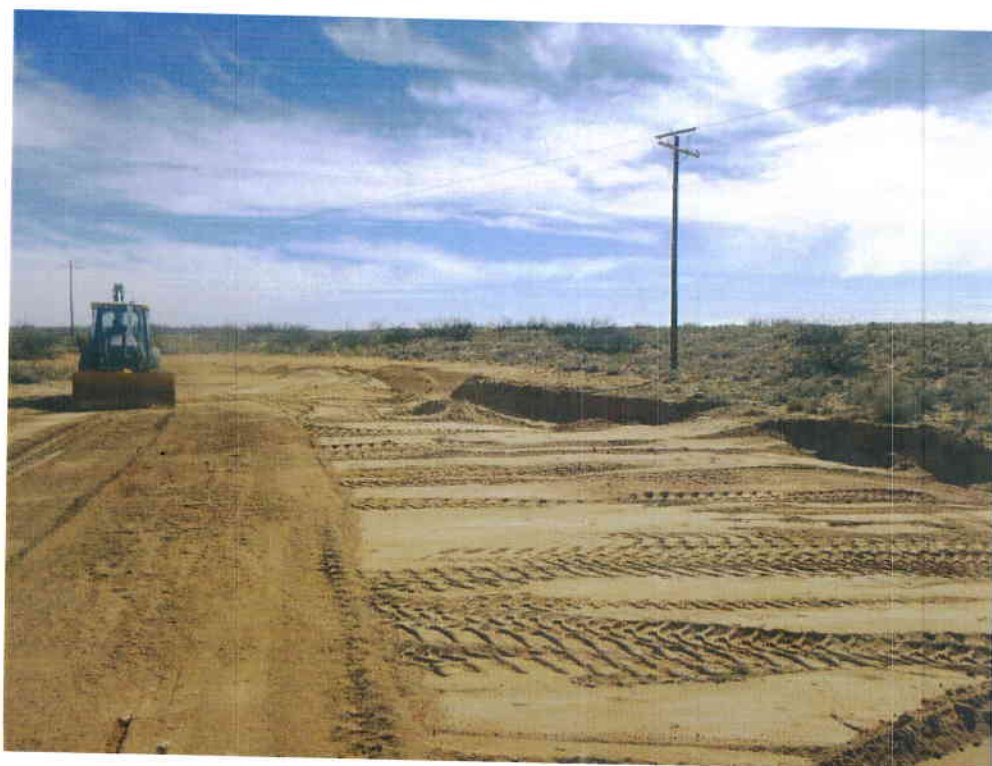
Backfilling lease road 1/28/14

NMOCD and BLM representatives approved backfill of the excavation. A total of 3706.8 tons of contamination was hauled to an approved disposal site. DFSI backfilled the pasture area with 2,214 tons of imported topsoil from an NMOCD approved facility. BOPCO provided the remainder of topsoil, and caliche from various other sundry sites. The area was then contoured to the surrounding landscape.

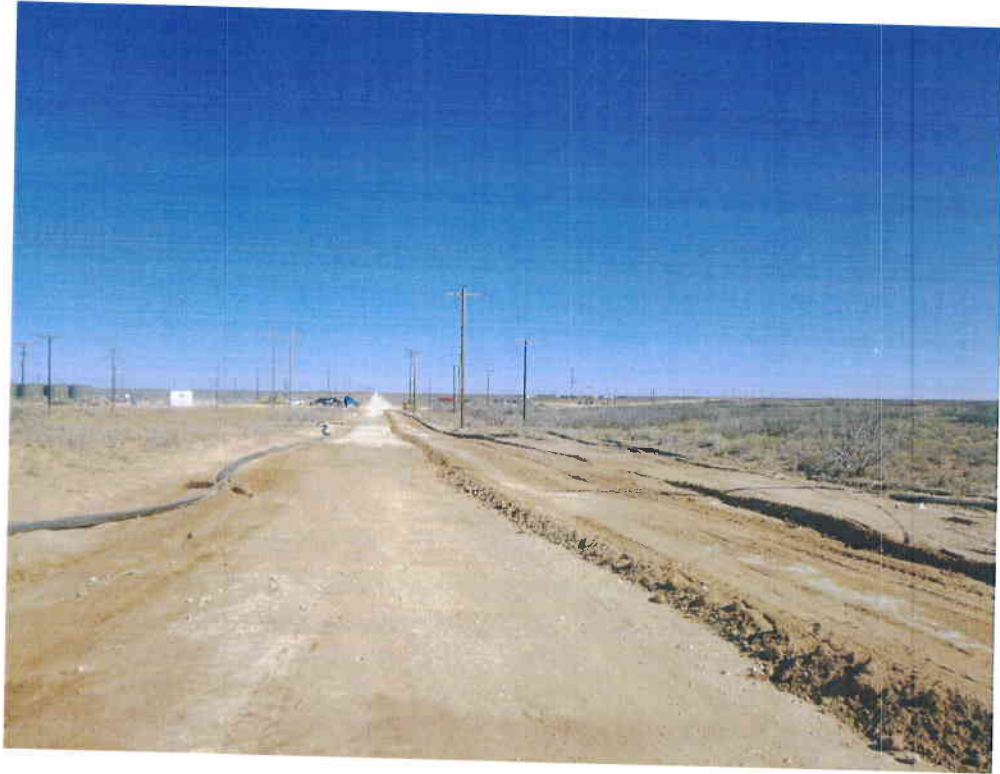
Excavation of impacted lease road 12/30/13

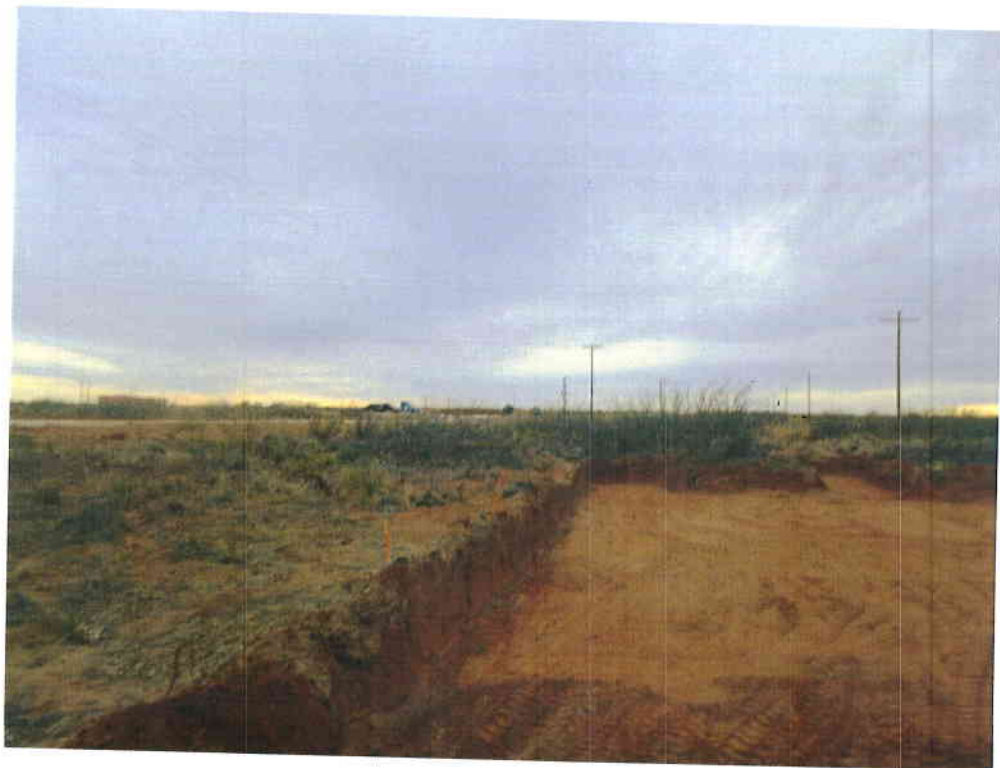
Excavation of impacted pasture area 1/8/14

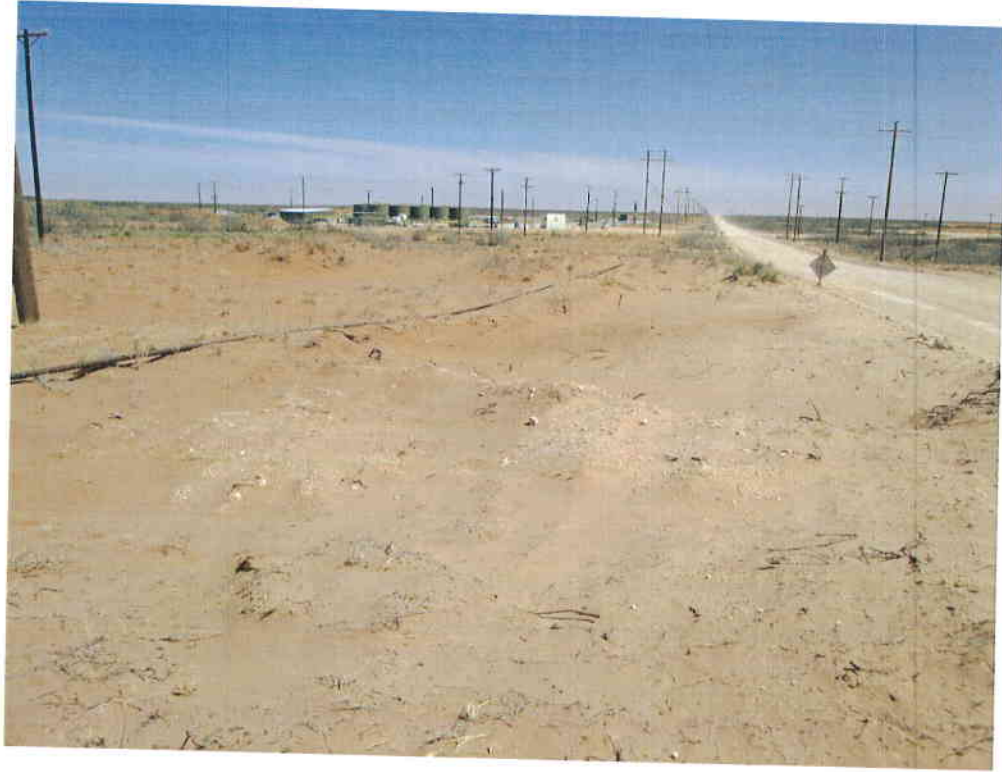
Completion of lease road 1/28/14

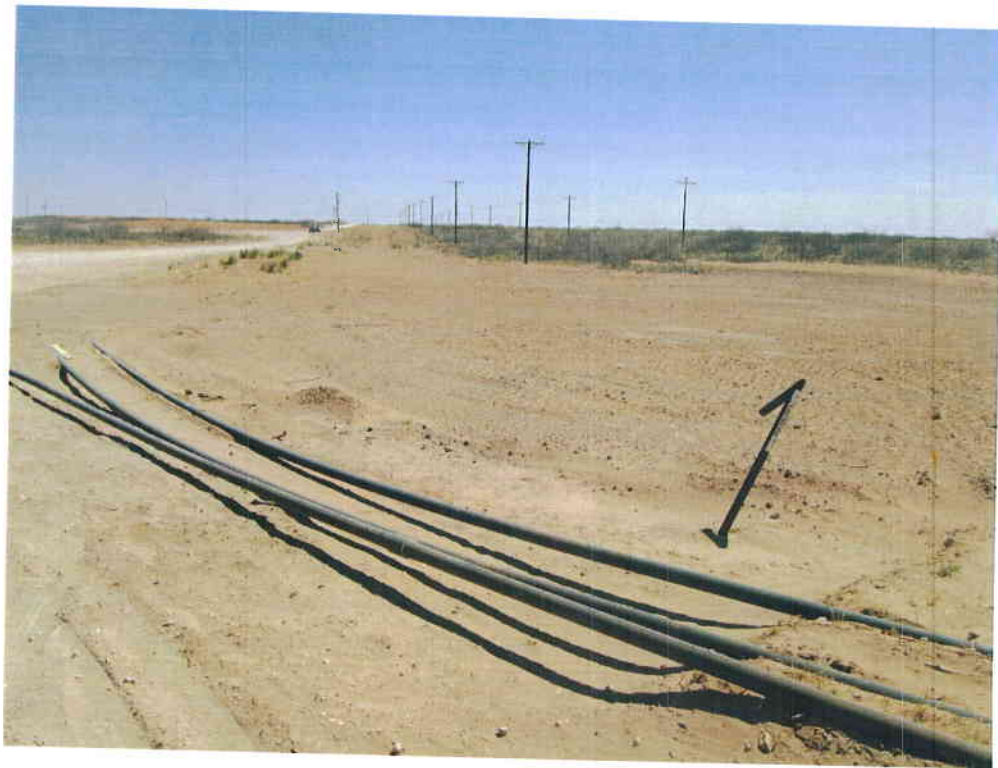
Completion of impacted pasture area 1/28/14
