REMEDIATION SUMMARY & RISK-BASED SITE CLOSURE REQUEST

**BOPCO, LP
BASS 3 FEDERAL #4
Eddy County, New Mexico
Unit Letter "I" (NE/SE), Section 3, Township 22 South, Range 28 East
Latitude 32.420218° North, Longitude 104.067417° West
NMOCD Reference #: 2RP-2371**

September 2014

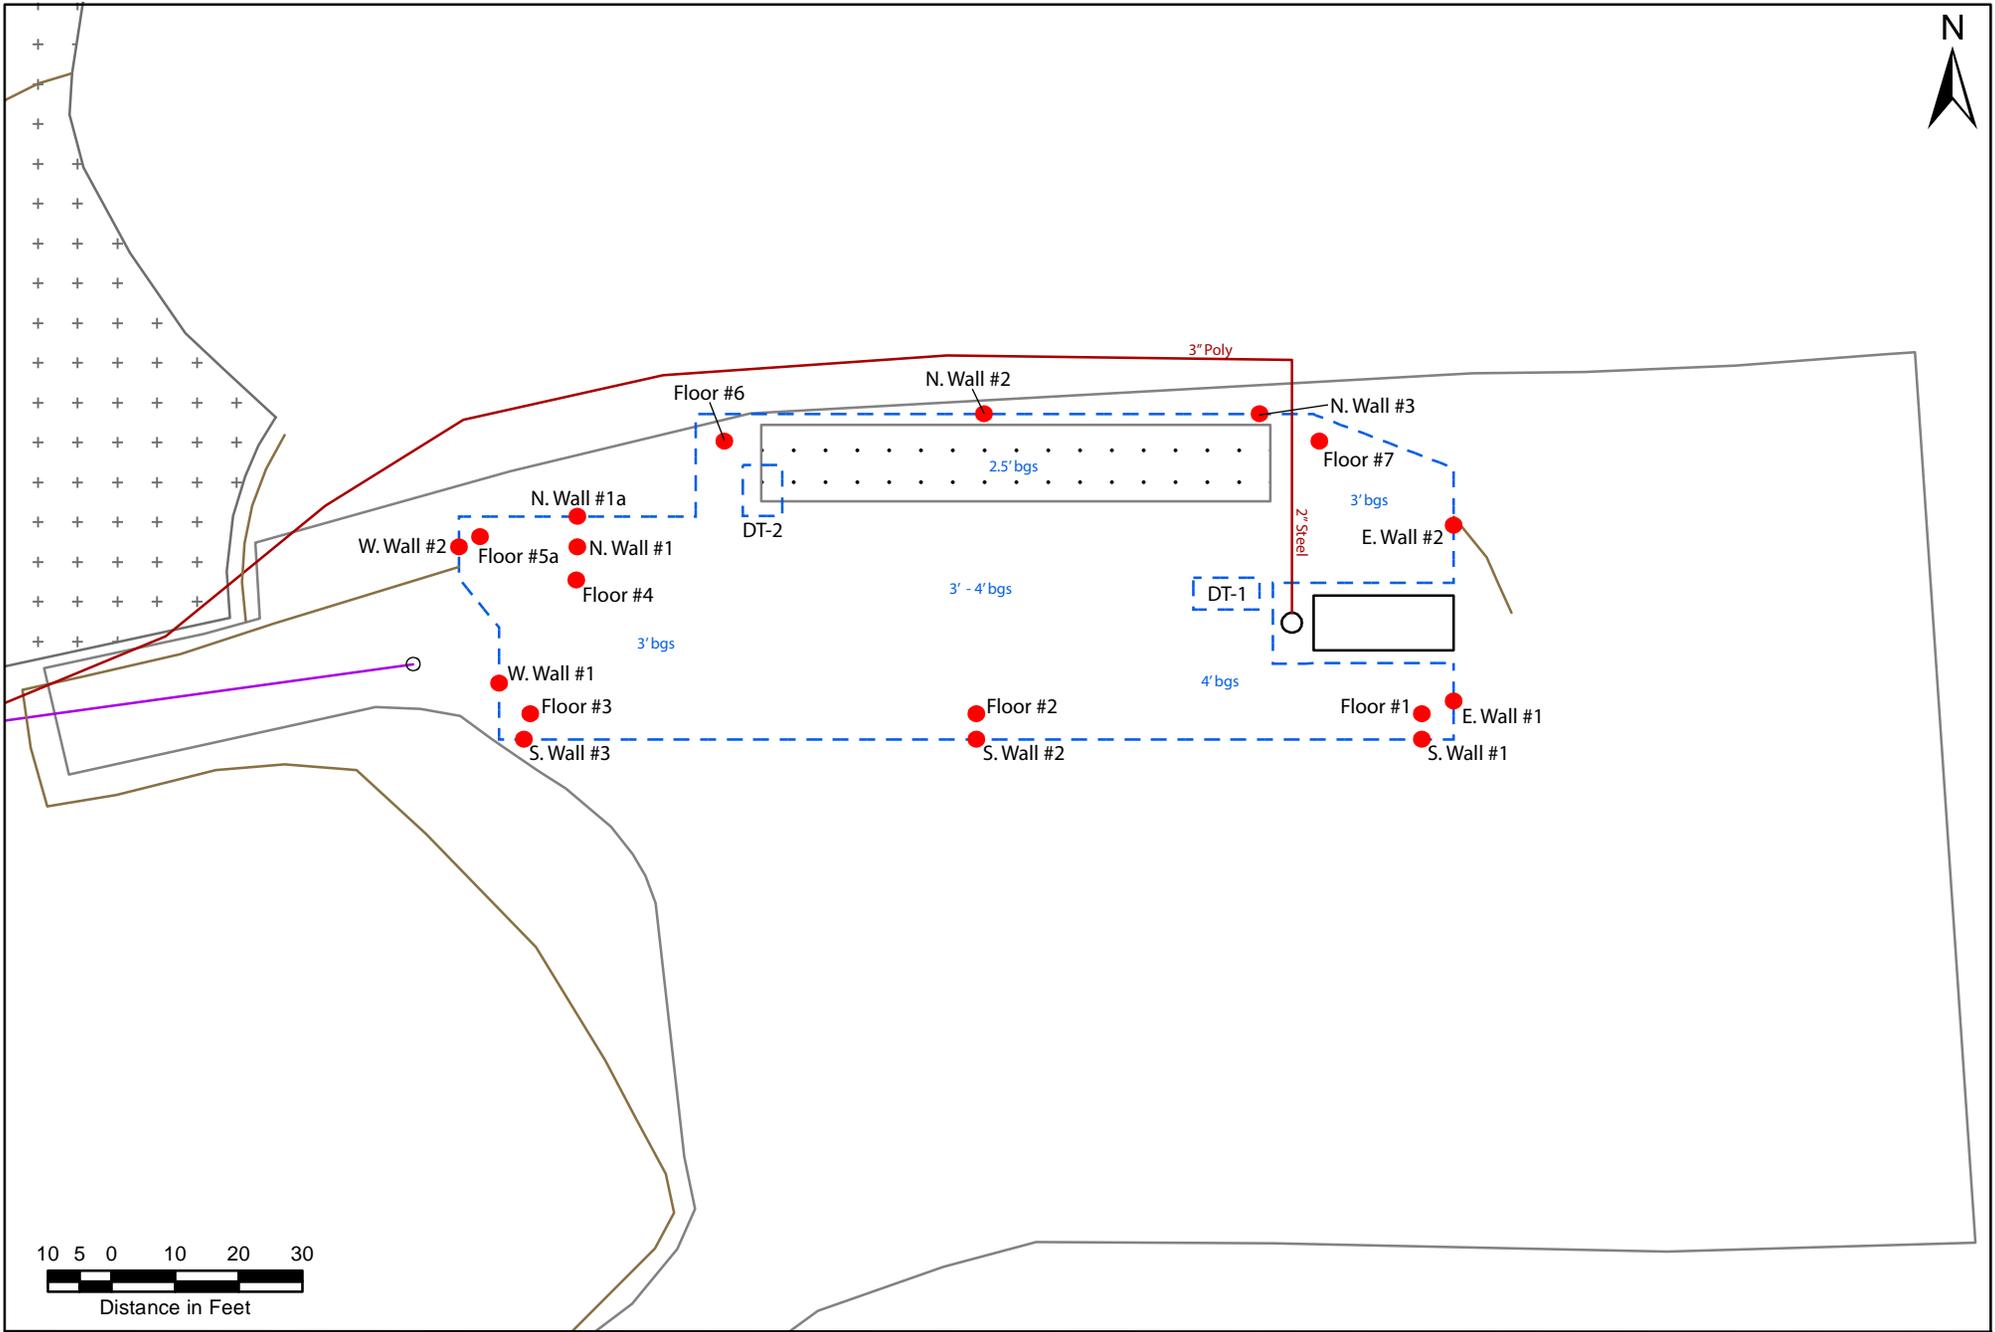
Figure 2
Site & Sample Location Map
BOPCO, LP
Bass 3 Federal Well #4
Eddy County, New Mexico
NMOCD Reference #: 2RP-2371

Soil sample locations are depicted in Figure #2, "Site & Sample Location Map". Laboratory analytical results are summarized in Table 1, "Concentrations of Benzene, BTEX, TPH & Chloride in Soil".

Prior to backfilling, the final dimensions of the excavation were approximately one hundred and fifty-six feet (156') in length, varying in width from approximately twelve feet (12') to approximately sixty-two feet (62'), and varying in depth from approximately two and one-half feet (2.5') bgs in the area of the encapsulation trench to approximately four feet (4') bgs in the eastern portion of the main excavation.

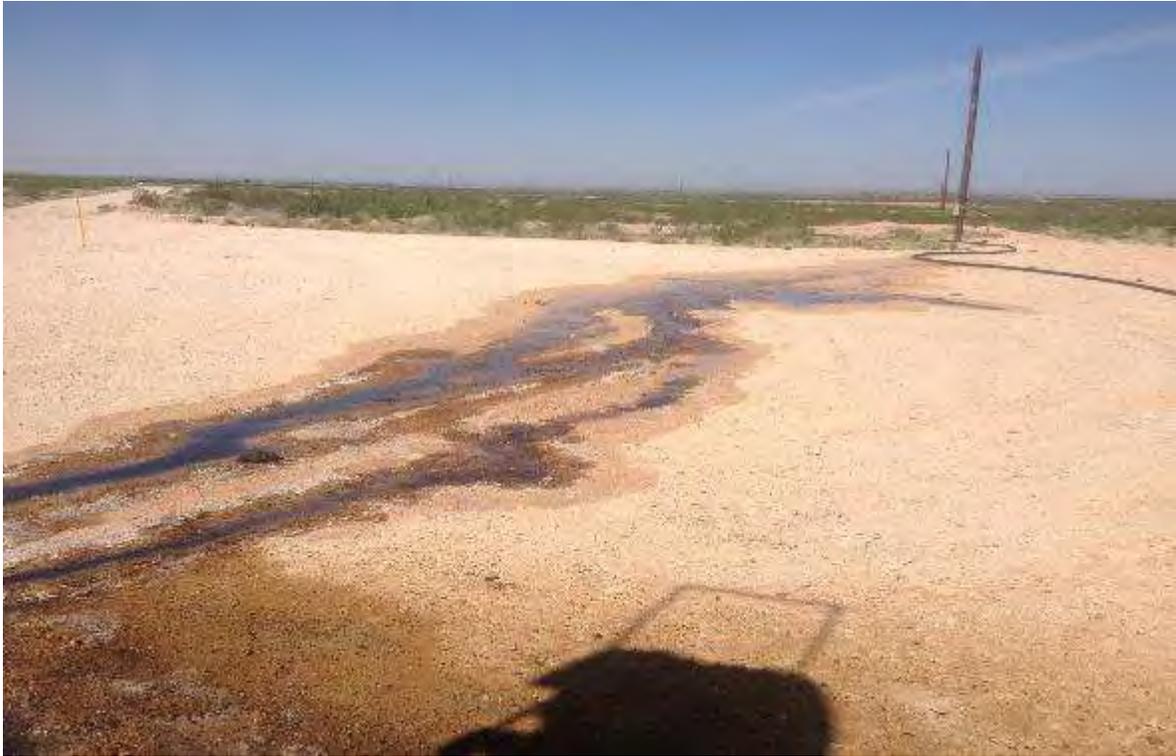
On June 22, 2014, BOPCO discovered a release had occurred at the Bass 3 Federal #4 well site. The packing in the stuffing box on the pump jack failed, resulting in a release of crude oil and produced water. The pump jack was equipped with an E-Pot system designed to contain fluid and shut down the pumping unit in the event of a release. However, the E-Pot system had been damaged at some point prior to the release and failed to operate as expected. During initial response activities, both the stuffing box packing and the E-Pot system were replaced.

Bass 3 Federal #4 - Release Site (Looking West)

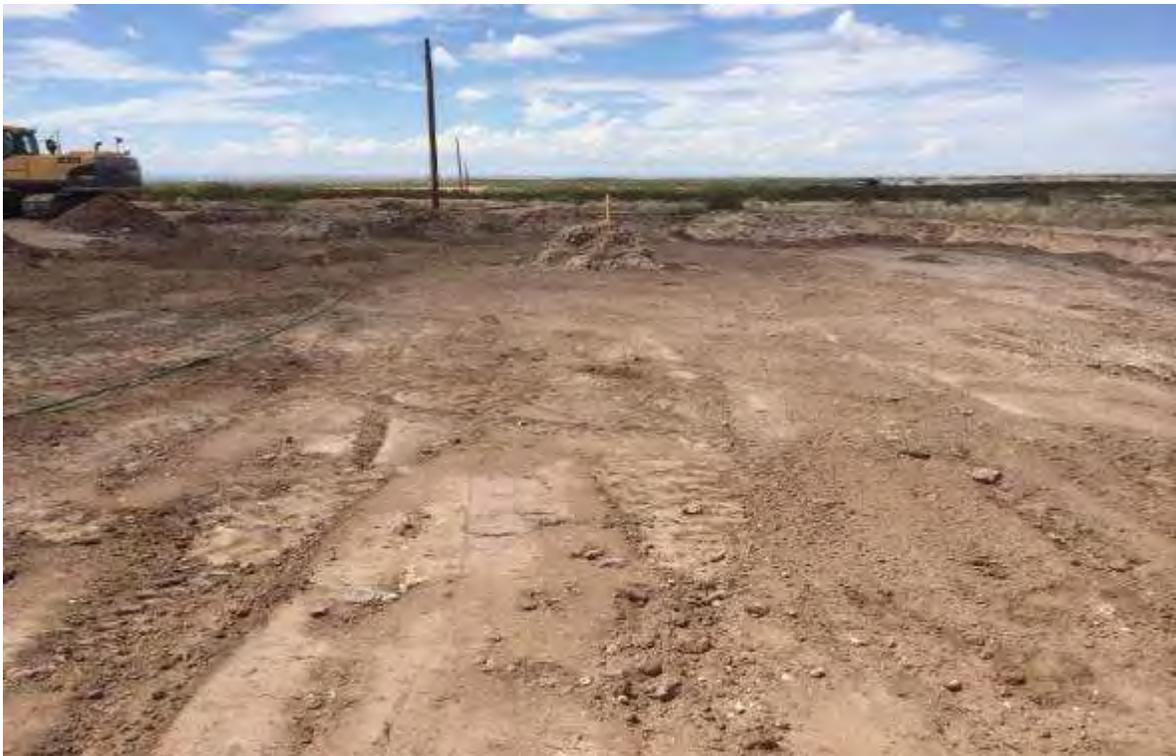
Bass 3 Federal #4 - Excavation (Looking West)

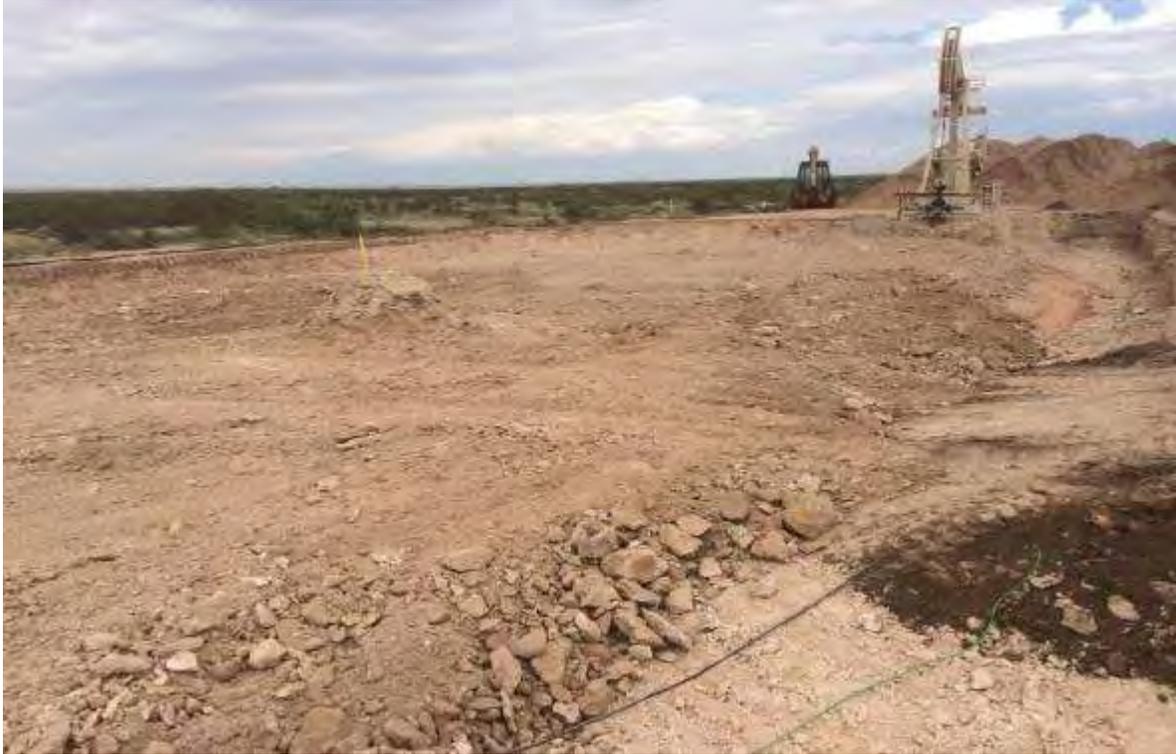
Bass 3 Federal #4 – Excavation (Looking East-Northeast)

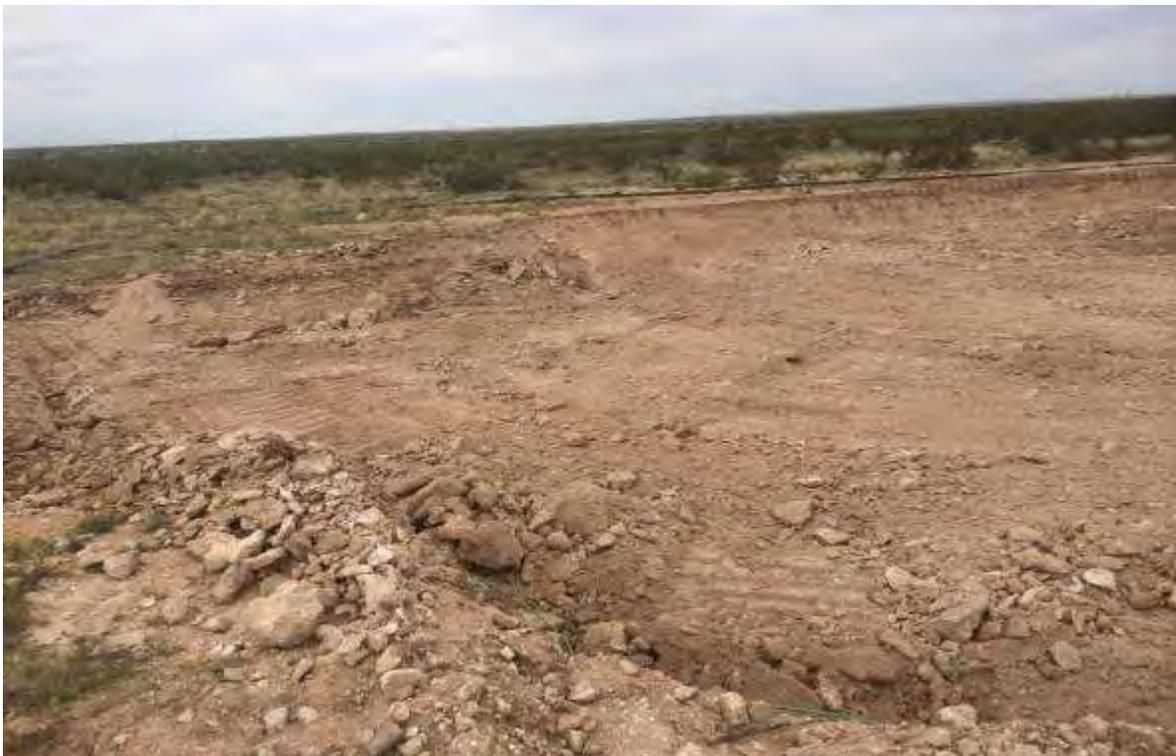
Bass 3 Federal #4 – Excavation (Looking Northeast)

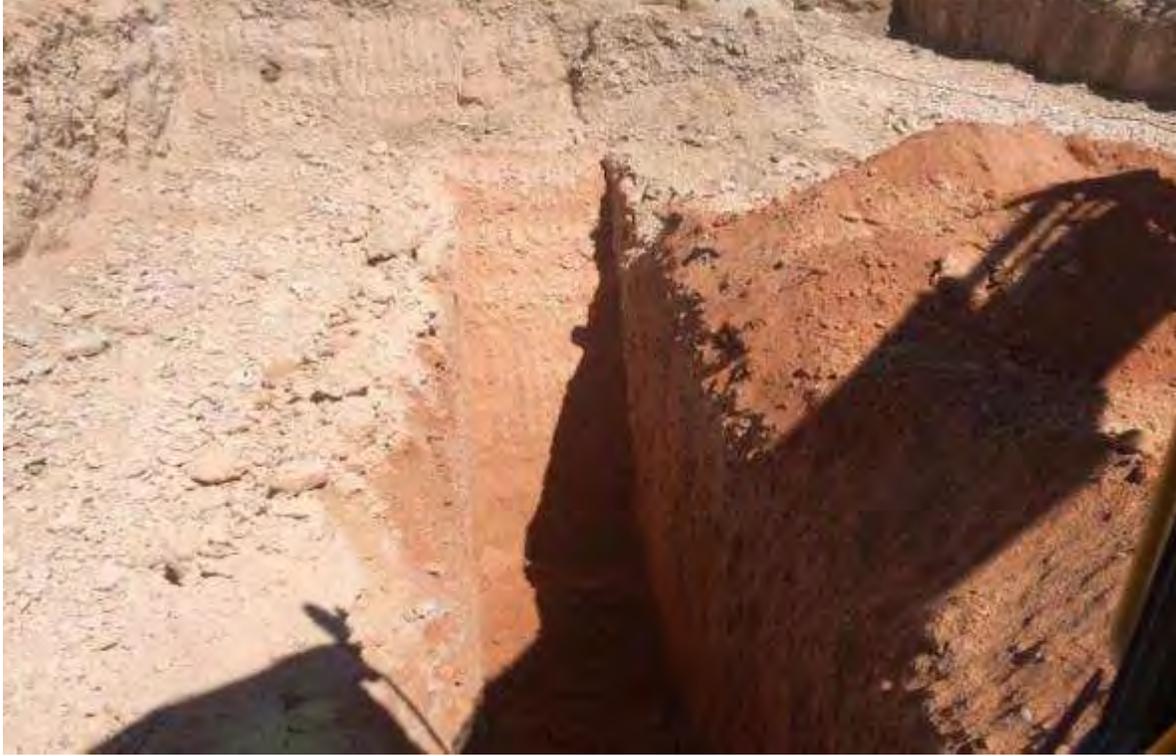
On August 20, 2014, a delineation trench (DT-1) was advanced adjacent to the Bass 3 Federal #4 wellhead to further investigate the vertical extent of impacted soil. Trench DT-1 was advanced to a total depth of approximately twenty feet (20') bgs. Soil samples were collected at two- (2) to three-foot (3') intervals and field-screened with a chloride test kit. Five (5) confirmation soil samples (DT-1 @ 11', DT-1 @ 13', DT-1 @ 15', DT-1 @ 18', and DT-1 @ 20') were submitted to the laboratory for analysis of chloride concentrations. Soil sample DT-1 @ 20' was also submitted for analysis of TPH and BTEX concentrations. Laboratory analytical results indicated chloride concentrations ranged from 320 mg/kg in soil sample DT-1 @ 18' to 1,920 mg/kg in soil sample DT-1 @ 11'. TPH and BTEX constituent concentrations in soil sample DT-1 @ 20' were less than the appropriate laboratory MDL.

Bass 3 Federal #4 – Delineation Trench DT-1

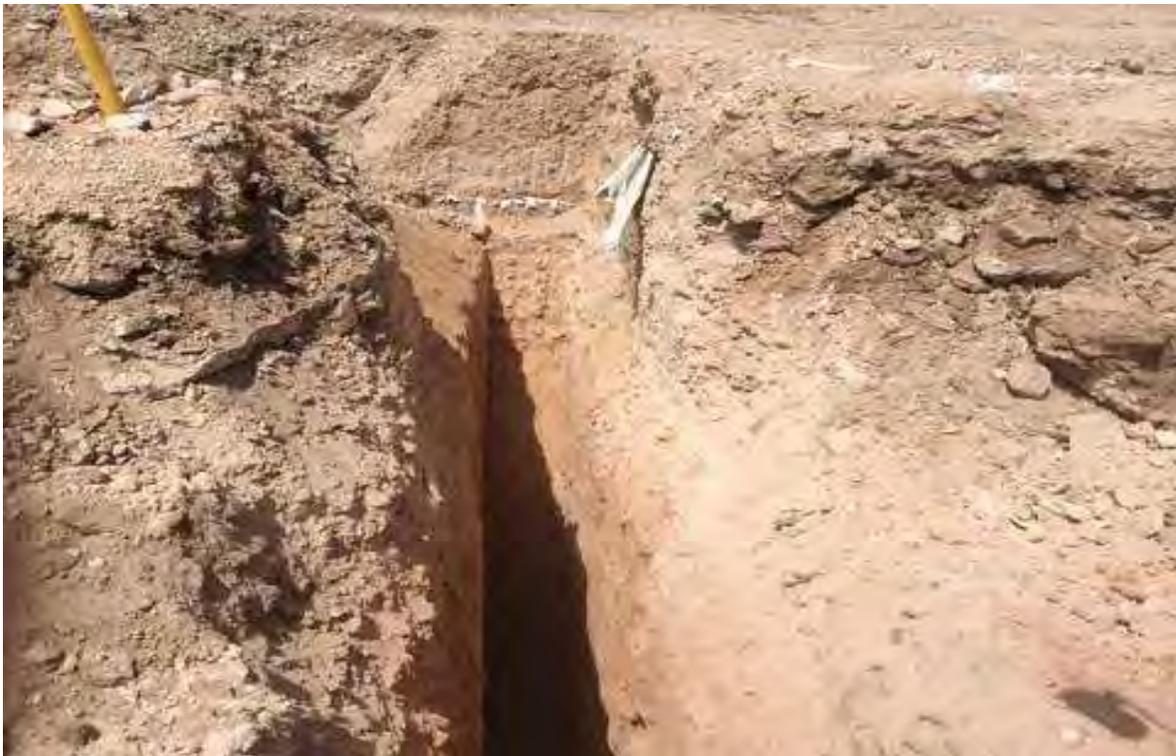
On August 26, 2014, a second delineation trench (DT-2) was advanced in the floor of the excavation in the westernmost corner of the encapsulation trench. Trench DT-2 was advanced to a total depth of approximately twenty-one feet (21') bgs. Soil samples were collected at one- (1) to three-foot (3') intervals and field-screened with a chloride test kit. Seven (7) confirmation soil samples (DT-2 @ 6', DT-2 @ 8', DT-2 @ 13', DT-2 @ 15', DT-2 @ 17', DT-2 @ 20', and DT-2 @ 21') were submitted to the laboratory for analysis of chloride concentrations. Soil sample DT-2 @ 21' was also submitted for analysis of TPH and BTEX concentrations. Laboratory analytical results indicated chloride concentrations ranged from 352 mg/kg in soil sample DT-2 @ 21' to 19,000 mg/kg in soil sample DT-2 @ 8'. TPH and BTEX constituent concentrations in soil sample DT-2 @ 21' were less than the appropriate laboratory MDL.

Bass 3 Federal #4 – Delineation Trench DT-2 (Looking North)

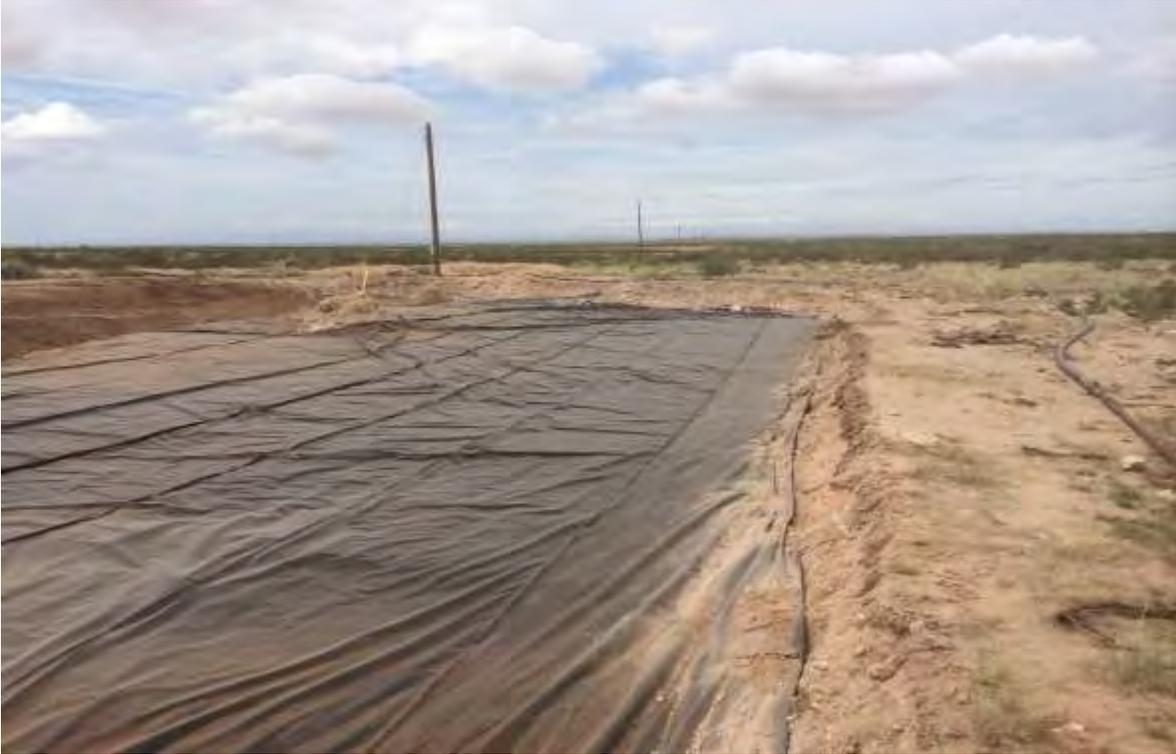
Bass 3 Federal #4 – Liner Installation (Looking West)

On September 5, 2014, a twenty-millimeter (20mm), polyurethane liner was installed on the floor of the excavation. From September 5 through September 10, 2014, approximately eighteen inches (18") of clean backfill material was placed atop the liner and covered with approximately six inches (6") of compacted caliche. Following backfill, the excavation was compacted and contoured to fit the surrounding topography.

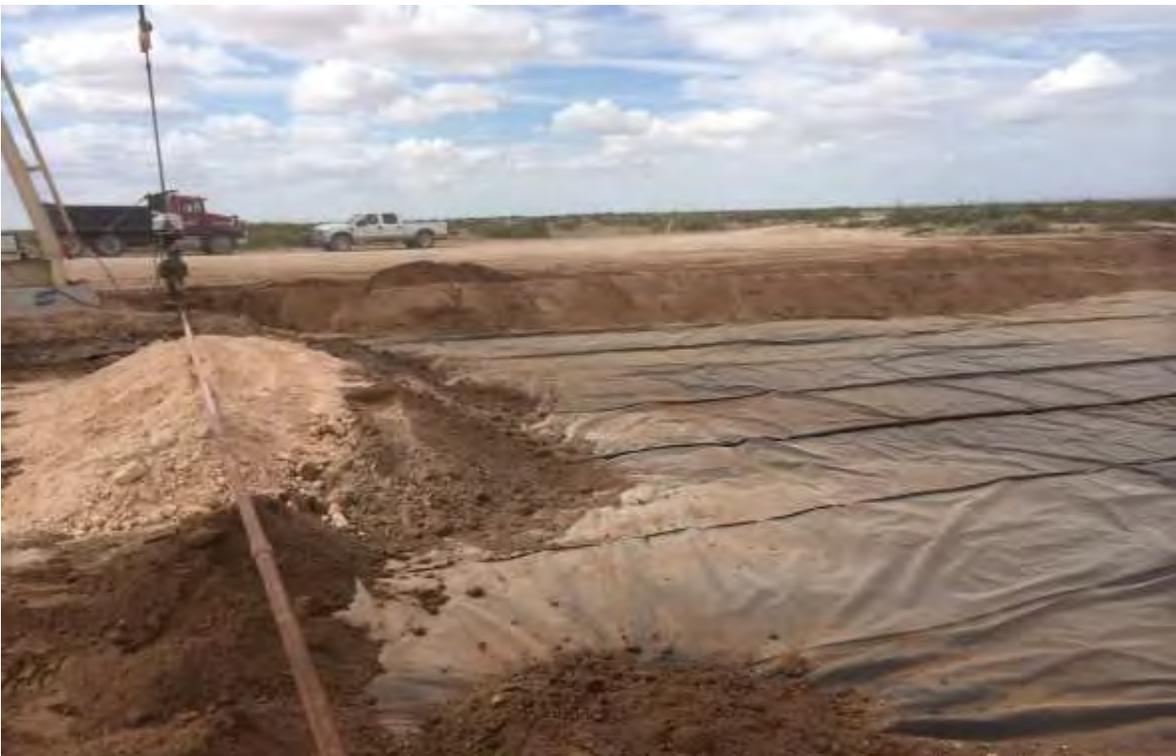
Bass 3 Federal #4 – Liner Installation (Looking South-Southwest)

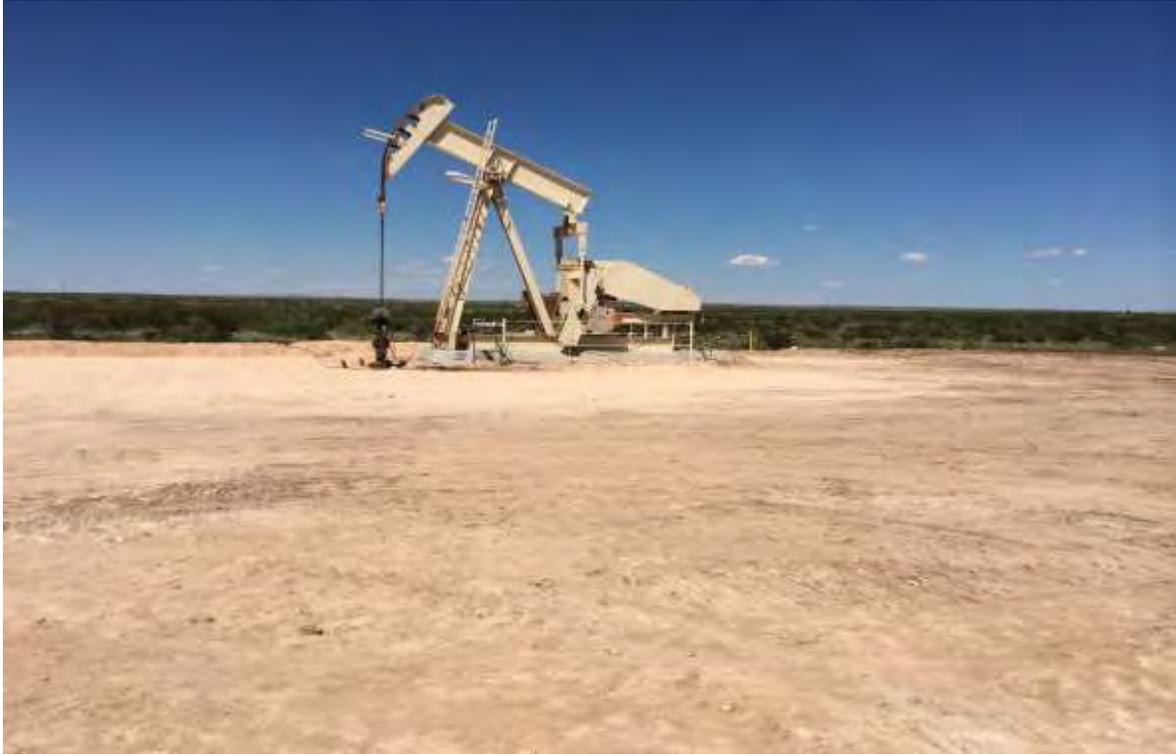
Bass 3 Federal #4 – Backfilled Excavation (Looking Northeast)

Following sample collection, with NMOCD approval, the main excavation was backfilled with clean material to approximately two and one-half feet (2.5') bgs and compacted to match the elevation of the encapsulation trench excavation. A cushion of sand was installed on the floor of the excavation and encapsulation trench area in preparation for the installation of an impermeable, polyurethane plastic liner at a later date.

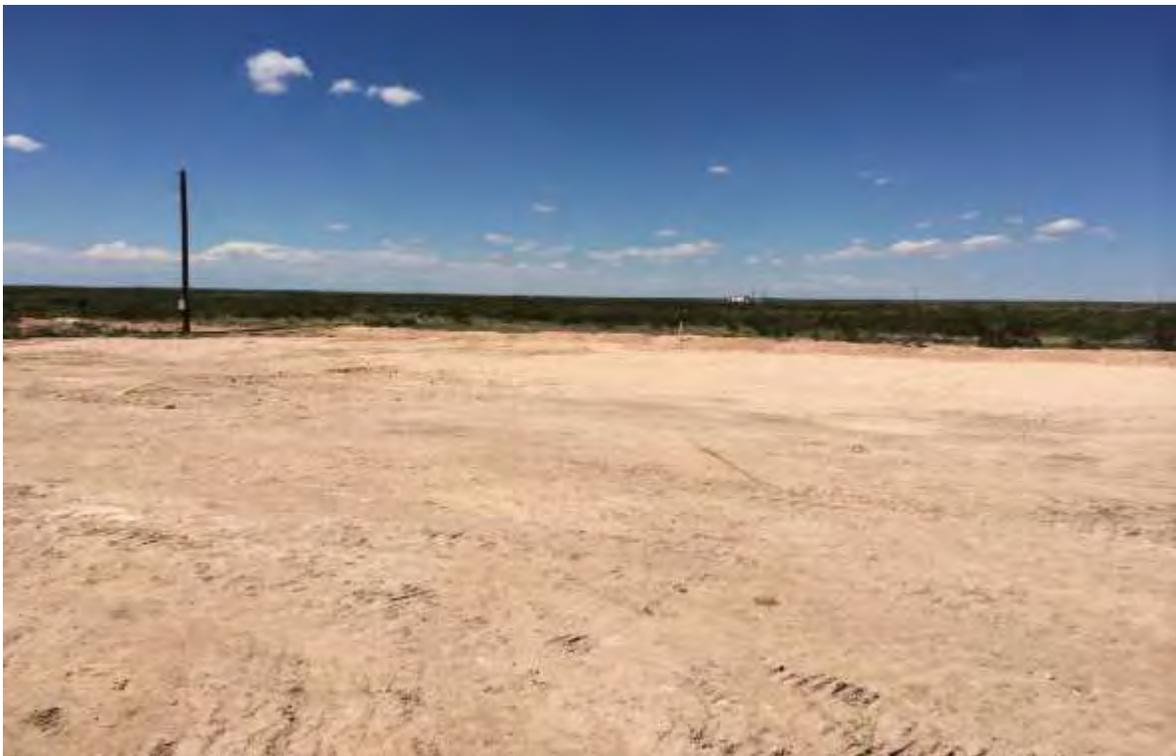
Bass 3 Federal #4 – Backfilled Excavation (Looking Northeast)
