Linn Energy Skelly #26

CLOSURE REPORT

API No. 30-015-05157

October 6, 2014

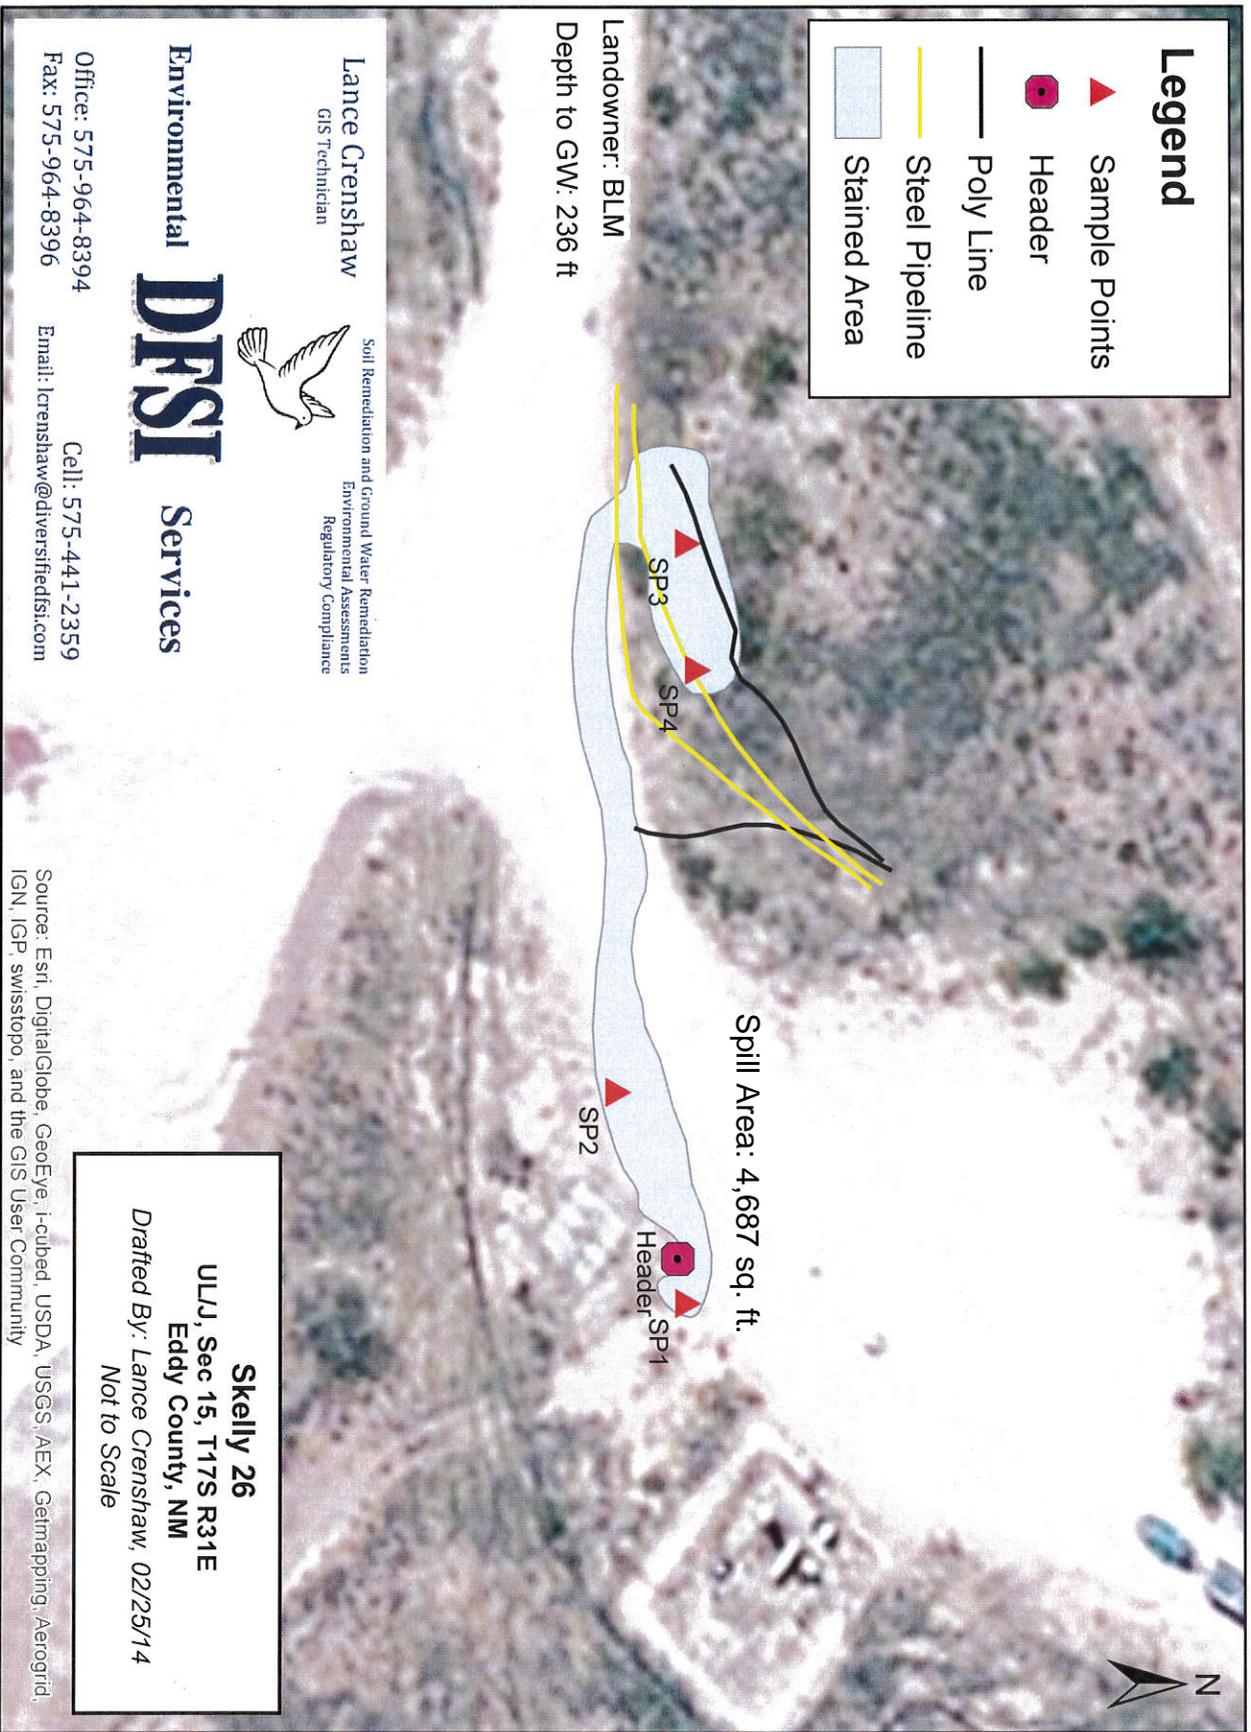
Excavation Plat

Spill Area: 4,687 sq. ft.

Landowner: BLM
Depth to GW: 236 ft

Skelly 26
ULJ, Sec 15, T17S R31E
Eddy County, NM
Drafted By: Lance Crenshaw, 02/25/14
Not to Scale

The site is located south west of Maljamar NM, Unit letter 'O', sec. 15, T17S R31E, in Eddy County. The incident at this site location was as the result of an injection line leak. There existed an approximate impact in volume of 30bbl of produced water. The fluids were generated from the injection line leak at the well head, traversing westward across the lease road to the pasture area. There was a combined impact of approximately 4,687 sq. ft. of impact to pad, and lease road inclusive of pasture area. (Figure).

On February 12, 2014 DFSI personnel paid an initial visit to the site in order to map the spill area and delineate the site. Four (4) sample points were established: SP1 located at the leak source, SP2 at point of impact on the lease road, SP3 west of lease road in pasture area and SP4 at end point of leak in the pasture. Using a hand auger, soil samples were collected at 1ft. bgs. intervals, and field tested using a Mini Rae Photoionization Detector (PID). SP1 was sampled to a depth of 11 ft. bgs., whereby auger refusal was encountered. The chloride return at that depth was 474 mg/kg. SP2 was tested to a depth of 1ft. bgs., SP3 was hand augured to 4ft. bgs. , whereby chlorides remained elevated. SP4 indicated acceptable Chloride levels at surface (Appendix IV field analyses).

On March 04, 2014 DFSI submitted to the NMOCD and BLM a written proposal to remediate the above site. The proposal was to excavate SP1 and SP3 to 4ft. bgs., install a 20 mil liner at SP1. Inclusive of removing all visual staining and impacted soils to an NMOCD approved facility. Backfill with fresh topsoil and reseed the pasture area.

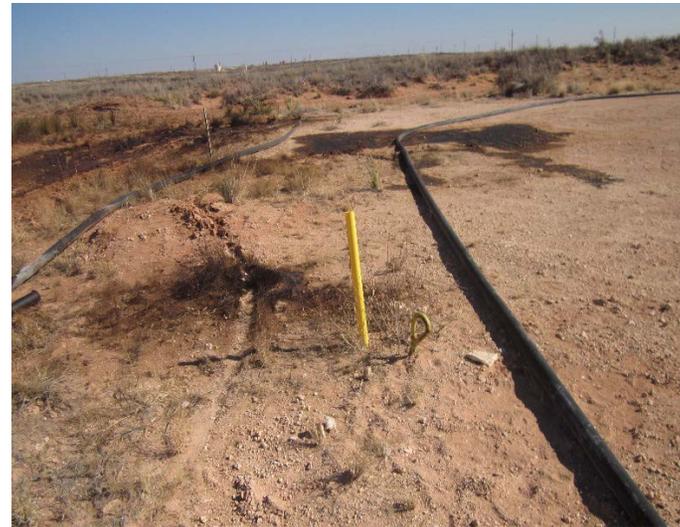
Impacted area 2013

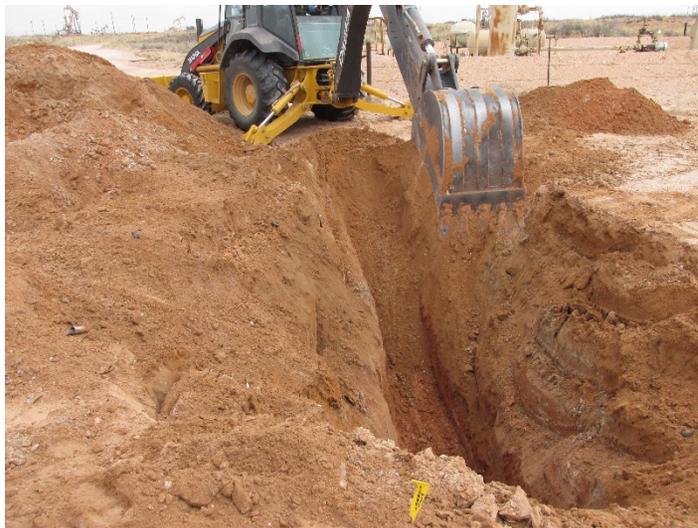
Excavation of Impact 02/25/2014

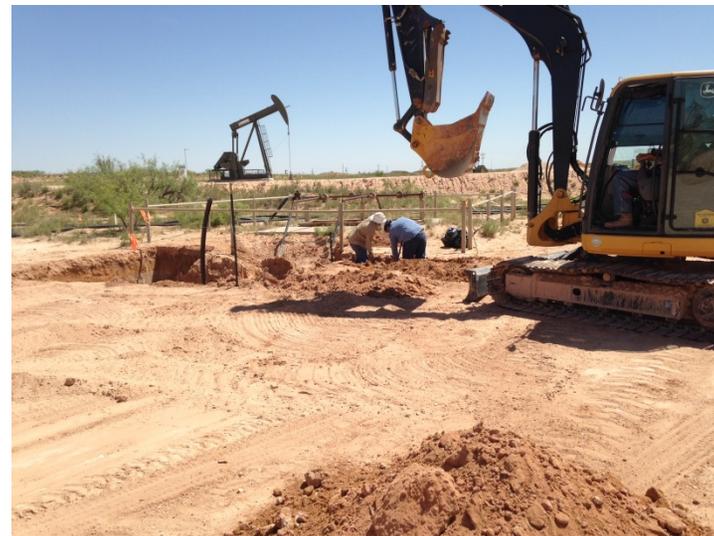
Hand excavation 06/10/14

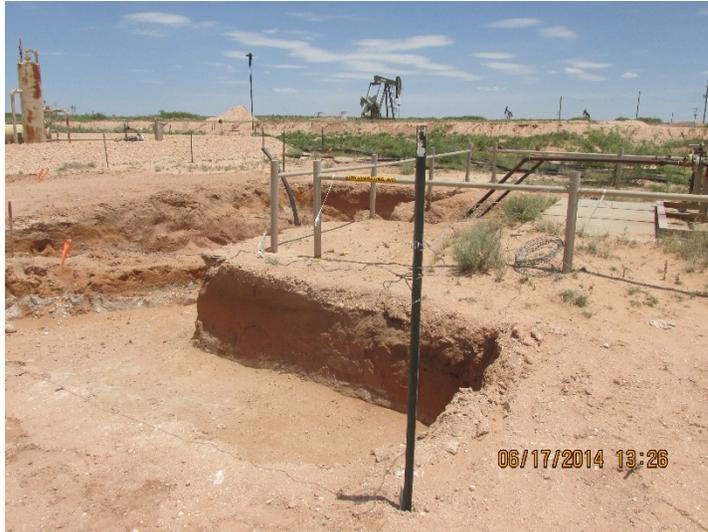
Excavated area at completion 06/17/14

On June 17, 2014 excavation activities were complete. And, on same said date representative sidewall soil samples were retrieved and sent to a commercial laboratory in order to confirm vertical delineation. The following is a recap of that analyses:

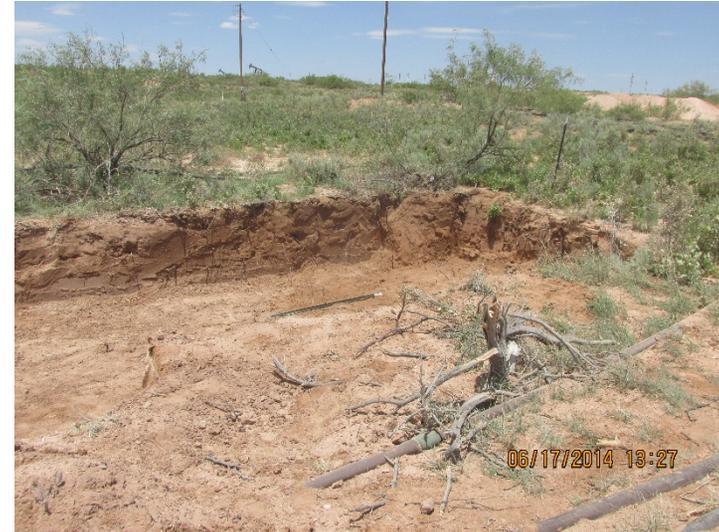
Excavated pasture area 06/17/14

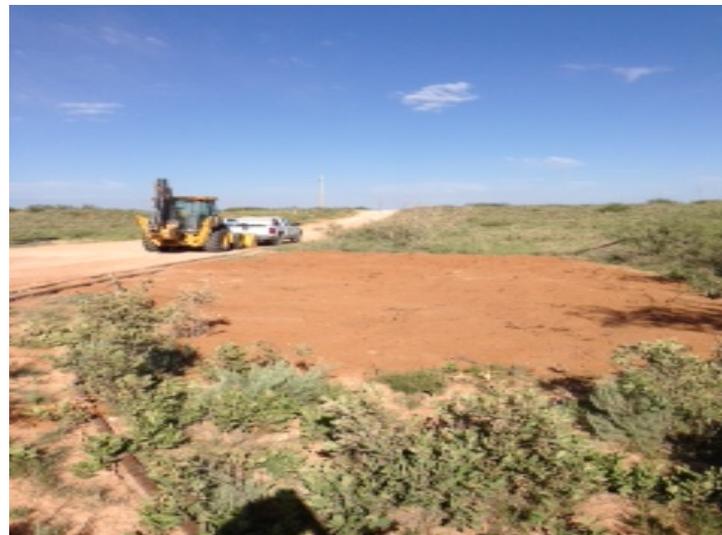
Seeded Pasture area at completion 06/28/14
