Report Type: Closure Report

Site:	Myox 31 State Com #13H Tank Battery					
Company:	COG Operating LLC					
Section, Township and Range	Sec 31	T 25S	R 28E			
Lease Number:	API-30-015-37497					
County:	Eddy County					
GPS:	32 04.736° N			104 07.075° W		
Surface Owner:	State					
Mineral Owner:						
Directions:	In Malaga, from the intersection of CR 720 and HWY 285 head SOUTH on Hwy 285 for 11.2 miles, turn WEST onto C.R. 724 (Whites City Road) and continue for approximately 2.0 miles, turn NORTH onto lease road for 1.1 miles, turn West onto lease road for .9 miles to location.

**Re: Closure Report for the COG Operating LLC., Myox 31 State Com #13H
Tank Battery, Unit P, Section 31, Township 25 South, Range 28 East,
Eddy County, New Mexico.**

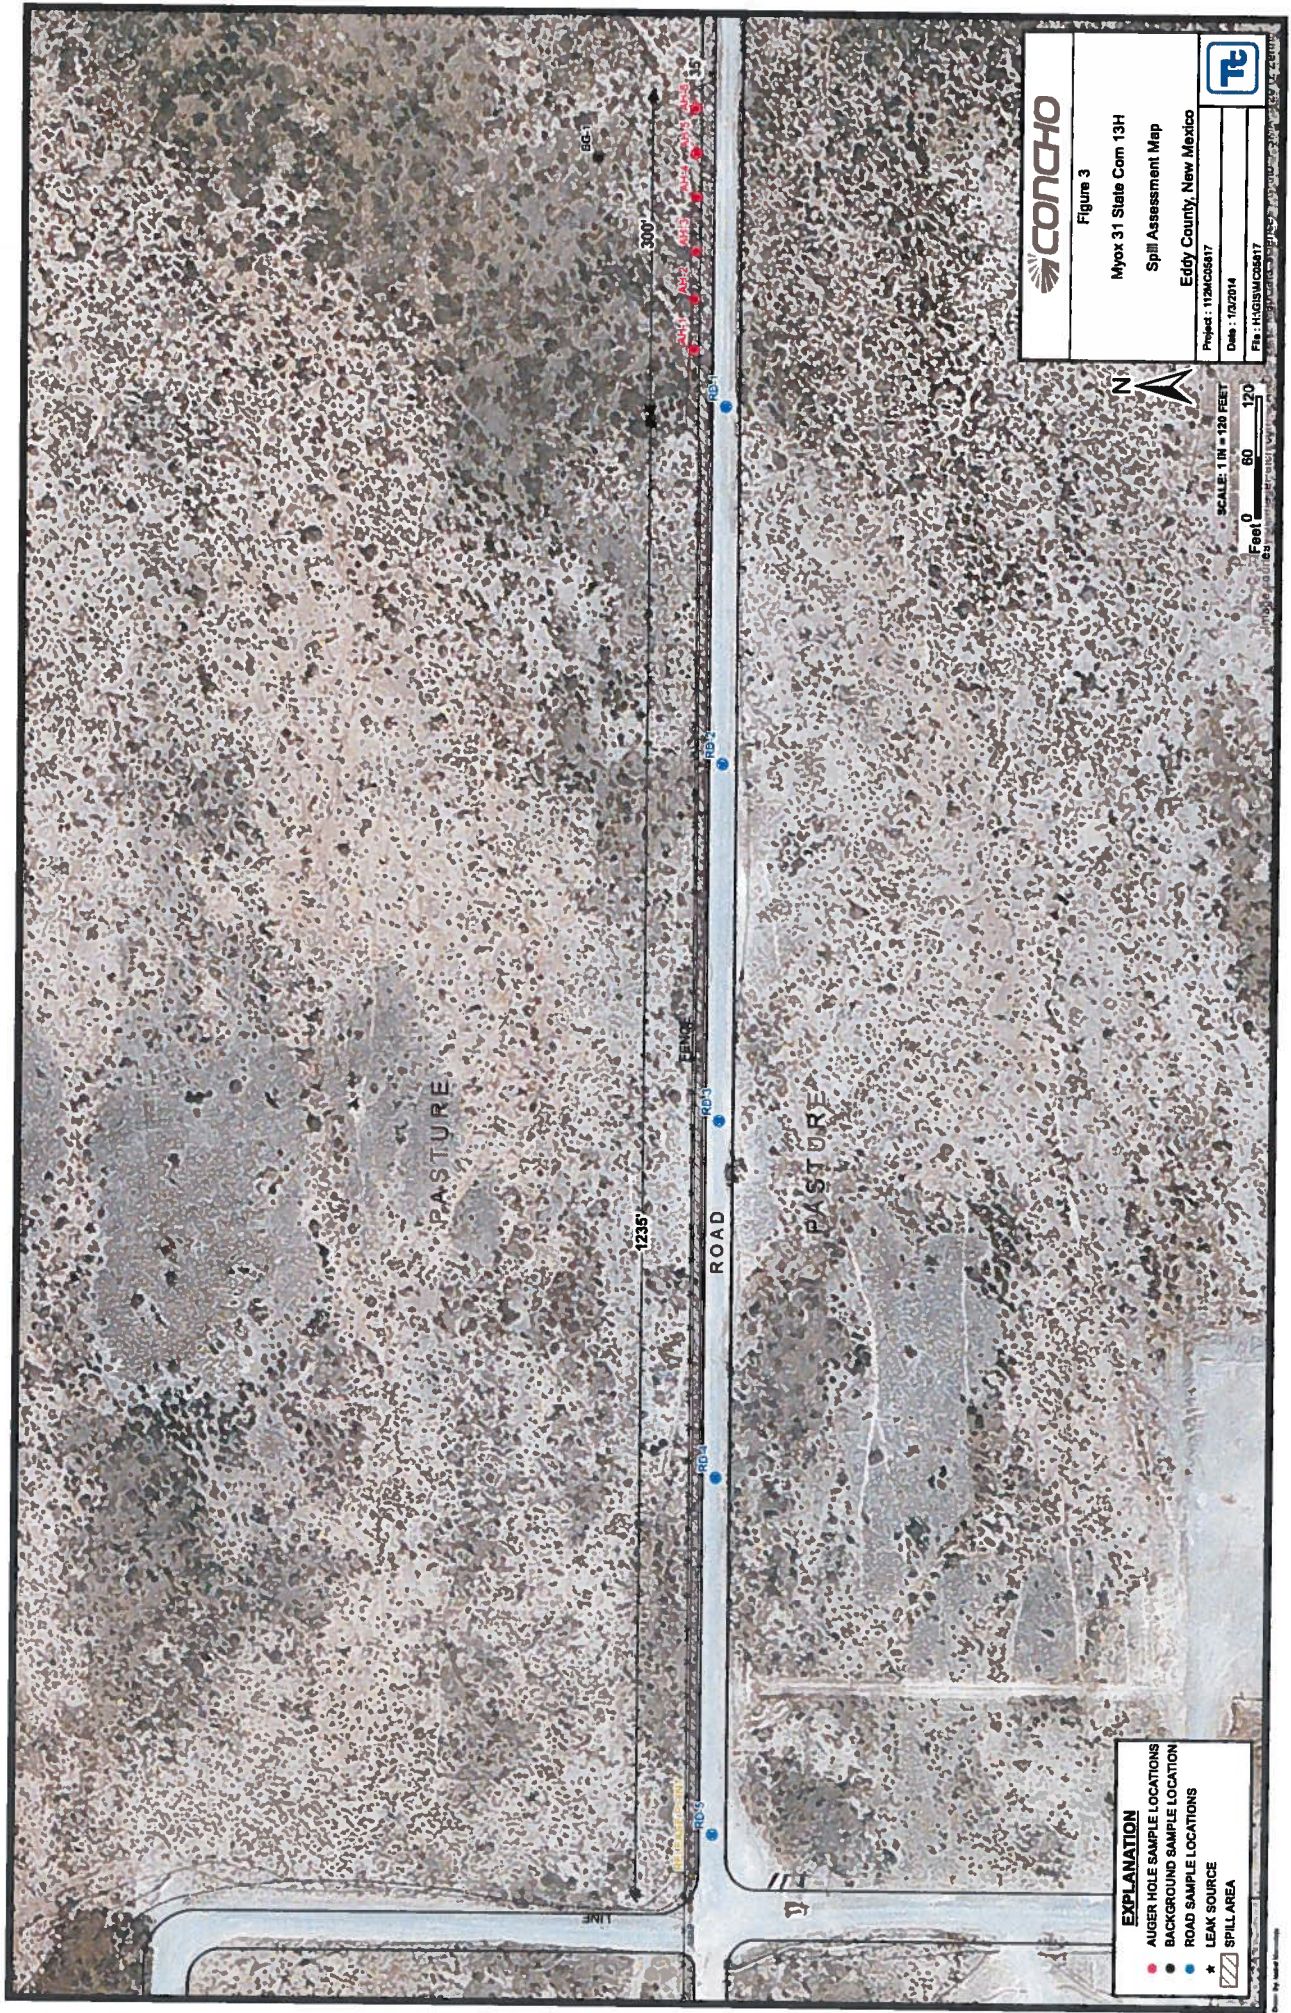
Figure 3

- AUGER HOLE SAMPLE LOCATIONS
- BACKGROUND SAMPLE LOCATION
- ROAD SAMPLE LOCATIONS
- LEAK SOURCE
- SPILL AREA

Spill Assessment Map

On December 19, 2013, Tetra Tech personnel inspected and sampled the spill area. Six (6) auger holes (AH-1 through AH-6) were installed using a stainless steel hand auger to assess the impacted soils. In addition, a total of five (5) surface samples (Road 1 through Road 5) were collected to evaluate the spill area along the edge of the road. Selected samples were analyzed for TPH analysis by EPA method 8015 modified, BTEX by EPA Method 8021B and chloride by EPA method 300.0. Copies of laboratory analysis and chain-of-custody documentation are included in Appendix C. The sampling results are summarized in Table 1. The auger hole locations are shown on Figure 3.

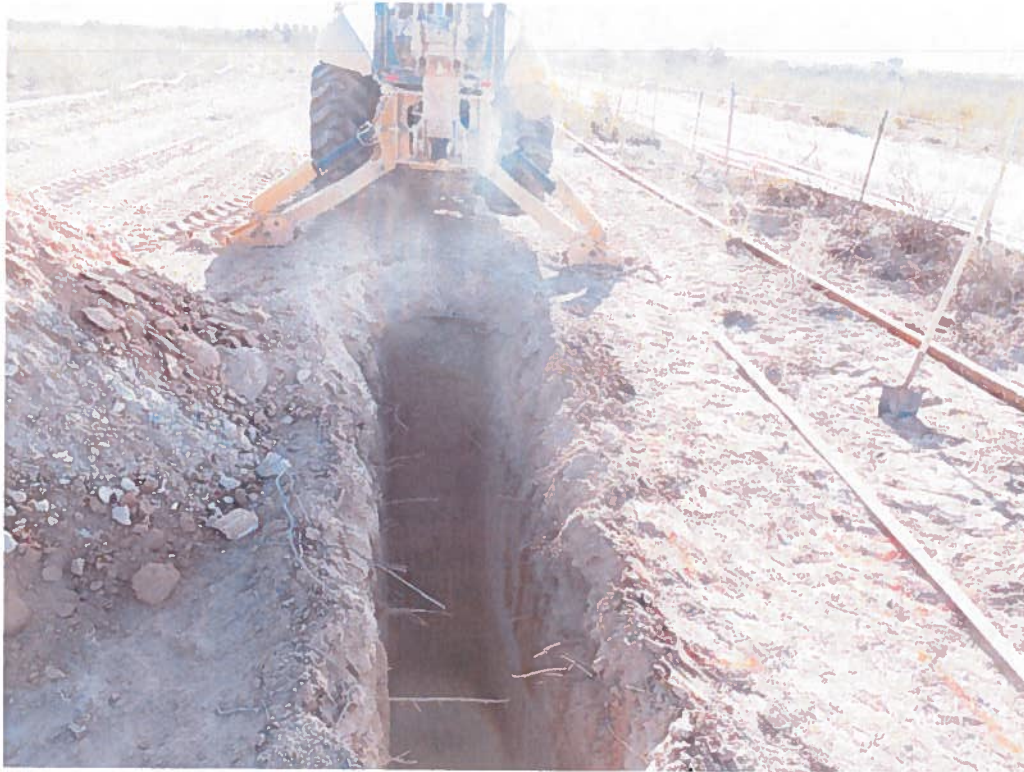
View West – T-1 in area of AH-4

Referring to Table 1, the trenches (T-1, T-2 and T-3) all declined with depth to background concentrations from 6.0' to 10.0' below surface. Based on the data, these impacted areas were excavated 6.0', 4.0', and 8.0', respectively. Once the areas were excavated to the appropriate depths, the excavations were backfilled with clean soil to surface grade. Approximately 916 cubic yards of soil was hauled to proper disposal.

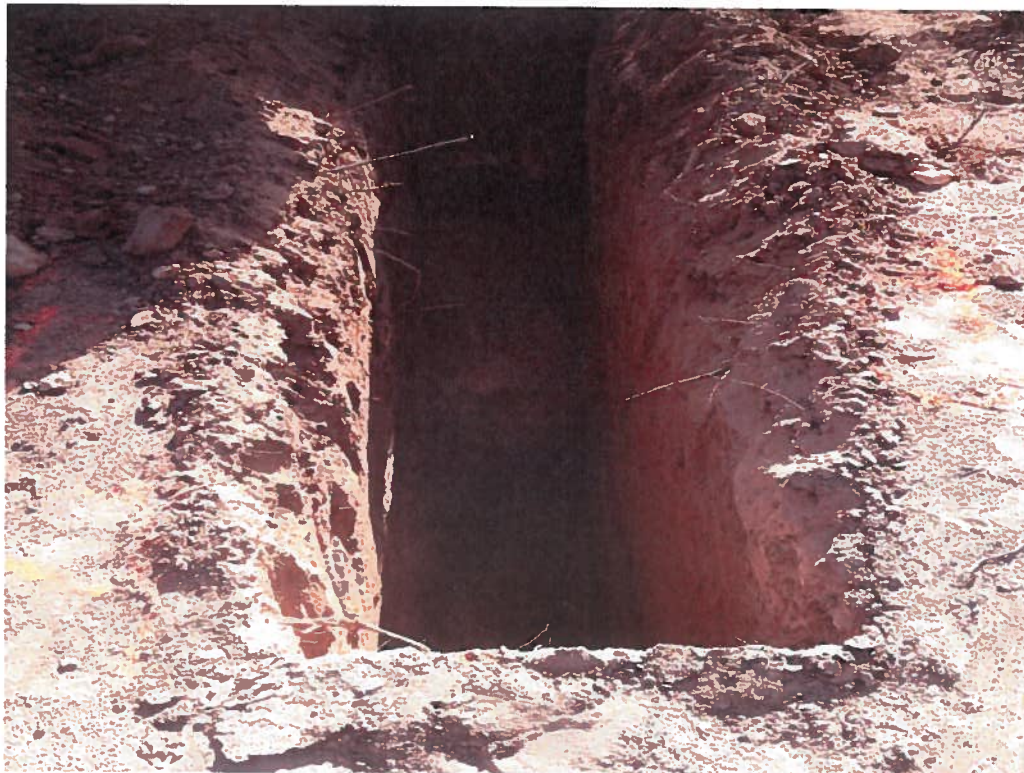
View East – T-3 in area of AH-6 at 10'

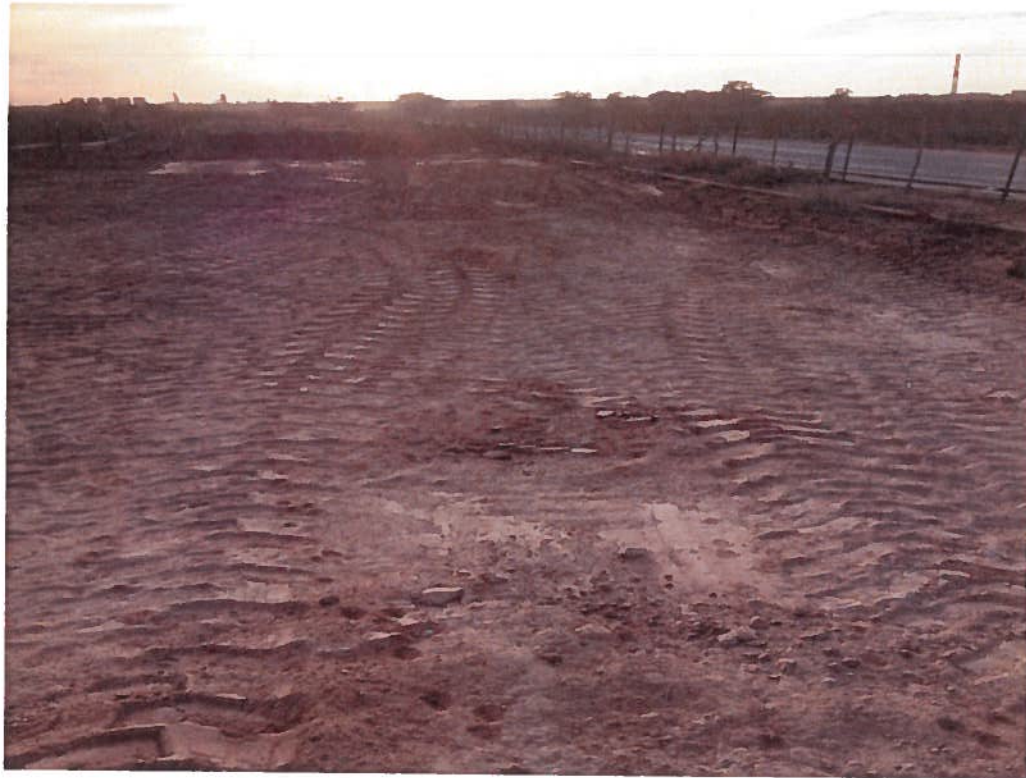
View West – Area of AH-3 at 1.0'

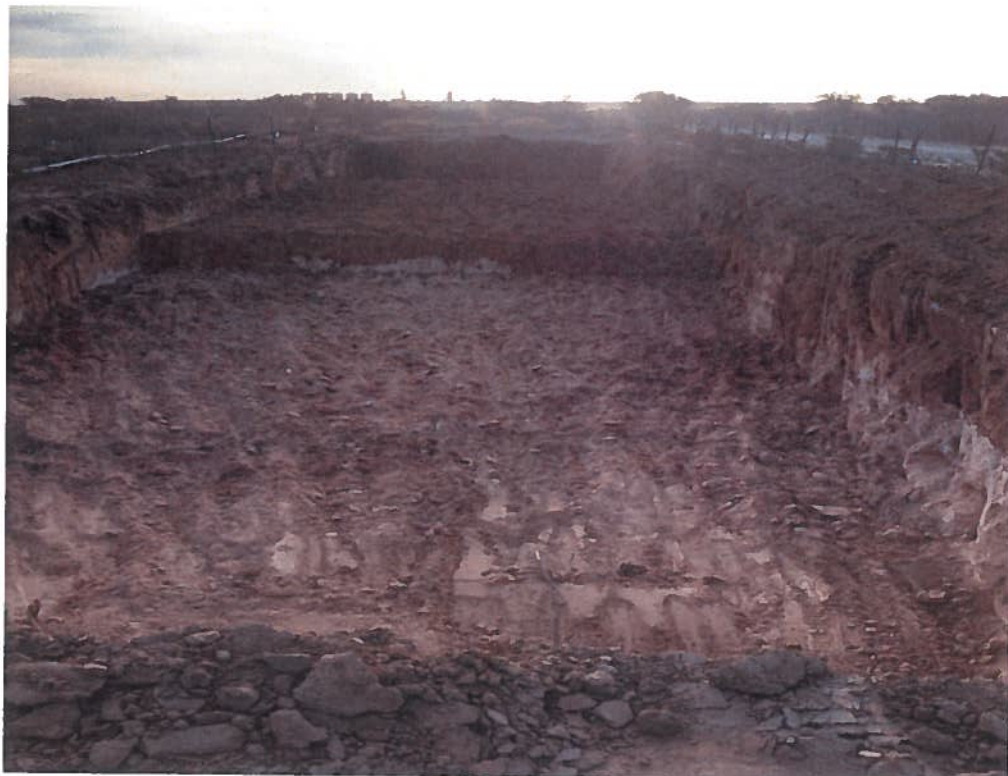
View West – Areas of AH-4, AH-5, and AH-6 Excavated

On March 26, 2014, Tetra Tech supervised the removal of the impacted material highlighted (green) in Table 1 and shown on Figure 4. Based on the background concentrations detected in the areas, the impacted areas were excavated to the appropriate depths. The area of AH-3 was excavated to a depth of 1.0' below surface. The additional areas (AH-4, AH-5 and AH-6) were assessed by installing backhoe trenches to define extents.

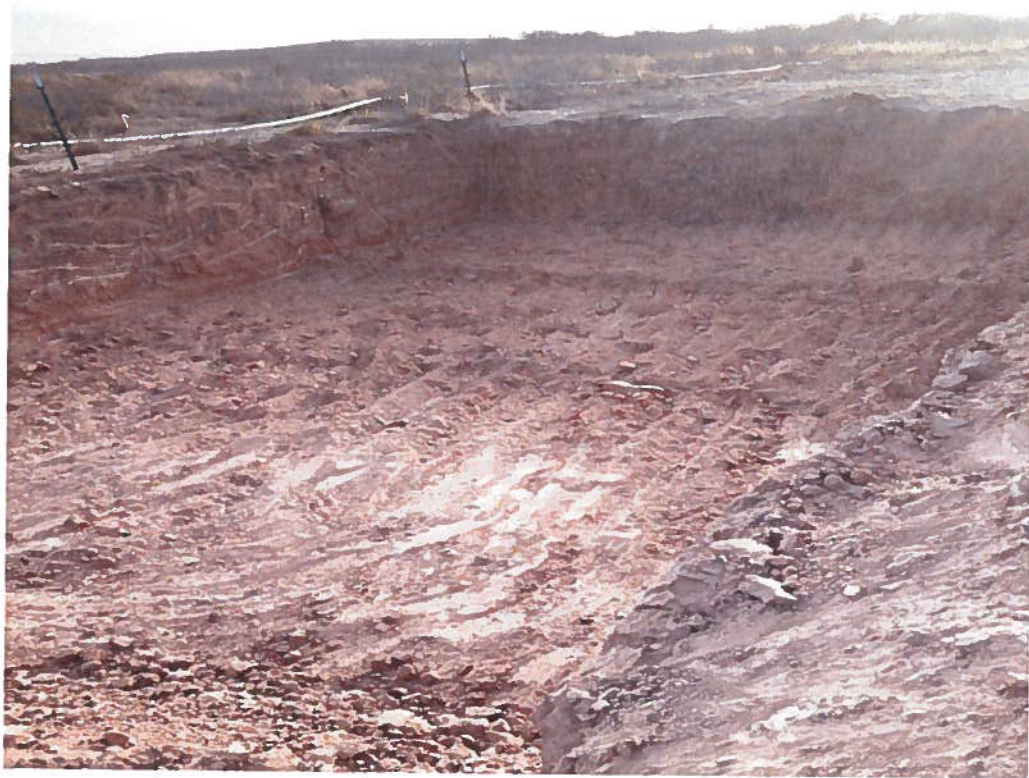
View East – Area of AH-6 at 8.0'

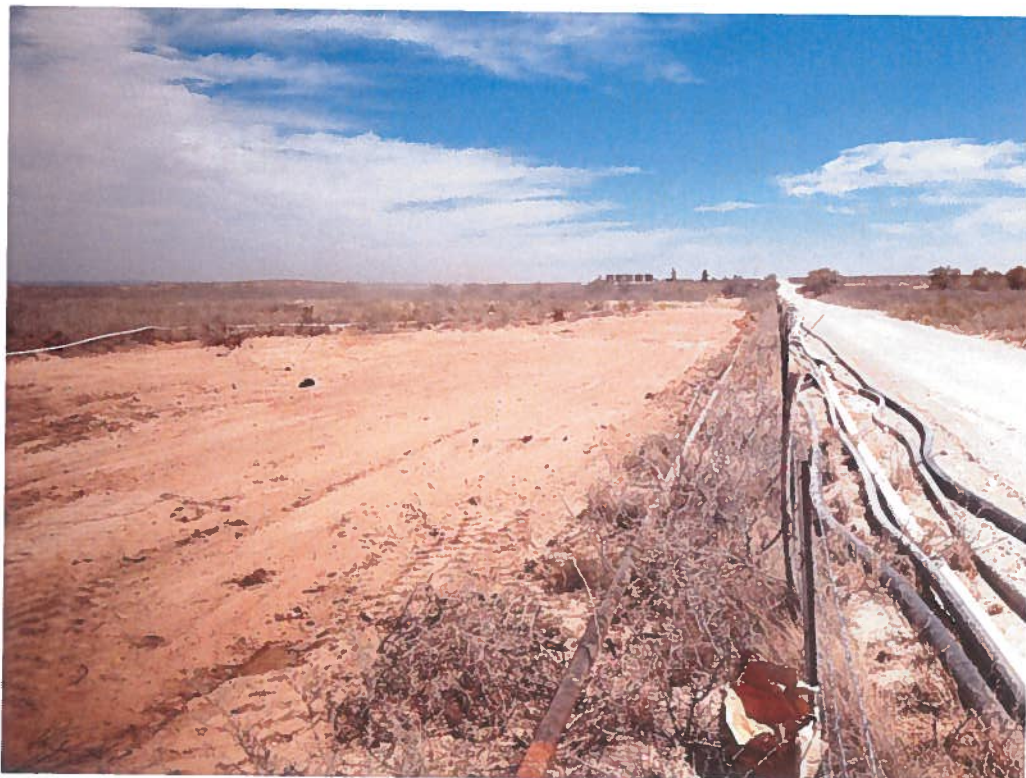
View West – Excavation Backfilled
