## Report Type: Closure Report

| Site: | Myox 32 Fee #2H | | | | | |

**Re: Closure Report for the COG Operating LLC., Myox 32 Fee #2H Main Line, Unit C, Section 32, Township 25 South, Range 28 East, Eddy County, New Mexico.**

Spill Assessment Map

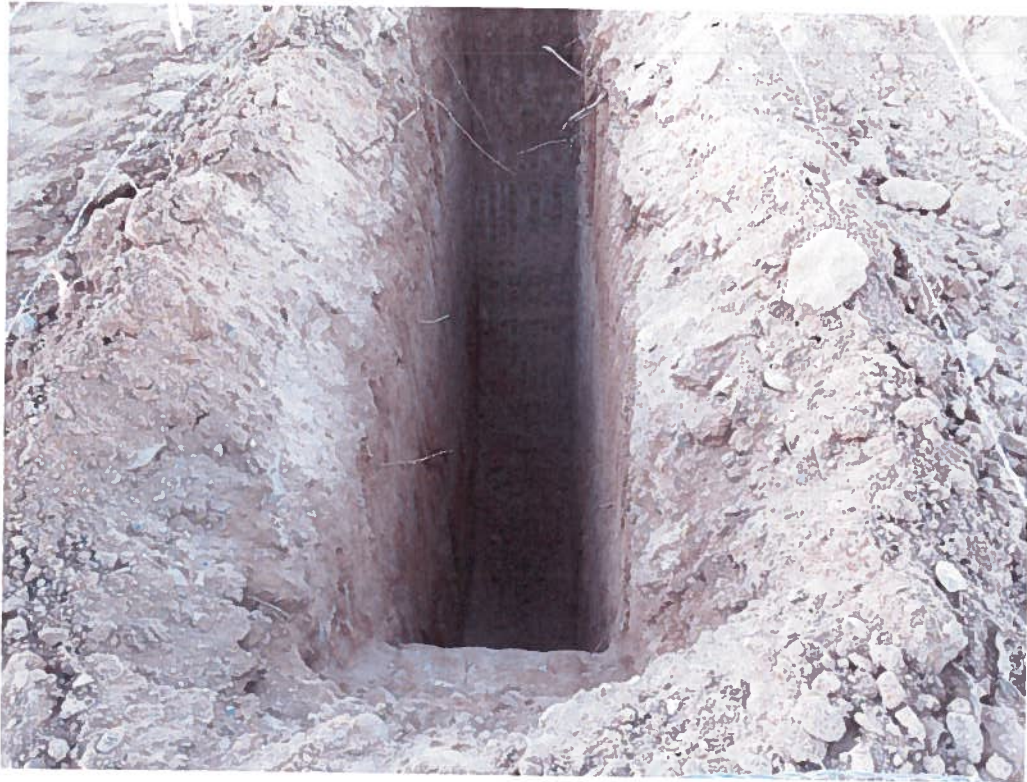
View East – T-1 in Area of AH-1

Based on the Trench (T-1 and T-2) results, Tetra Tech installed boreholes (BH-1 and BH-2) in the areas of AH-1 and AH-2 to define extents. In addition, a borehole (BG-3) was installed 300' west of the facility for additional chloride background concentrations. As shown in Table 1, some samples in the deeper soils of background (BG-3) showed chloride highs of 1,240 mg/kg at 6-7', 1,010 mg/kg at 6-7' and 1,450 mg/kg at 9-10'. Boreholes (BH-1 and BH-2) did show a deeper chloride impact to the soils. The chloride concentrations declined with depth to 1,660 mg/kg at 44-45' and 1,680 mg/kg at 39-40', respectively.

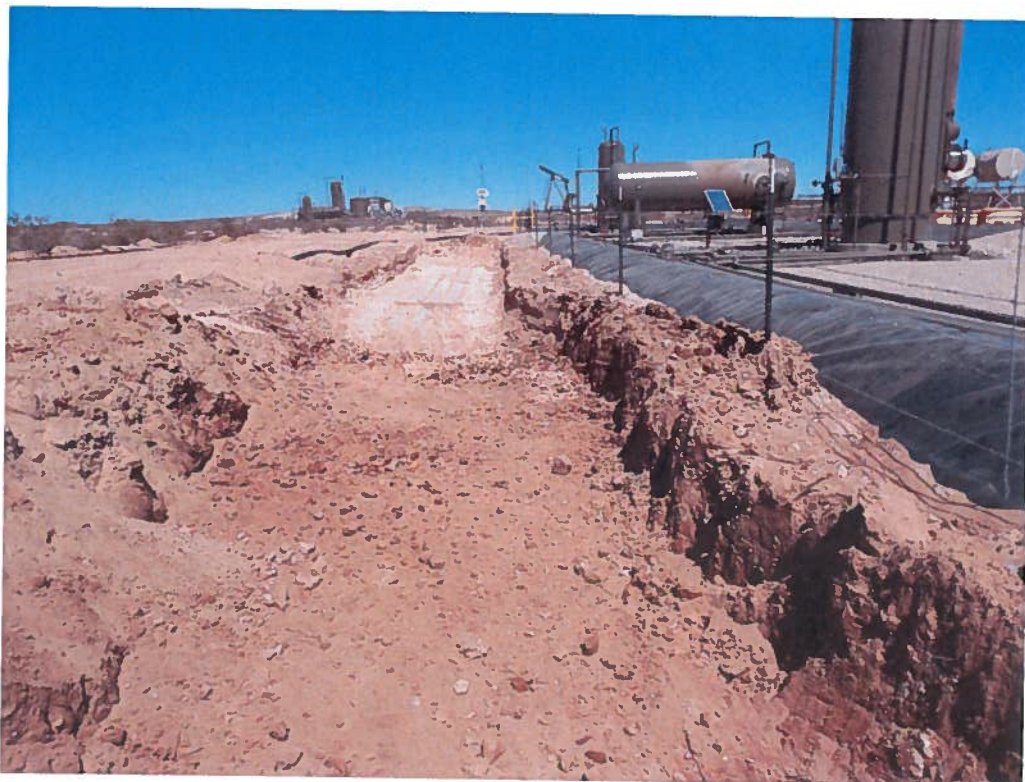
View North – Areas of AH-1 and AH-2 at 3.0'

On March 10, 2014, Tetra Tech supervised the removal impacted material as highlighted (green) in Table 1 and shown on Figure 4. Auger holes (AH-3 and AH-5) were excavated to depths of approximately 2.0' below surface. In the areas of AH-1 and AH-2, backhoe trenches were installed to define extents and confirm the detected chloride concentrations. Based on the field data, these areas were excavated 3.0' below surface, and a 40 mil plastic liner was installed to cap and prevent further migration of contaminants left in place.

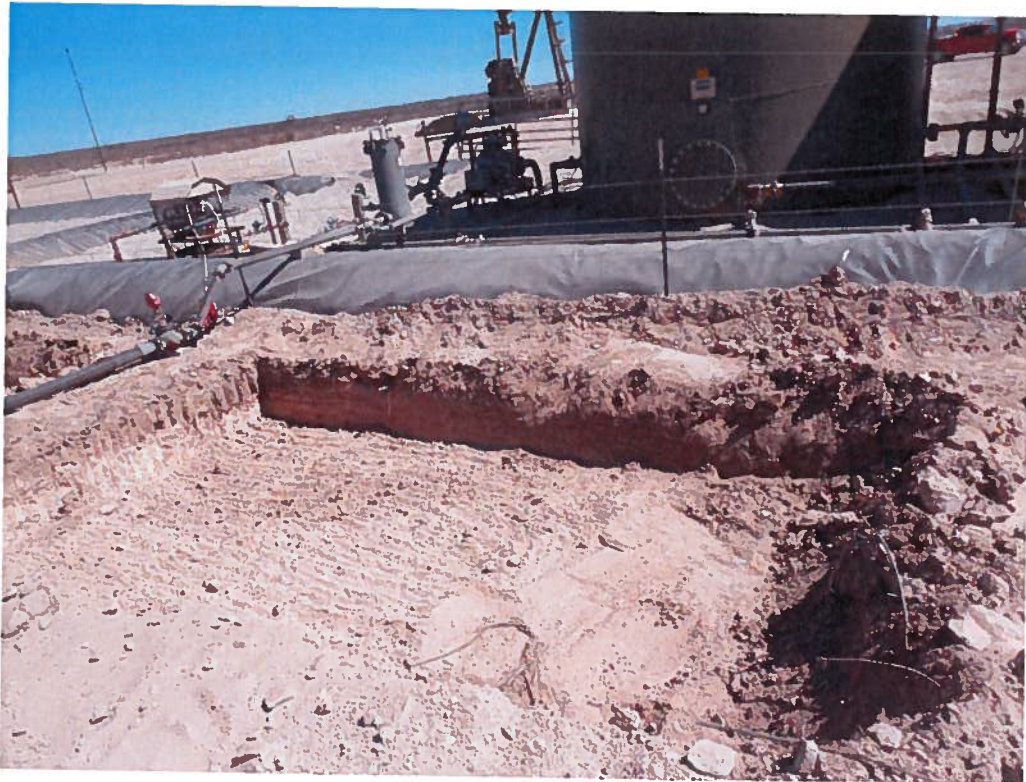
View North – Area of AH-3 at 2.0'

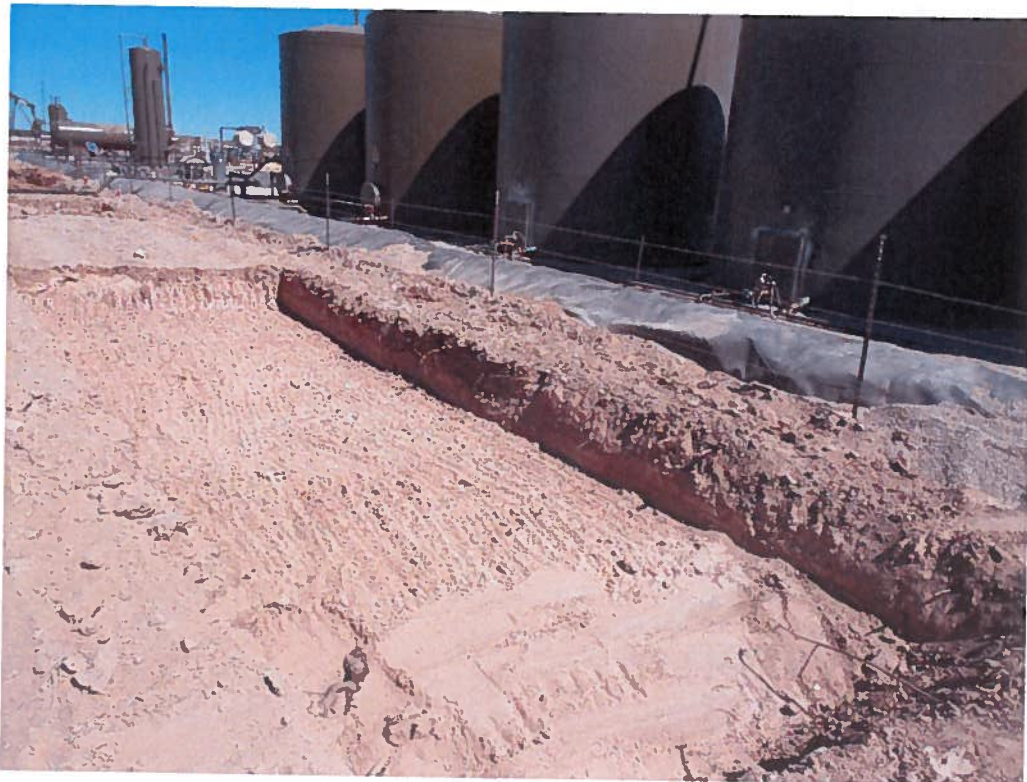
View North – Area of AH-5 at 2.0'

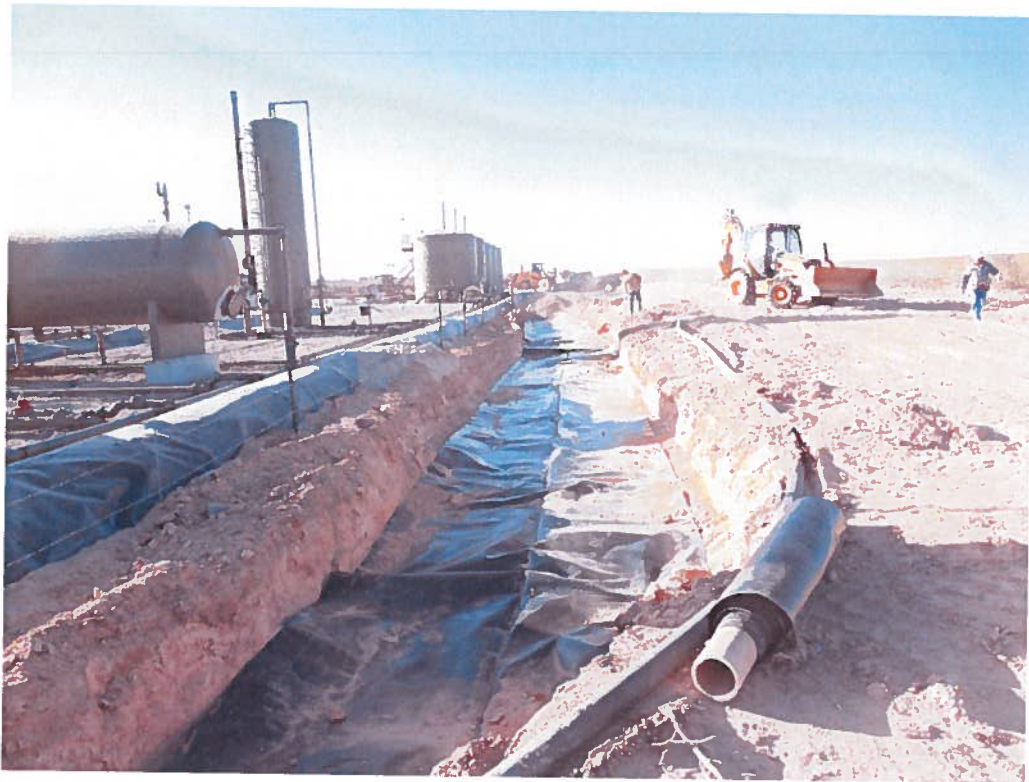
View South – Areas of AH-1 and AH-2 with Liner Installed

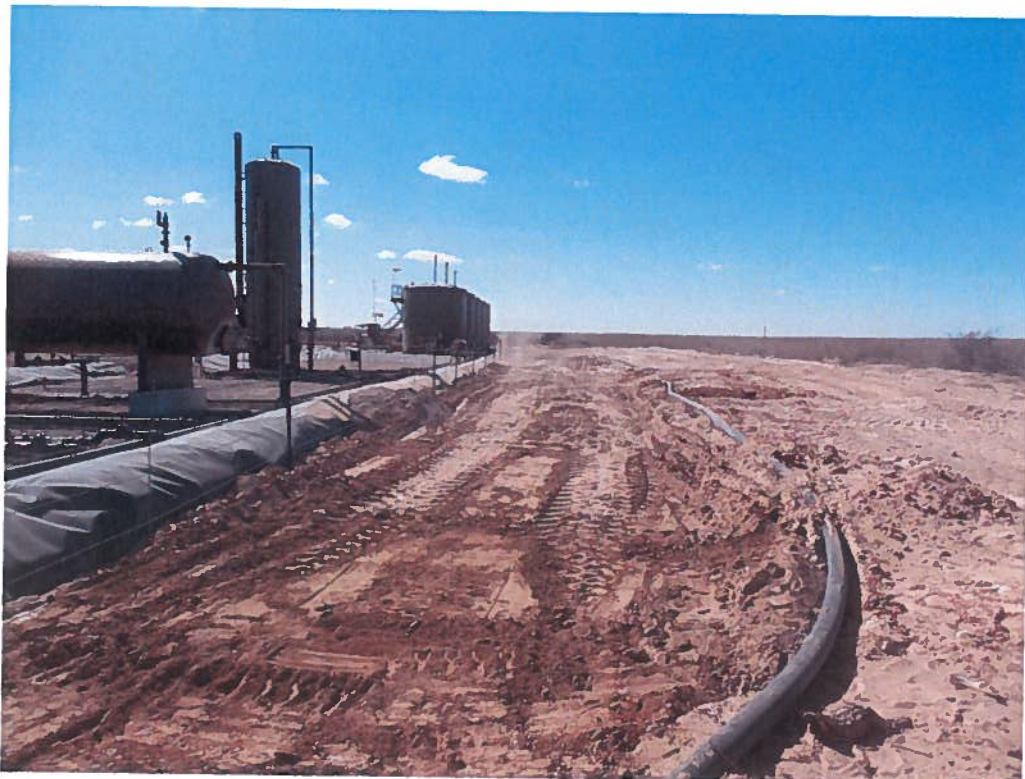
View South – Excavation Backfilled

Once the areas were excavated to the appropriate depths, the excavations were backfilled with clean soil to grade, and approximately 240 cubic yards of excavated material was hauled to proper disposal.
