CLOSURE REPORT

BOPCO, LP
Poker Lake Unit #57
Eddy County, New Mexico
Unit Letter "N", Section 28, Township 25 South, Range 31 East
Latitude 32.094735 North, Longitude 103.785760 West
NMOCD Reference #2RP-1730

RE: Final Closure Report
Bopco – Poker Lake Unit #57
UL-N, Section 28, Township 25 South, Range 31 East
Eddy County, New Mexico
NMOCD Reference # 2RP 1730

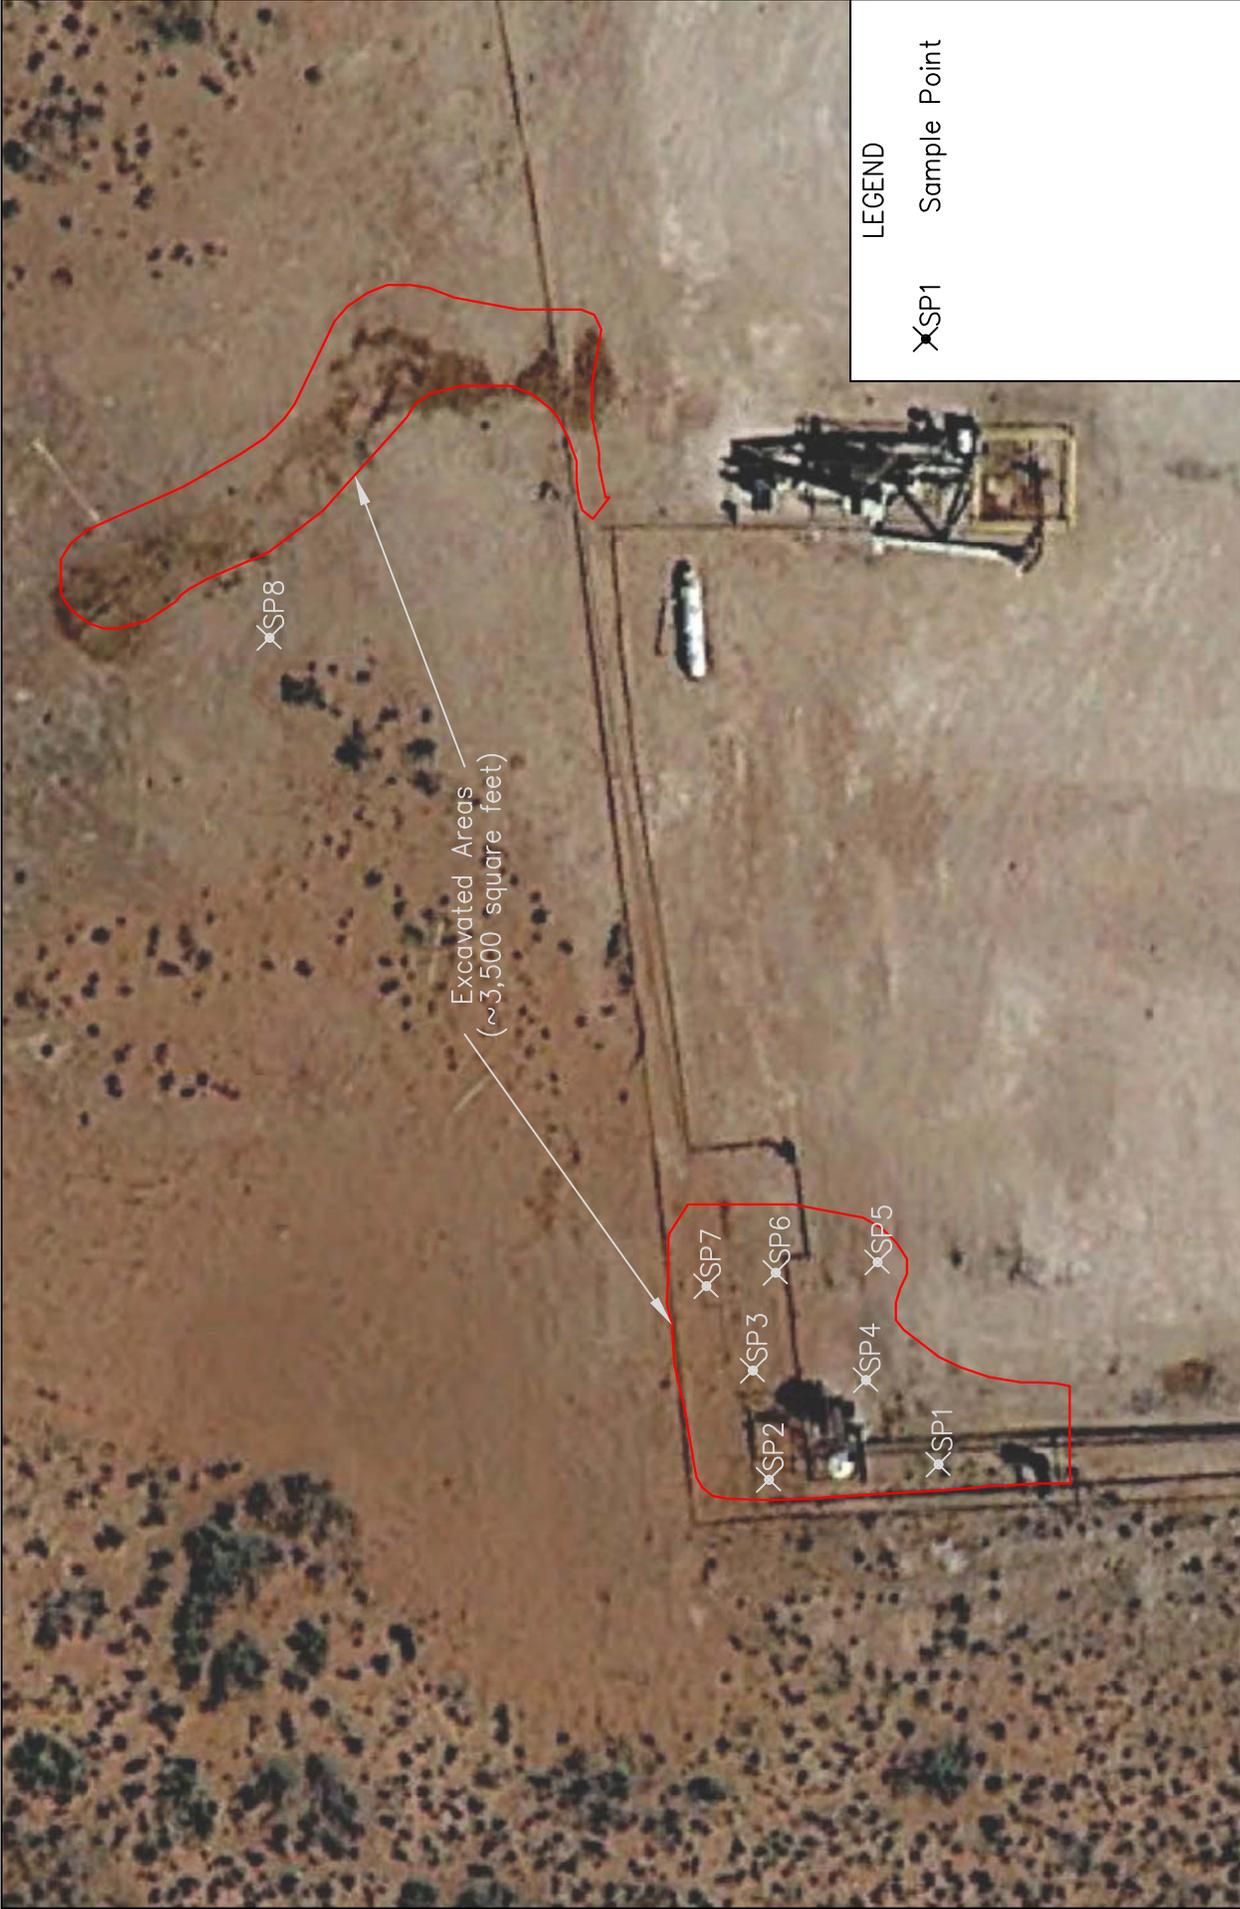
Figure 3
 Site/Sample Map
 Bopco, L.P.
 Poker Lake Unit #57

EPI personnel mobilized on the site on October 6, 2014 to collect soil samples via hand auger to determine the vertical extent of contamination. A total of twenty-two (22) soil samples were collected from seven (7) sample locations. On October 14, 2014 one (1) soil sample was collected in the area of the pasture release; all samples were sent to Cardinal Labs in Hobbs, New Mexico, for testing. Laboratory analytical results indicate the excavation in general is void of Benzene, BTEX, TPH and Chloride concentrations in excess of NMOCD Recommended Remedial Action Levels (RRALs) of 10 mg/Kg, 50 mg/Kg, 5,000 mg/Kg, and 1,000 mg/Kg, respectively. Sample SP6 indicates TPH and Chloride concentrations in excess of NMOCD RRALs at surface level with the Chloride level rising just over NMOCD RRALs at two (2) feet bgs then falling below NMOD RRALs at three (3) feet bgs. Sample SP7 indicates TPH concentrations in excess of NMOCD RRALs at surface level (reference *Figure 3* and *Table 2*).

From October 8-24, 2014 approximately 330 cubic yards of contaminated material were excavated and transported to Lea Land for disposal. The release areas were excavated to a depth of one (1) foot bgs.

The excavation was backfilled with approximately 188 yards of topsoil, 102 yards of caliche, and 40 yards of chat until the entire excavation was brought to grade with the existing pad area to protect against wind/water erosion. The disturbed area off the working location has been disced

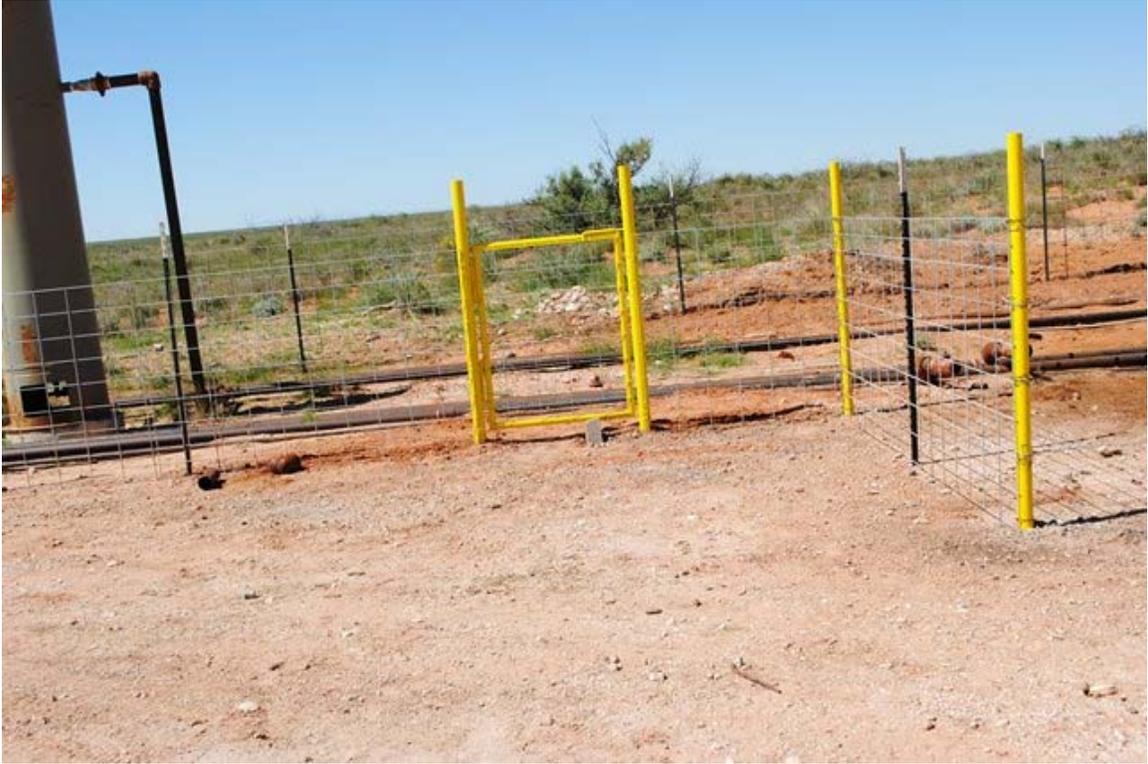
Photograph #1 – Looking east across release area

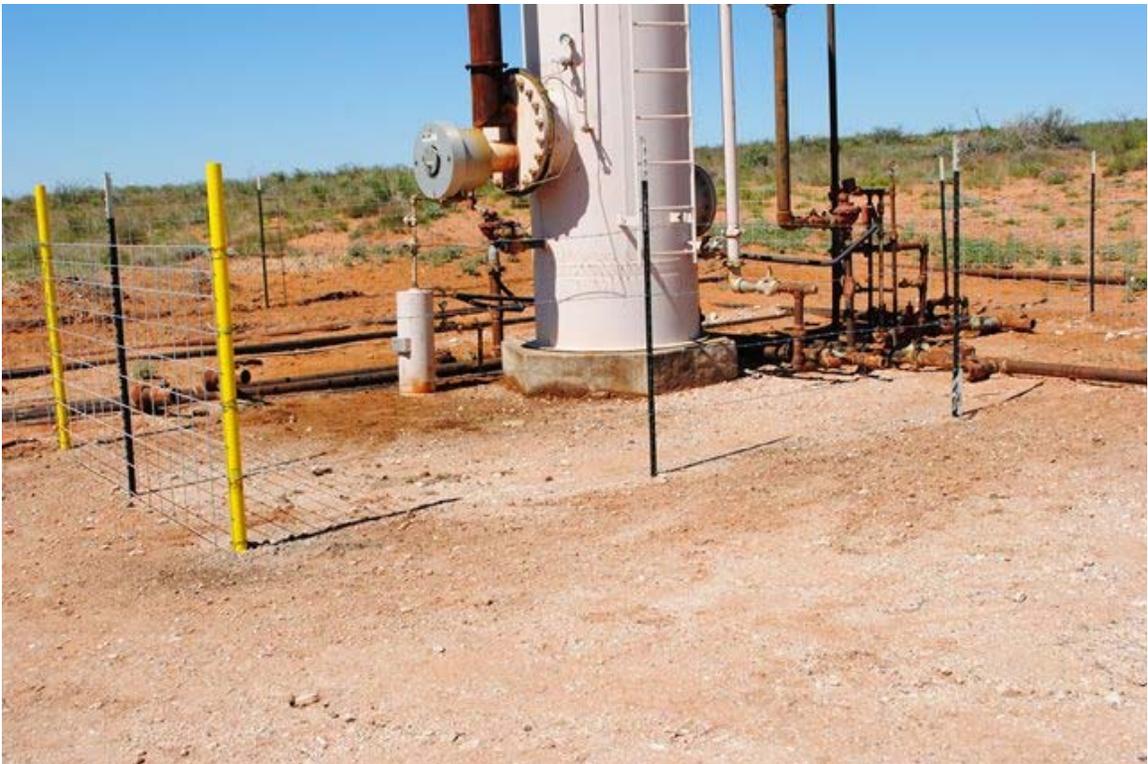
Photograph #2 – Looking north-east across release area

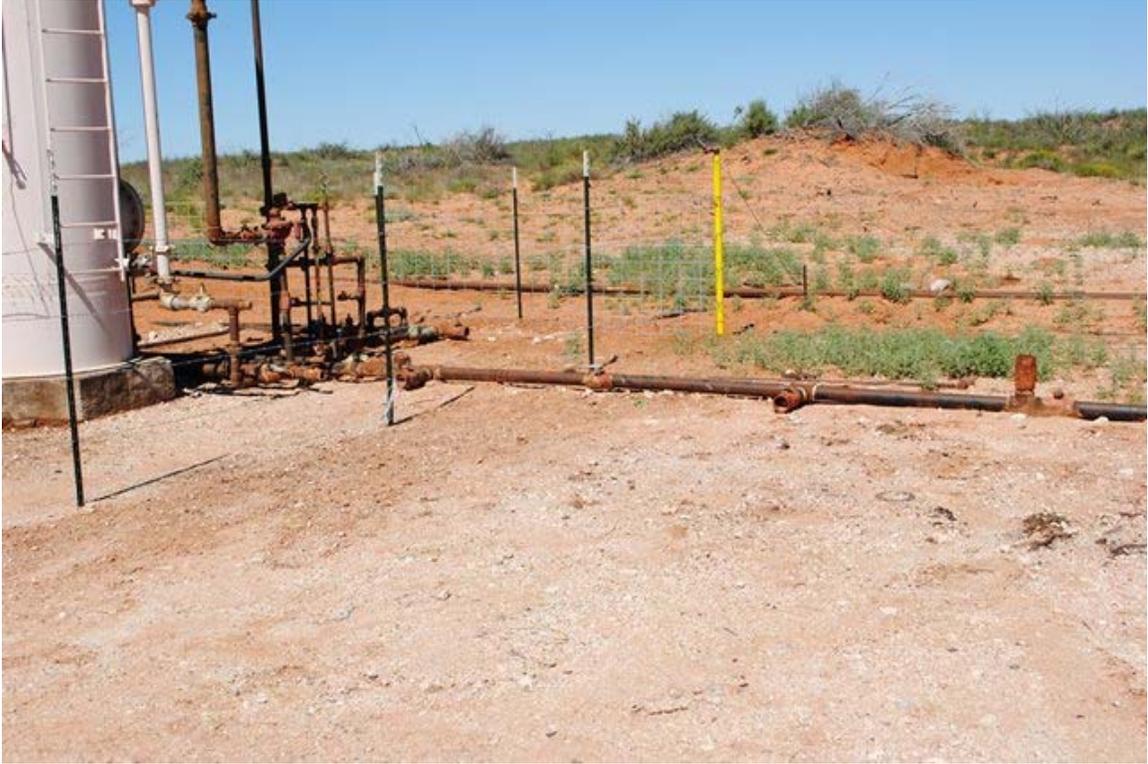
Photograph #3 – Looking north across release area

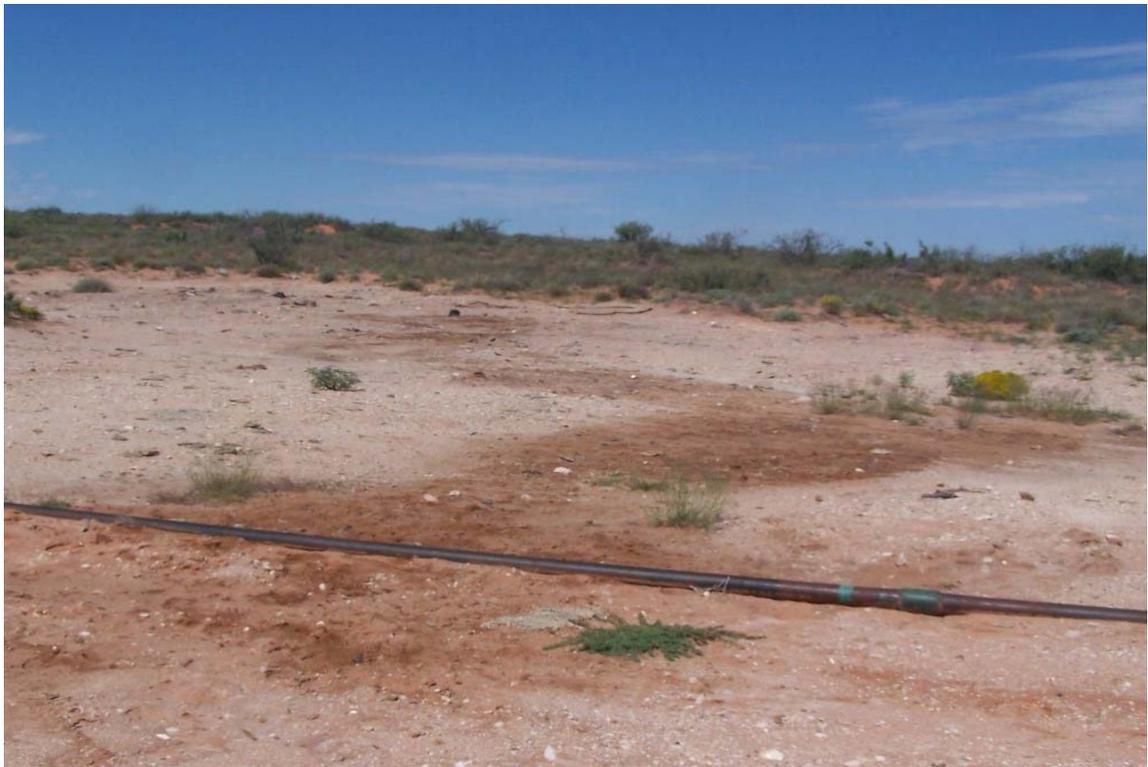
Photograph #4 – Looking north across pasture area release

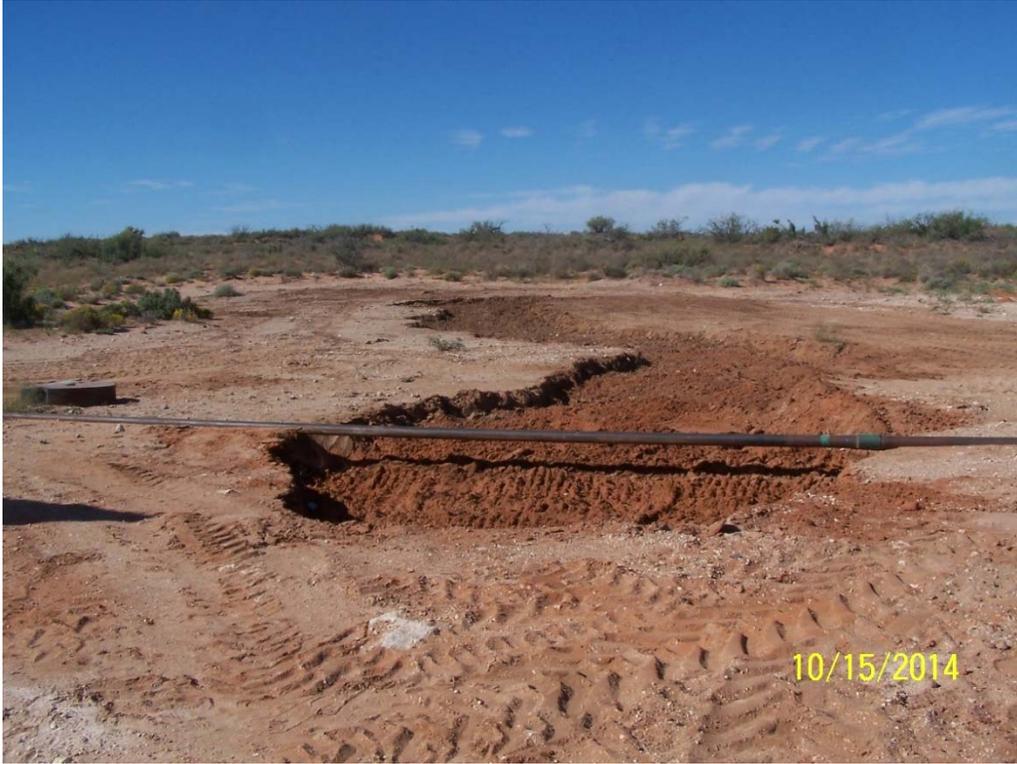
Photograph #5 – Excavated pasture area

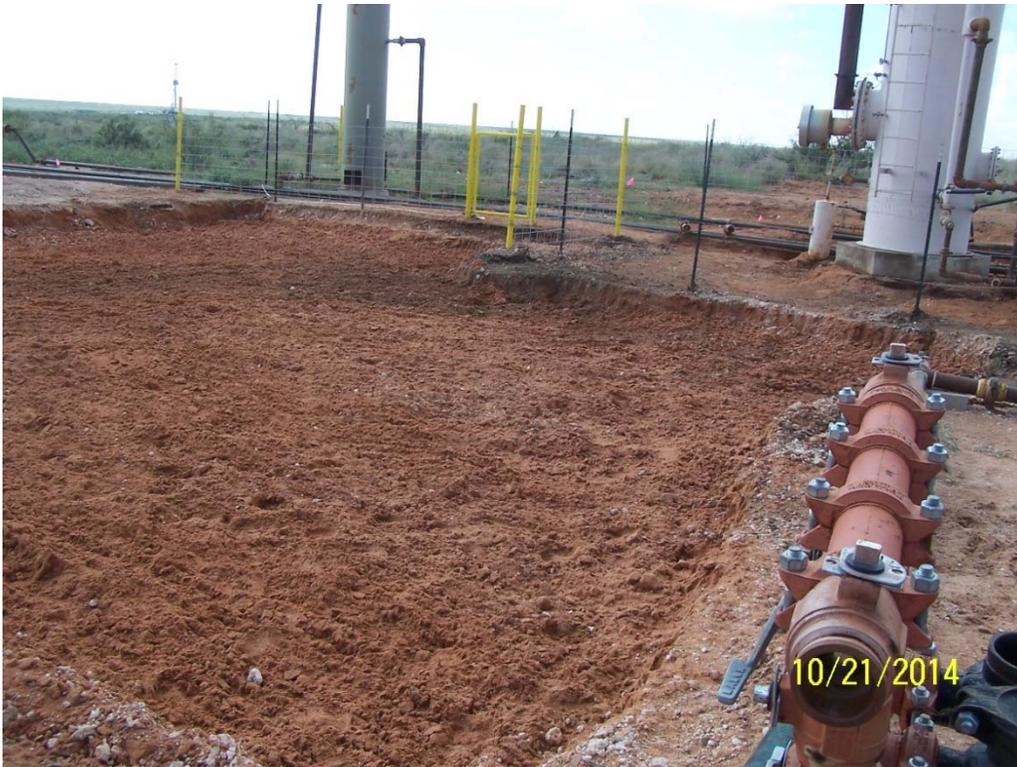
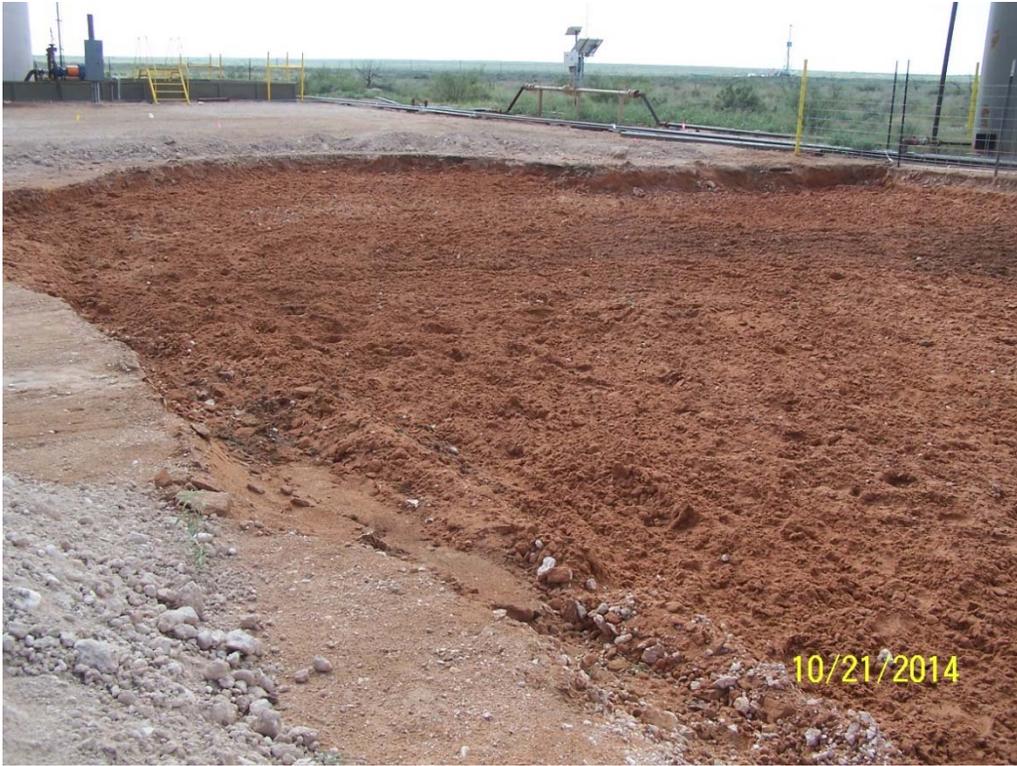
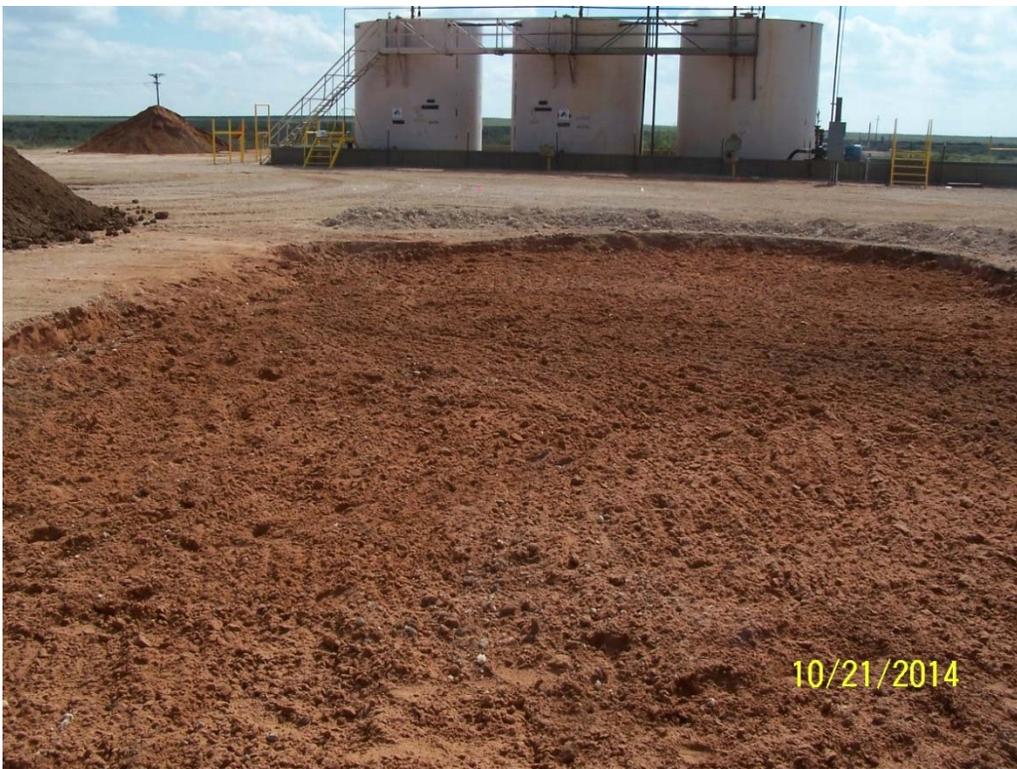
Photograph #6 – Excavated area

Photograph #7 – Excavated area

Photograph #8 – Excavated area

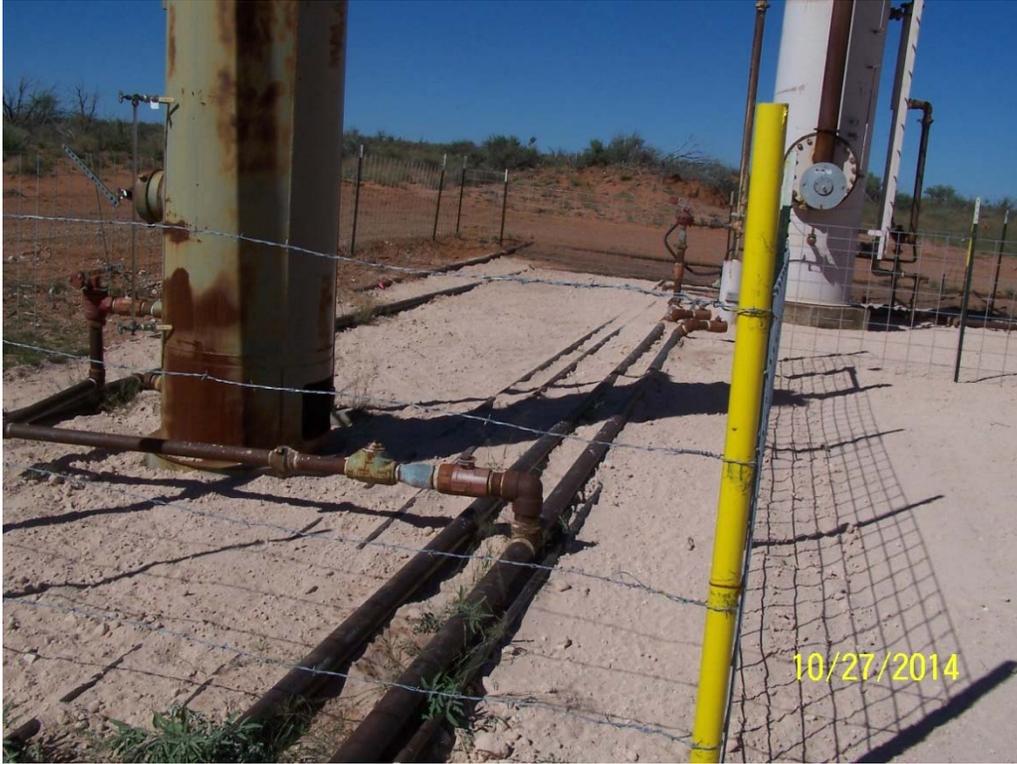
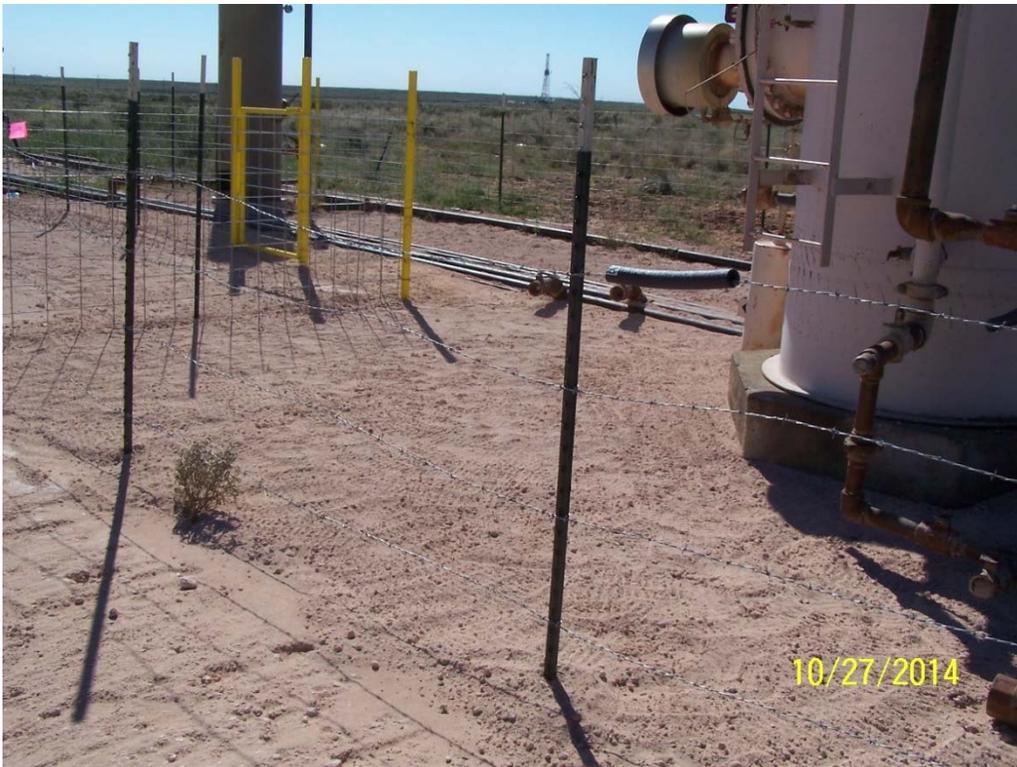
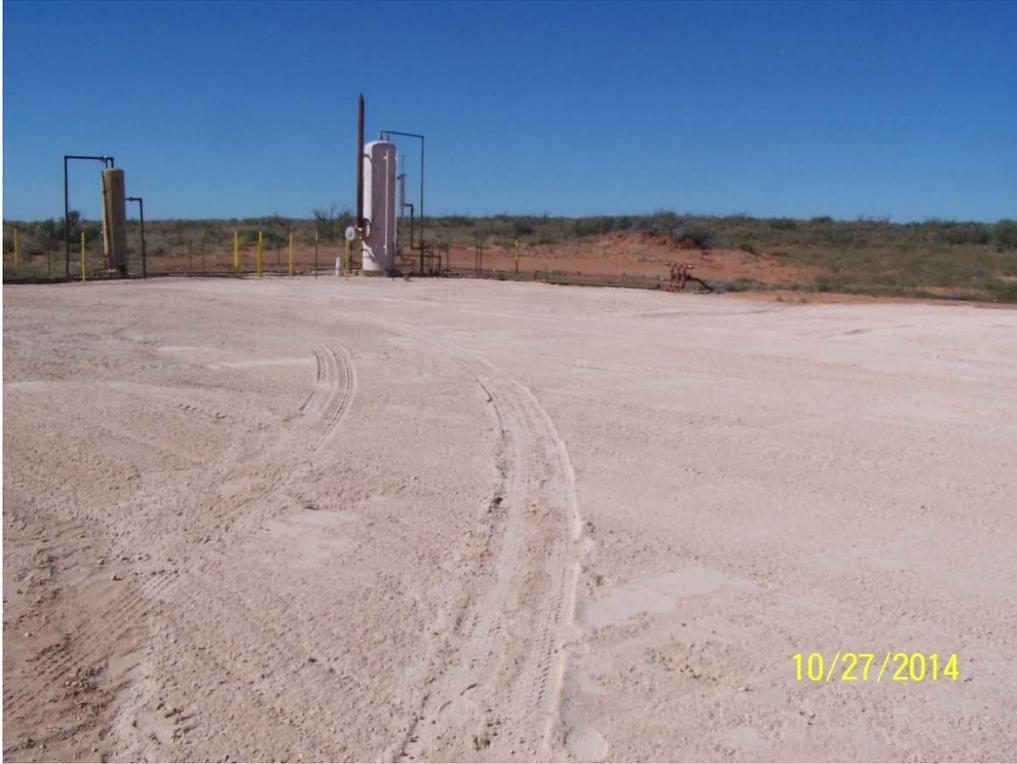
Photograph #9 – Backfilled area

Photograph #10 – Backfilled area

Photograph #11 – Backfilled area

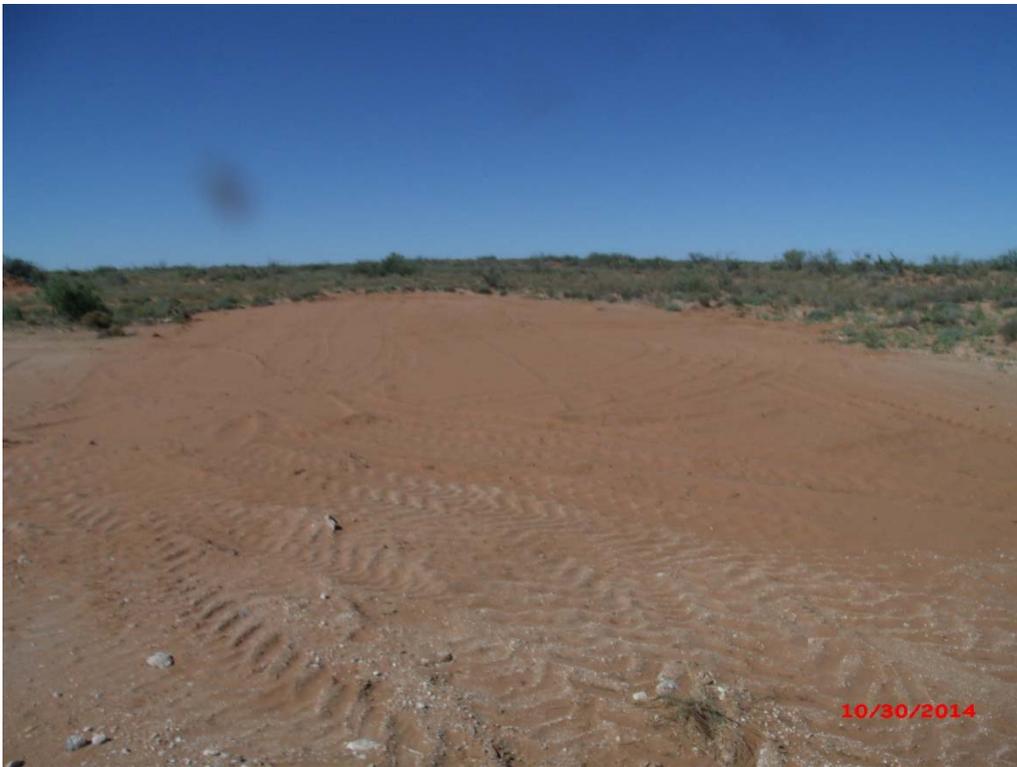
Photograph #12 – Backfilled pasture area

and deep drill seeded with a mixture approved by the property owner.
