CLOSURE REPORT

**BOPCO, LP
POKER LAKE UNIT #78
Eddy County, New Mexico
Unit Letter "A", Section 25, Township 24 South, Range 30 East
Latitude 32.194222 North, Longitude 103.827411 West
NMOCD Reference #2RP-2372**

RE: Final Closure Report
Bopco – Poker Lake Unit #78
UL-A, Section 25, Township 24 South, Range 30 East
Eddy County, New Mexico
NMOCD Reference # 2RP 2372

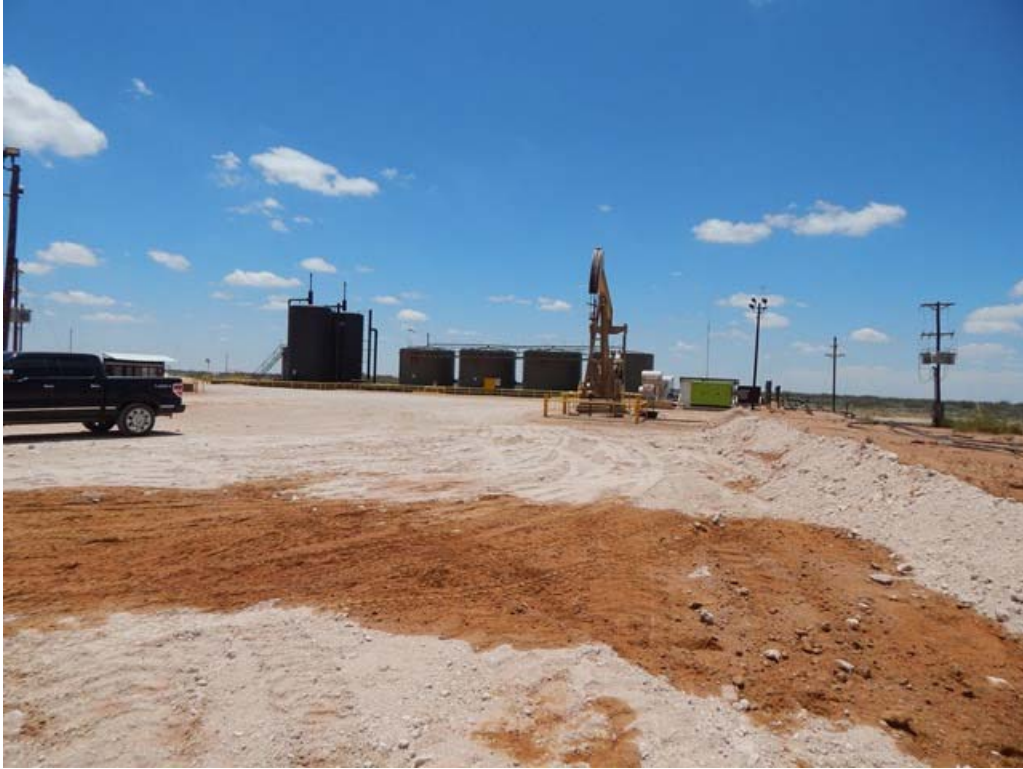
Photograph #1 – Looking west across release area

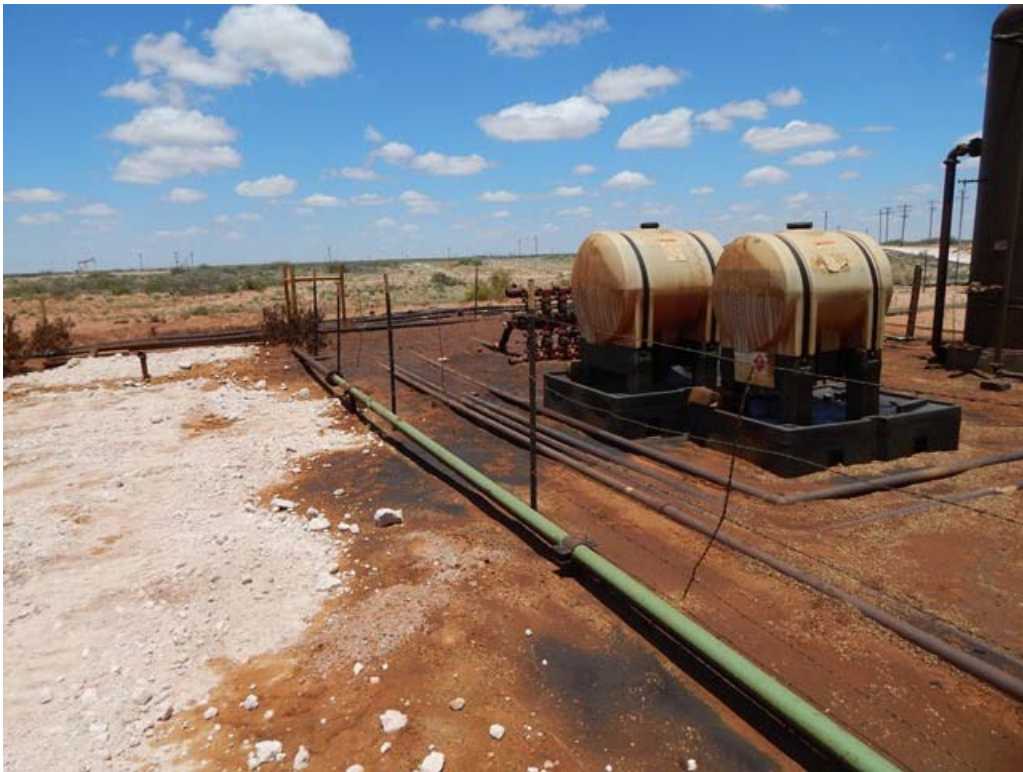
Photograph #2 – Looking east across release area

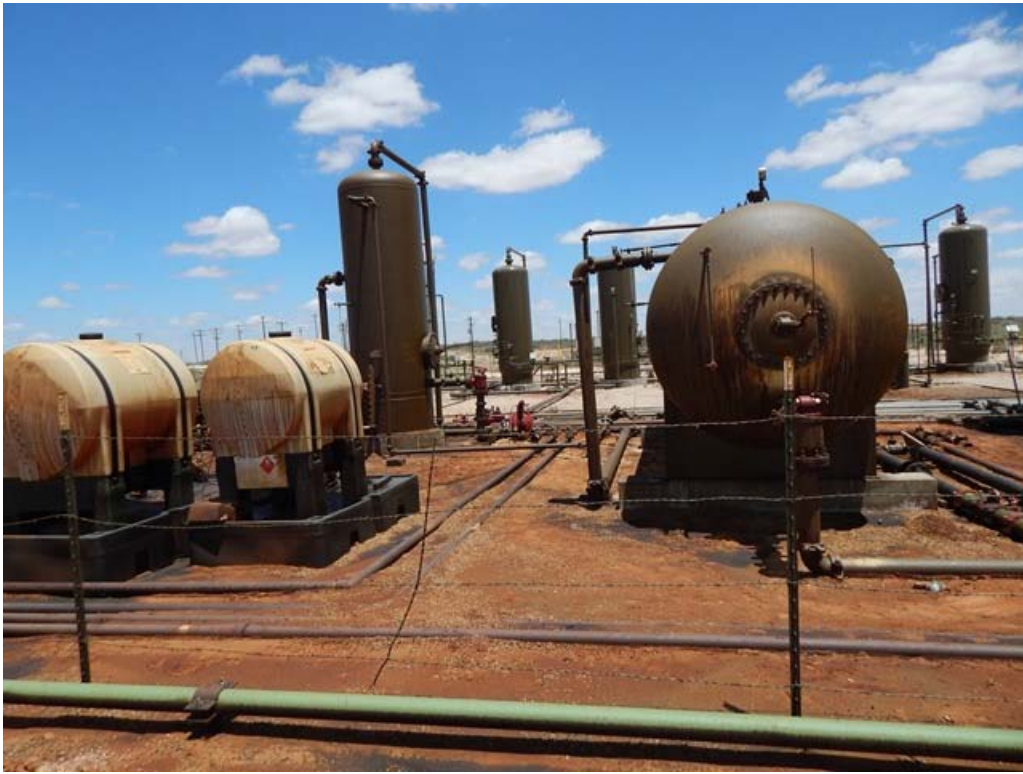
Photograph #3 – Looking east across release area

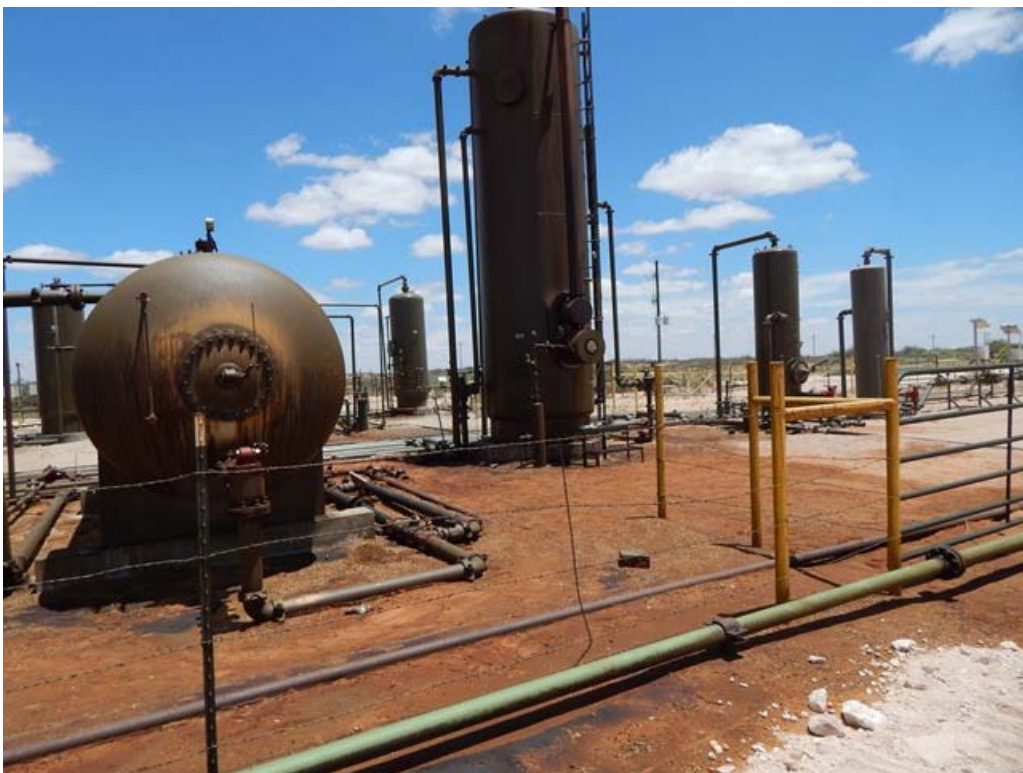
Photograph #4 – Looking east across release area

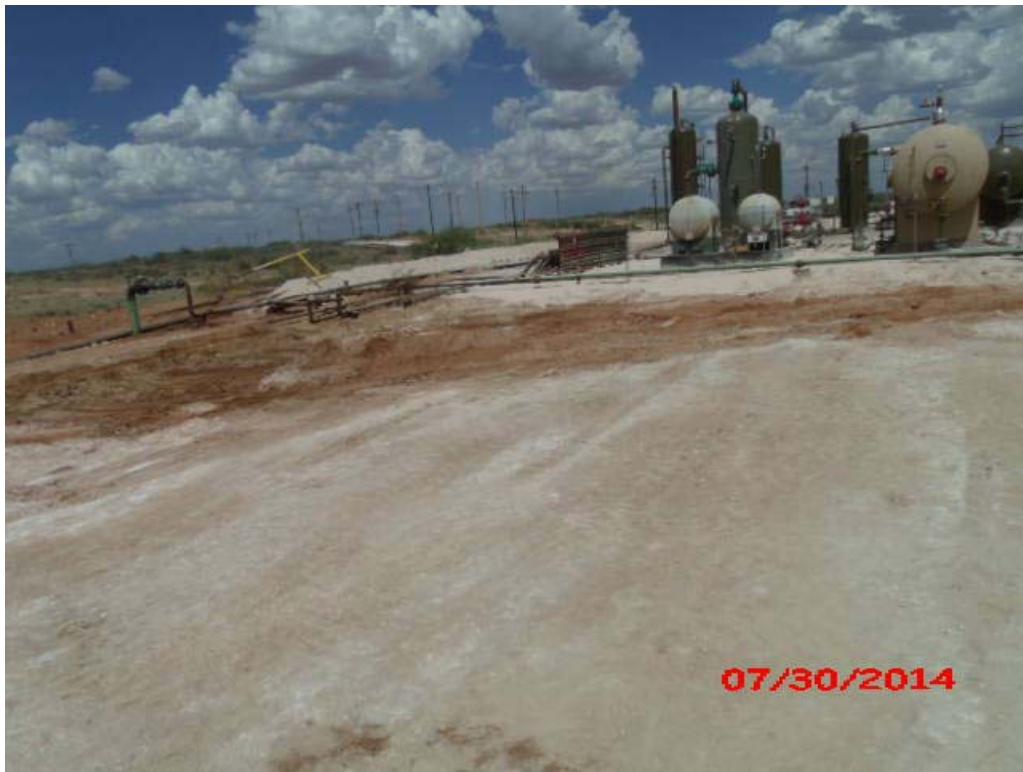
Photograph #5 – Looking east across excavation

Throughout the month of August approximately 264 cubic yards of contaminated material were excavated and transported to Lea Land for disposal. The overspray area was excavated approximately six (6) inches deep and the release area was excavated to a depth of approximately one (1) to two (2) feet, depending on contamination levels.

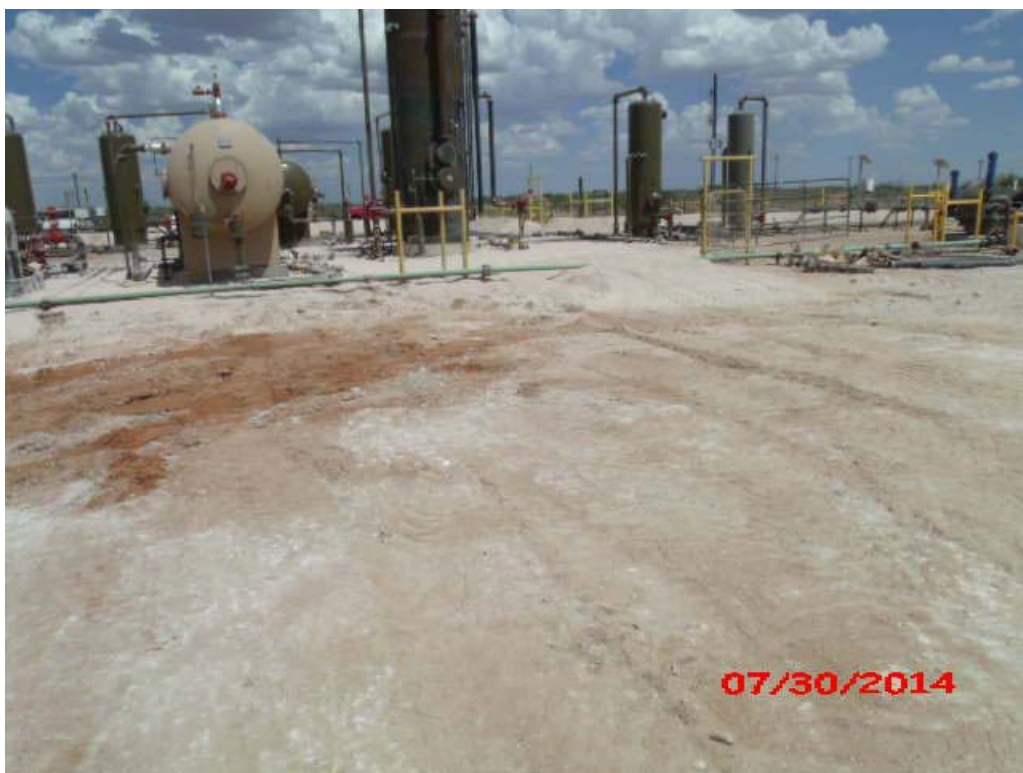
Photograph #6 – Looking east across excavation

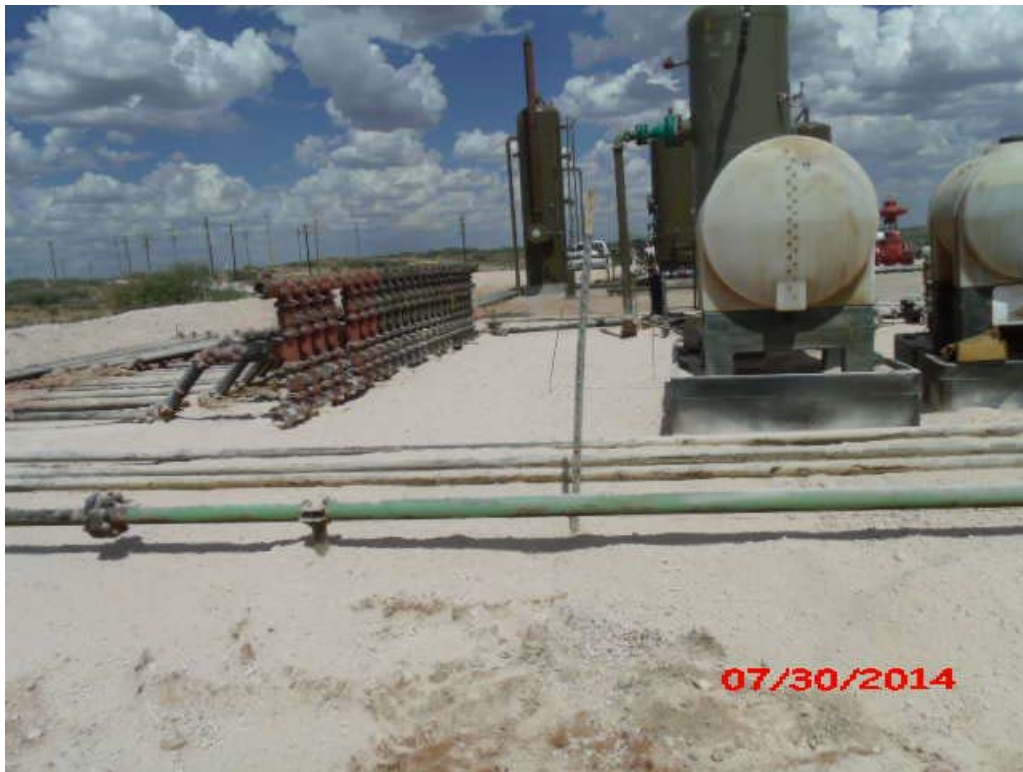
Photograph #7 – Backfilled area

Backfilling continued until the entire excavation was closed and the entire disturbed area was contoured to blend with existing pasture area and pad to protect against wind/water erosion. Disturbed areas off the working location and caliche pad will be disced and deep drill seeded with a mixture approved by the property owner. However, it is recommended completing this activity in late spring 2015 when ground conditions are more conducive to vegetative growth.

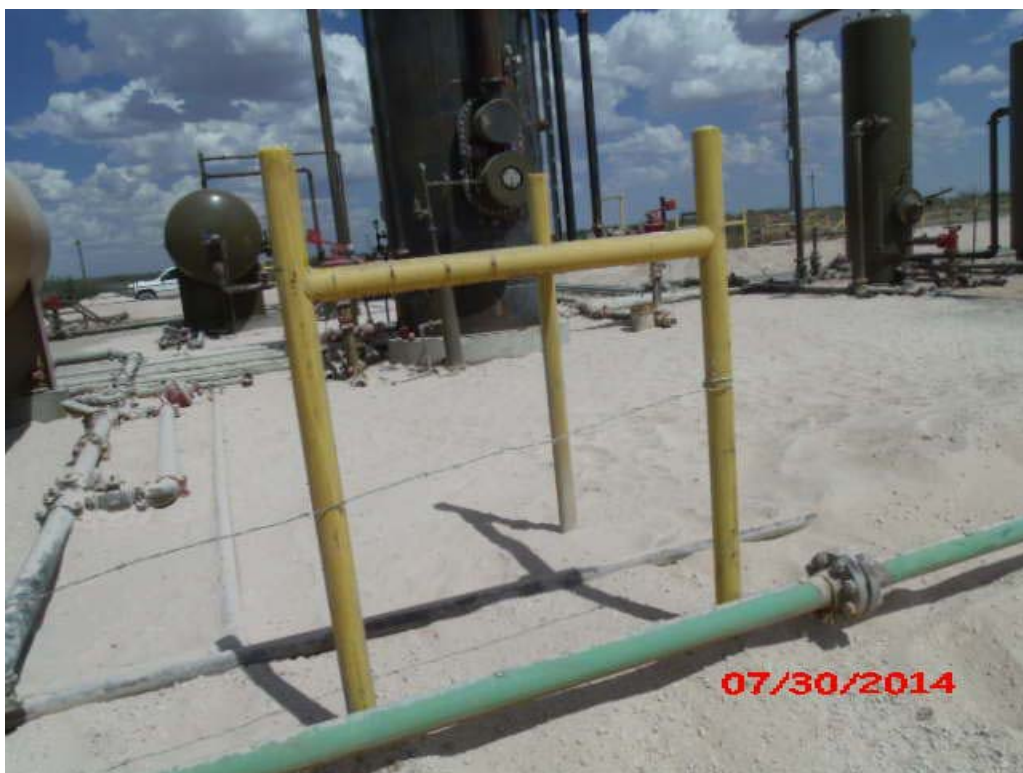
Photograph #8 – Backfilled area

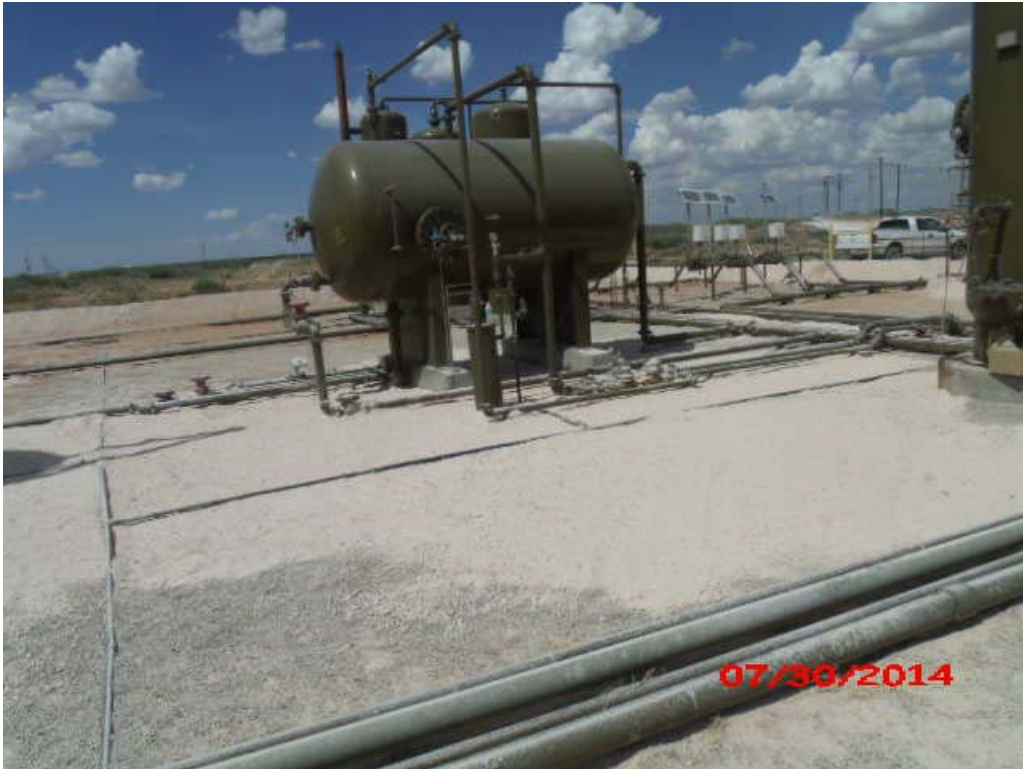
Photograph #9 – Backfilled area

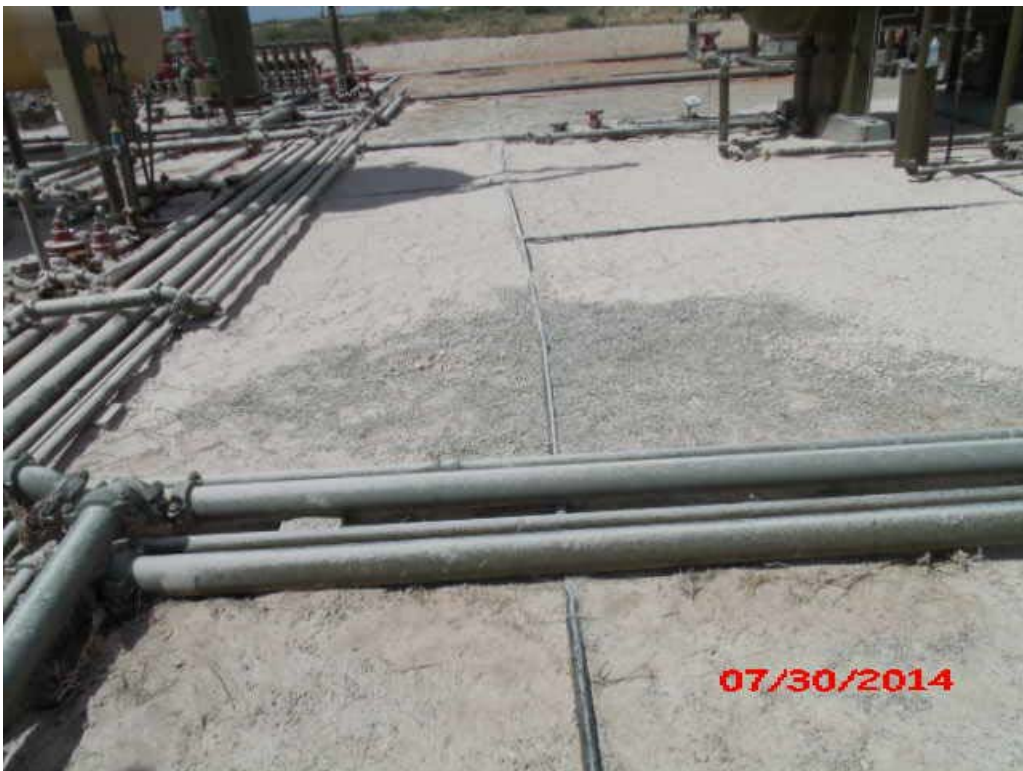
Photograph #10 – Backfilled area

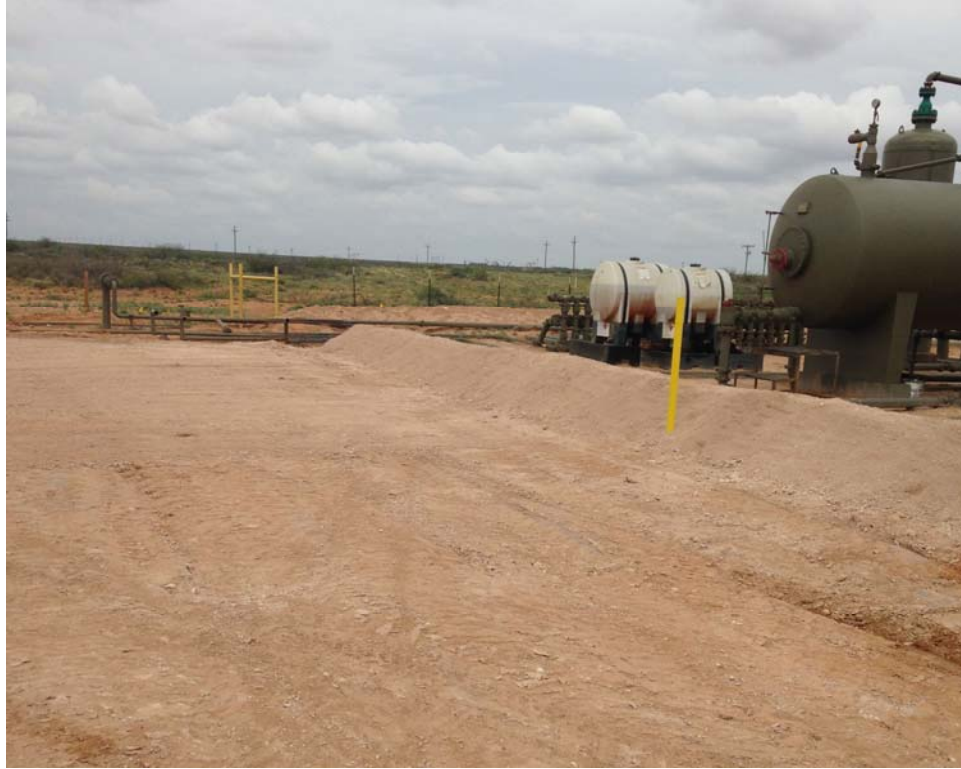
Photograph #11 – Backfilled area

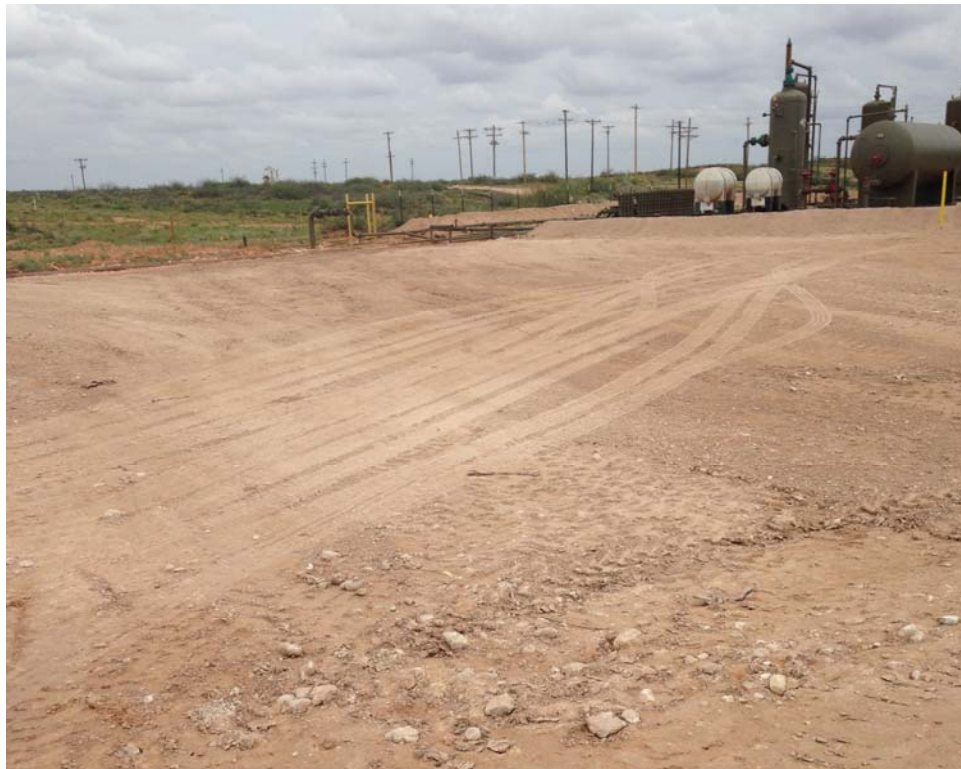
Photograph #12 – Backfilled area
