REMEDIATION SUMMARY AND SITE CLOSURE REQUEST

**BOPCO, LP
JAMES RANCH UNIT #105 FLOW LINE
Eddy County, New Mexico
Unit Letter "J" (NW/SE), Section 36, Township 22 South, Range 30 East
Latitude 32.346486° North, Longitude 103.833236° West
NMOCD Reference #2RP-1731**

January 2015

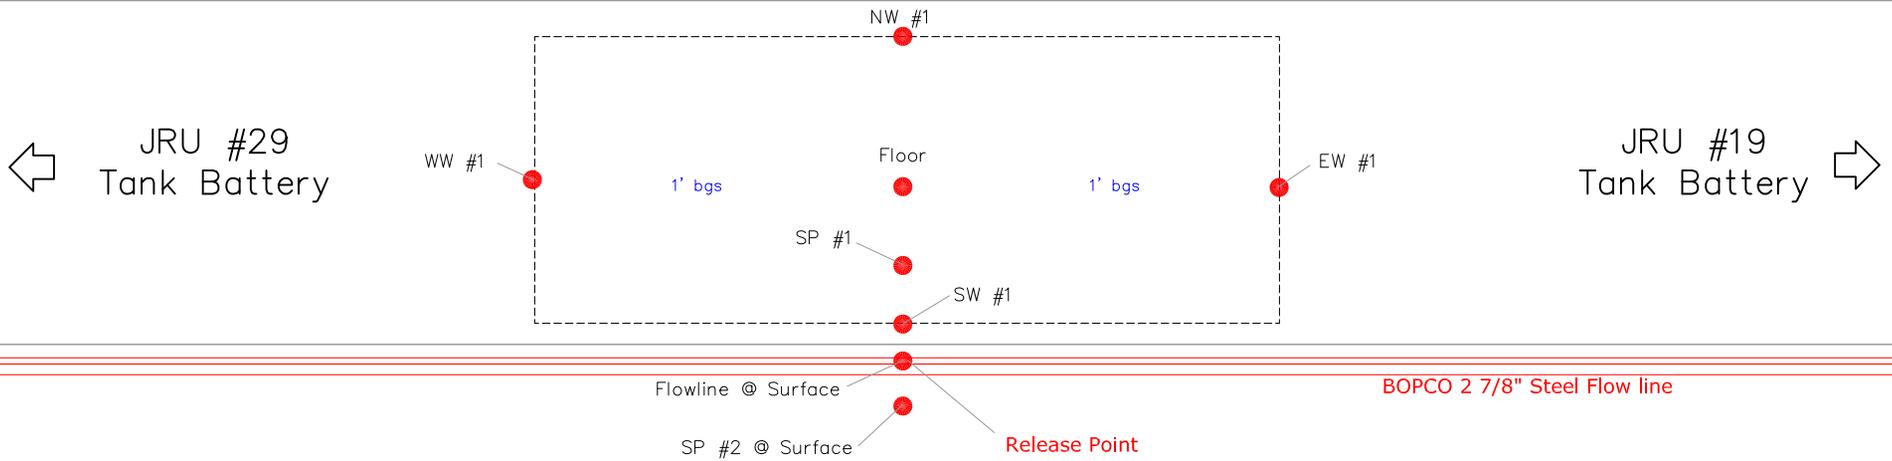
Figure 2
 Site & Sample Location Map
 BOPCO, L.P.
 JRU #105 Flow Line
 Eddy County, New Mexico
 NMOCD Ref# 2RP-1731

BOPCO 2 7/8" Steel Flow line

- Excavation Extent
- Sample Location
- 1' bgs
- Steel Flow Line
- Oilfield Access Road
- X Release Point

On January 9, 2015, Basin conducted an initial investigation at the release site. During the initial investigation, five (5) soil samples (SP #1 @ Surface, SP #1 @ 1', SP #1 @ 2', SP #2 @ Surface and Flowline @ Surface) were collected from within the inferred release margins and submitted to the laboratory for analysis of chloride concentrations. Laboratory analytical results indicated chloride concentrations ranged from 7,120 ppm for soil sample SP #1 @ Surface to 32.0 ppm for soil samples SP #2 @ Surface. Soil samples SP #1 @ Surface, SP #1 @ 1' and SP #2 @ Surface were also analyzed for concentrations of TPH, which were determined to be less than the laboratory method detection limit (MDL). A summary of "Concentrations of Benzene, BTEX, TPH & Chloride in Soil" is provided in Table 1. A "Site & Sample Location Map" is provided as Figure 2. Laboratory analytical reports are provided as Appendix C.

On January 13, 2015, Basin began excavating impacted soil at the release site. The floor and sidewalls of the excavation were advanced until field tests suggested concentrations of BTEX, TPH and chloride were below NMOCD regulatory standards. Excavated soil was stockpiled on-site, pending final disposition.

Upon excavating the impacted area, five (5) confirmation soil samples (NW #1, EW #1, SW #1, WW #1 and Floor) were collected from the excavated area and submitted to the laboratory for analysis of chloride concentrations. Laboratory analytical results indicated chloride concentrations ranged from 448 ppm for soil sample SP #1 @ 1' to 272 ppm for soil sample Floor. Soil sample Floor was also analyzed for concentrations of BTEX and TPH, which were determined to be less than the appropriate laboratory MDL.

Approximately forty cubic yards (40 yd³) of impacted material was transported to Lea Land, Inc. (NMOCD Permit #WM-01-035) for disposal. The final dimensions of the excavation were approximately fifteen feet (15') in width, thirty-five feet (35') in length and one foot (1') in depth. Upon receiving laboratory analytical data from confirmation soil samples, the excavated area was backfilled with locally purchased, non-impacted caliche.

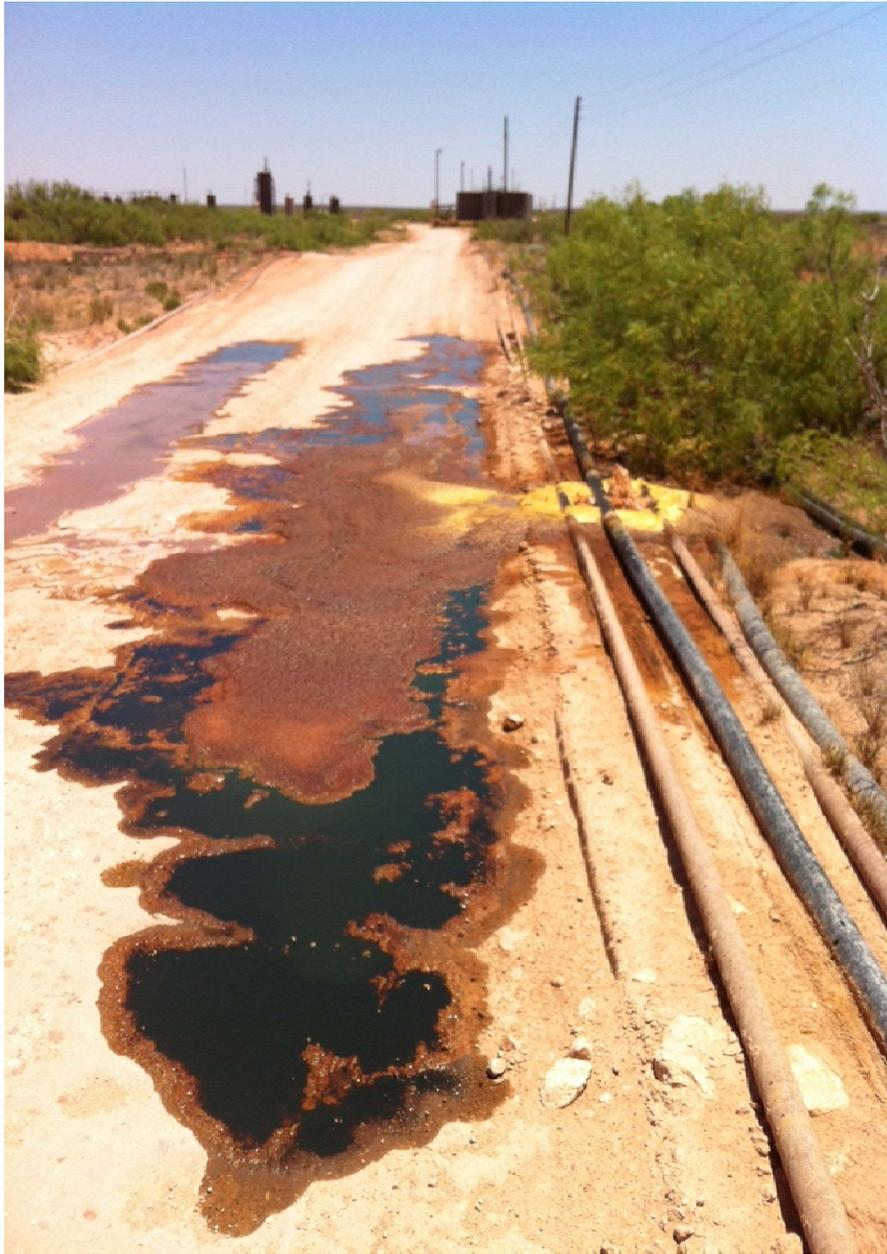
Photograph of the initial release at the JRU #105 flow line release site.

On May 19, 2013, BOPCO discovered a release had occurred on the JRU #105 flow line. The release was attributed to the failure of a section of two and seven-eighths inch (2 7/8") flow line, resulting in the release of approximately two barrels (2 bbls) of crude oil and six barrels (6 bbls) of produced water. The "Release Notification and Corrective Action" (Form C-141) indicated approximately three hundred square feet (300 ft²) of caliche road and two hundred square feet (200 ft²) of pasture was affected by the release. During initial response activities, approximately two barrels (2 bbls) of free-standing fluid was recovered using a vacuum truck. The affected segment of pipe has since been replaced. The Form C-141 is provided as Appendix A. General photographs of the release site are provided as Appendix B.

The flow developed a leak due to external corrosion, a temporary repair clamp was placed on the line. The bad section of pipe will be replaced.

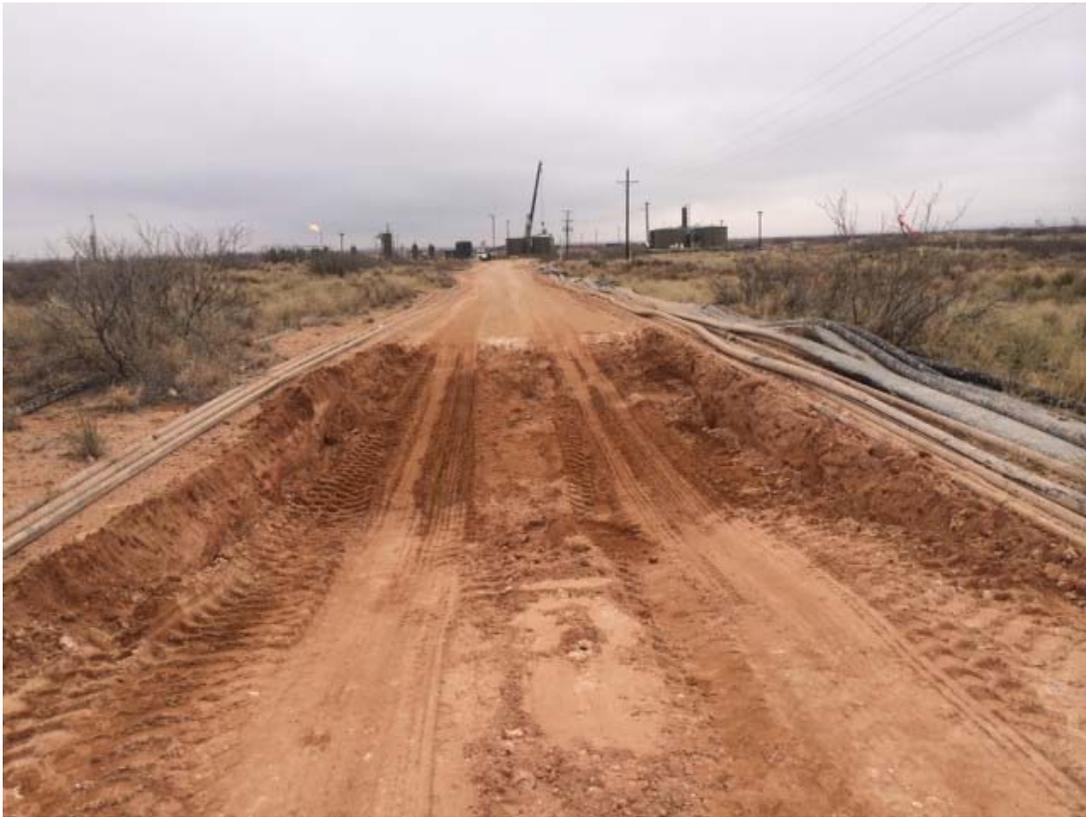
Photograph of the excavated area at the JRU #105 flow line release site.

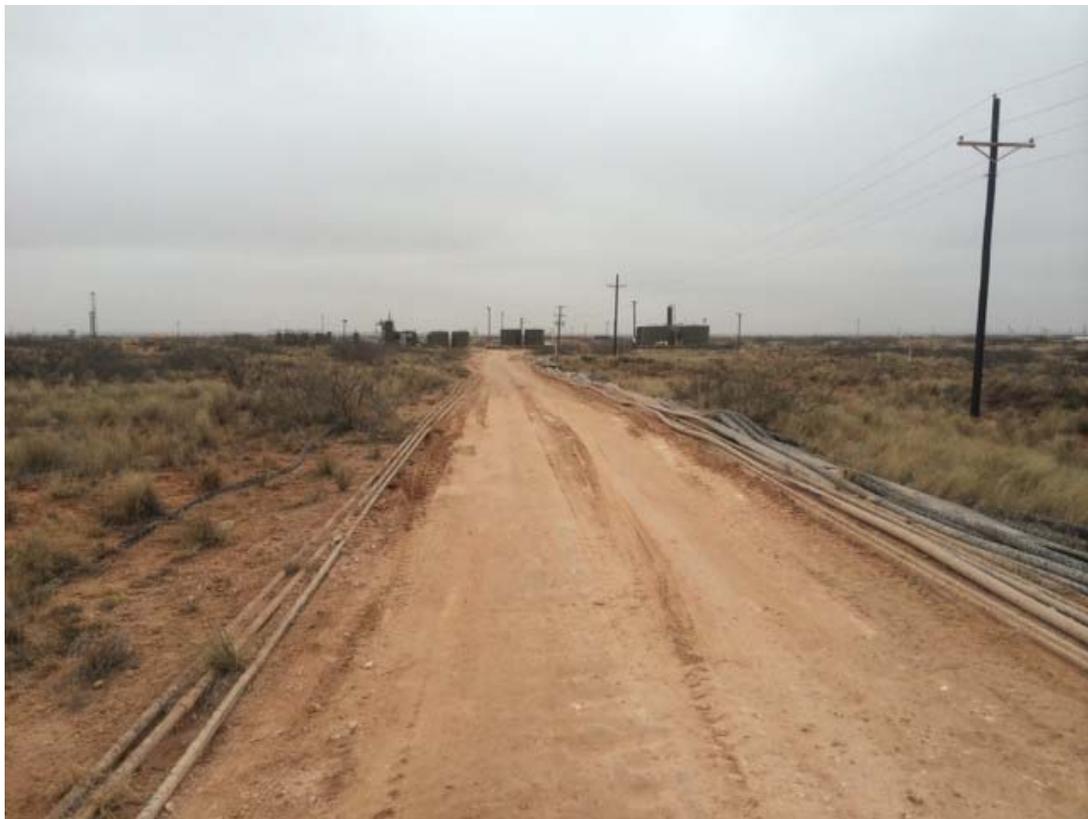
Photograph of the JRU #105 flow line release site after remediation activities.
