Barclay Fed #27

REMEDIATION WORK PLAN

API No. 30-015-30883

RE: Linn Energy Barclay Fed #27 – Remediation Work Plan UL/I, Section 1, T23S, R31E API No. 30-015-30883

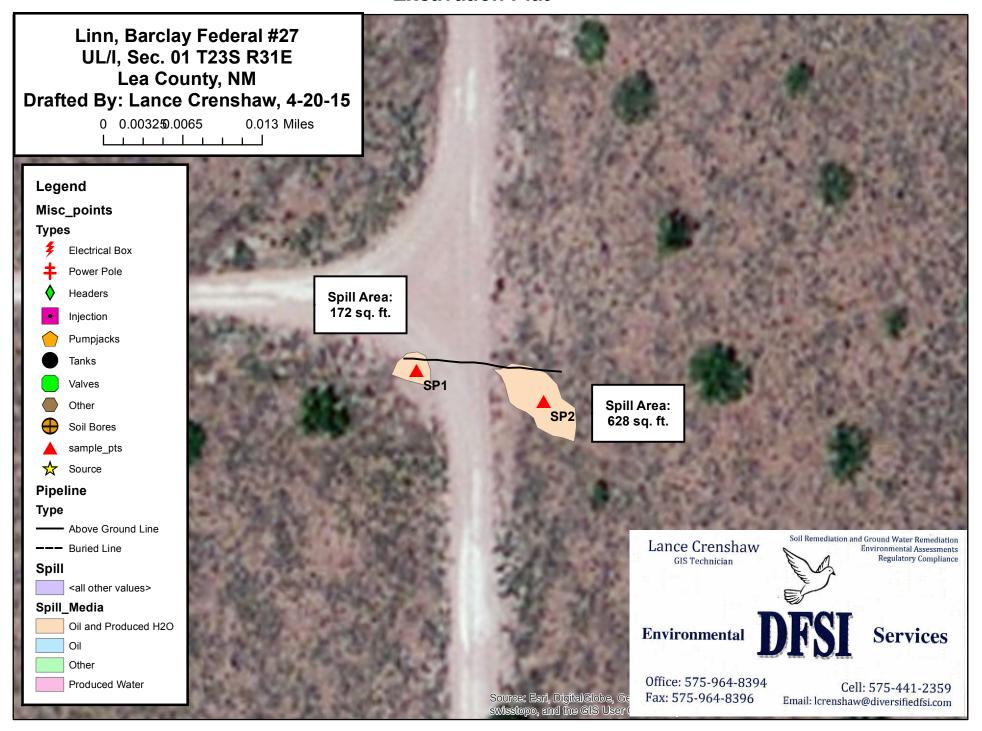
The site is located east of Loving NM, in Eddy County. The leak site resulted from a failure of a steel flow line. The impacted area is the west and east sides of the caliche road near the intersection. Approx. 1 bbs of produced water was released, and 0 bbl recovered. Approx. 1 bbl of oil was released, and 0 bbl recovered. A C-141 was submitted to the NMOCD on April 20th, 2015.

Remove the contaminated soil in the affected area to 3' bgs and backfill. We plan to use the surrounding soil and re contour the affected area. Then seed with a BLM, NMOCD approved seed mix.
