Release Notification and Corrective Action

SITE CLOSURE REPORT RJU SOUTH 4" PIPELINE RELEASE 2RP-2367

SW/4 of Section 26, Township 17 South, Range 29 East
Eddy County, New Mexico

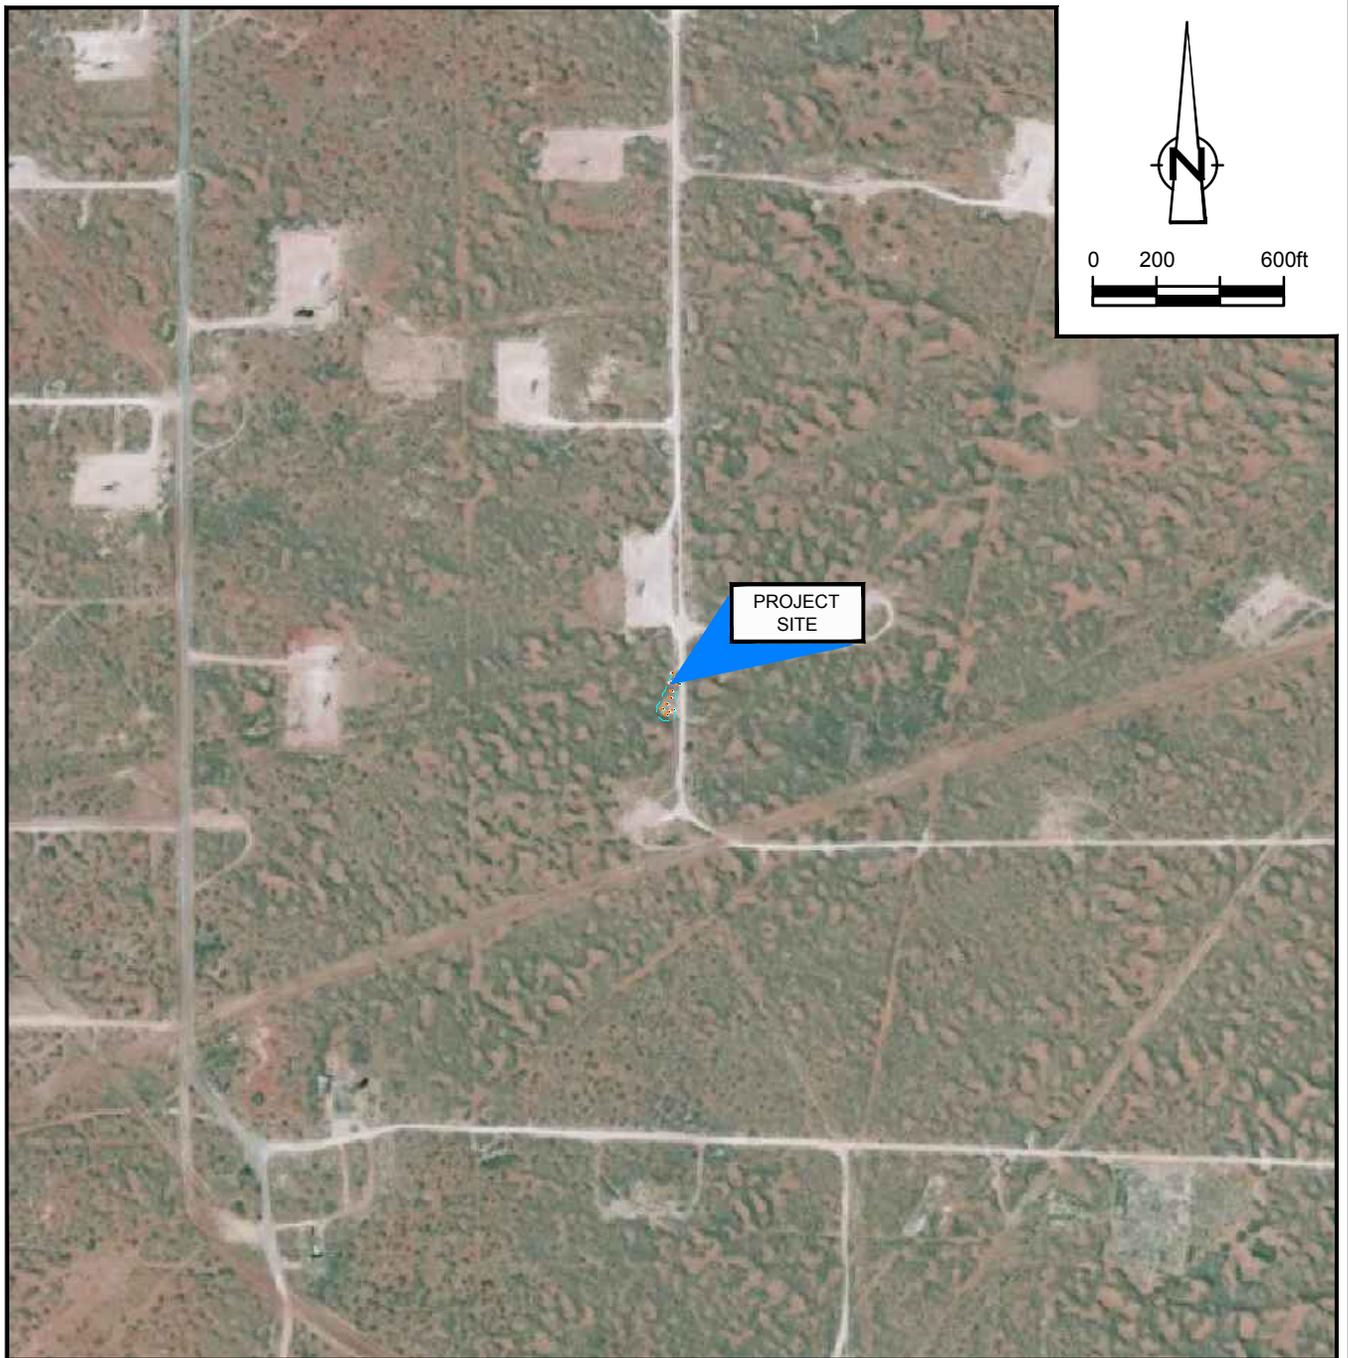
Figure 2
SITE AERIAL MAP
RJU SOUTH 4" CRUDE OIL RELEASE SITE
SECTION 26, T-17-S, R-29-E
EDDY COUNTY, NEW MEXICO
Holly Energy Partners

CRA inspected the Site on March 26, 2014 with a HEP representative and OneSource Industrial (One Source) to evaluate the site conditions and plan for additional assessment and remedial actions. Additionally, CRA met with HEP Operations to obtain details on the incident and coordinate subsequent activities. A composite waste soil sample was collected for waste characterization purposes and NMOCD Form C-138 completion, Request for Approval to Accept Solid Waste, generation and approval. The RJU South 4" crude oil pipeline is not directly associated with Exploration and Production (E&P) activities as the liquids have changed custody from lease operations. The waste materials associated with the release are considered "RCRA non-exempt". A Site aerial map is presented as Figure 2.

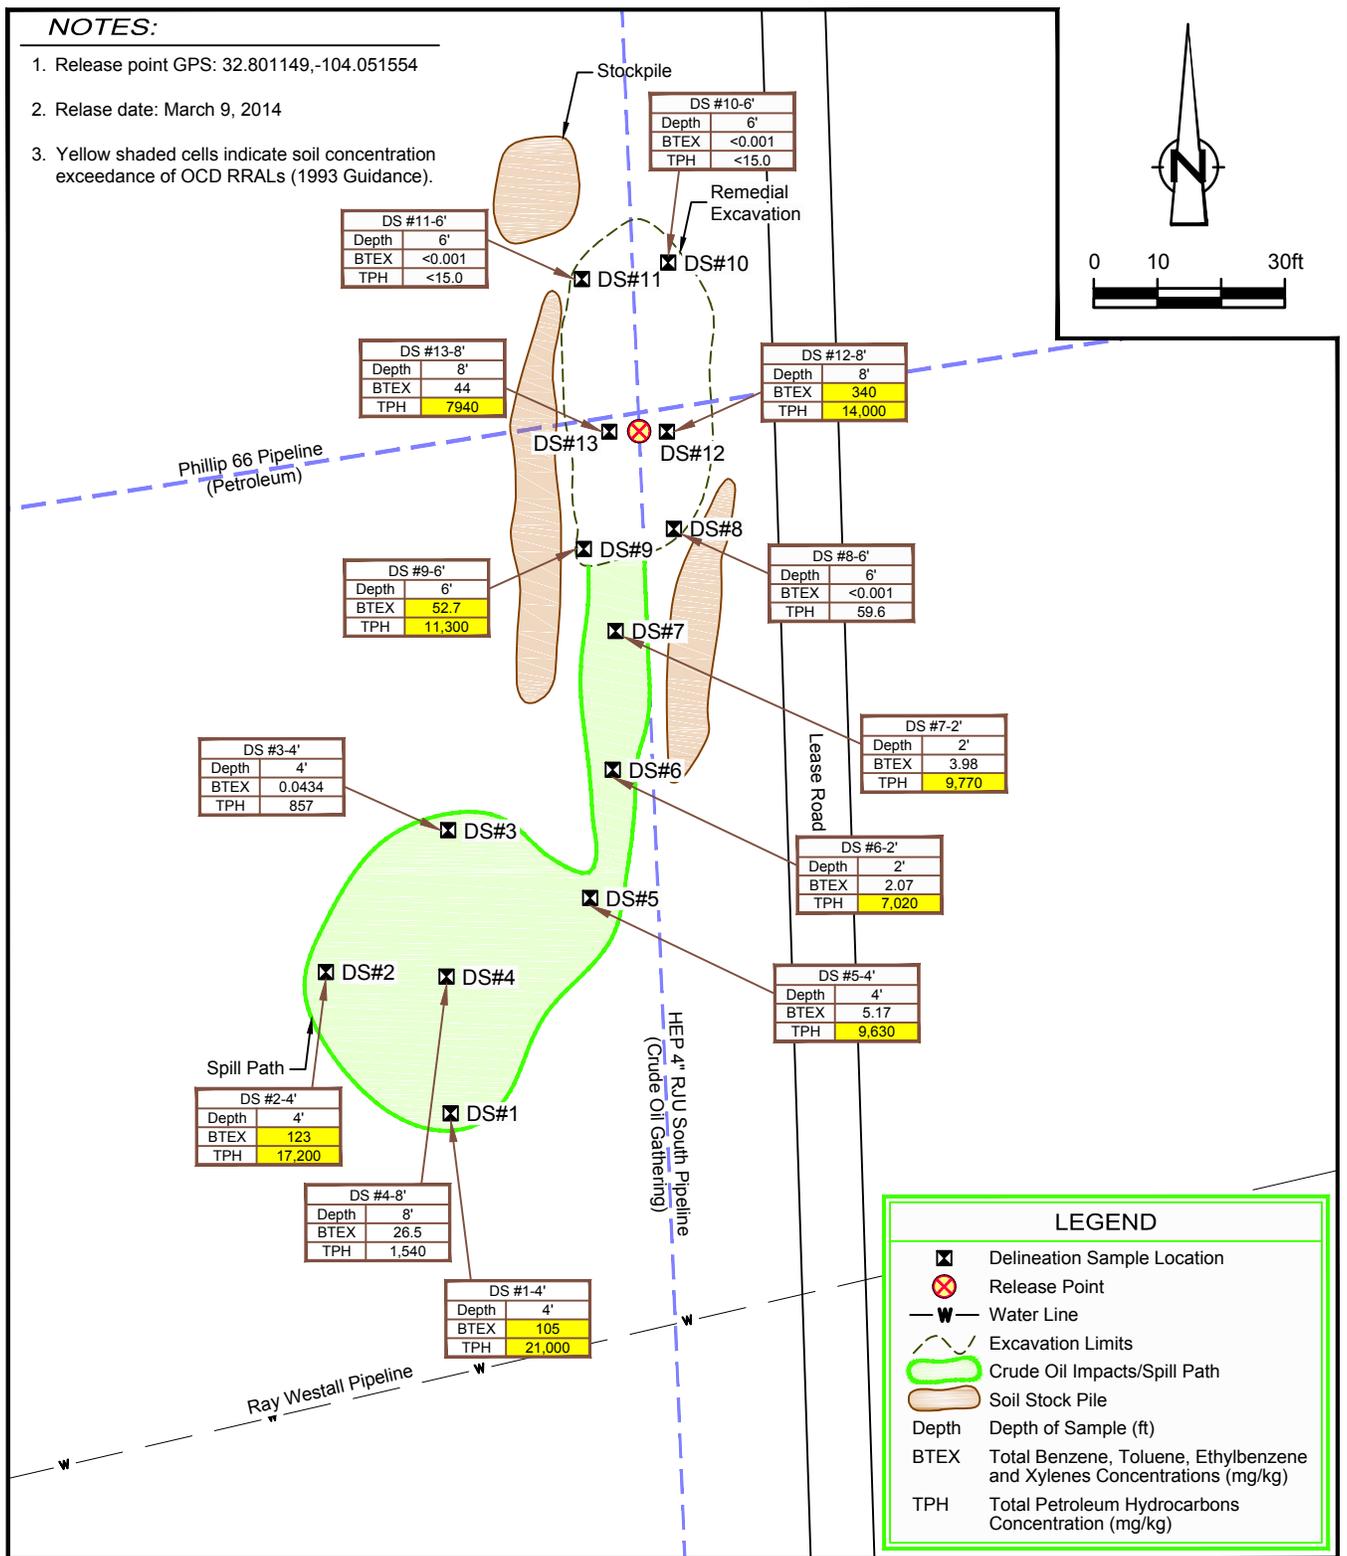
Figure 3

Test pit samples (delineation samples, DS) were collected on August 7, 2014 from each of the test pit locations at depths of 2-8 feet below ground surface (bgs). The samples were submitted to Xenco Laboratories in Odessa, Texas and analyzed for TPH by SW 8015 Modified method (C6 to C35) and BTEX by EPA method 8021B. Results of the assessment analytical data are summarized in Table 1. Samples collected from the edges of the crude oil pool, DS #1 and 2, exhibited BTEX and TPH concentrations above the NMOCD Recommended remediation action levels (RRALs). Along the spill path, DS #5, 6 and 7 exhibited TPH concentrations above the RRALs. Within the emergency excavation area, DS # 9 and 12 exhibited BTEX and TPH concentrations above the RRALs and DS #13 exhibited TPH concentrations above RRALs. The remaining DS locations (1, 2, 3, 4, 8, 10, and 11) exhibited BTEX and TPH concentrations below RRALs. Site photographs depicting the affected areas and test pits are presented in Appendix C. Copies of certified laboratory reports and chain of custody documentation are attached in Appendix D.

1. Release point GPS: 32.801149,-104.051554
2. Release date: March 9, 2014
3. Yellow shaded cells indicate soil concentration exceedance of OCD RRALs (1993 Guidance).

**SITE DETAIL AND DELINEATION SAMPLES
 RJU SOUTH 4" CRUDE OIL RELEASE SITE
 SECTION 26, T-17-S, R-29-E
 EDDY COUNTY, NEW MEXICO
 Holly Energy Partners**

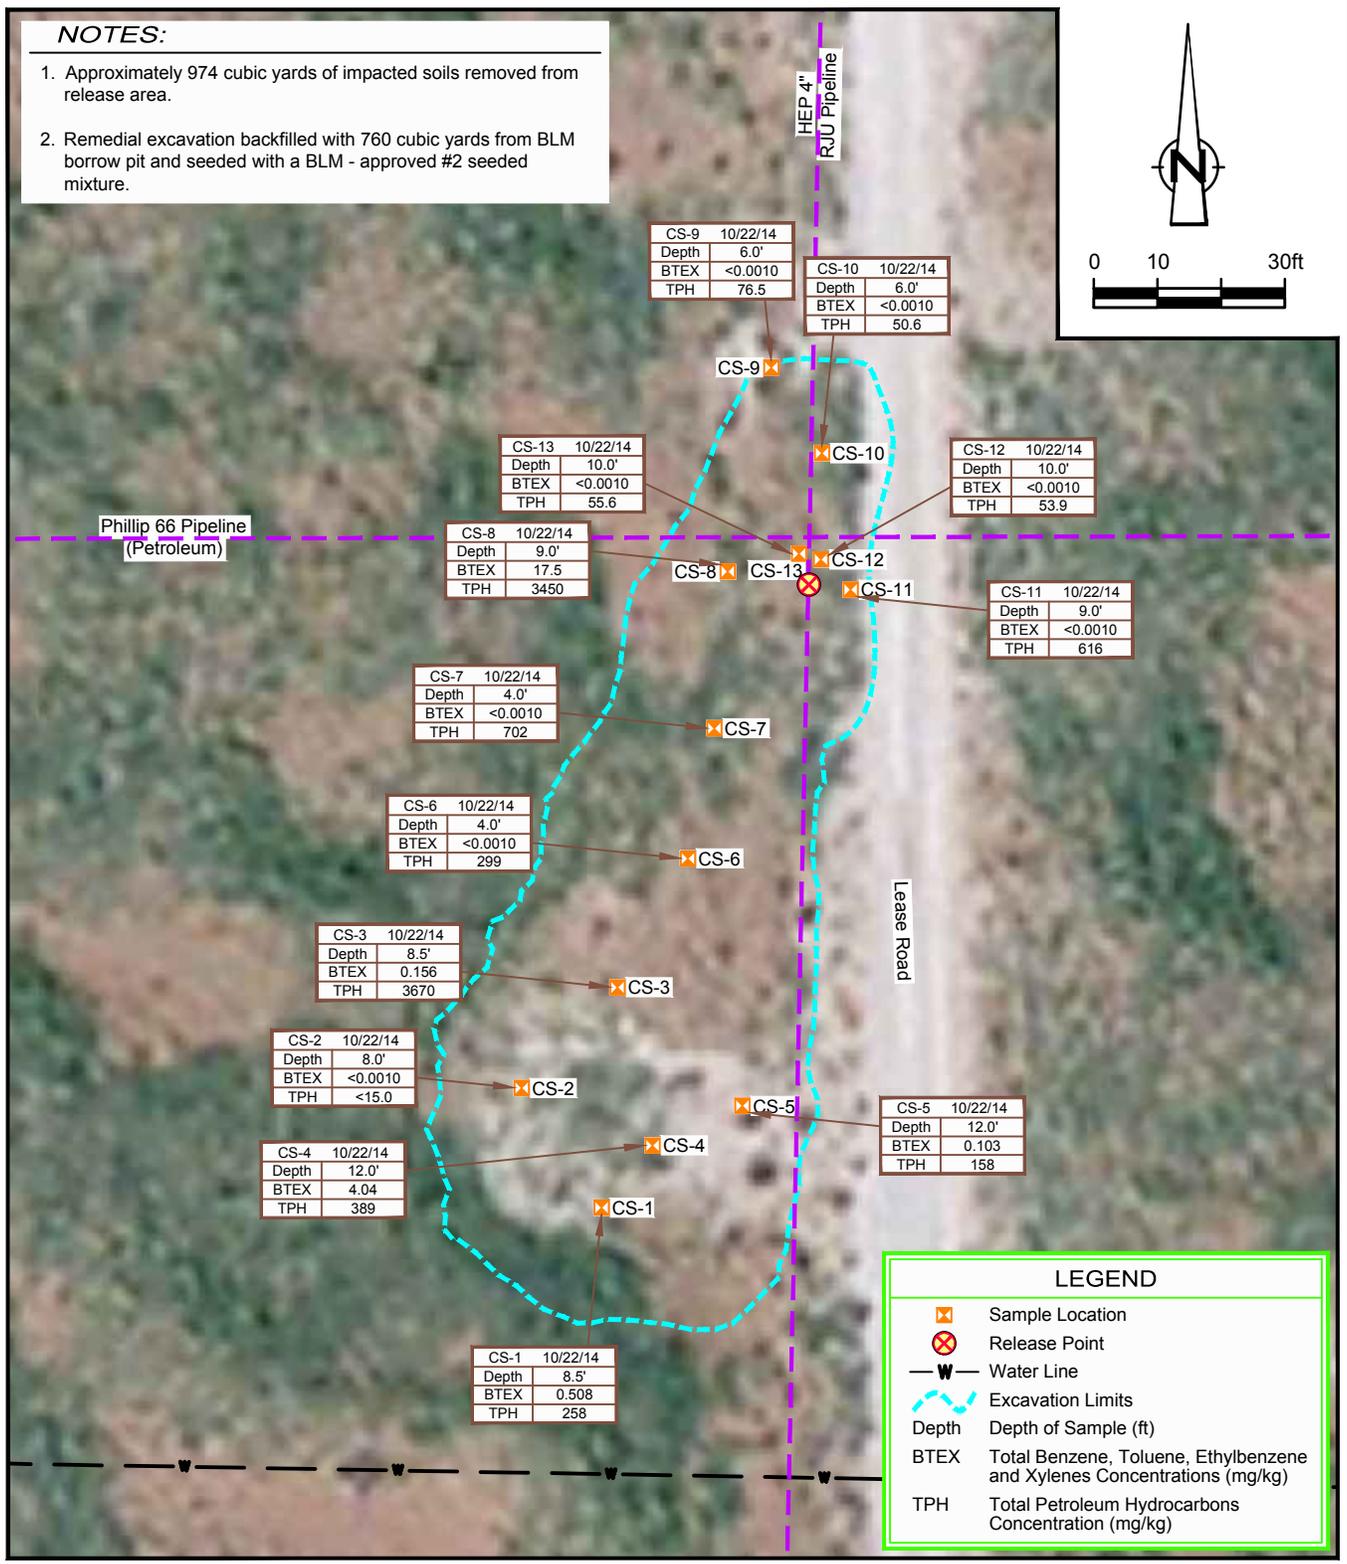
Soil excavating operations were conducted at the Site on August 7, 2014 and re-commenced between August 27 and September 17, 2014. The heavily stained soil around the affected areas was removed and stockpiled adjacent to the remedial excavations. A Petroflag TPH field screening kit was utilized during excavations to evaluate TPH concentrations to below RRALs as the impacted soils were being over-excavated. Approximately 974 cubic yards (cy) of soil was removed from the remedial excavations.

1. Approximately 974 cubic yards of impacted soils removed from release area.
2. Remedial excavation backfilled with 760 cubic yards from BLM borrow pit and seeded with a BLM - approved #2 seeded mixture.

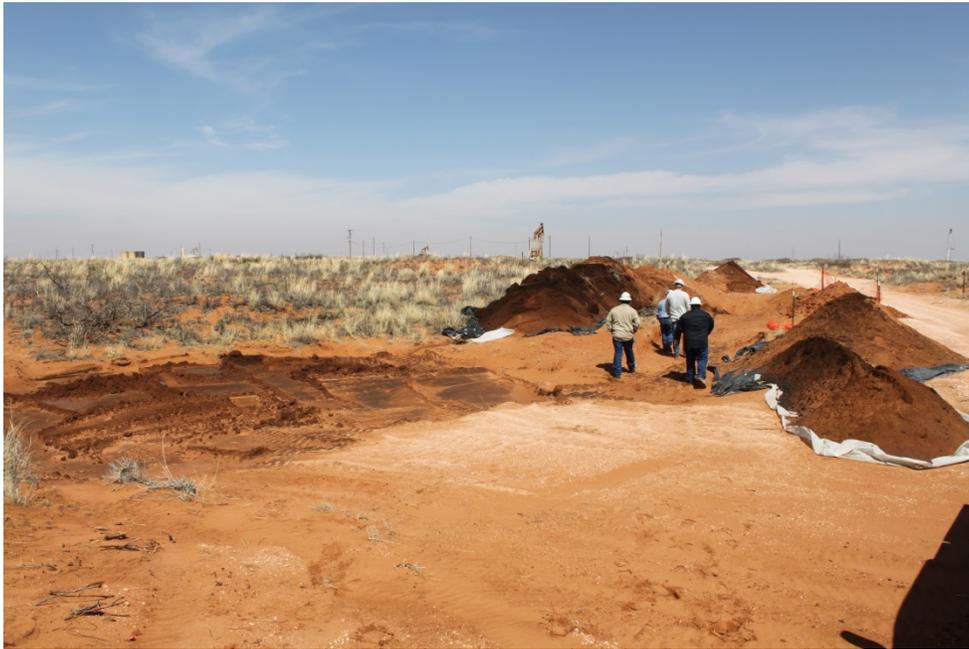
Photo 1 – March 26, 2014: looking north showing impacted soils and stockpiles.

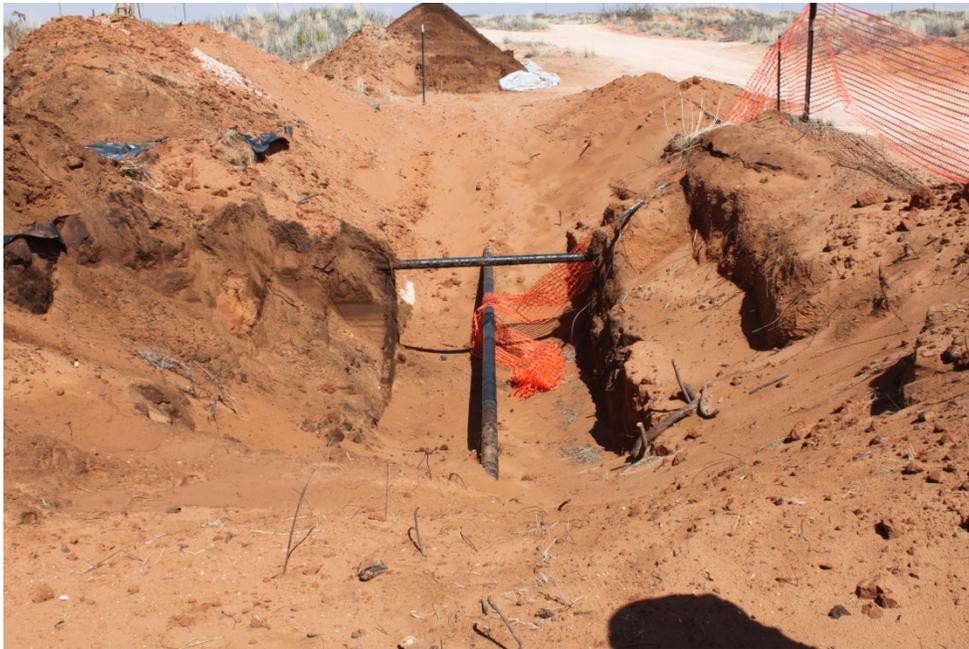
Photo 2 – March 26, 2014: looking north showing the emergency excavation around the Phillips 66 Pipeline (top) and HEP RJU South 4" Pipeline (bottom).

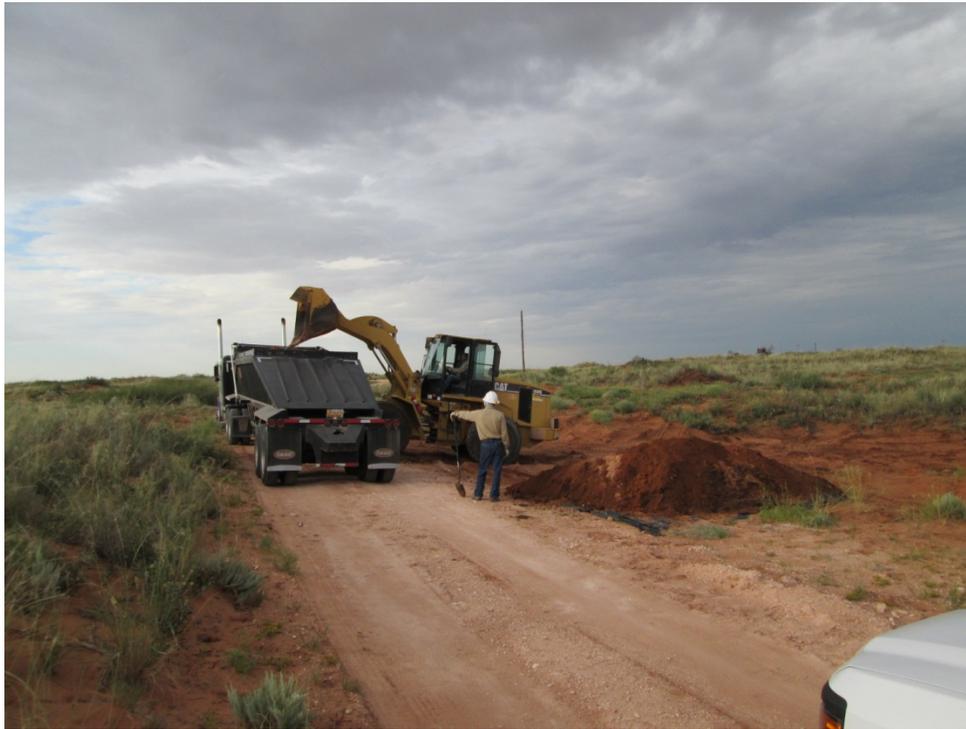
Photo 3 – August 27, 2014: looking south as excavations along the spill path began.

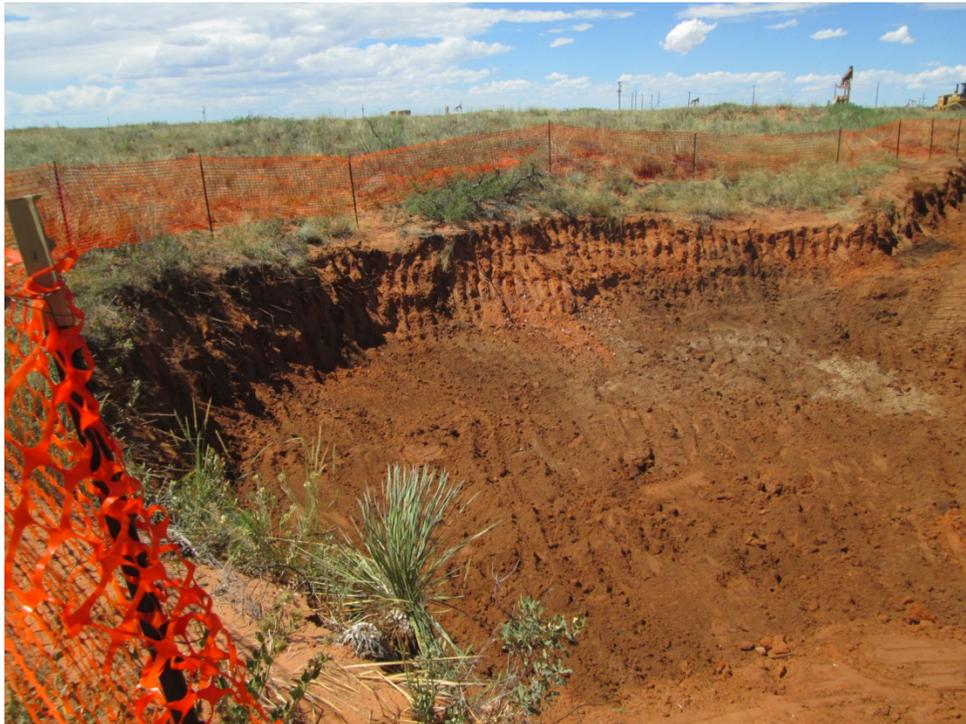
Photo 4 – August 28, 2014 facing northwest showing western extent of the spill path excavation.

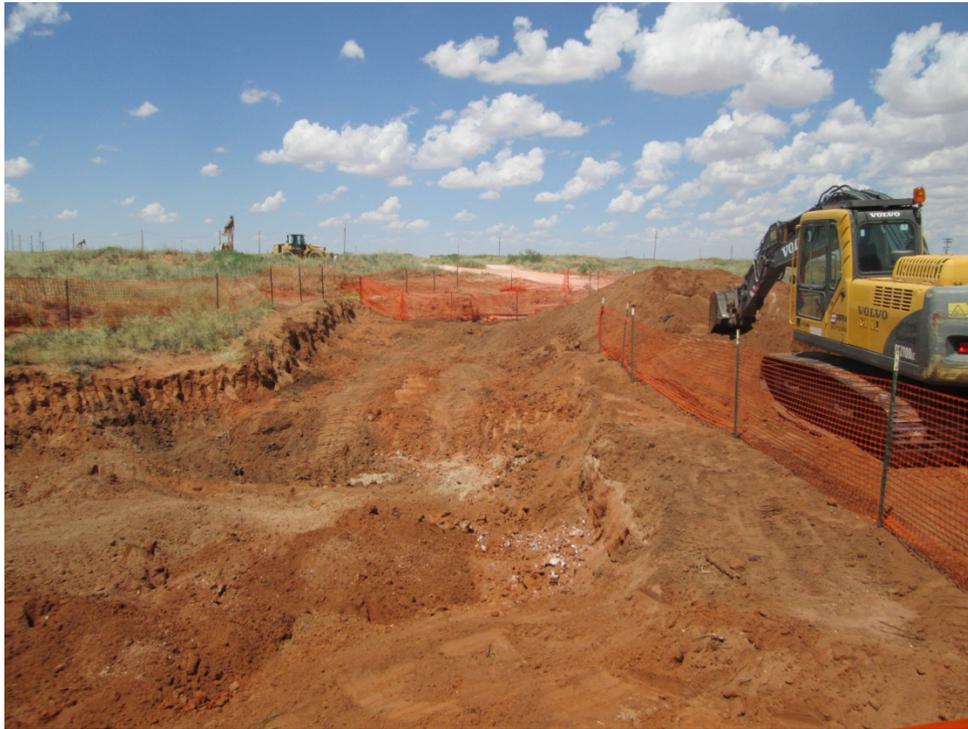
Photo 5 – August 29, 2014: looking north along the spill path.

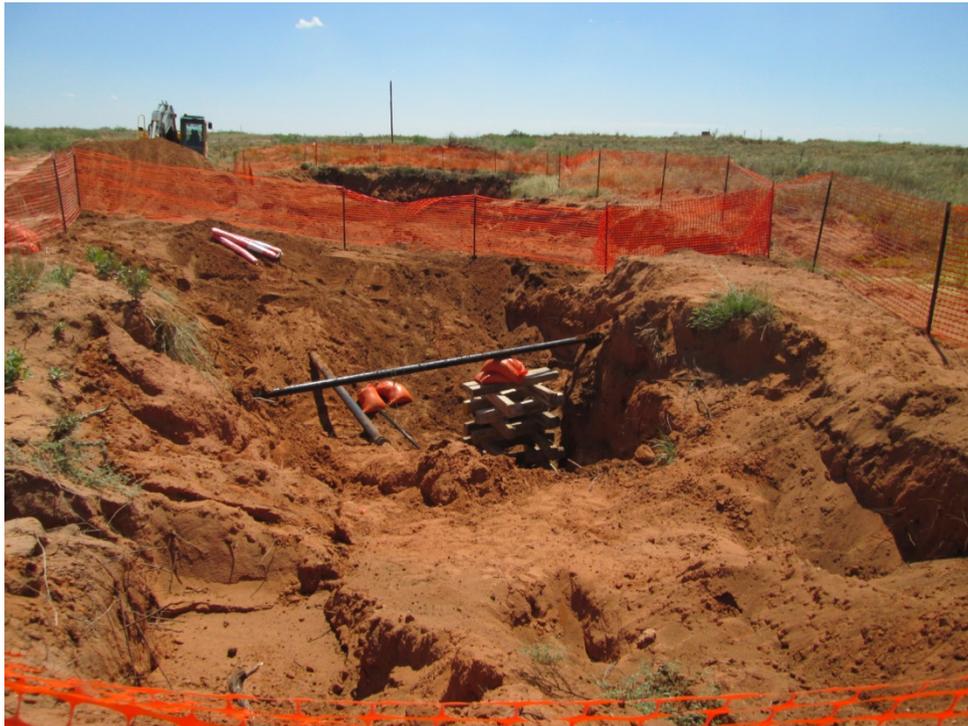
Photo 6 – August 29, 2014 facing south west. The emergency excavation is in the foreground with the spill path excavation in the background.

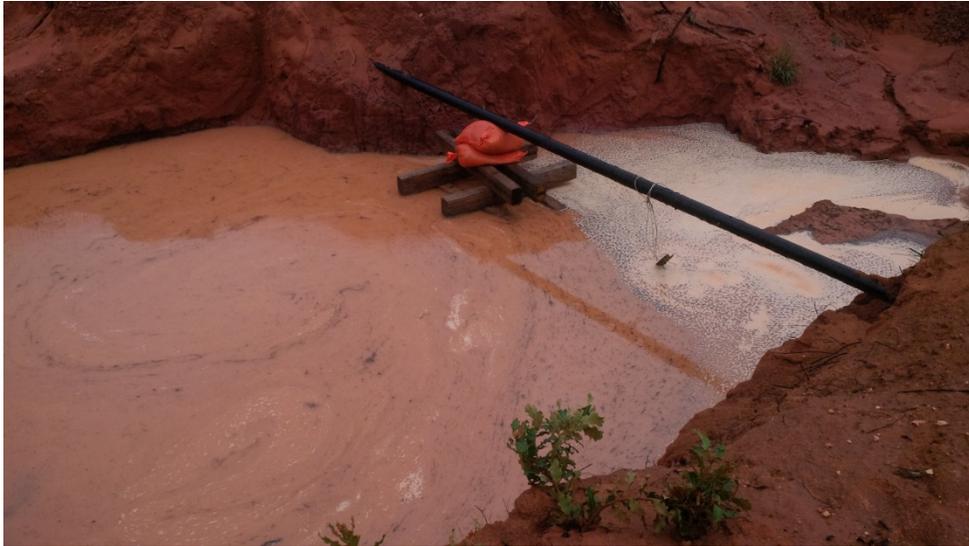
Photo 7 – September 22, 2014: Emergency excavation following heavy rains on September 18-20, 2014.

September 15, 2014 (Monday)	Site visit postponed due to rain in the forecast.
September 18-20, 2014 (Thursday-Saturday)	Heavy rainfall in and around the site location caused areal flooding and pooling of water in the excavation bottom.
October 1, 2014 (Wednesday)	Site visit made by Steven Perez out of the Albuquerque office to assess site conditions following heavy rainfall in the area. Mr. Perez reported approximately 4 feet of standing water in the excavation area.
October 7, 2014 (Tuesday)	Additional site visit made by Steven Perez to assess amount of water still in the excavation area. Water level had not changed much since the last visit and approximately four feet of water still stood in the excavation.
October 13, 2014 (Monday)	Arrived on-site to assess the amount of water in the bottom of the excavation. A transfer pump was used to remove approximately 4 feet of water from the excavation. Additionally, the fence around the excavation was repaired.

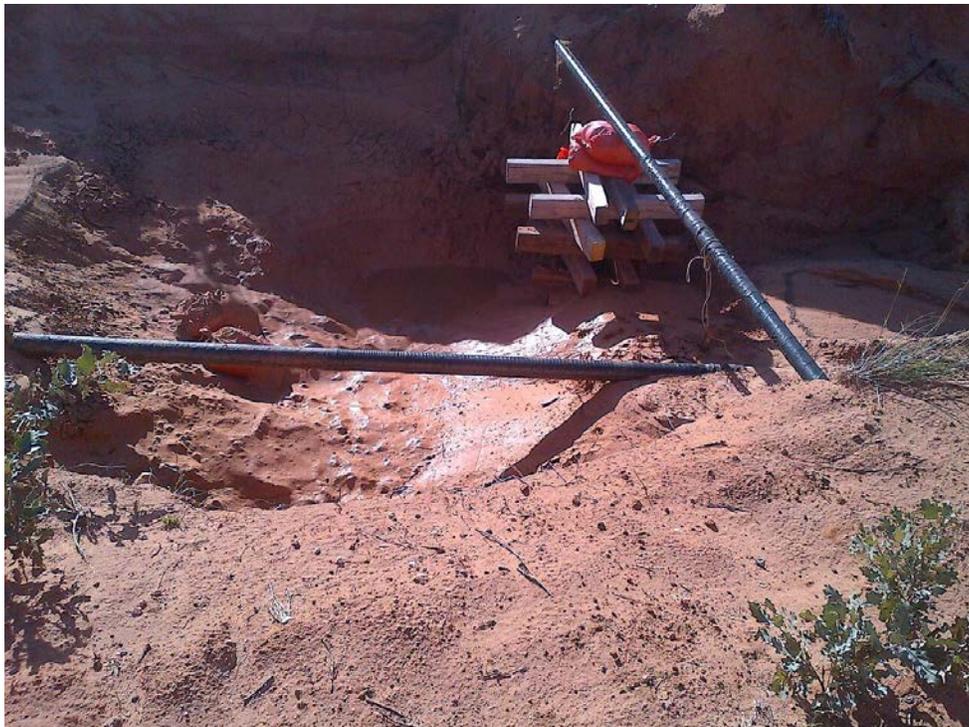
Photo 8 – October 7, 2014: Emergency excavation following heavy rains in September.

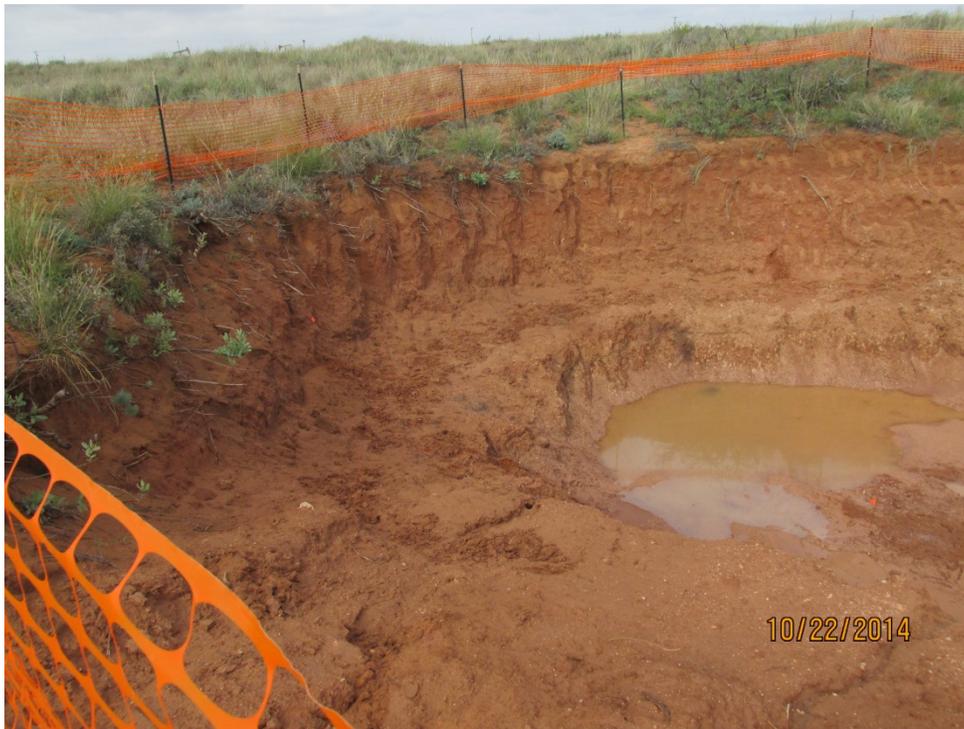
Photo 9 – October 22, 2014: facing west following removal of approximately 4 feet of water from the spill path excavation.

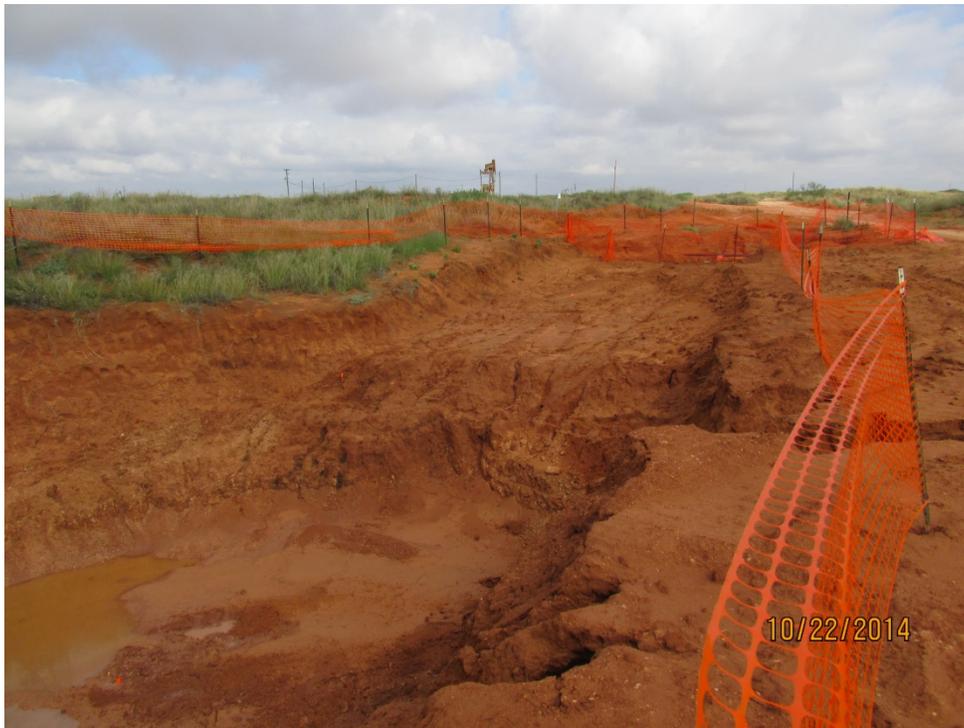
Photo 10 – October 22, 2014: looking north along the spill path excavation.

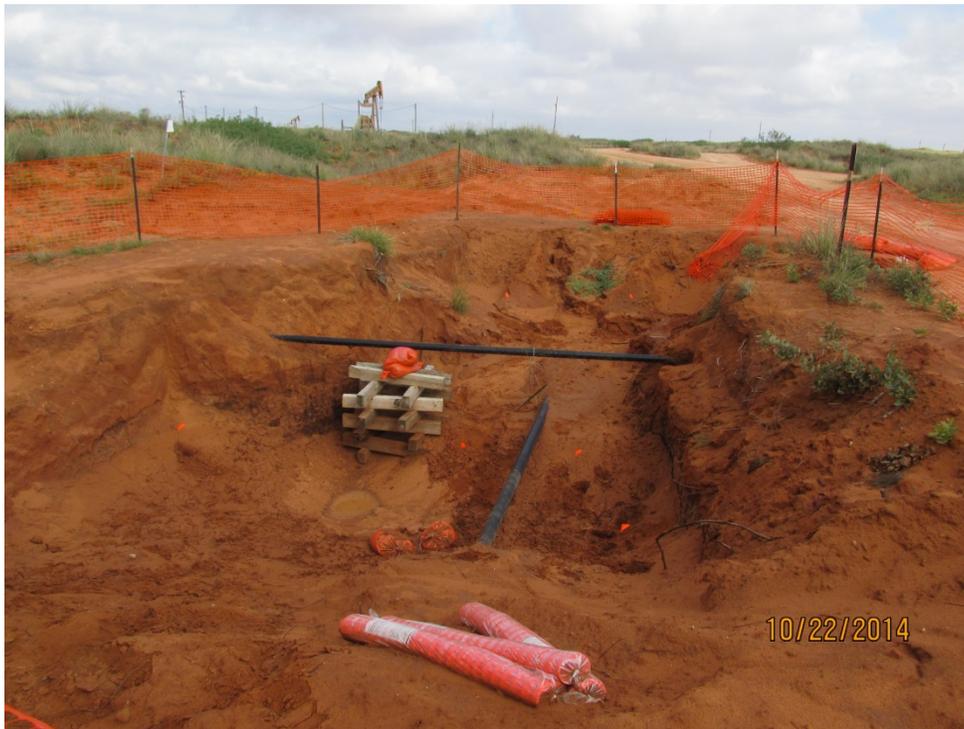
Photo 11 – Emergency excavation on October 22, 2014 looking north.

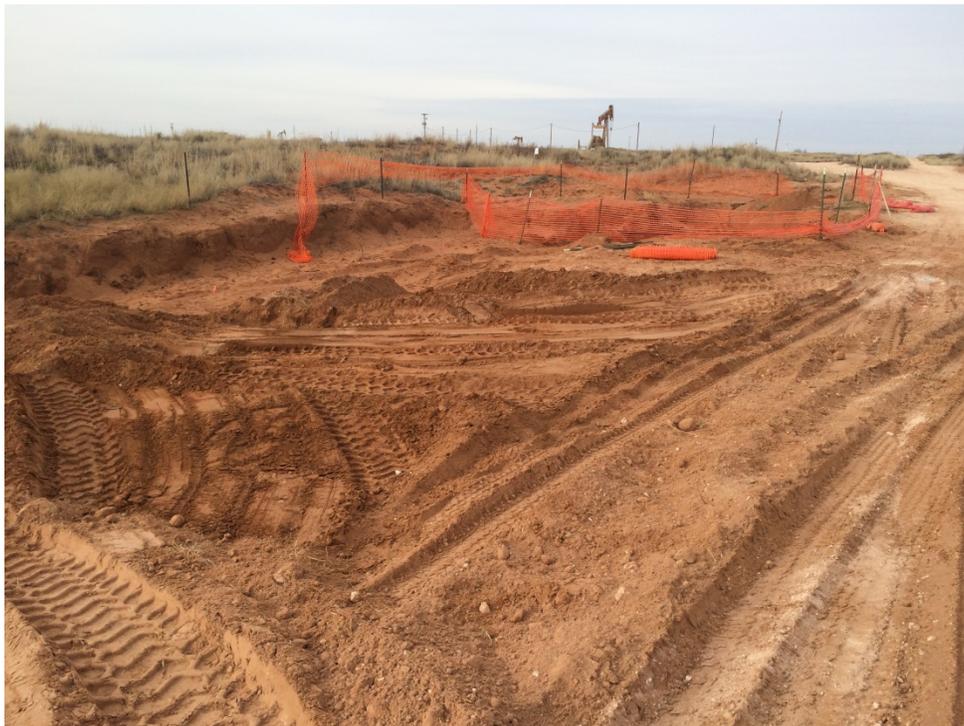
Photo 12 – December 16, 2014: looking north/northwest during backfill activities.

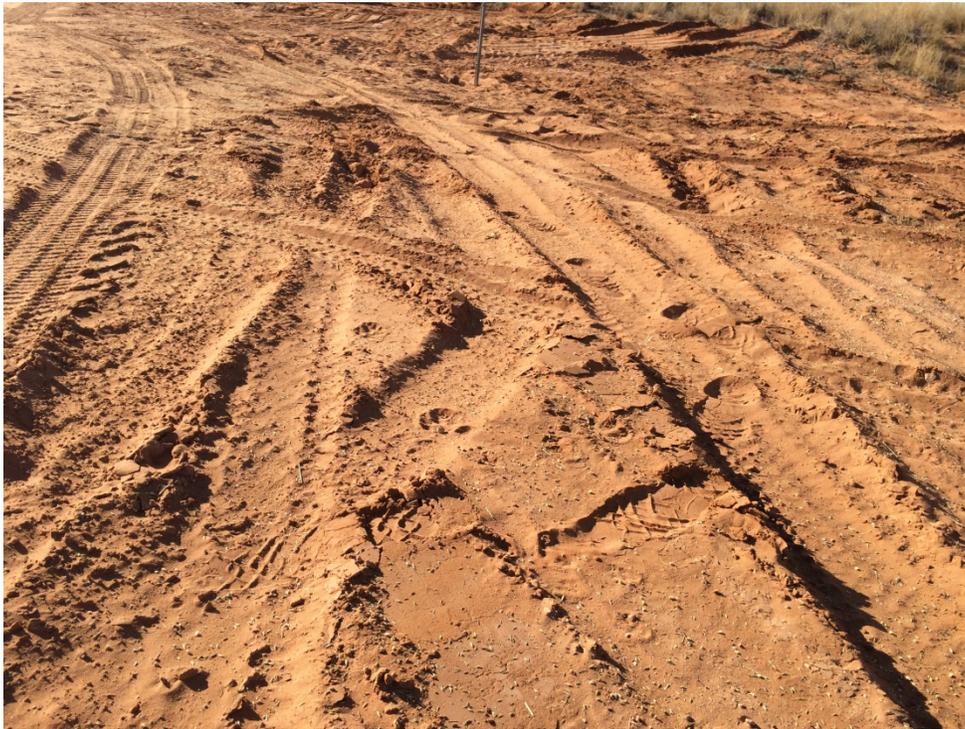
Photo 13 – December 16, 2014: Hand-broadcasting of BLM-approved Lesser Prairie Chicken (LPC) seed mix over the backfilled excavations.

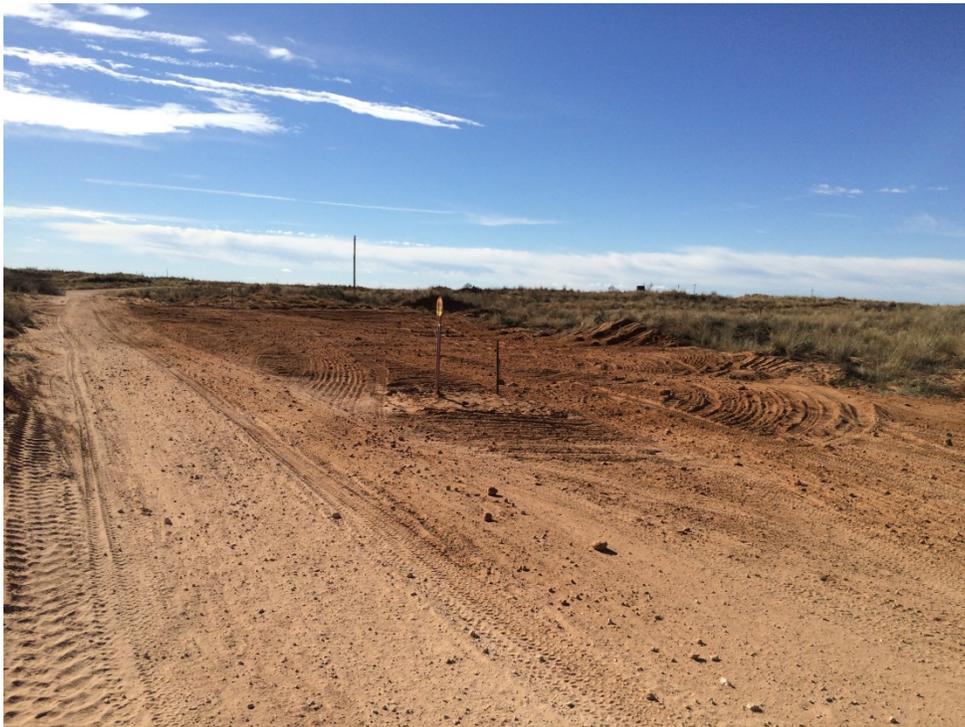
Photo 14 – December 16, 2014: looking south at the backfilled excavations.
