Report Type: Closure Report

Site:	State S-19 Tank Battery					
Company:	COG Operating LLC					
Section, Township and Range	Unit J	Sec 19	T17S	R29E		
Lease Number:	30-01532502					
County:	Eddy County					
GPS:	32.8173			104.11283		
Surface Owner:	State					
Mineral Owner:						
Directions:	From the intersection of CR 217 and Hwy 82, travel west on Hwy 82 for 7.5 miles, turn right go 0.5 miles, turn right go 0.1 miles to location .

**Re: Closure Report for the COG Operating LLC., State S-19 Tank Battery,
Unit J, Section 19, Township 17 South, Range 29 East, Eddy County,
New Mexico.**

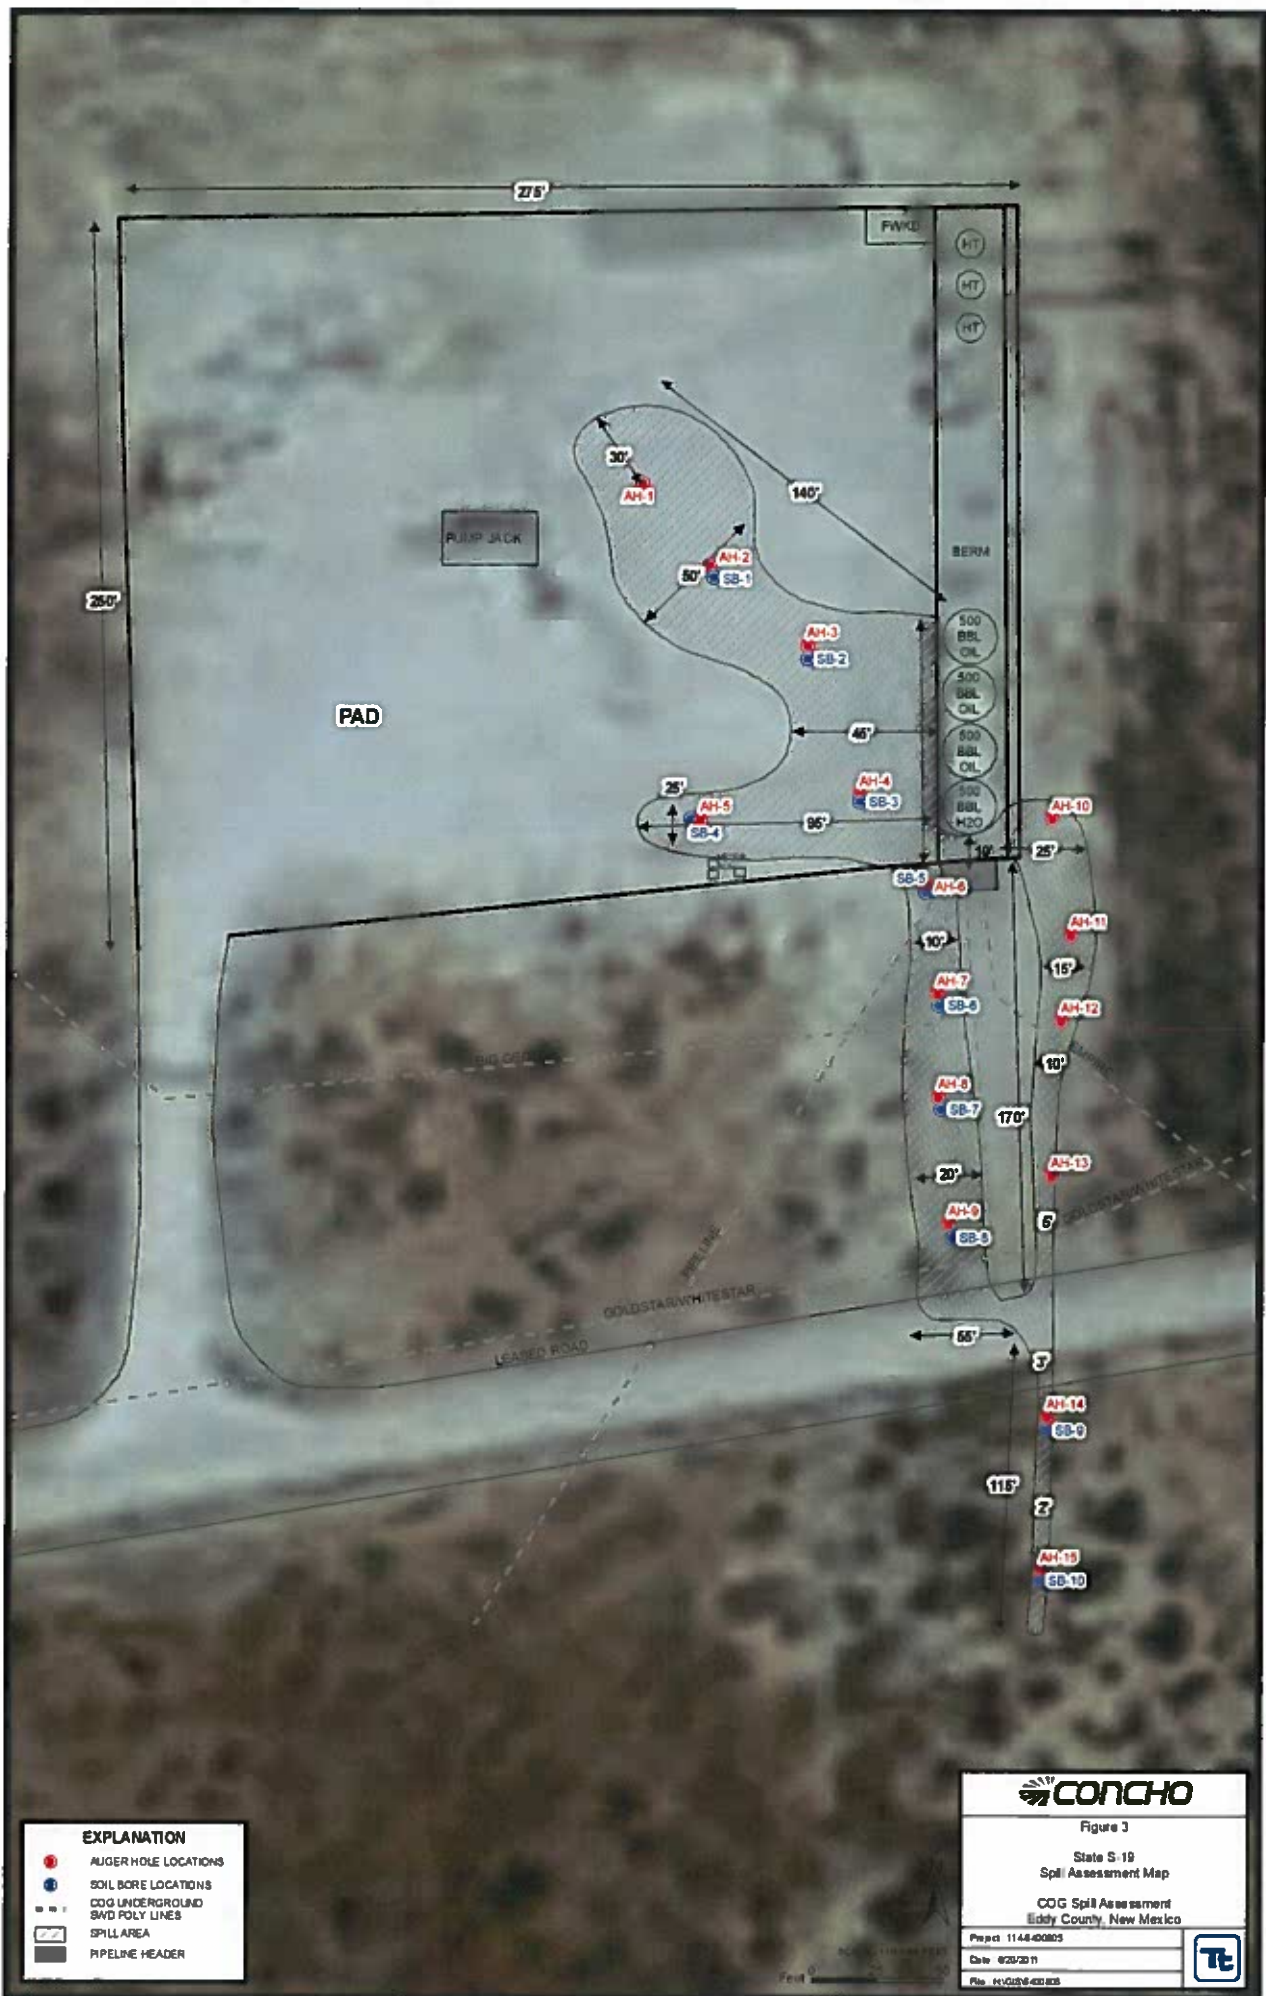
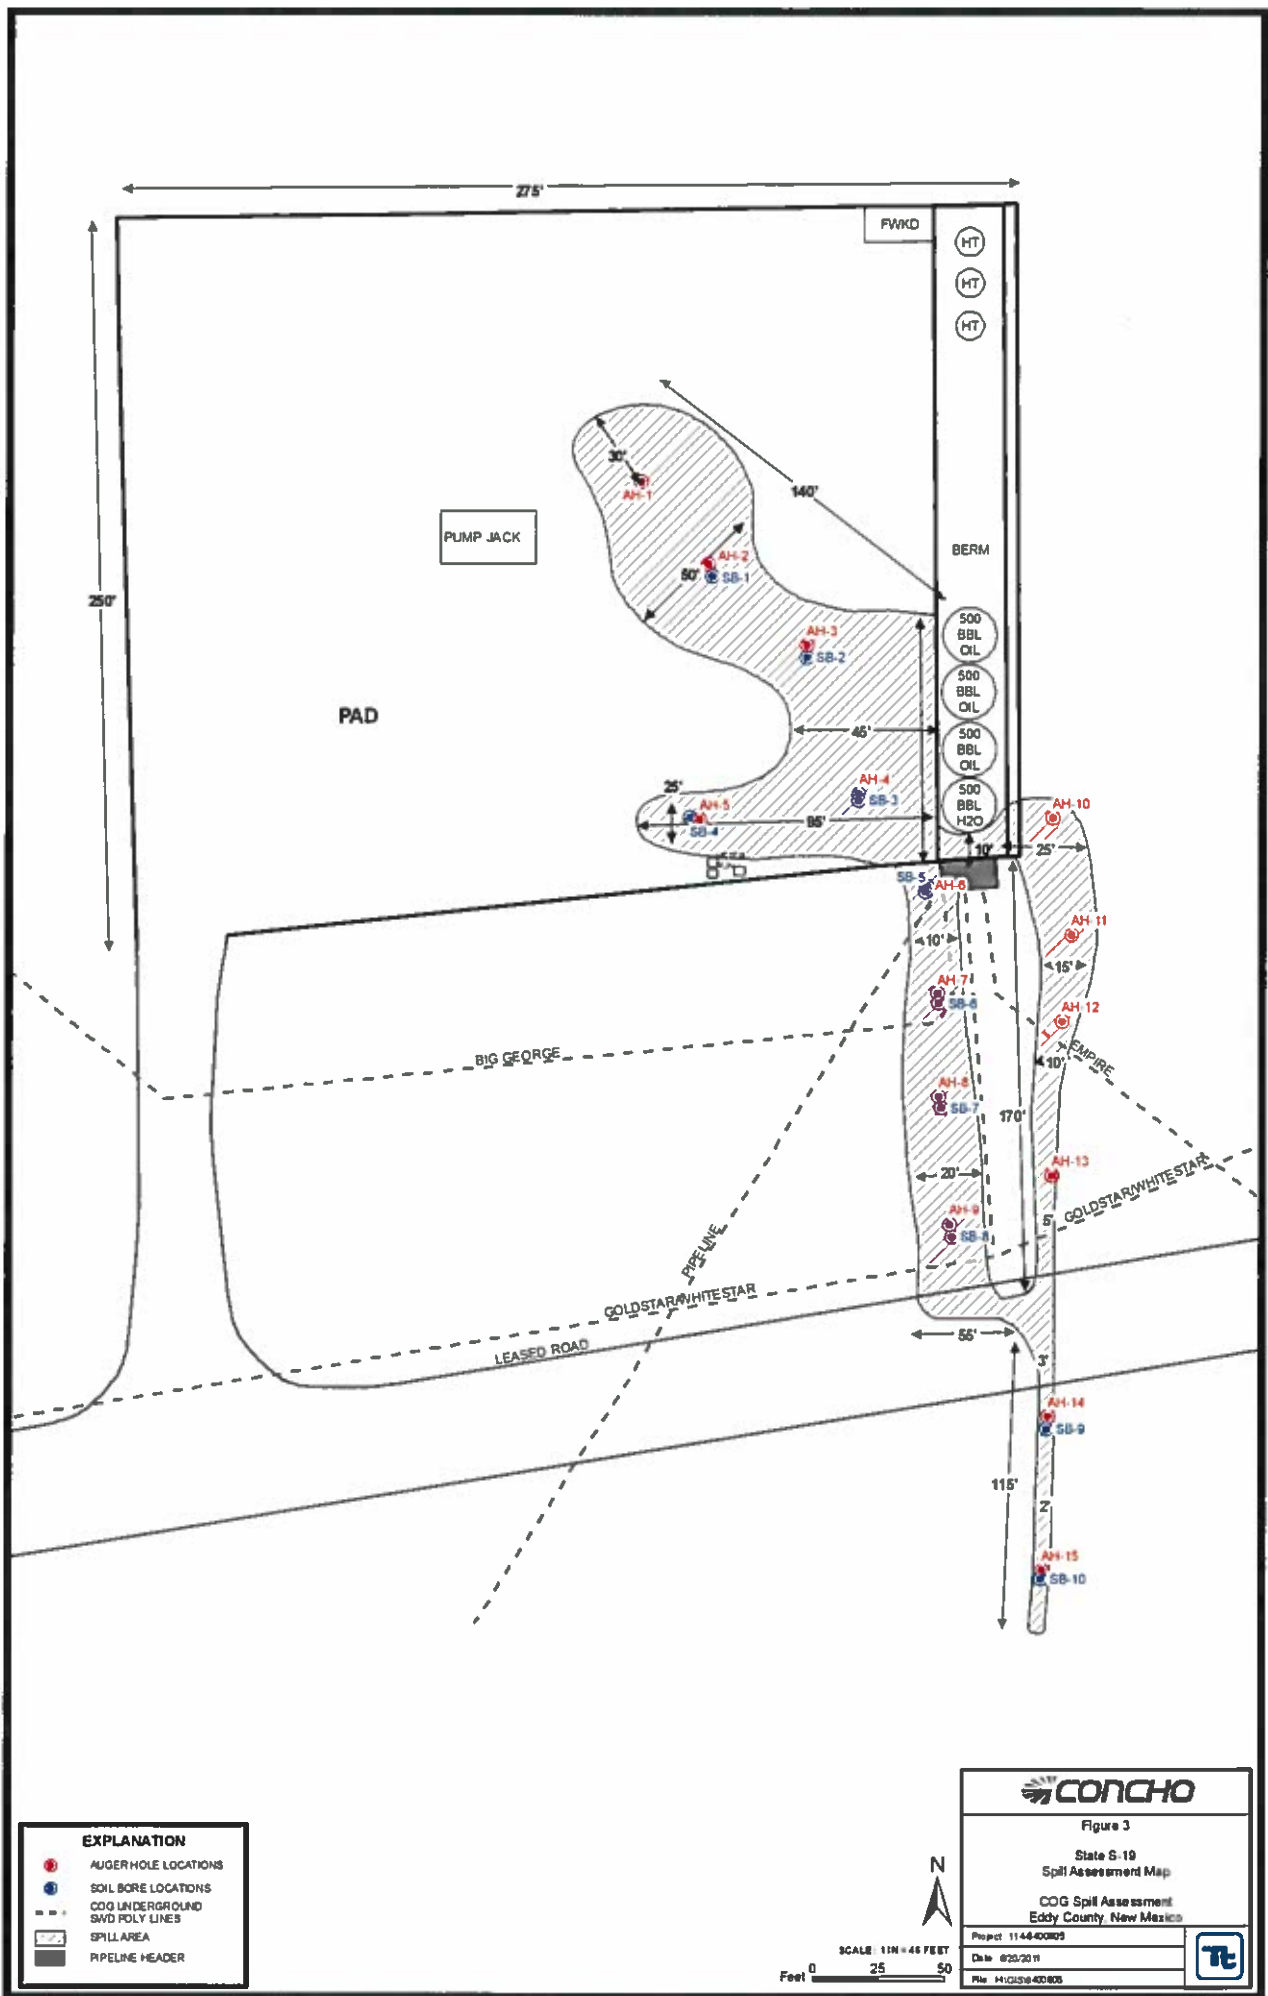
On January 31, 2011, Tetra Tech personnel inspected and sampled the spill area. Fifteen auger holes (AH-1 through AH-15) were installed using a stainless steel hand auger to assess the impacted soils. Select samples were analyzed for TPH analysis by EPA method 8015 modified, BTEX by EPA Method 8021B and chloride by EPA method 300.0. Copies of laboratory analysis and chain-of-custody documentation are included in Appendix C. The sampling results are summarized in Table 1. The auger hole locations are shown on Figure 3.

In order to vertically define the spill, soil borings were installed to collect deeper samples. On May 2, 2011, Tetra Tech personnel supervised the installation of ten (10) soil bores (SB-1 through SB-10) utilizing an air rotary rig. The results of the sampling are summarized in Table 1. The soil bore locations are shown on Figure 3.

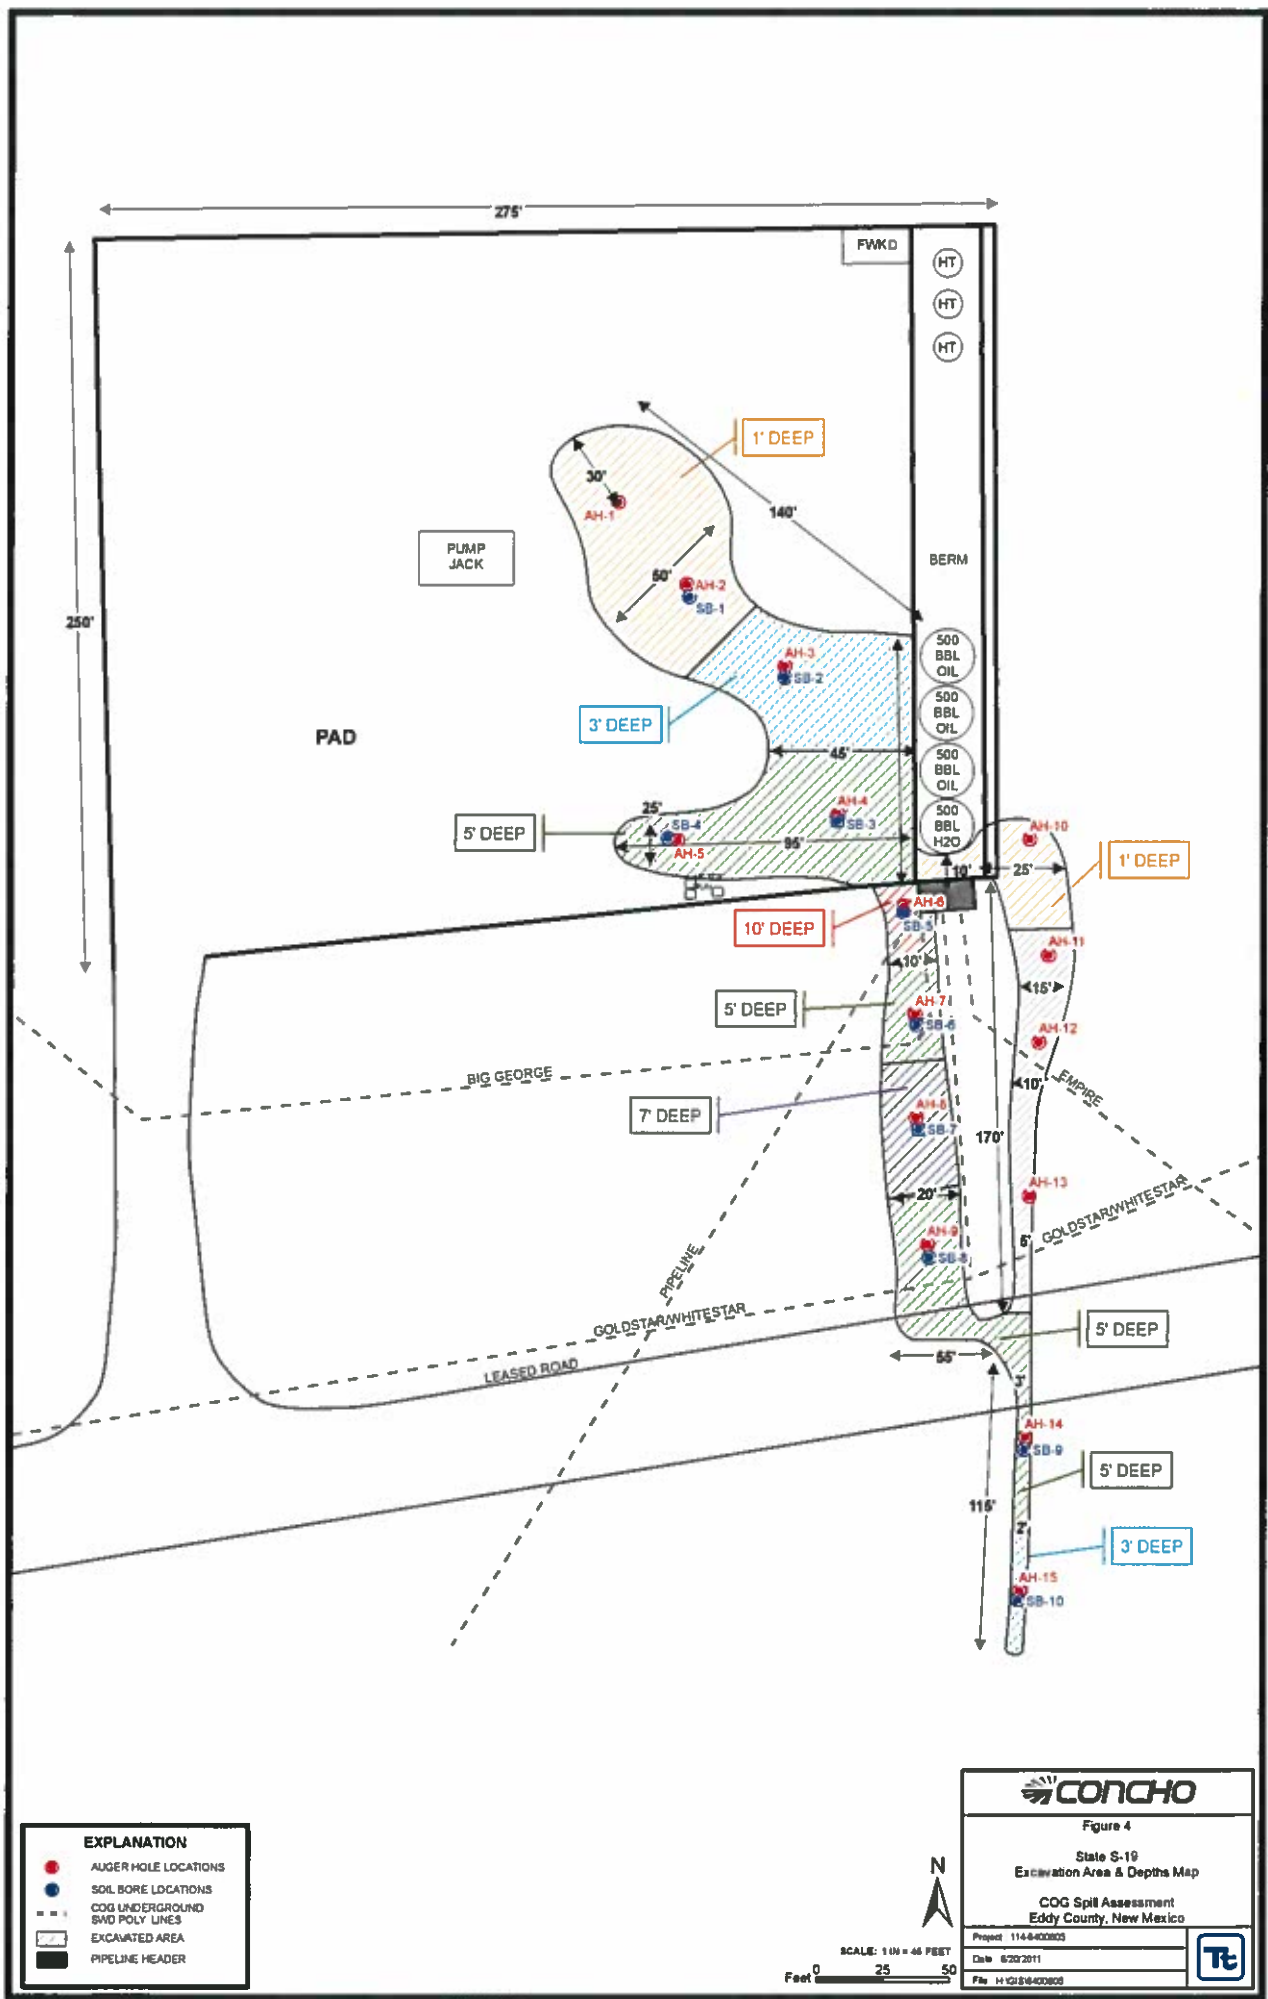
Based on the approved work plan, Tetra Tech personnel supervised the excavation of the site. The final excavation depths of the soil remediation were met as stated in the approved work plan. A total of 1,680 cubic yards of soil were excavated and hauled to CRI Inc. for proper disposal. Once excavated to the appropriate depths, the excavation was backfilled with clean soil to grade. The excavation depths are highlighted in Table 1 and shown on Figure 4.

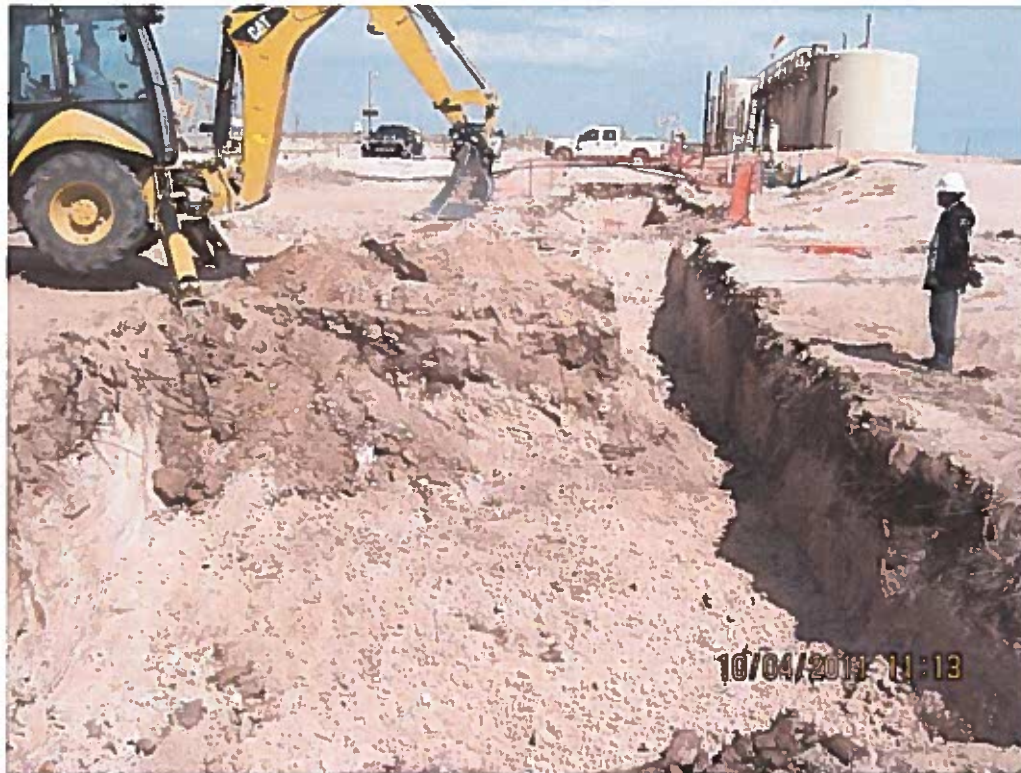
View North – SB-6 and 5

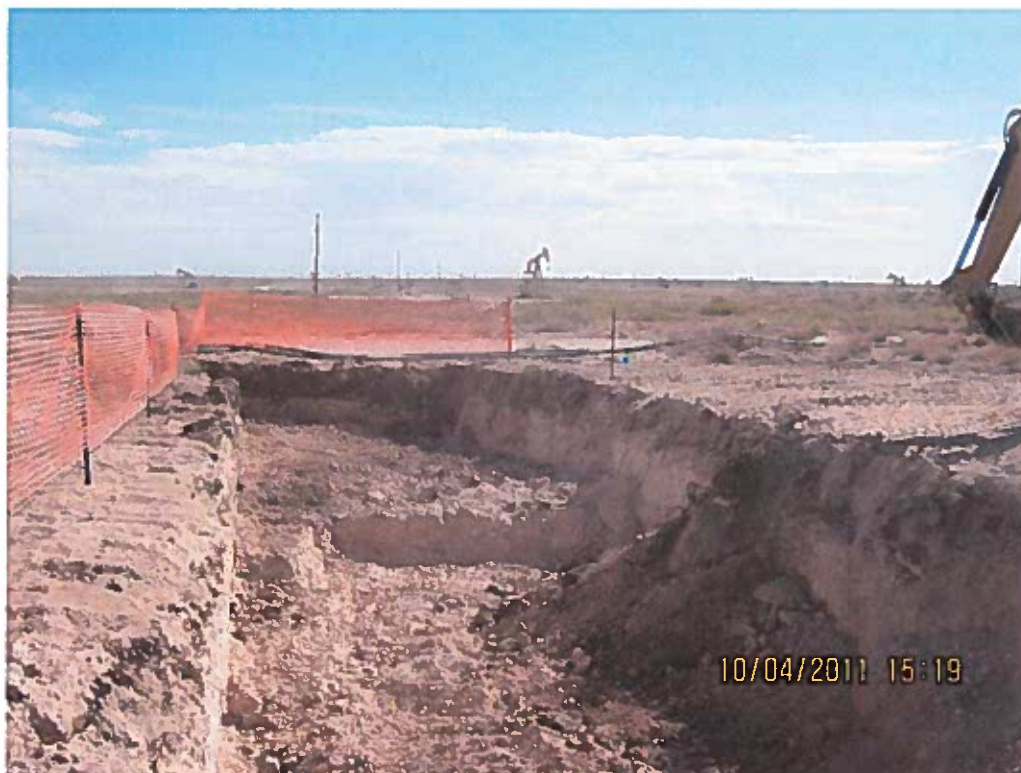
View South – SB-7 and 8

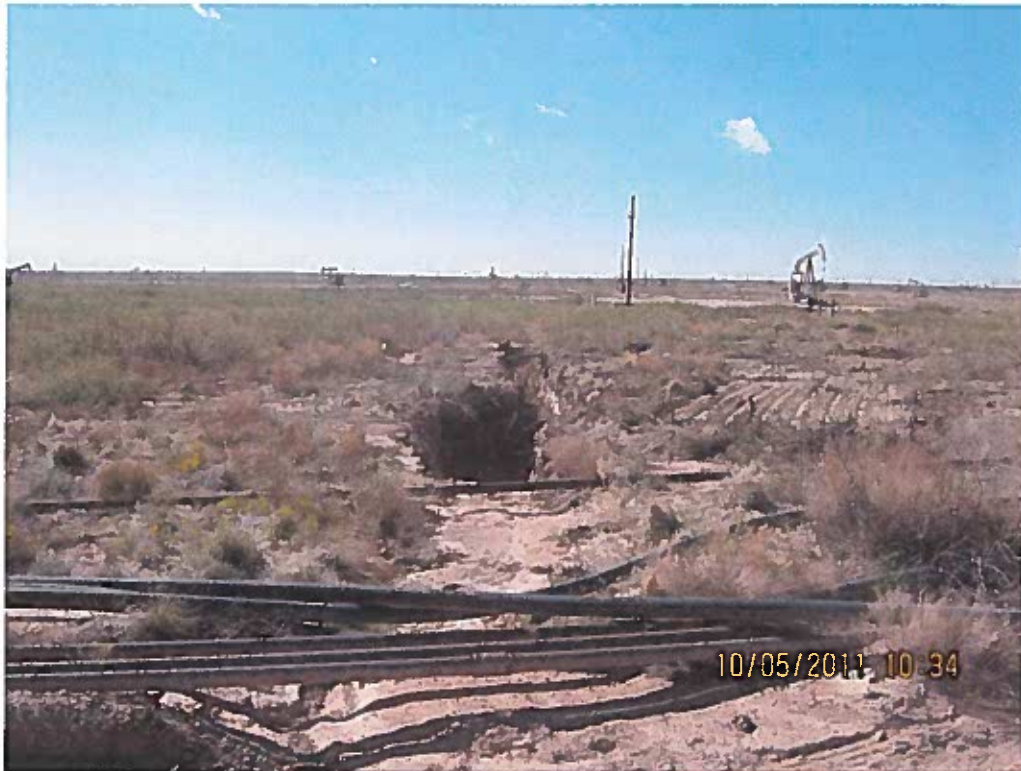
View South – SB-9 and 10

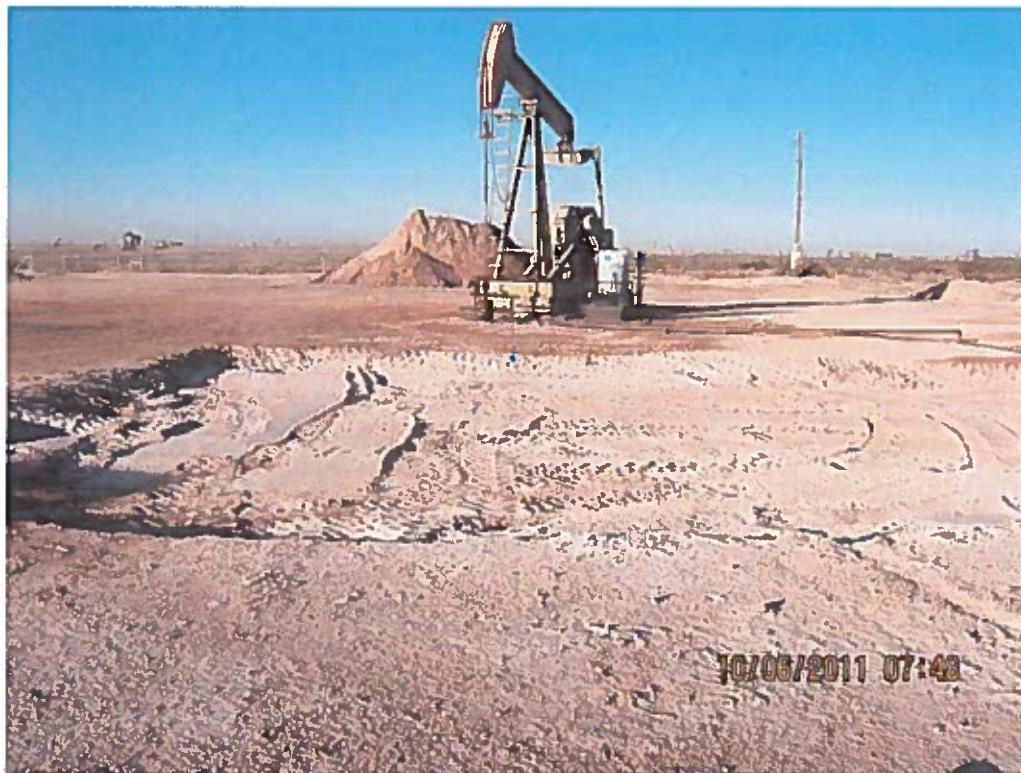
View West – SB-1

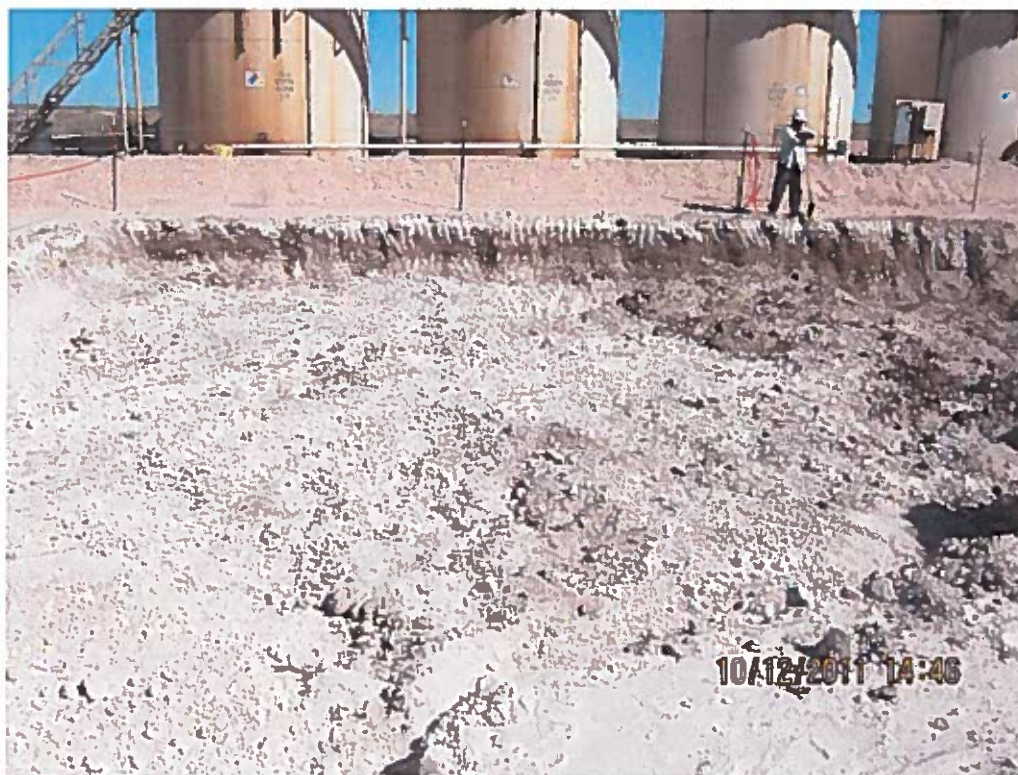
View East – SB-3

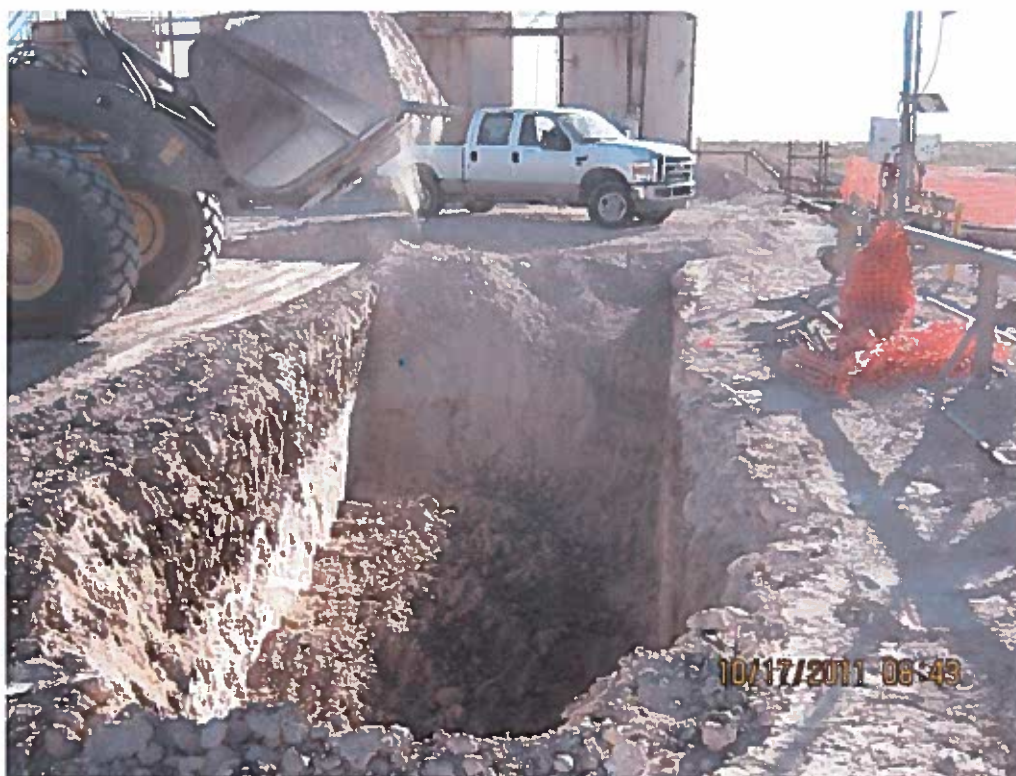
View East – SB-4

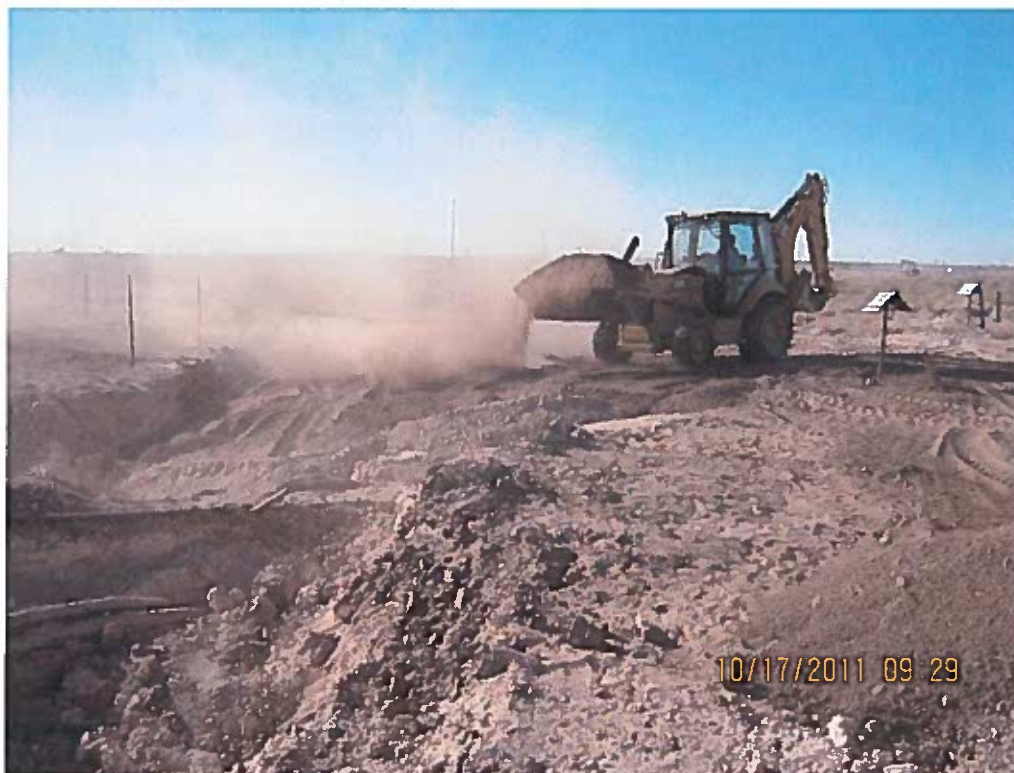
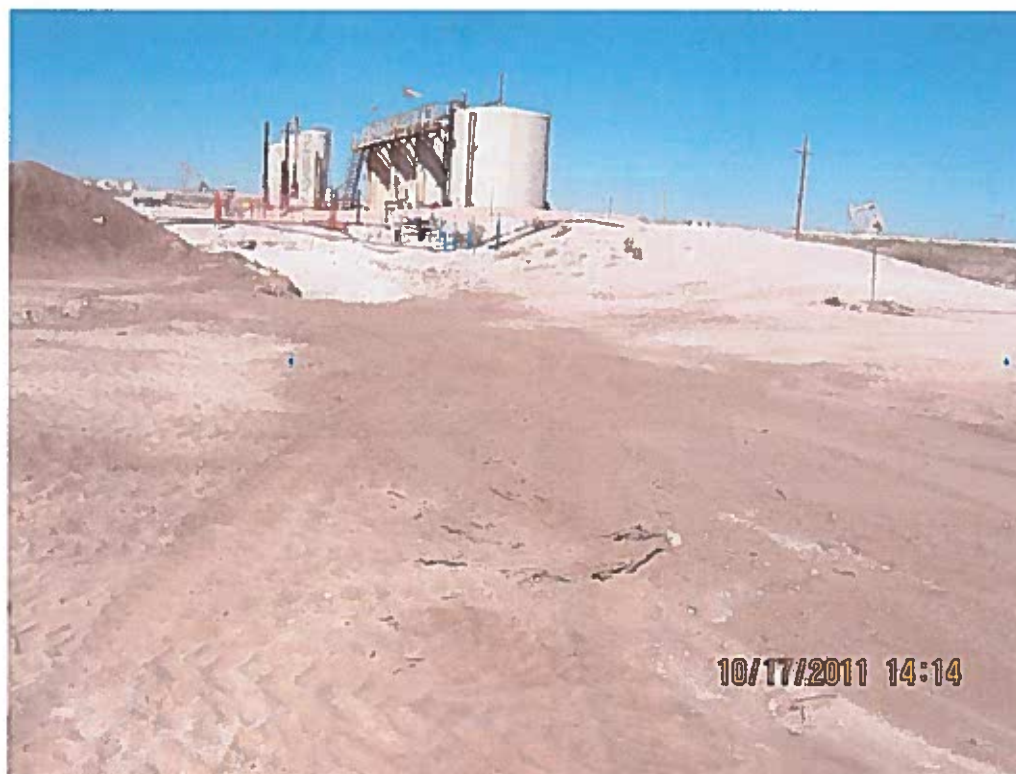
Backfill
