FINAL REPORT SUMMARIZING CLOSURE FOR INCIDENT 2RP-2919

RICHARDS ENERGY COMPRESSION
RJ UNIT #129
API# 30-015-03780
SECTION 35, T17S R29E, NM
EDDY, NM

April 07, 2015
Reference 5B23838 BG1

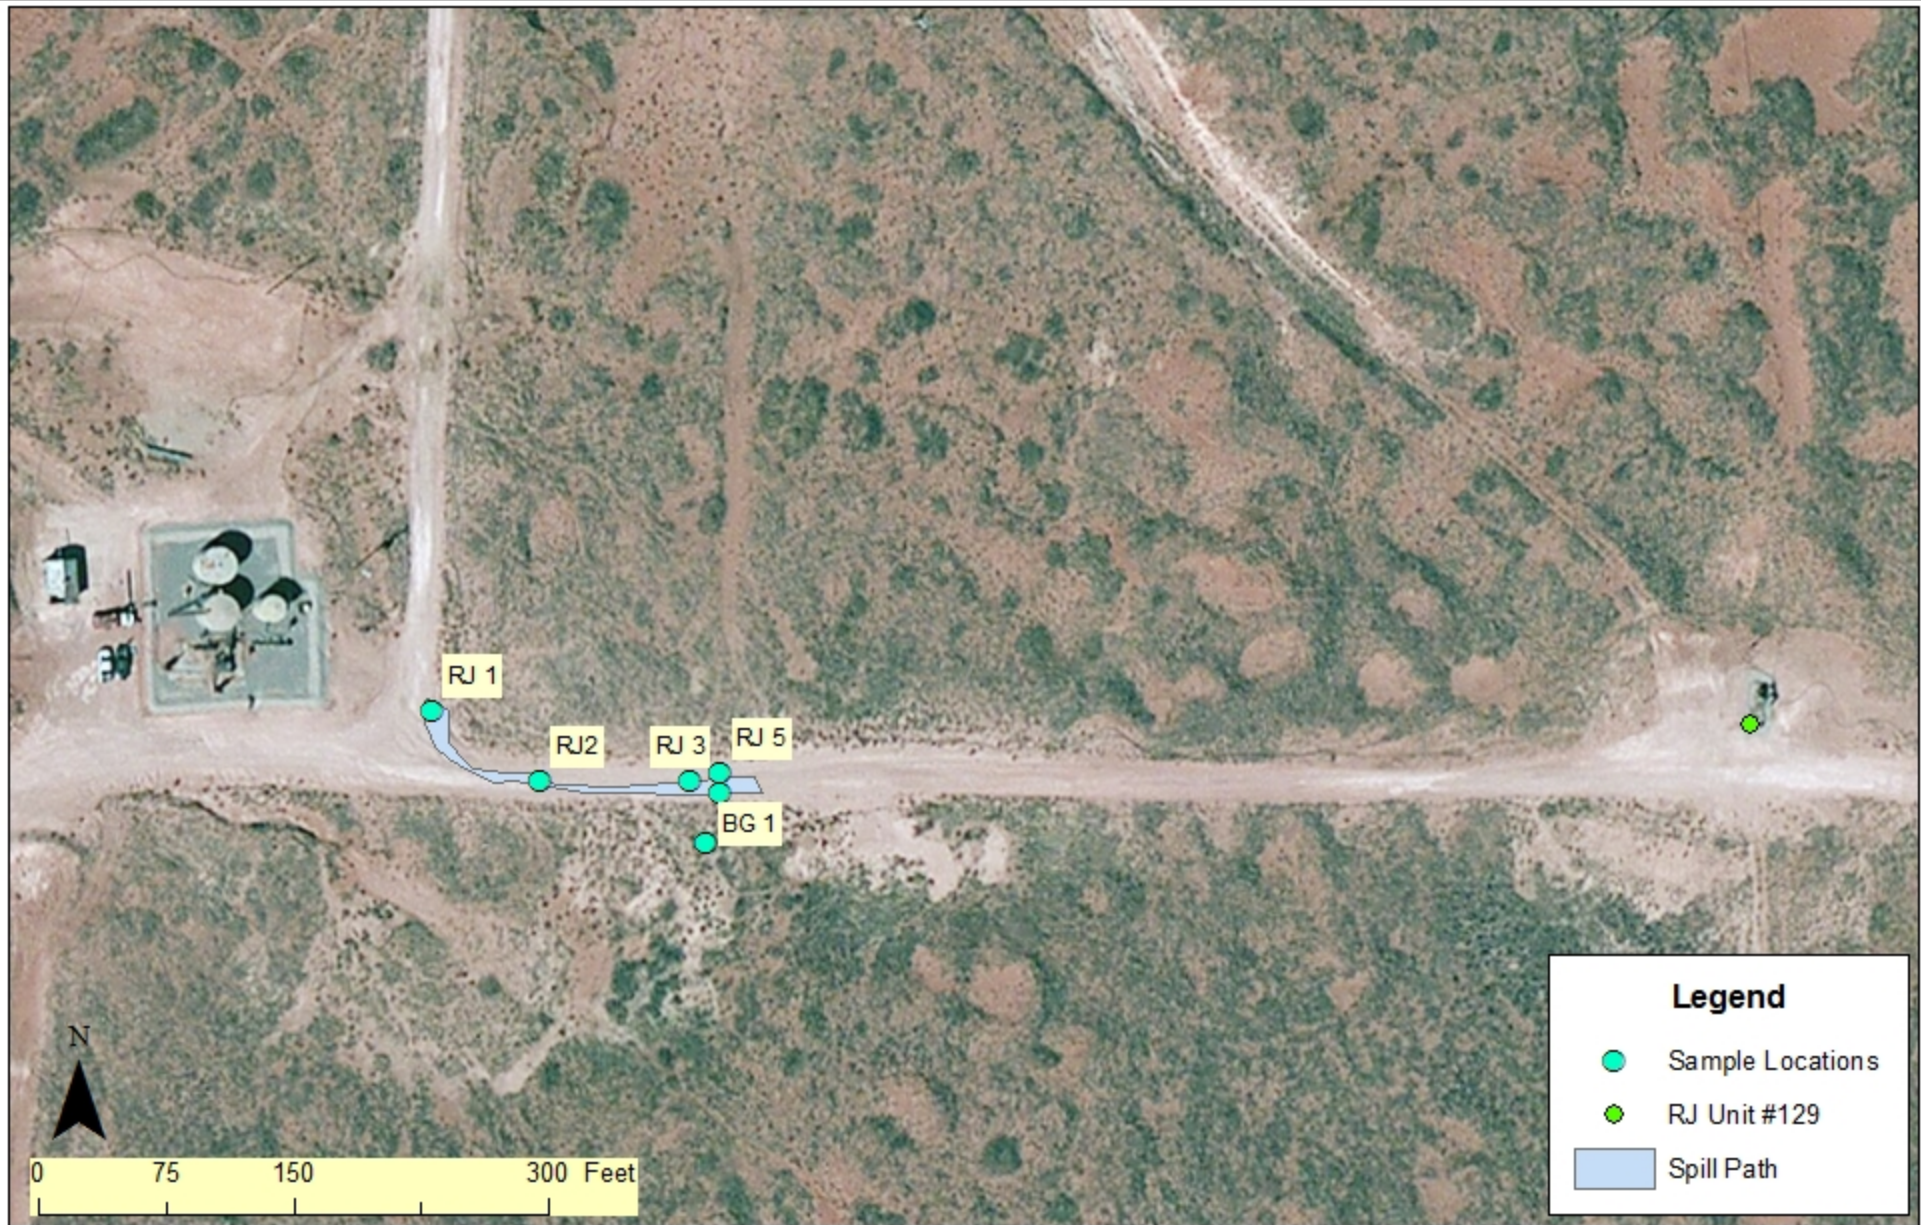
FIGURE 2
SITE DETAILS AND SAMPLE
LOCATIONS MAP

The initial samples taken by SMA, will act as confirmation samples as well. Locations of the confirmation samples in the spill area (Figure 2). Each sample container was labeled, placed on ice in an insulated cooler, and chilled to a temperature of approximately 40°F (4°C). The cooler was sealed for shipment to the laboratory, accompanied by proper chain-of-custody documentation. The soil samples were delivered on 03/18/15 to Hall Environmental Analysis Laboratory, Inc., in Albuquerque, New Mexico for analysis by EPA METHOD 8015D, EPA METHOD 8021B and EPA METHOD 300.

- Sample Locations
- RJ Unit #129
- Spill Path

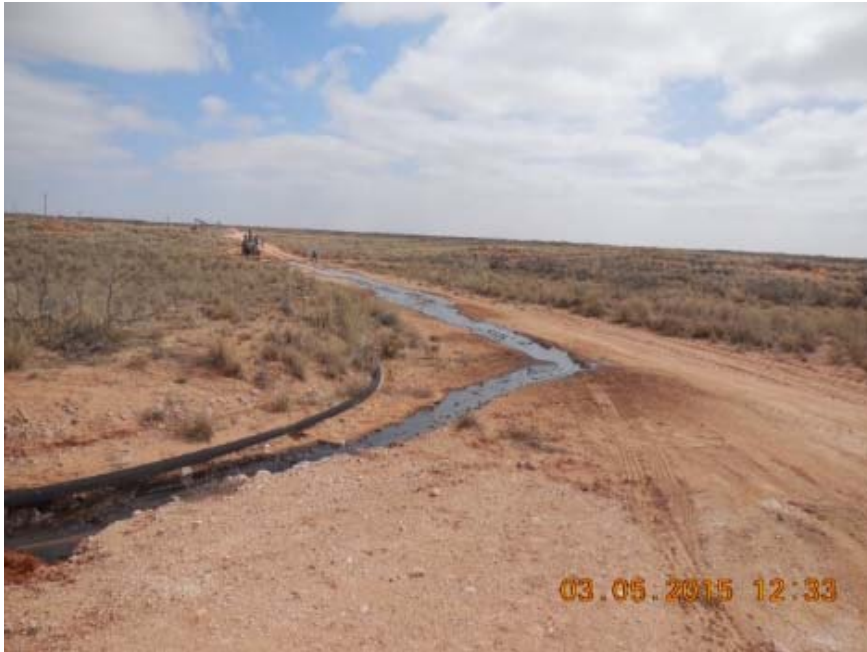
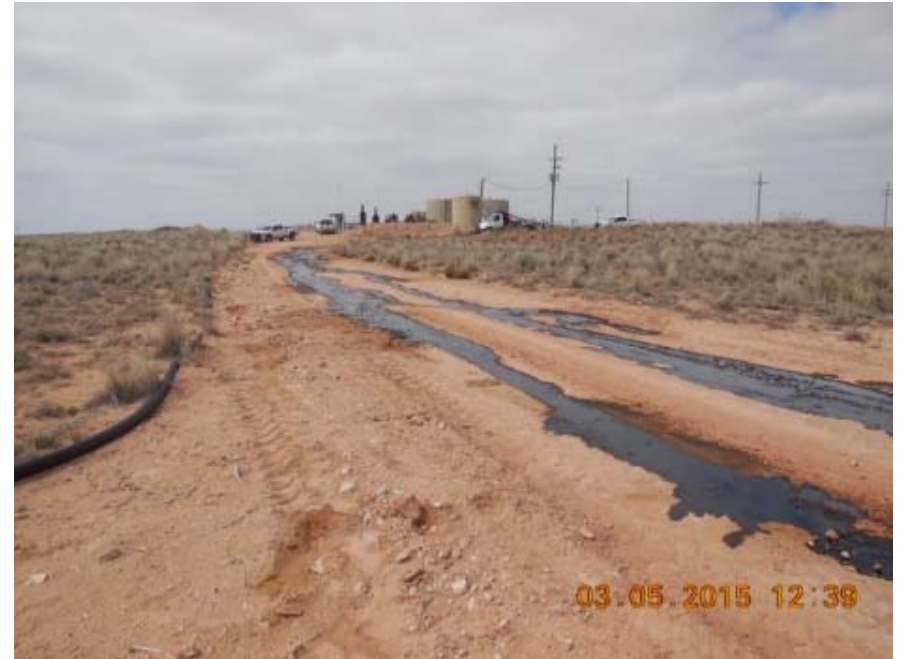
The impacted area was approximately 10' x 300' in the roadway. The backhoe scraped up the impacted soil and hauled to an NMOCD approved facility. Souder Miller & Associates completed work in accordance with NMOCD and BLM guidelines.

Spill path on road. Taken on 03/05/15

A driver from Richard's Energy Compression Services drove over the line causing the line to break. A backhoe was on site and able to isolate the impacted area quickly.

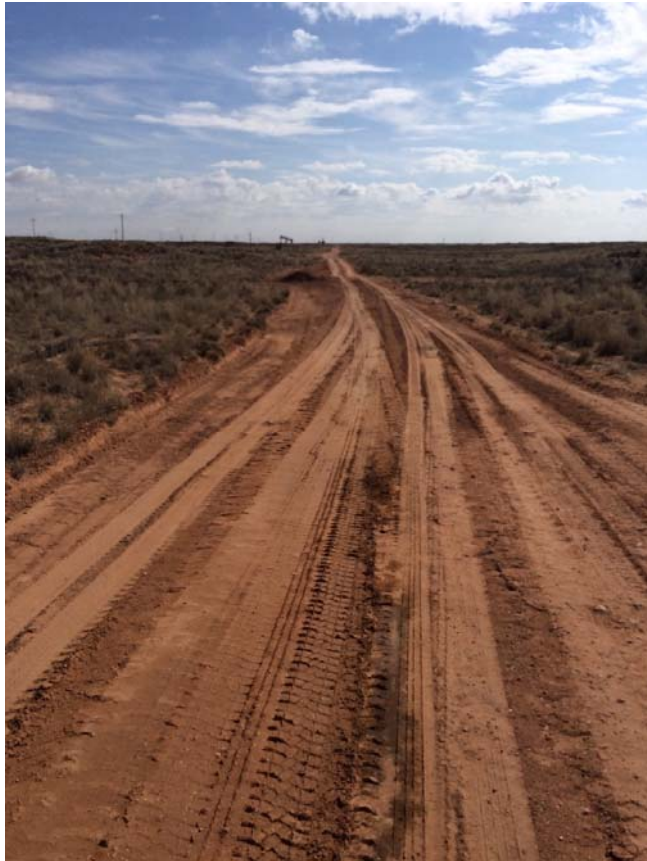
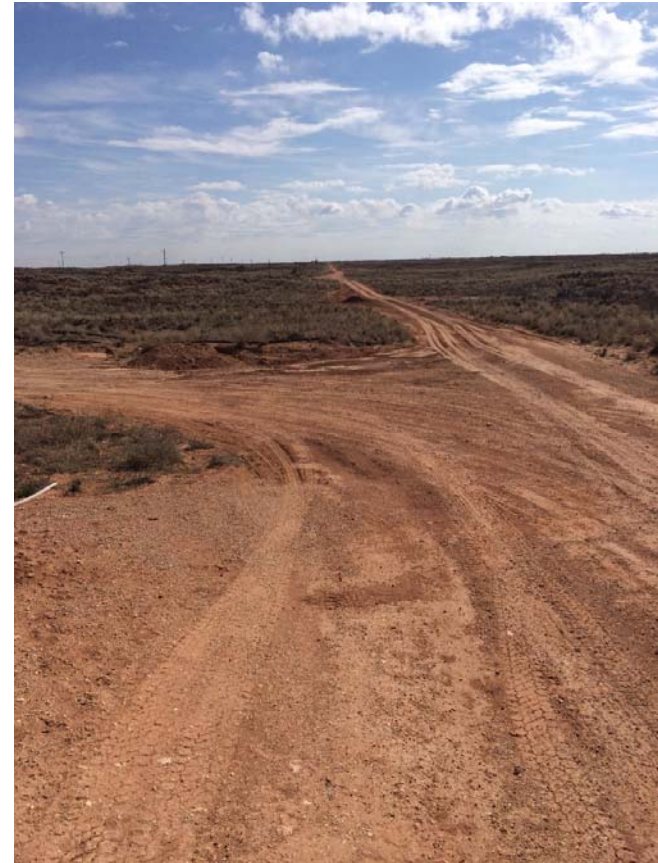
Road after remediation action occurred. Taken on 03/31/15

All excavated contaminated soil was transported to an NMOCD approved disposal facility. The soils was sampled by SMA and tested by a third party laboratory (Table 1) confirming that the soil meets the site-specific NMOCD is cleanup levels of 10 mg/Kg Benzene, 50 mg/Kg total BTEX and 5000 mg/Kg TPH. A closure request was submitted to the NMOCD as a C-141 final on 04/06/15 (Appendix B).
