### Report Type: Work Plan

| Site: | SRO 17 State Com | | | | | |

**RE: Work Plan for the COG Operating LLC., SRO 17 State Com., Unit D, Section 9, Township 26 South, Range 28 East, Eddy County, New Mexico.**

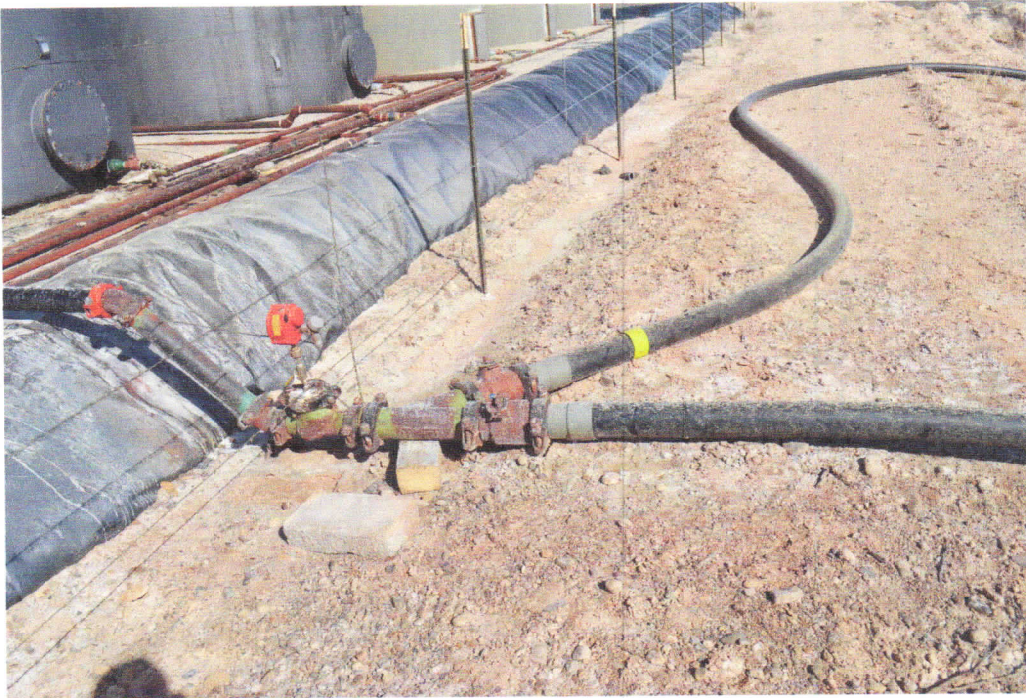
According to the State of New Mexico C-141 Initial Report, the leak was discovered on January 21, 2014, and released approximately 15 barrels of produced water from a "Y" on a poly line. COG personnel shut down the transfer pump and fused the line back together. Approximately 14 barrels of standing fluids were recovered. The initial C-141 form is enclosed in **Appendix A**.

**View looking East at area where failure occurred**

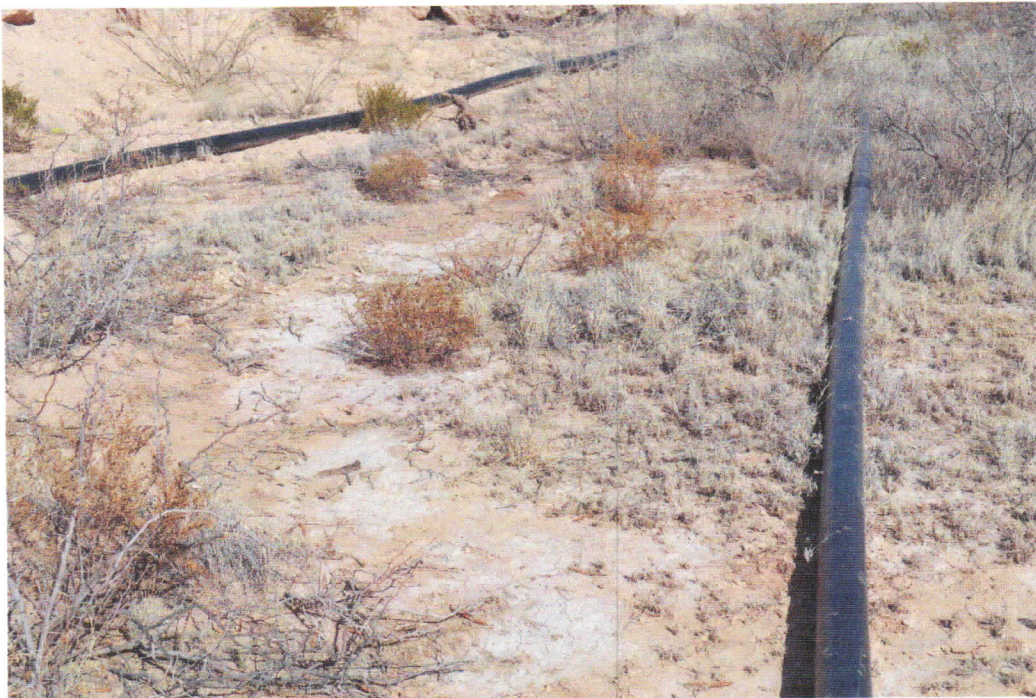
**View looking East**

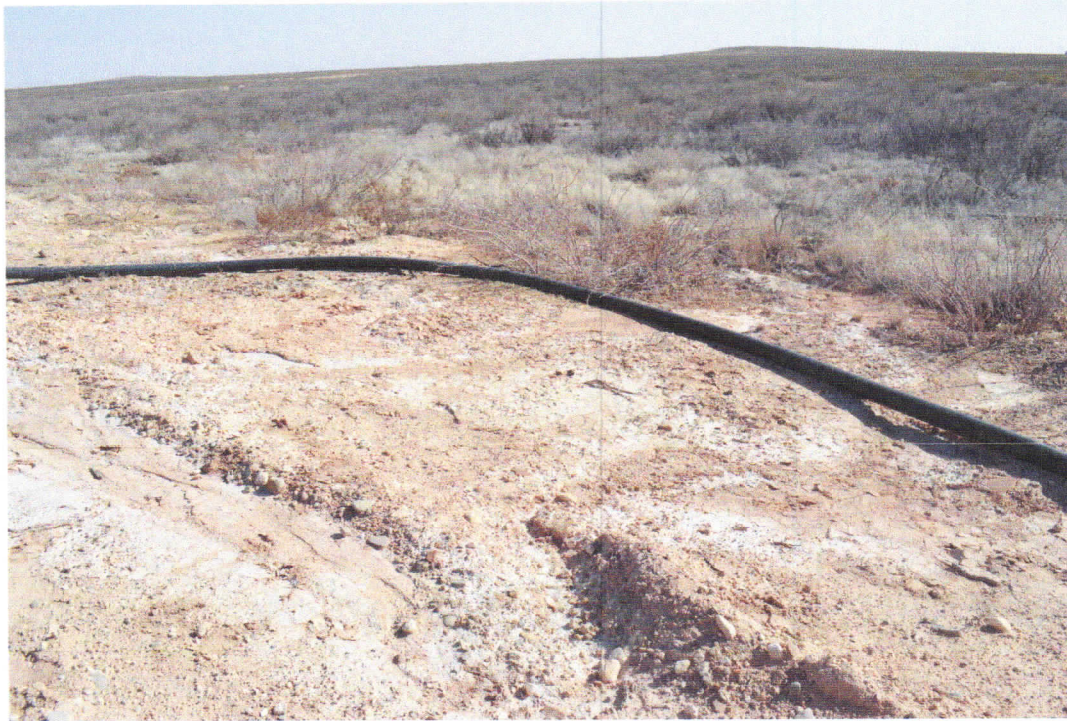
**View looking Southeast**
