REMEDIATION SUMMARY & RISK-BASED SITE CLOSURE REQUEST

**BOPCO, LP
NASH DRAW 8 SWD #1
API 30-015-41351
Eddy County, New Mexico
Unit Letter "L" (NW/SW), Section 8, Township 24 South, Range 30 East
Latitude 32.231646° North, Longitude -103.910656° West
NMOCD Reference #2RP-2081**

December 2015

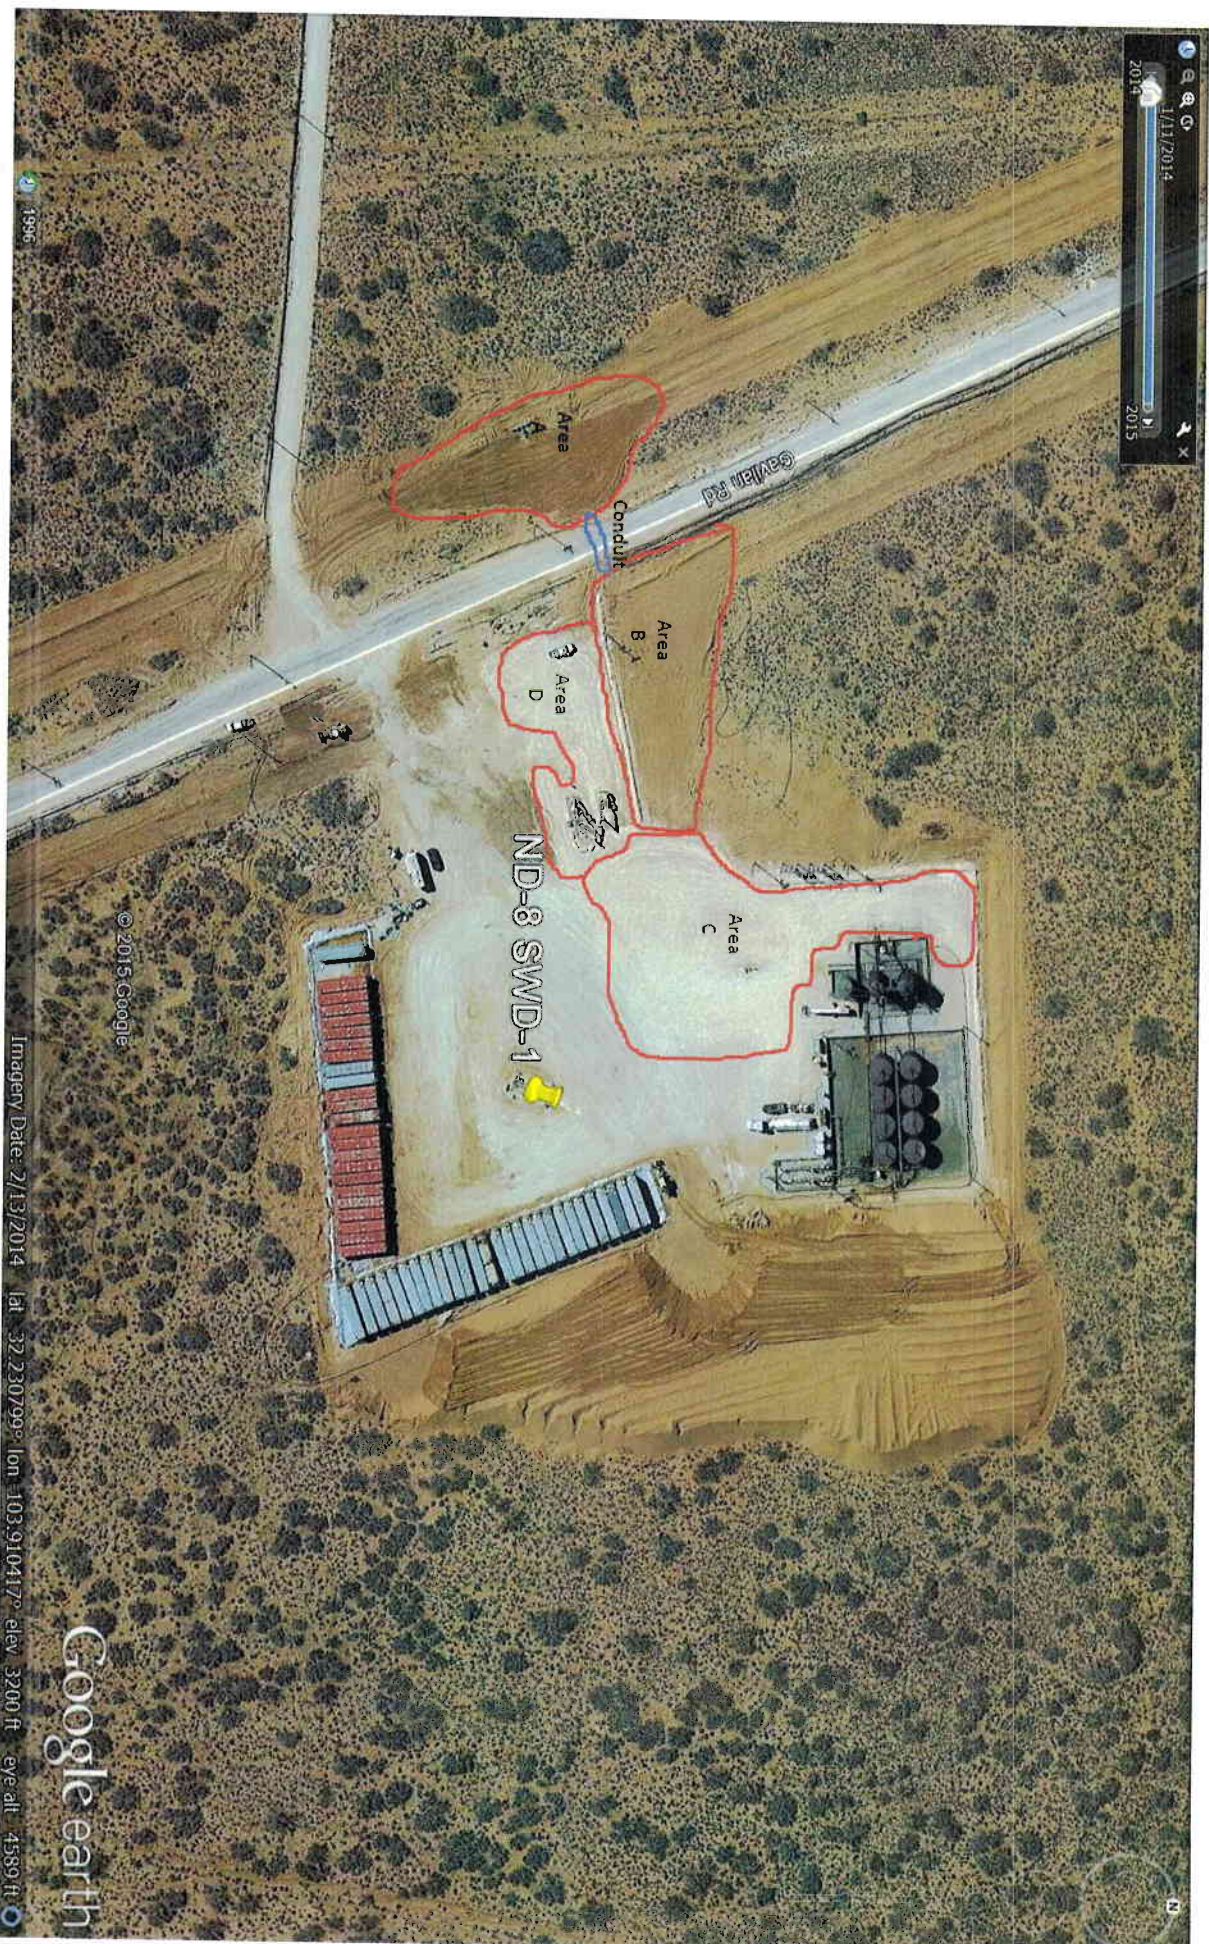
WEST SIDE OF ROAD
NORTH END
12' - 7 2700 ppm
14' ~~15~~' - 2616 ppm
16' ~~15~~' - ¹⁴²⁸~~1240~~ ppm

Area "A"

Test Hole 12/11/13

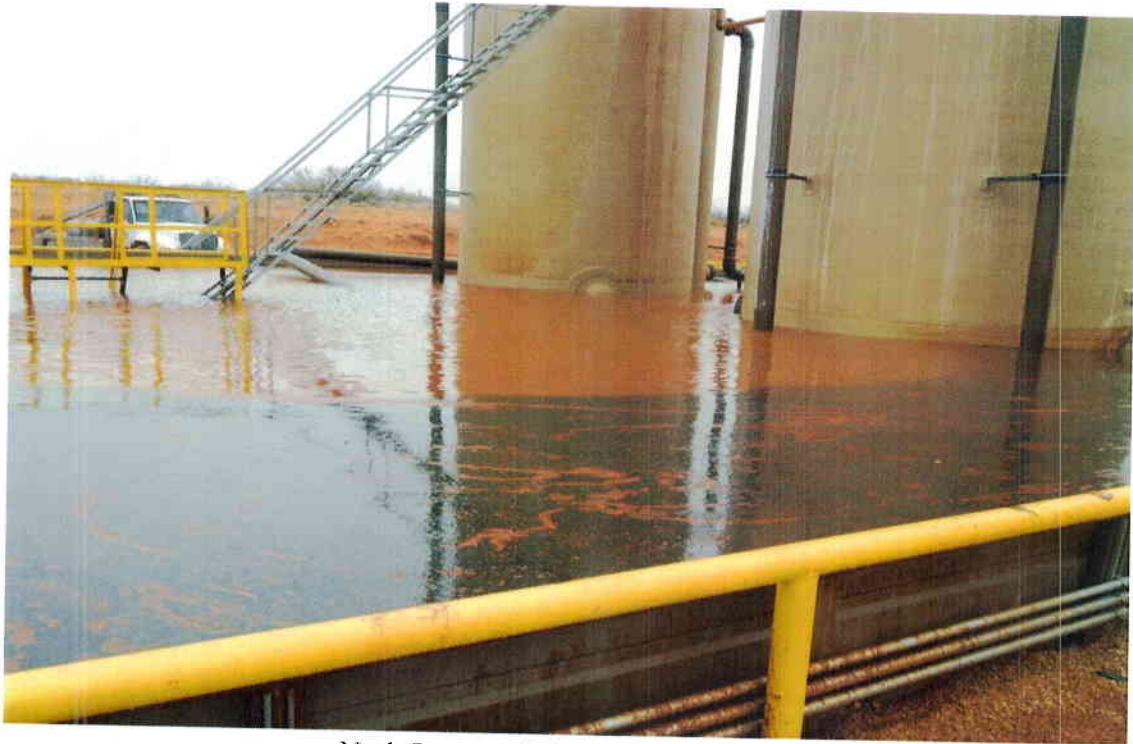
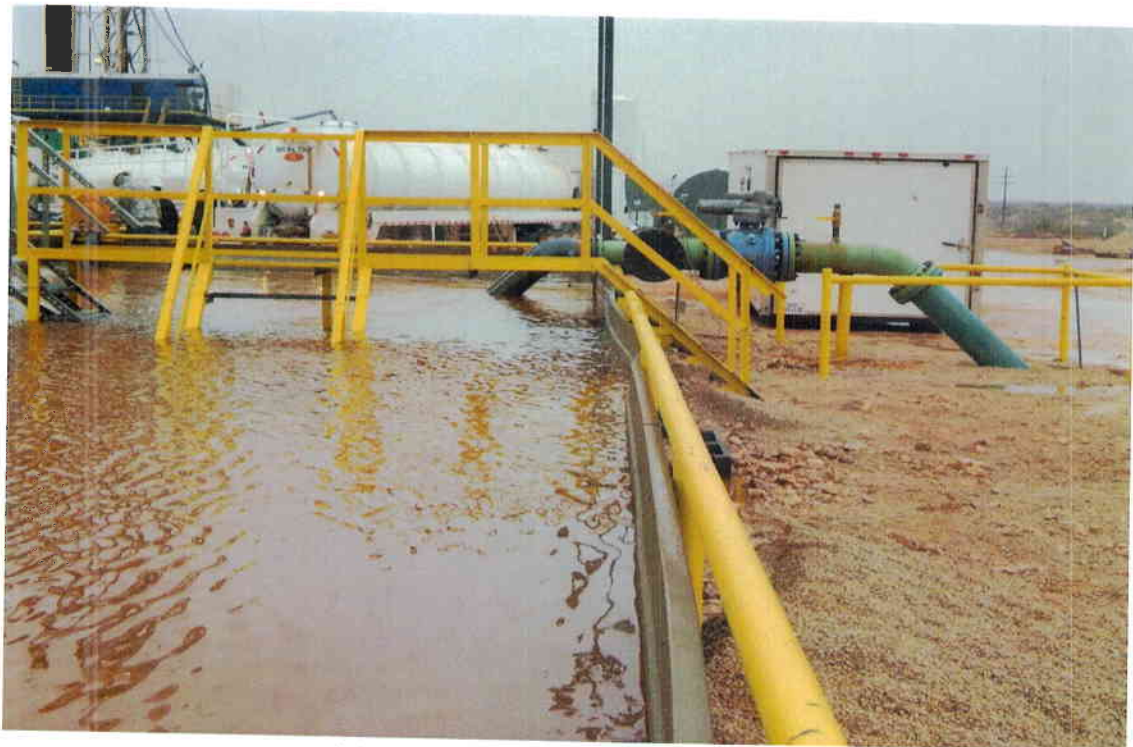
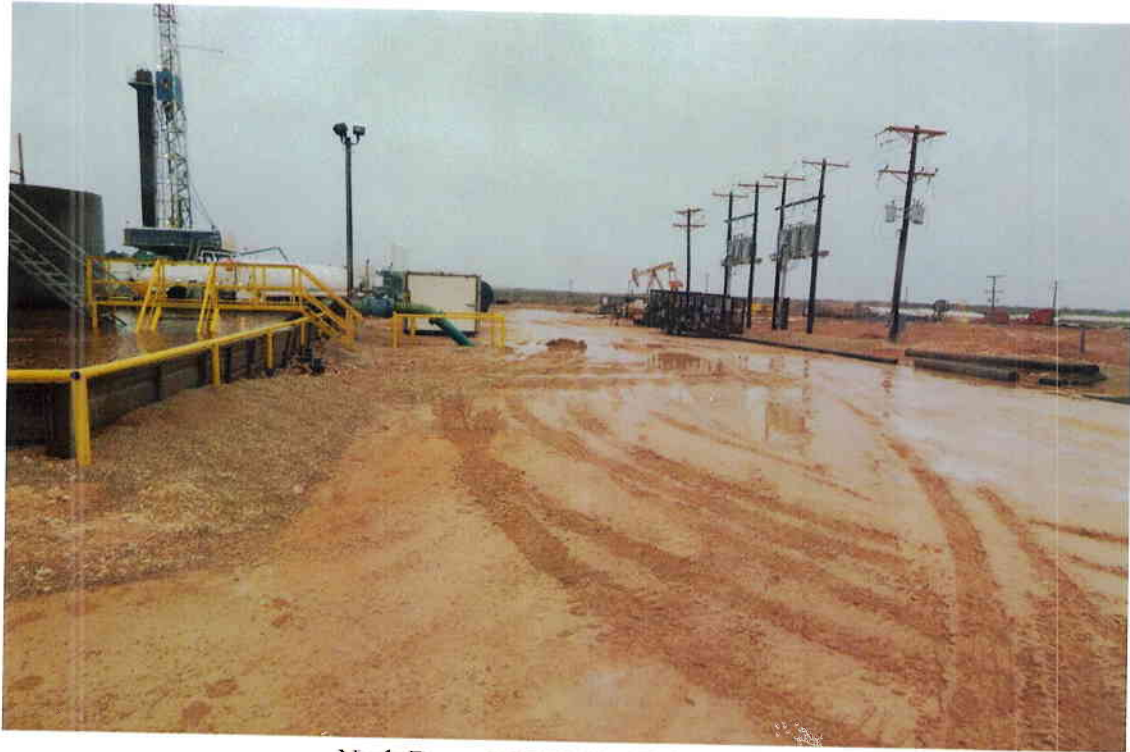
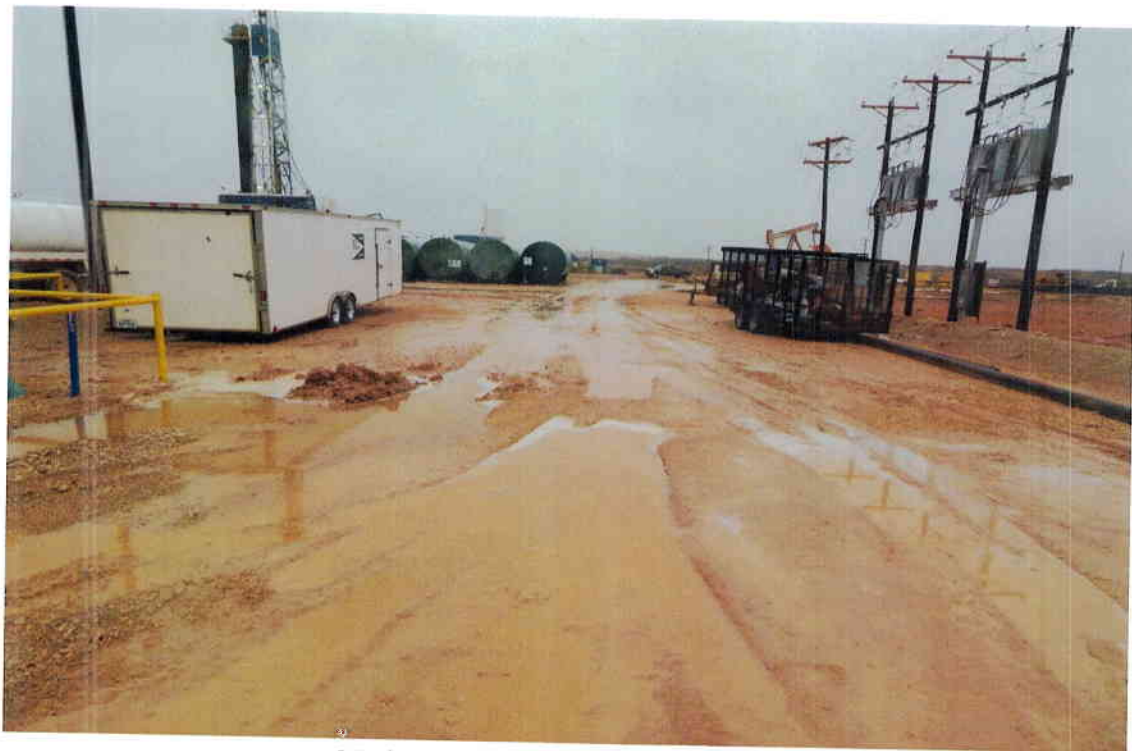
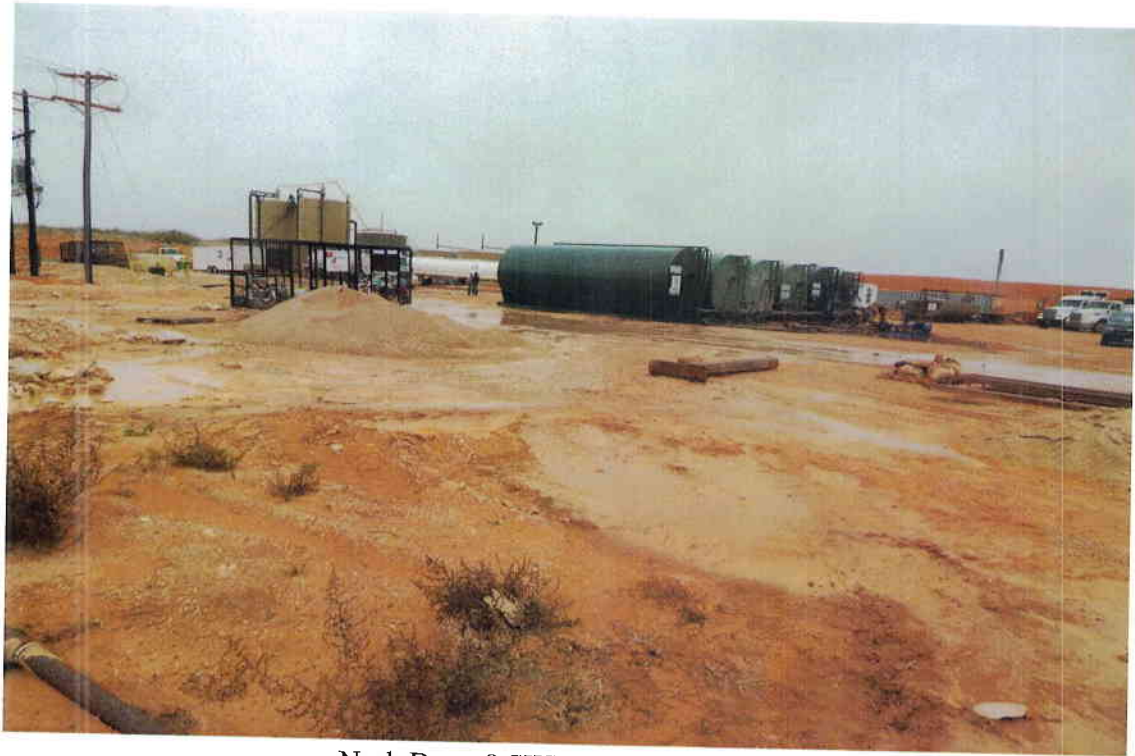
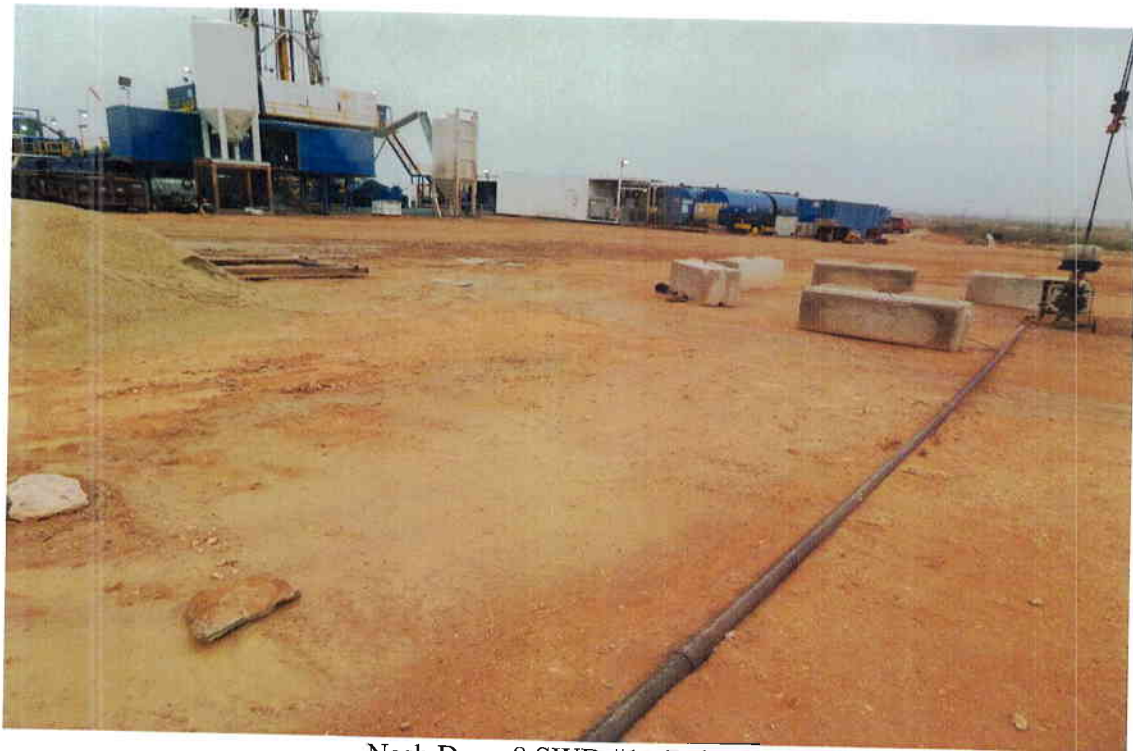
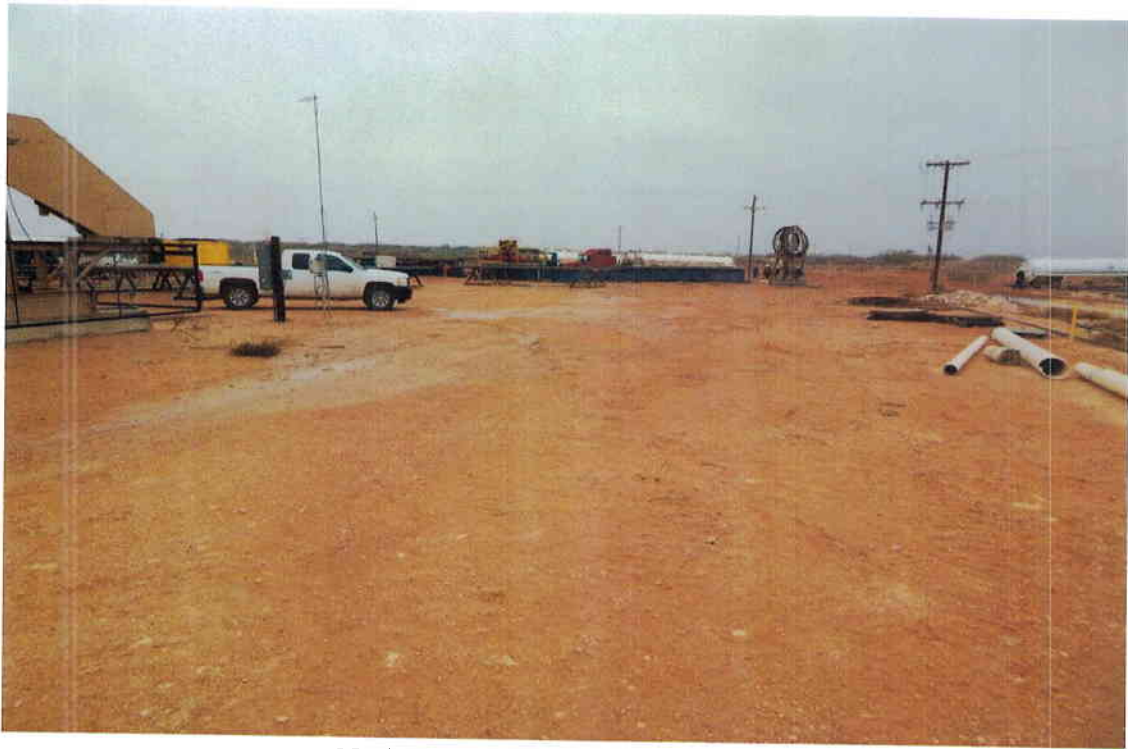
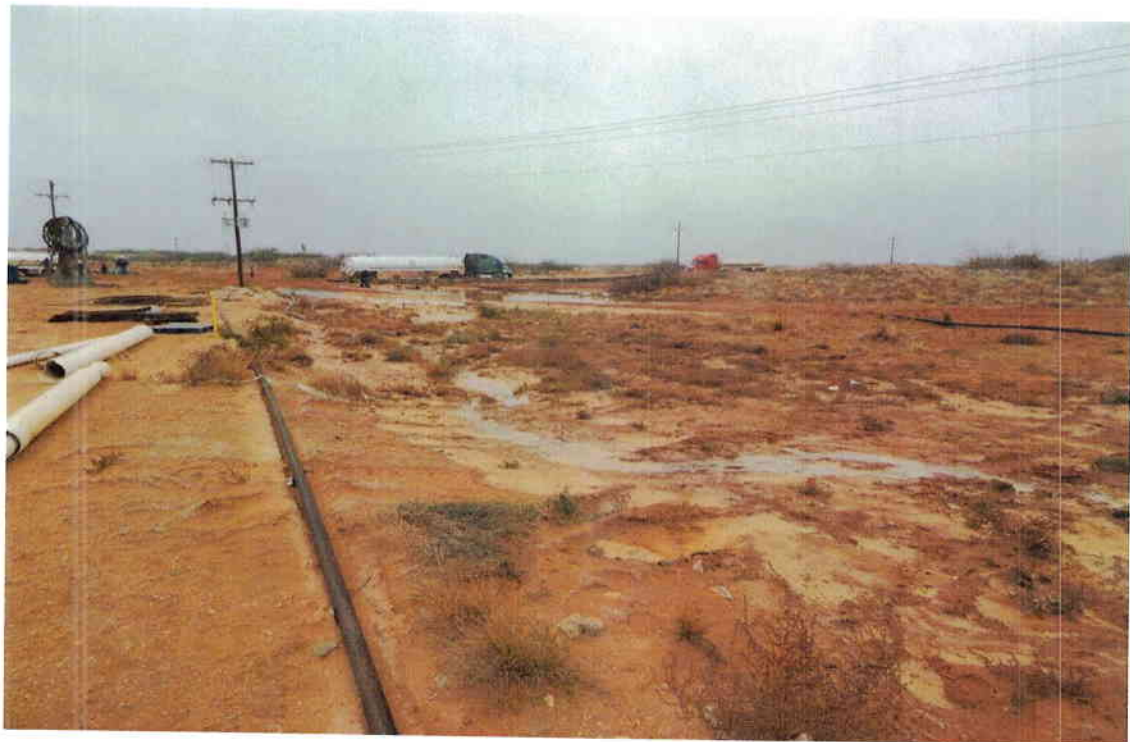
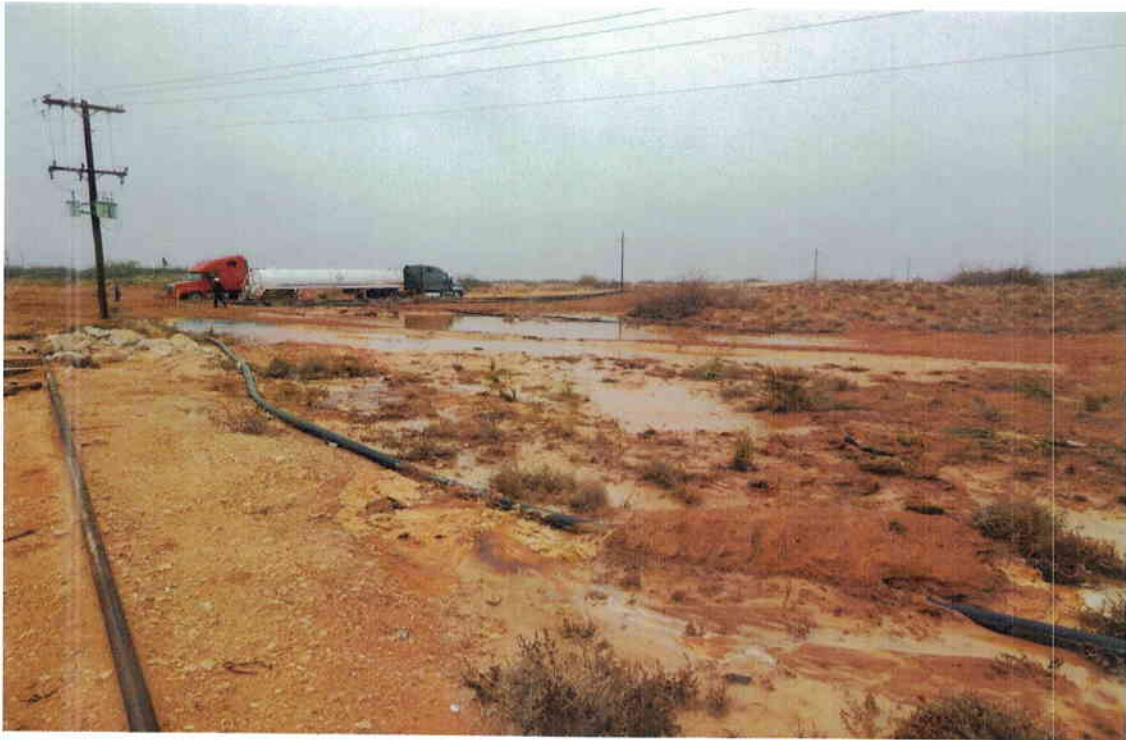
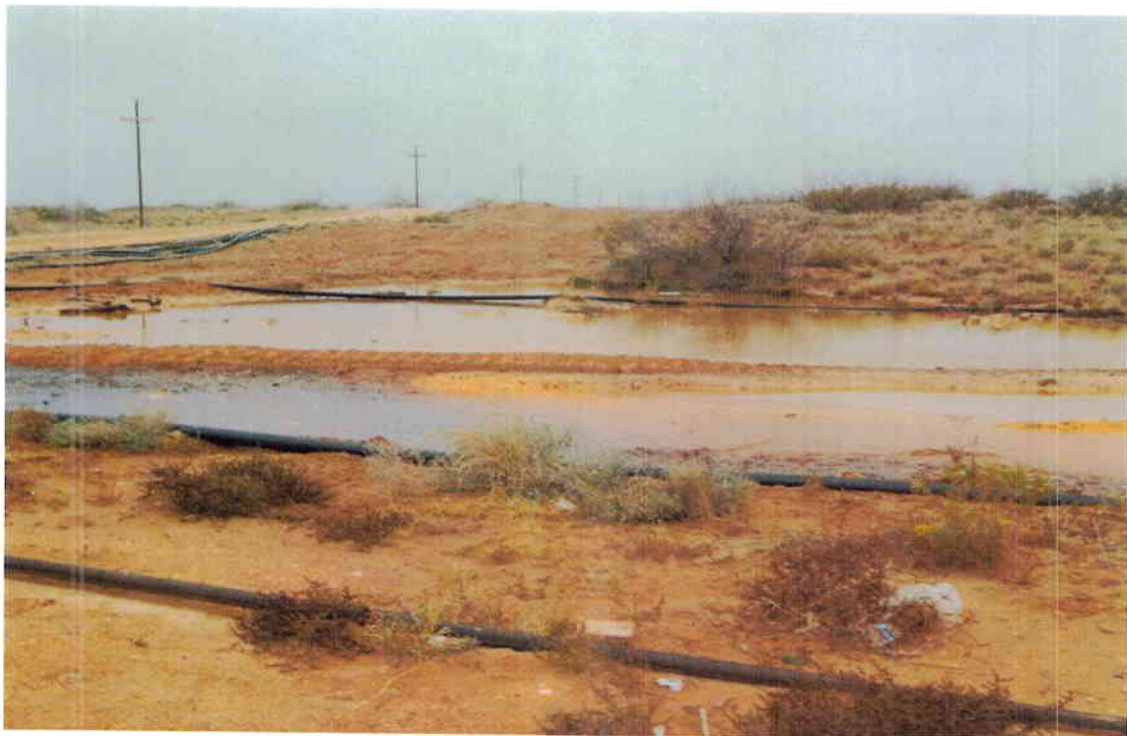
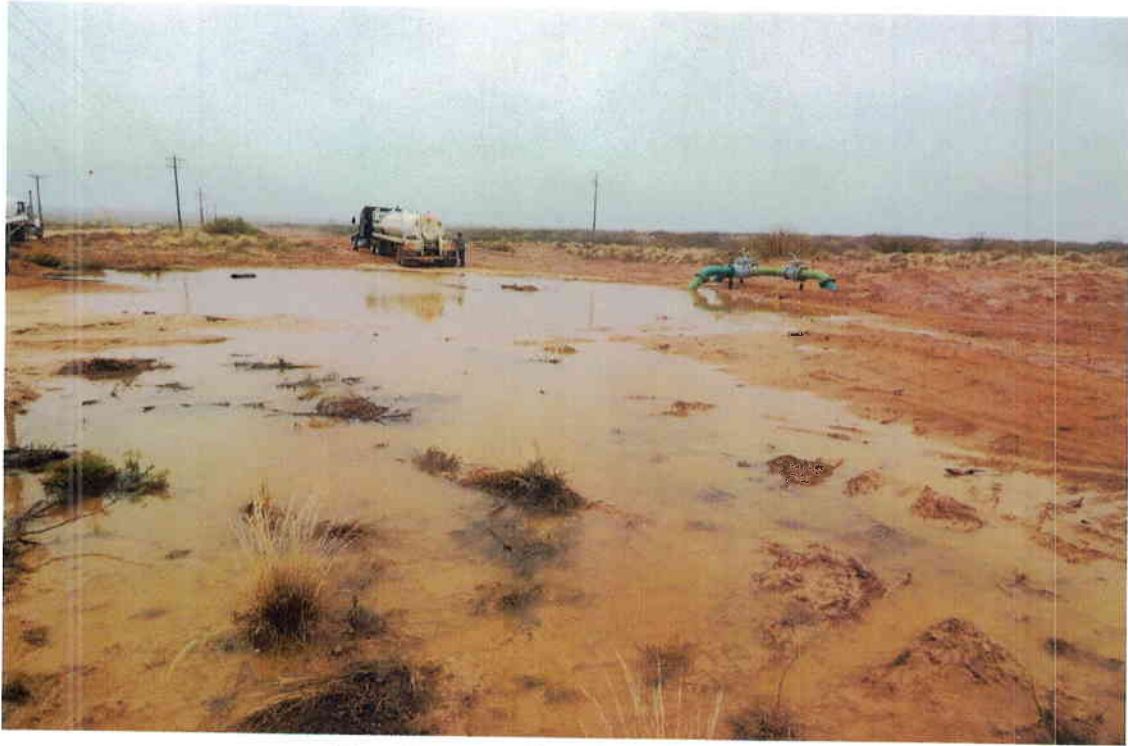
Nash Draw 8 SWD #1 - Release Site

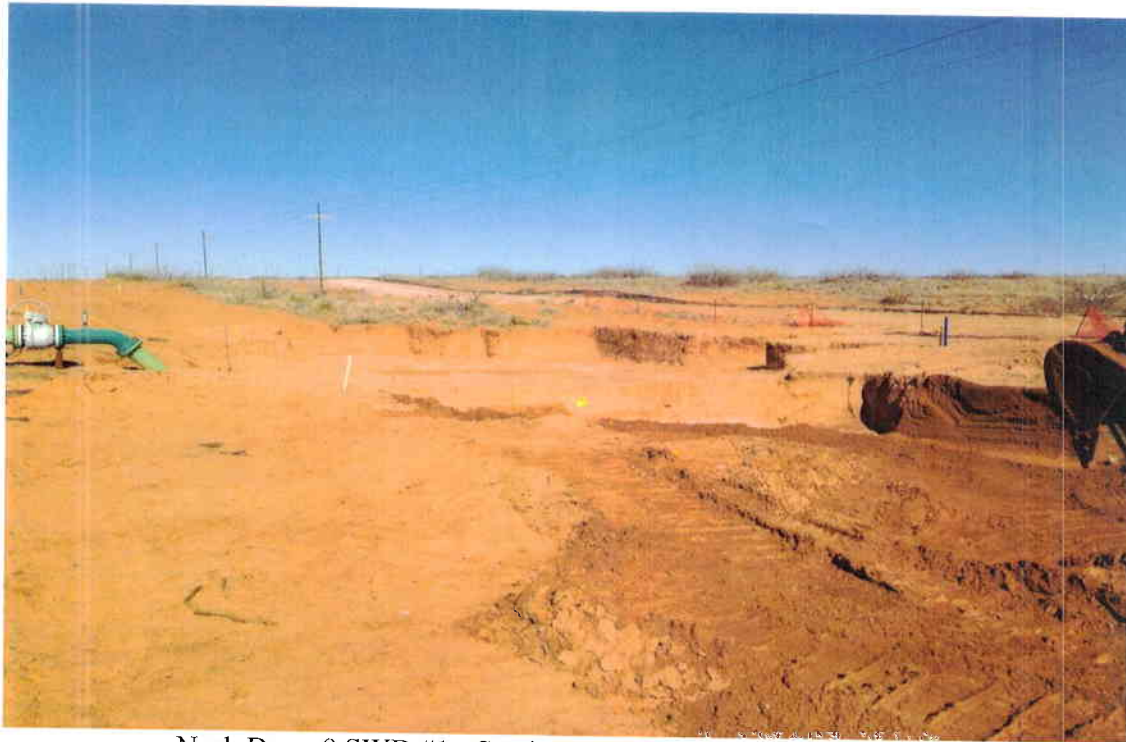
Nash Draw 8 SWD #1 - Section A Excavation (Looking North)

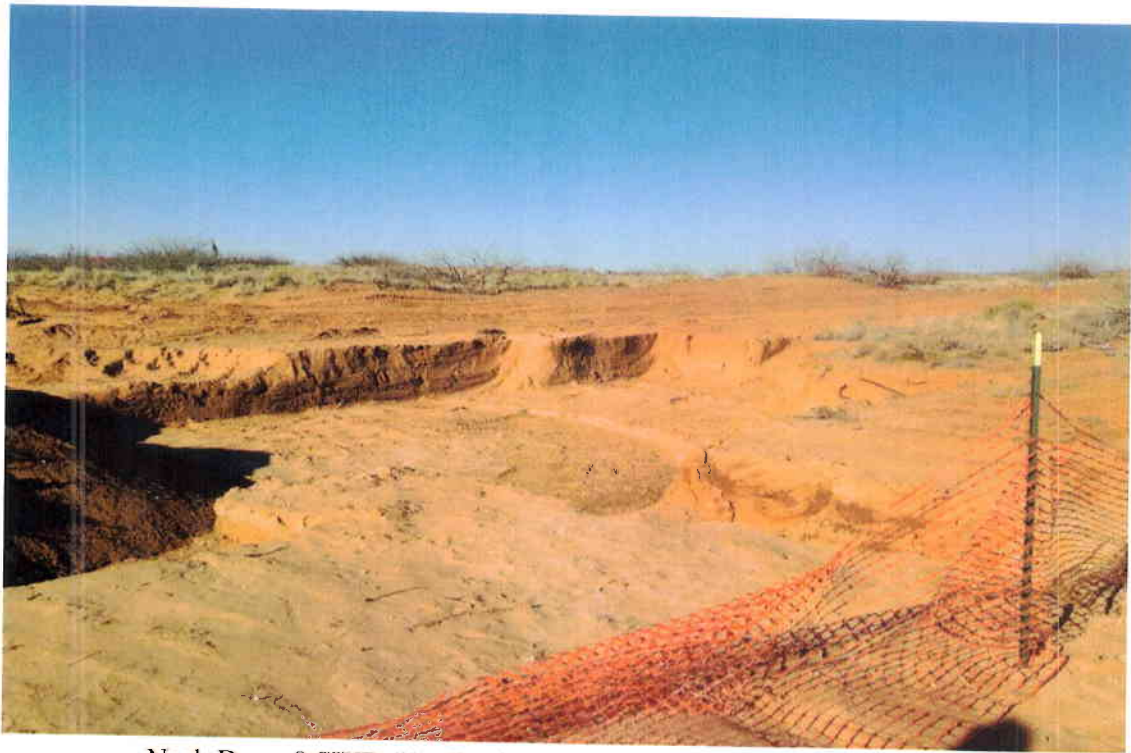
Nash Draw 8 SWD #1 - Section A Excavation (Looking Northwest)

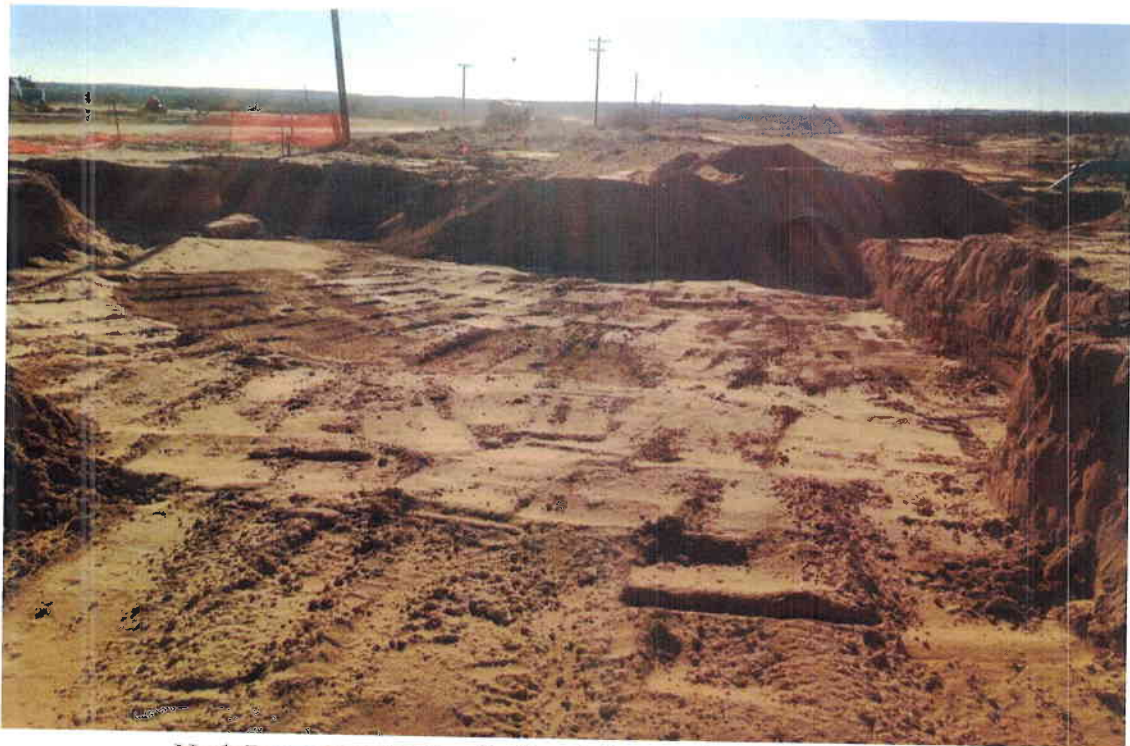
Nash Draw 8 SWD #1 - Section A Excavation (Looking South)

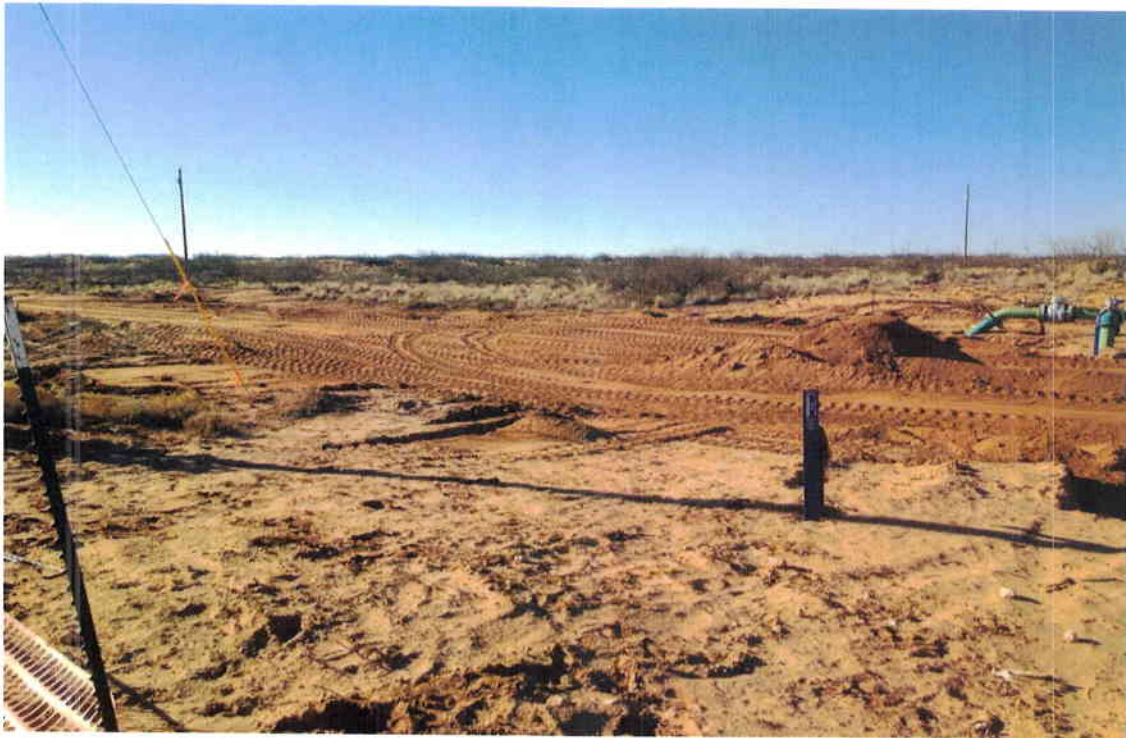
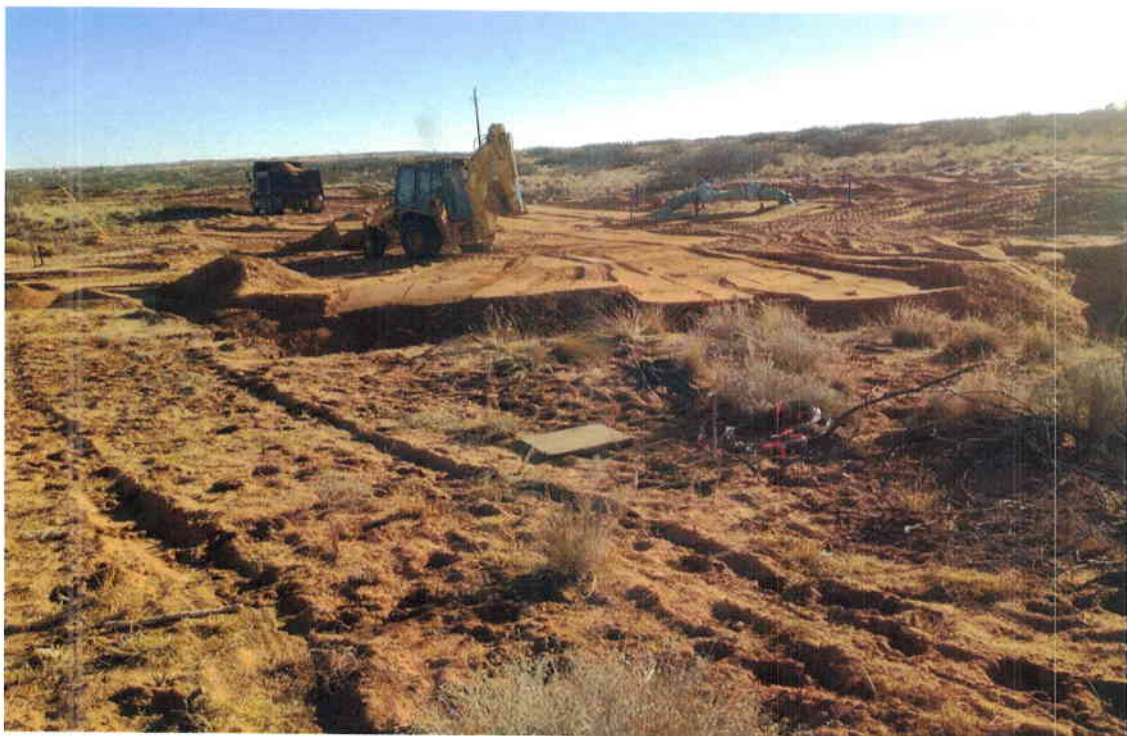
Nash Draw 8 SWD #1 - Section A Excavation (During Backfill)

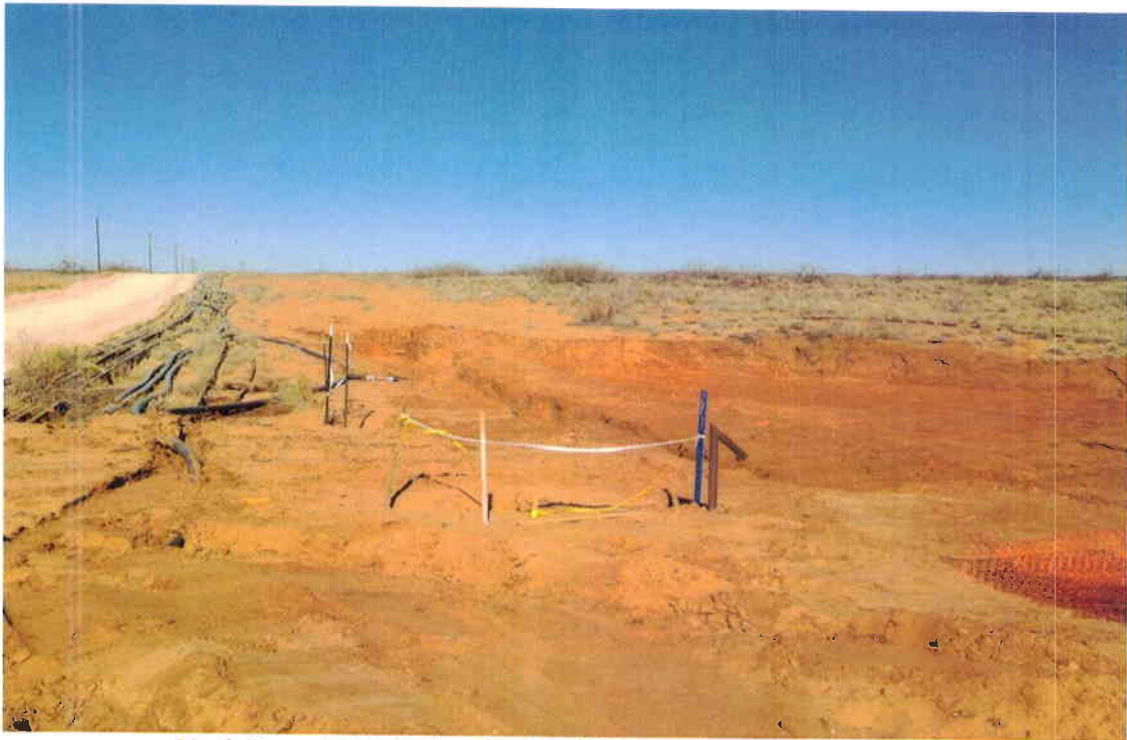
Nash Draw 8 SWD #1 - Section B Excavation (Looking North)

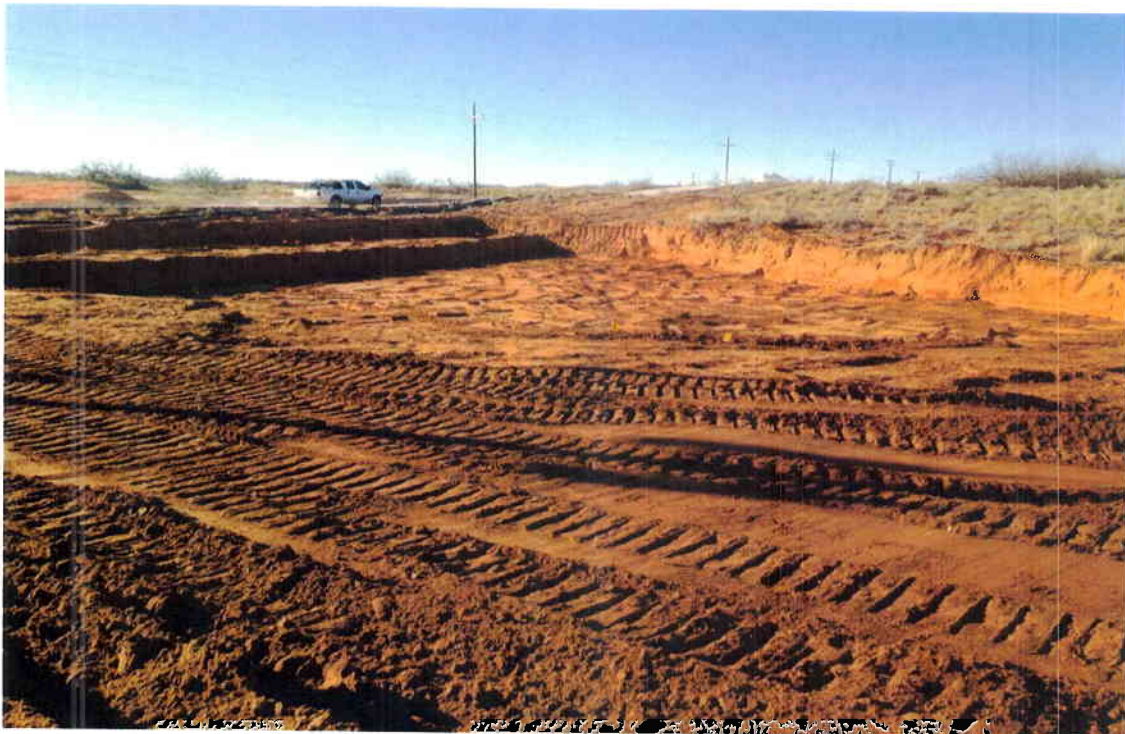
Nash Draw 8 SWD #1 - Section B Excavation (Looking Northeast)

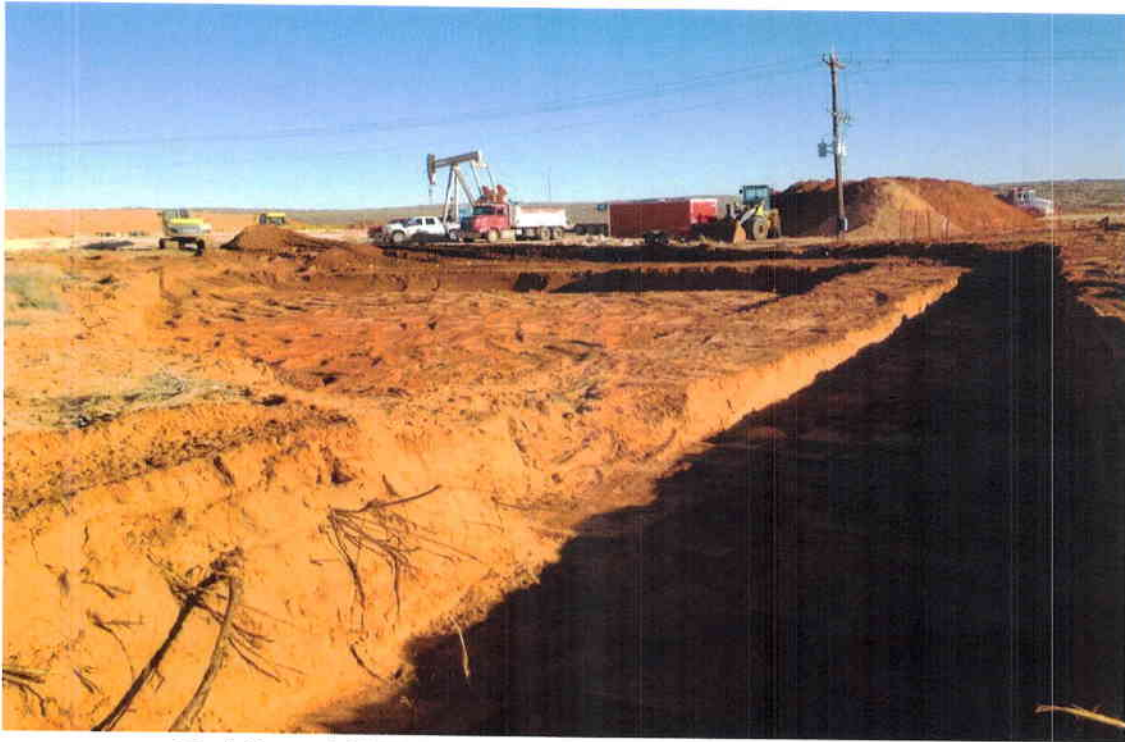
Nash Draw 8 SWD #1 - Section B Excavation (Looking South)

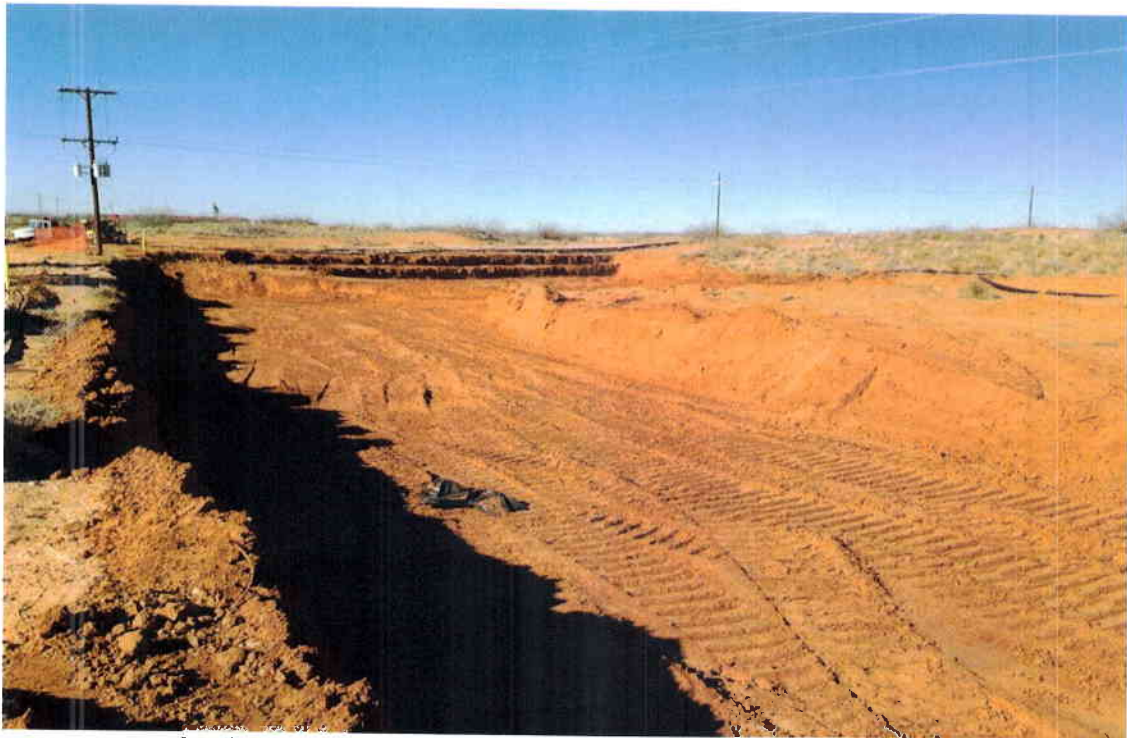
Nash Draw 8 SWD #1 - Section B Excavation (Looking West)

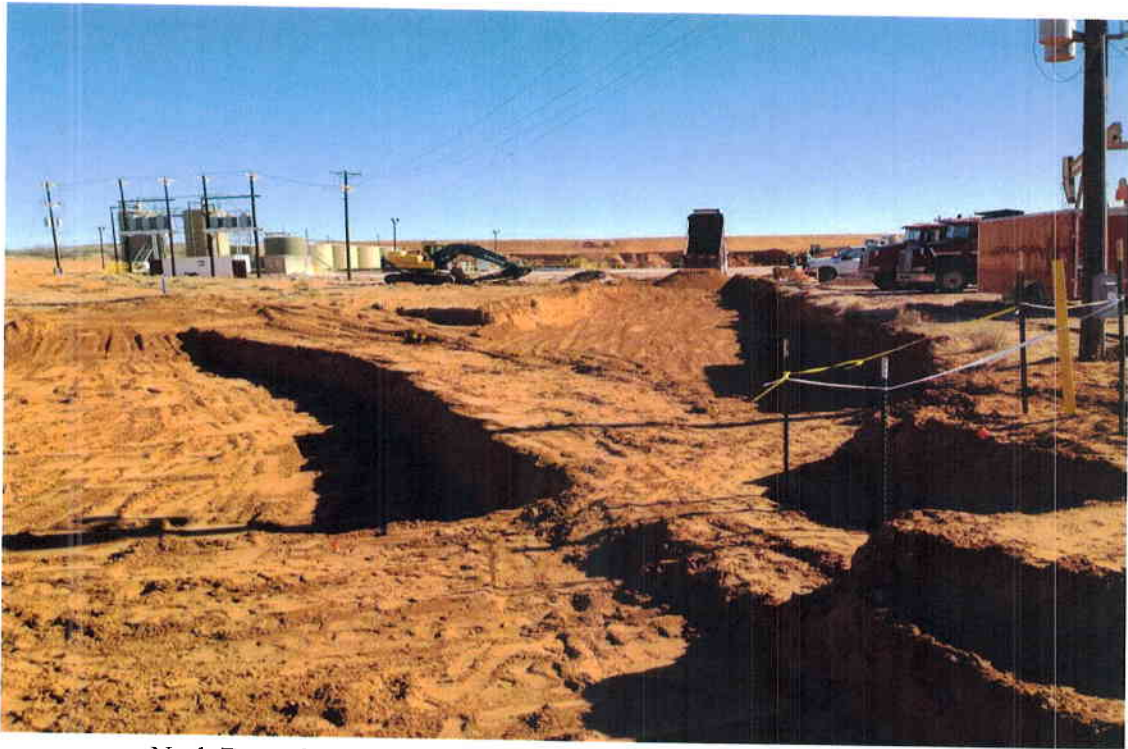
Nash Draw 8 SWD #1 - Section B Excavation (Looking Southeast)

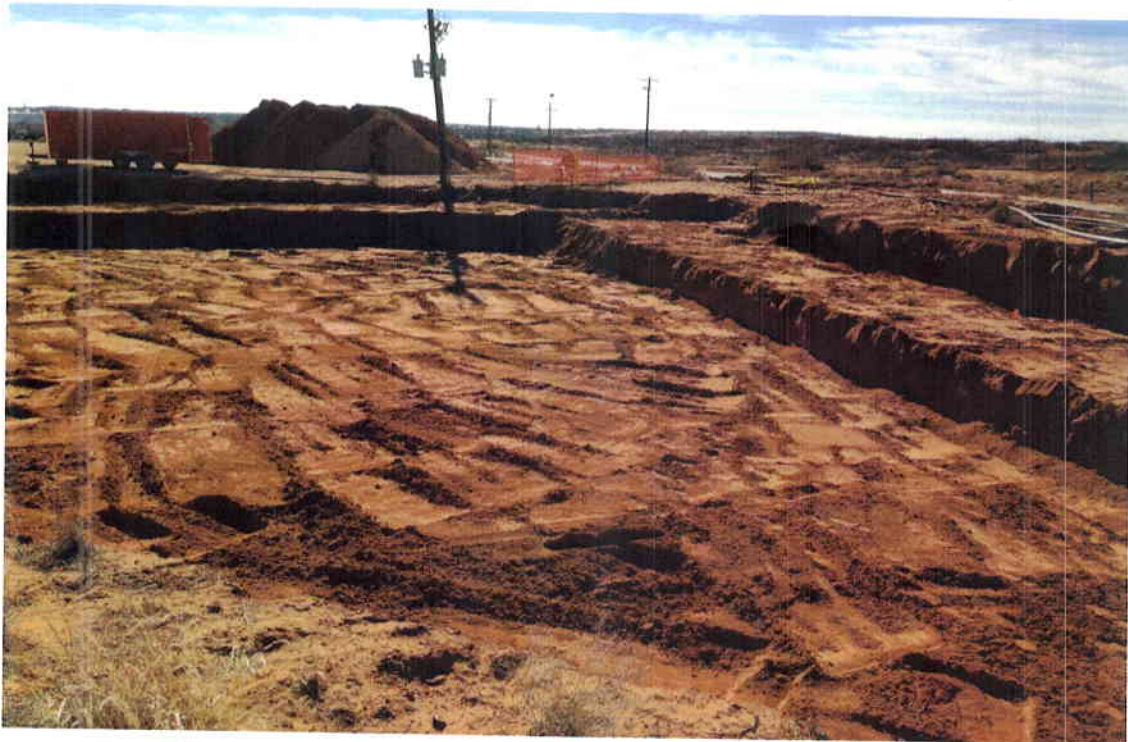
Nash Draw 8 SWD #1 - Section B Excavation (Looking South)

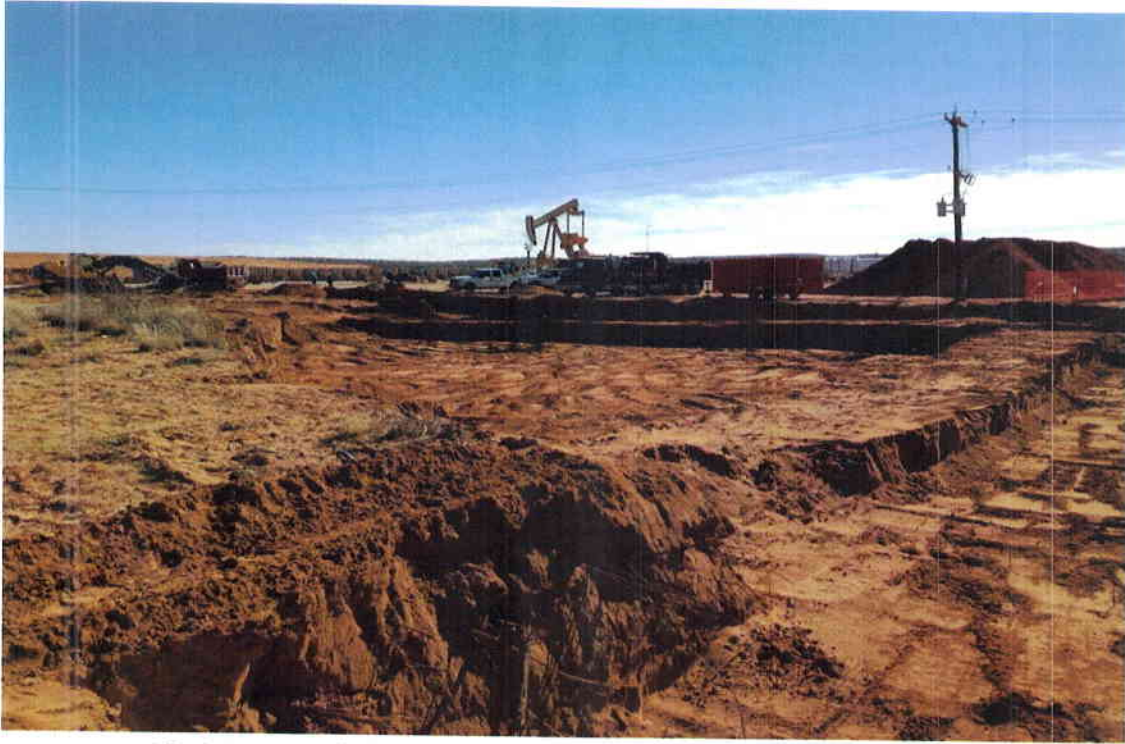
Nash Draw 8 SWD #1 - Section B Excavation (Looking Southeast)
