REMEDIATION SUMMARY & RISK-BASED SITE CLOSURE REQUEST

**BOPCO, LP
NASH DRAW 8 SWD #1
API 30-015-41351
Eddy County, New Mexico
Unit Letter "L" (NW/SW), Section 8, Township 24 South, Range 30 East
Latitude 32.231646° North, Longitude -103.910656° West
NMOCD Reference #2RP-2081**

December 2015

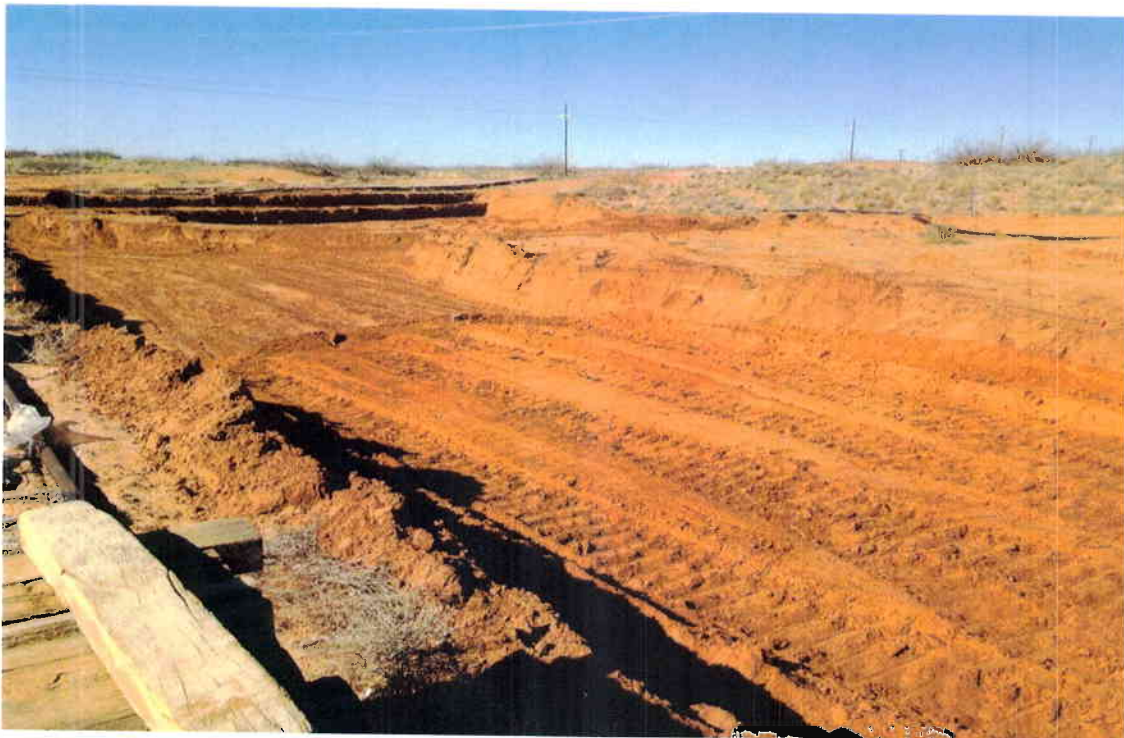
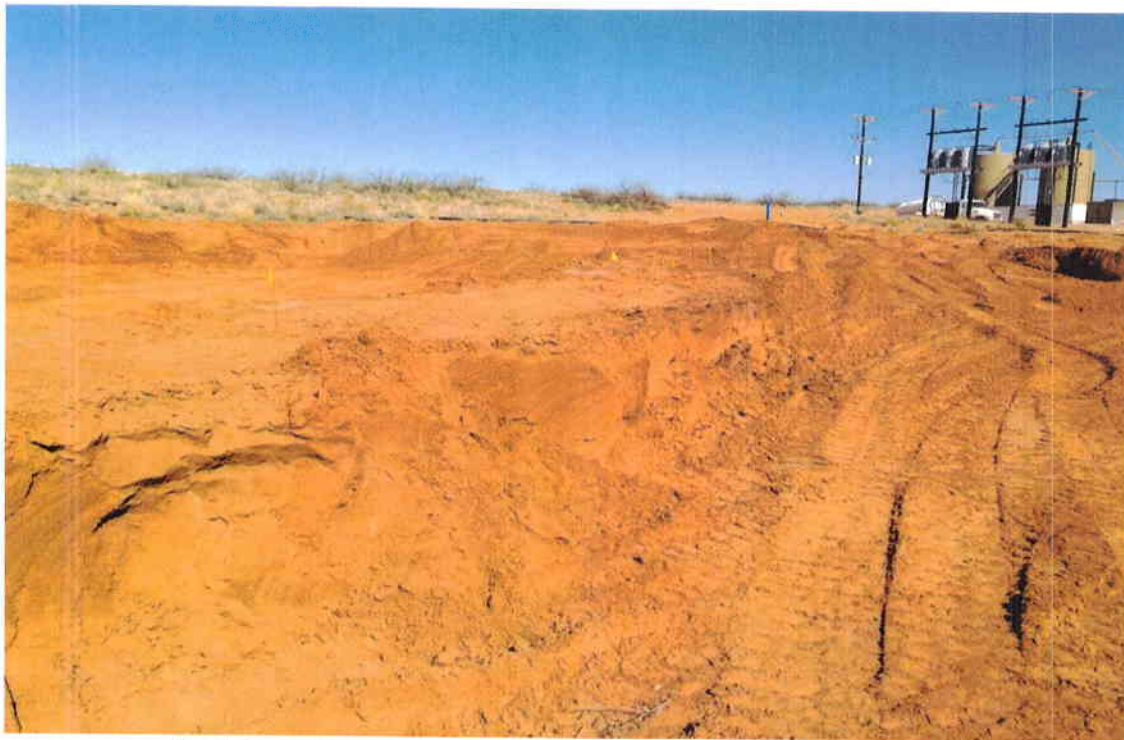
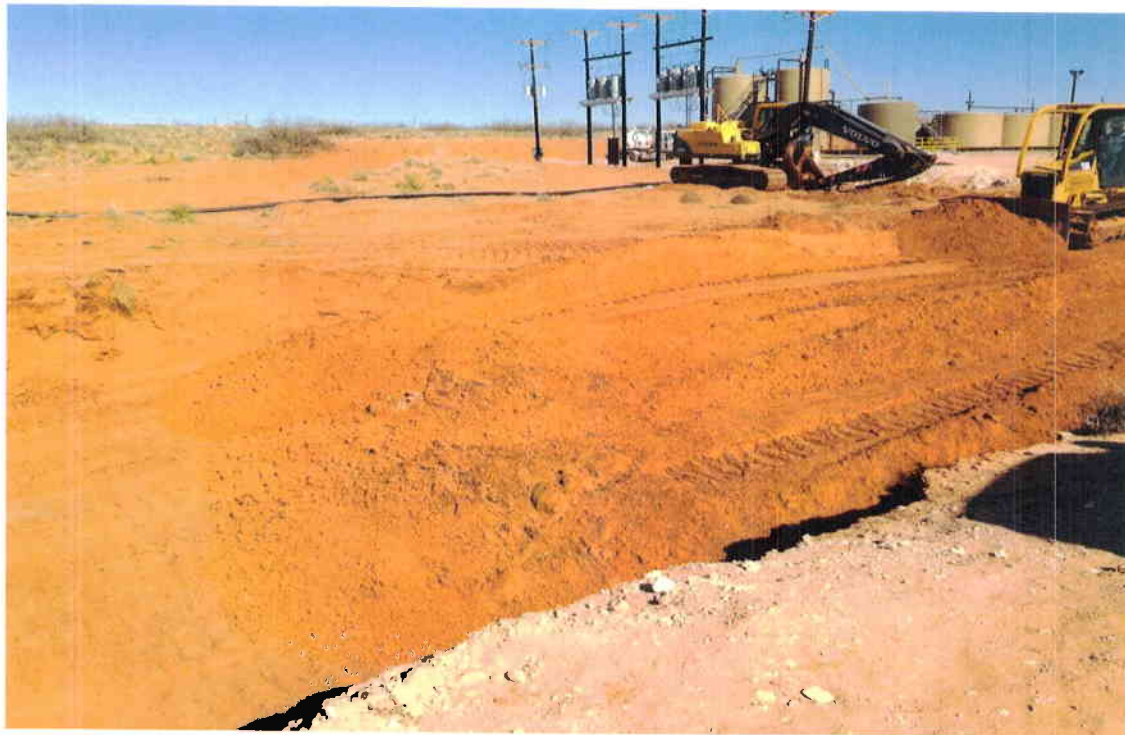
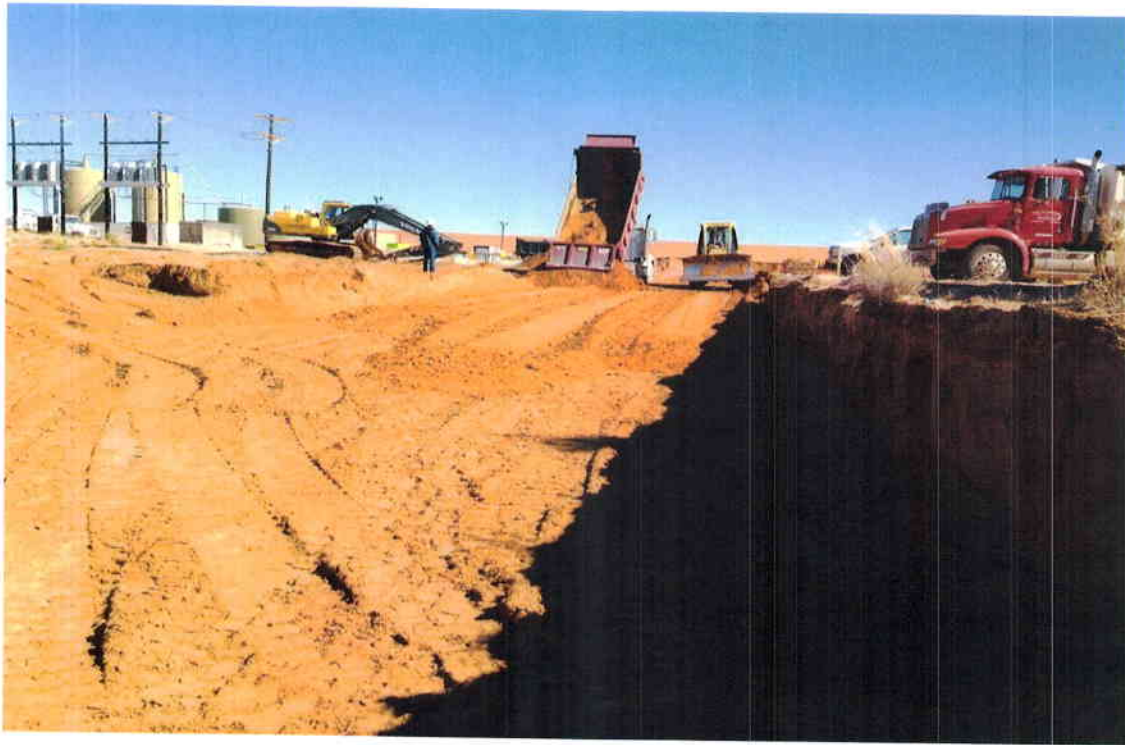
Nash Draw 8 SWD #1 - Section B Excavation (During Backfill)

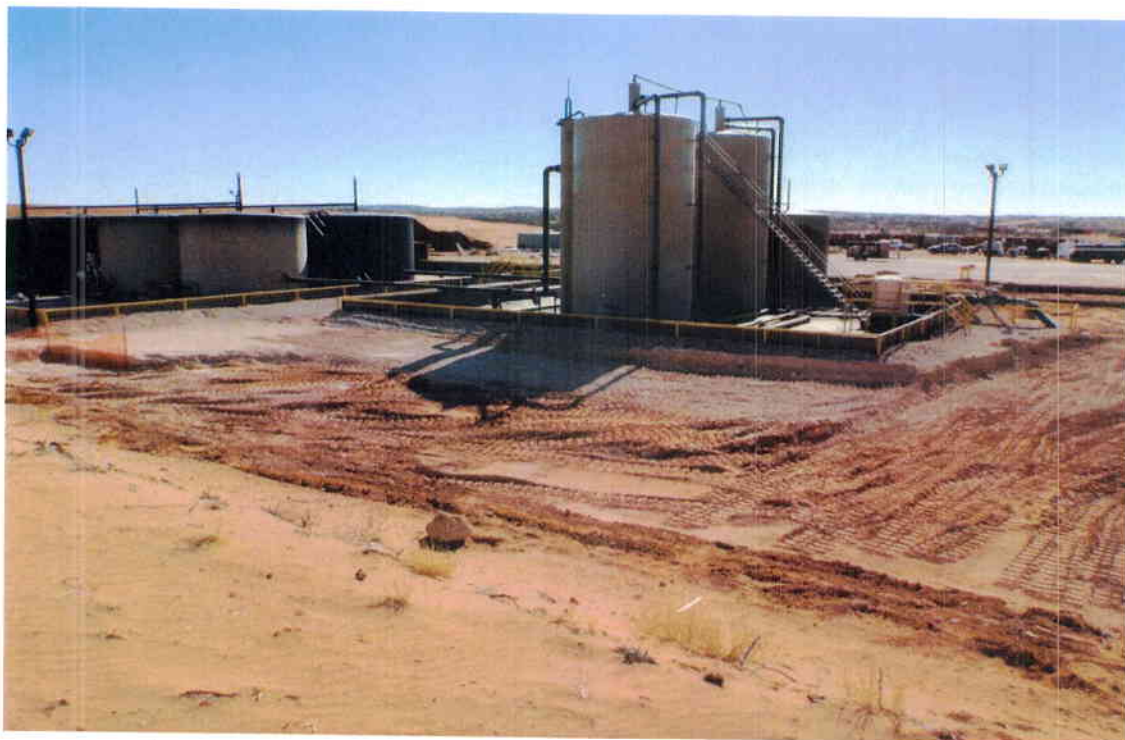
Nash Draw 8 SWD #1 - Section C Excavation (Looking Southeast)

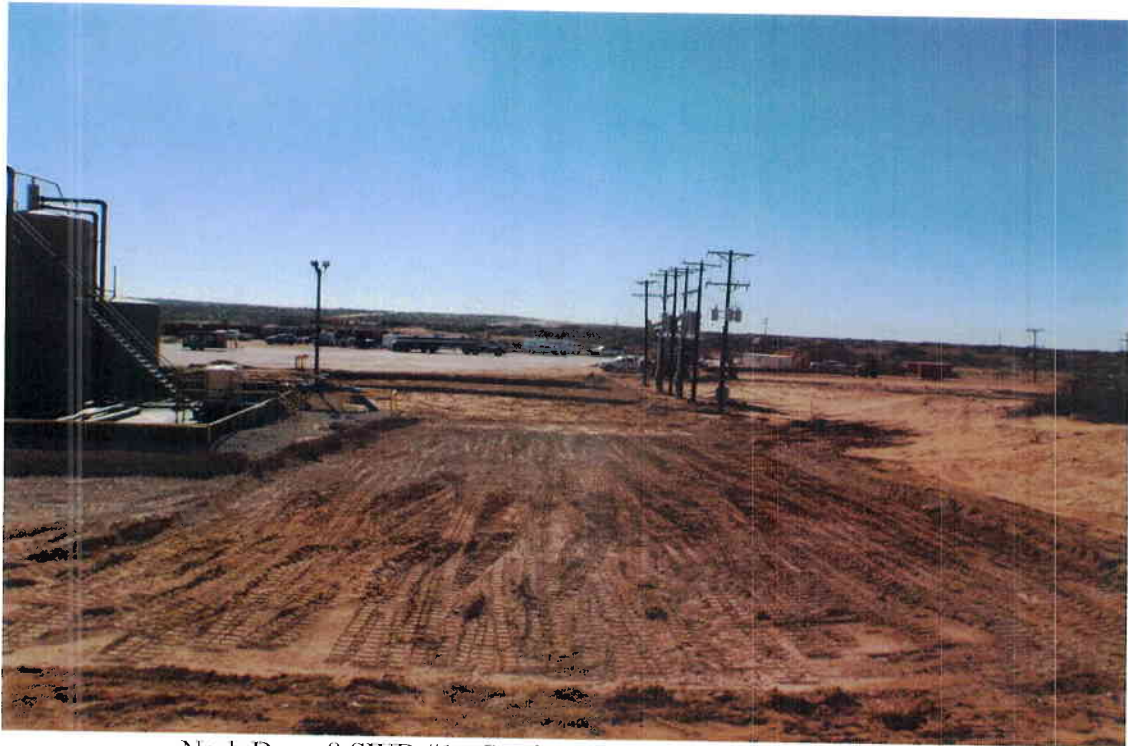
Nash Draw 8 SWD #1 - Section C Excavation (Looking South)

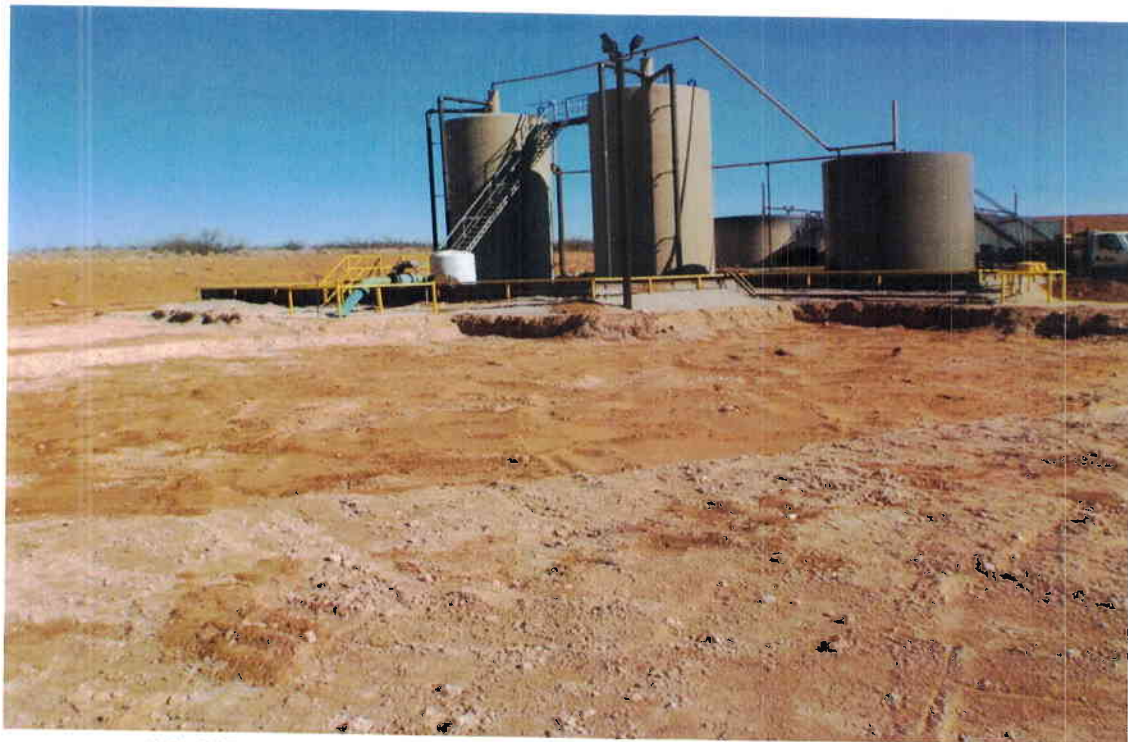
Nash Draw 8 SWD #1 - Section C Excavation (Looking Northeast)

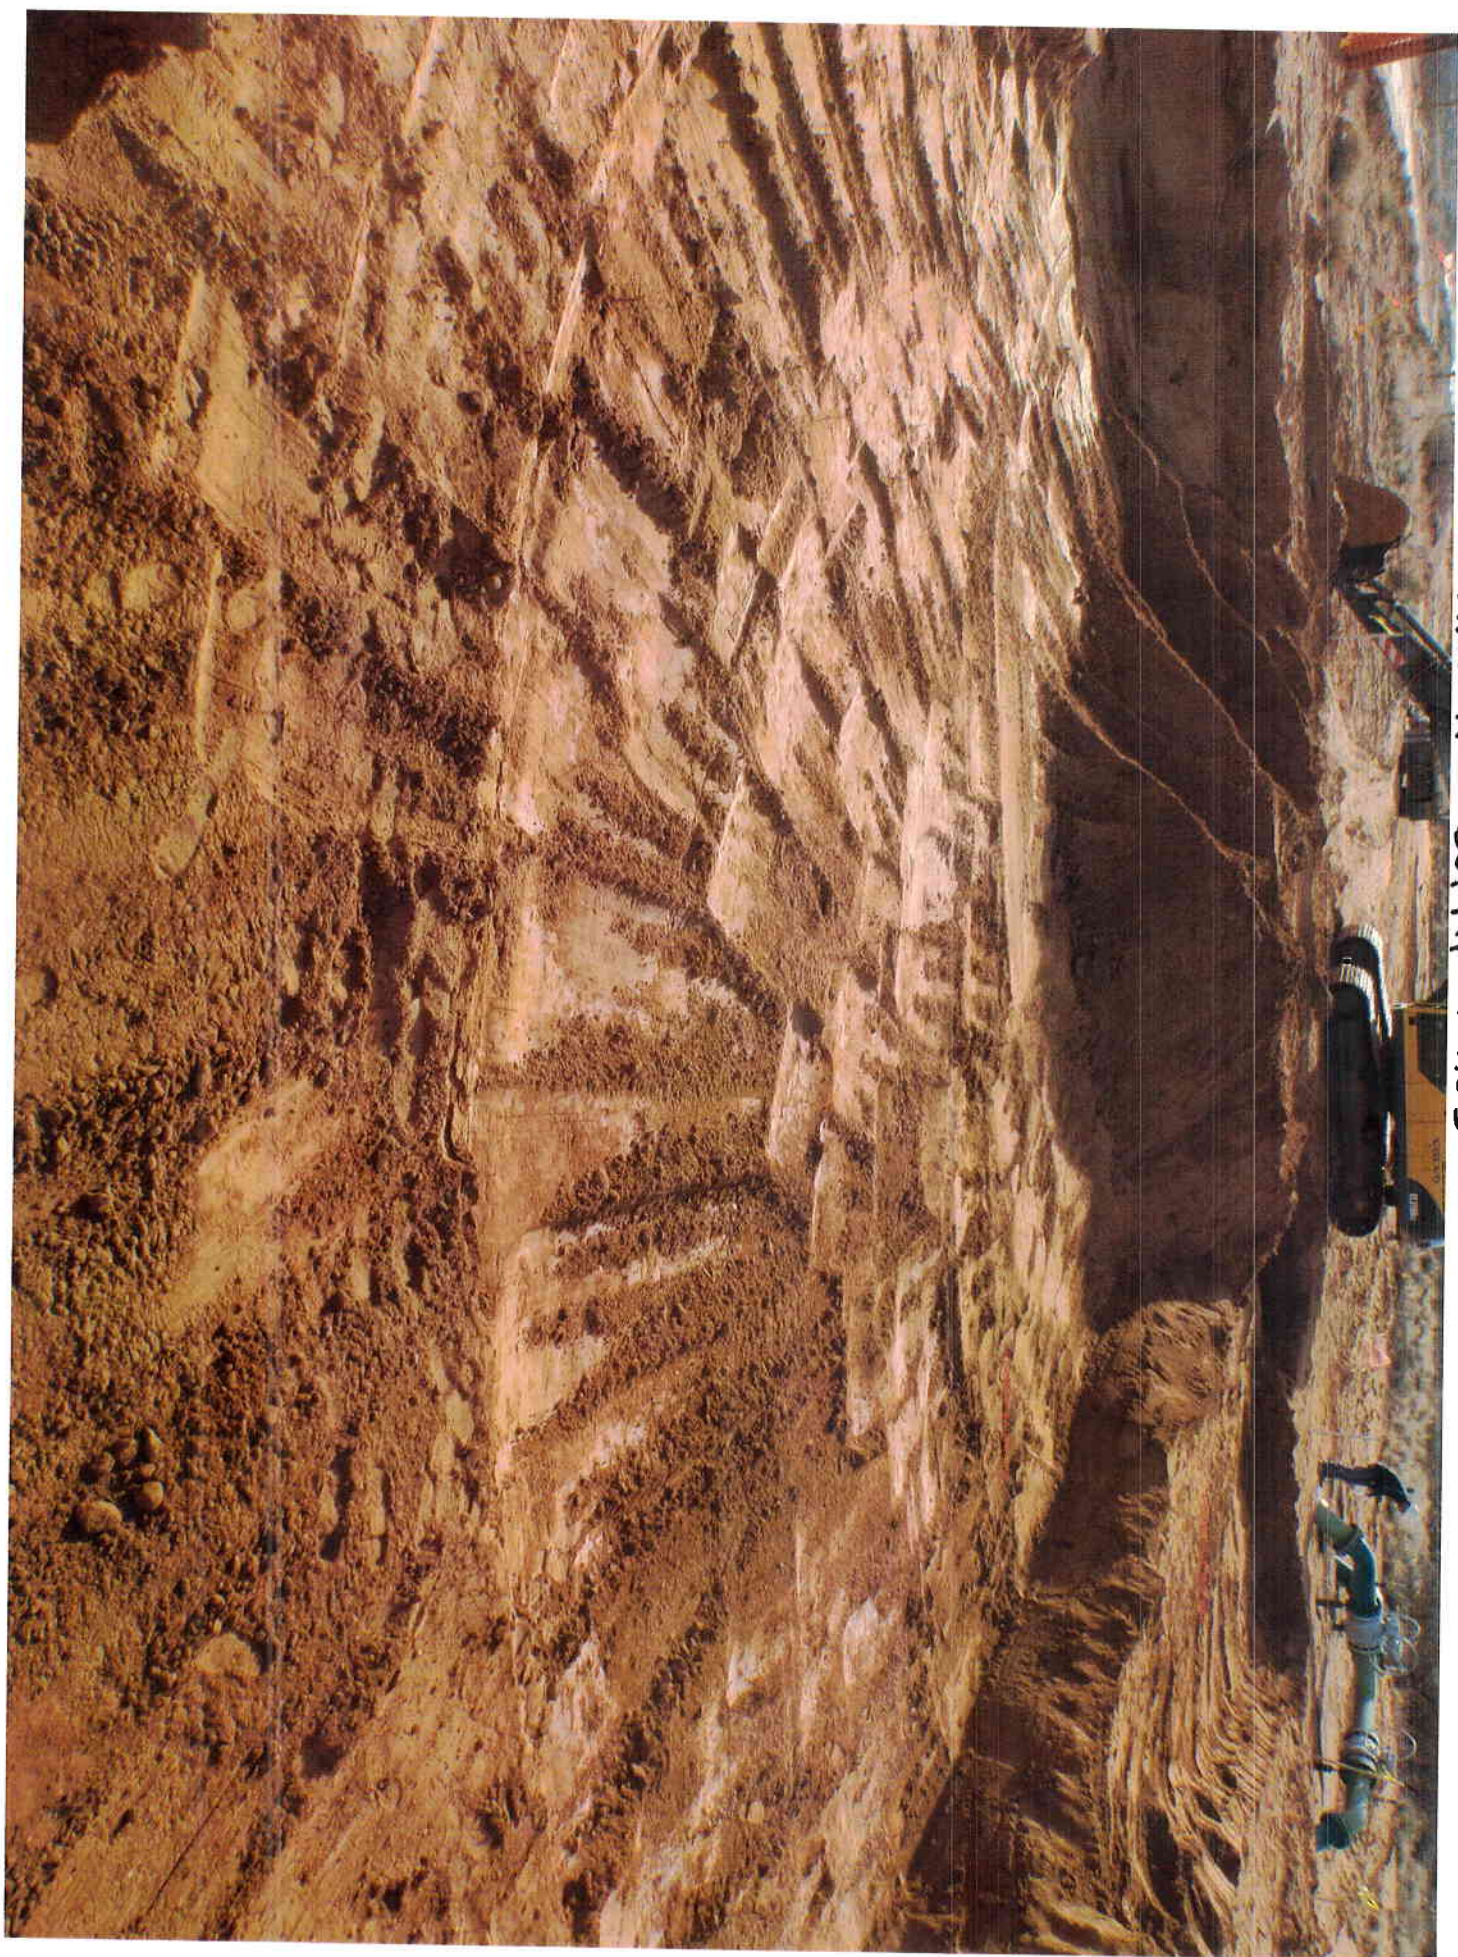
Area 'A' Buffer Zones

The elevated in-situ samples identified in the soil chemistry report were due to soil left in place as safety buffers for the 2 high pressure gas lines and 2 large diameter poly lines that ran north by south thru the ponded areas. Contaminated soil was removed as far as practicable above and adjacent to the buried lines. Soil samples were collected from the soil left above and to the sides of the pipelines. The areas are can be seen in photographs taken on 12/19/13 included in this report.
