SOIL REMEDIATION WORK PLAN

EXCAVATION, SOIL SHREDDING AND MONITORING

**HACKBERRY 18 FEDERAL NO.1
EDDY COUNTY, NEW MEXICO
API#30-015-29789
2RP-3272**

Subject: **Soil Assessment and Remediation Work Plan (Revised)**
Devon Energy Corporation
Hackberry 18 Federal No. 1
API # 30-015-29780 (2RP-3272)

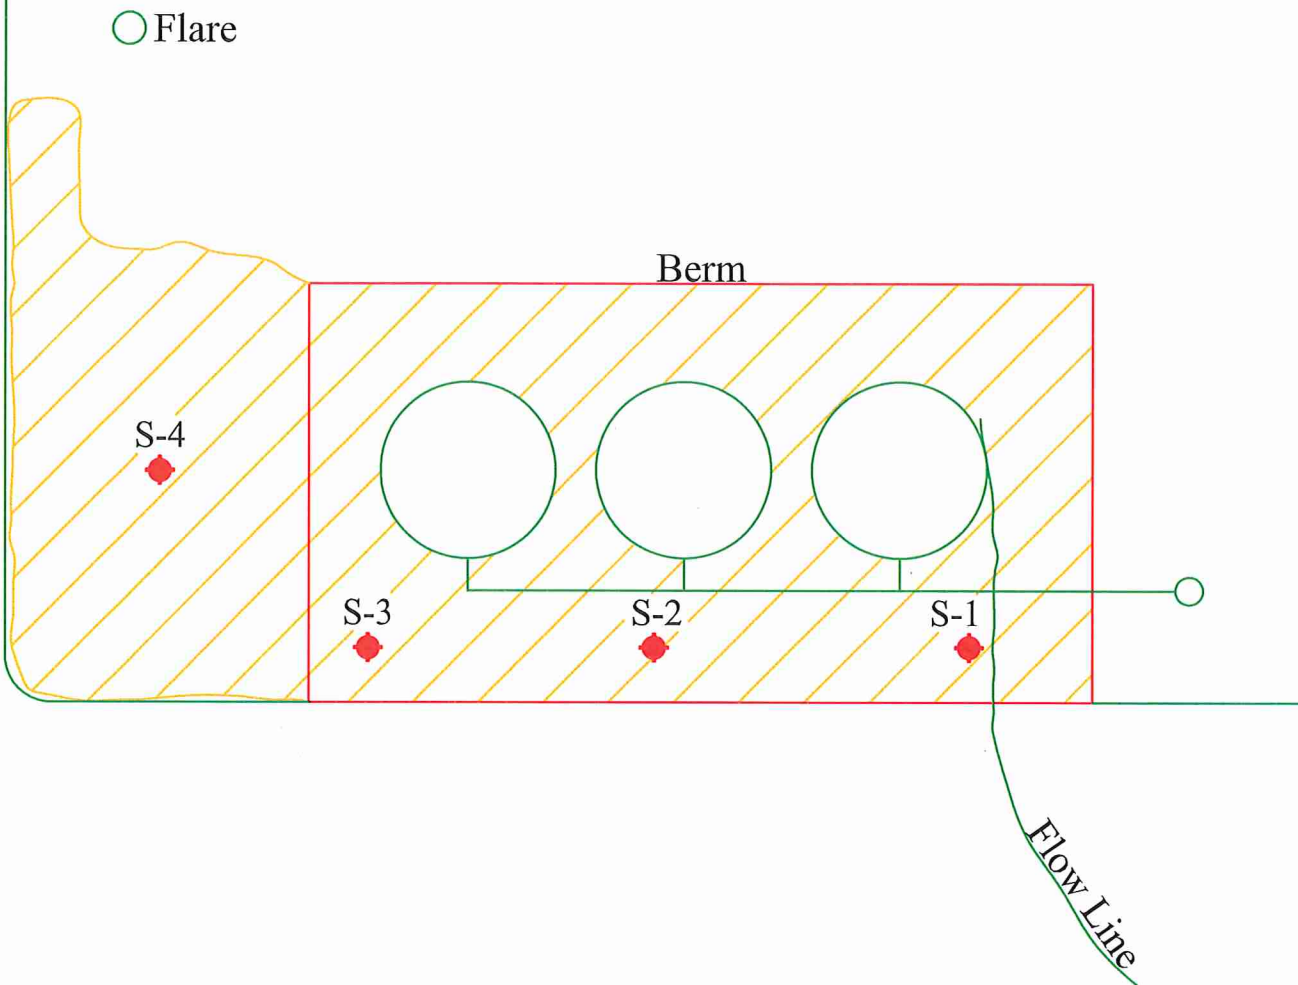
Hackberry 18 Fed 1
Devon Energy Corporation
Eddy County, New Mexico
Figure 2 - Site Plan

Legend	
	- Sample Location
	- Pipeline
	- Impacted Area

Table 2 Release date September 14, 2015, Figure 2

Sample ID	Depth (feet)	BTEX (mg/kg)	Chlorides (mg/kg)	TPH (mg/kg) GRO	TPH (mg/kg) DRO
S-4	0'	620	64	6450	61700
	1'	<0.300	<16	<10	20.8
	2'	<0.300	<16	<10	<10
	3'	<0.300	<16	<10	<10
	4'	<0.300	32	<10	<10

- The previously impacted area within the battery was already excavated (and stockpiled on site) to a depth of 4-feet deep and treated with microblaze. This excavated area (now impacted again), the remainder of the battery and the flow path on the location will be excavated an additional 1-foot deep to address the impacts from the most recent release. See Figure 2.
