MicroBind Case Study – Kingfisher County, OK

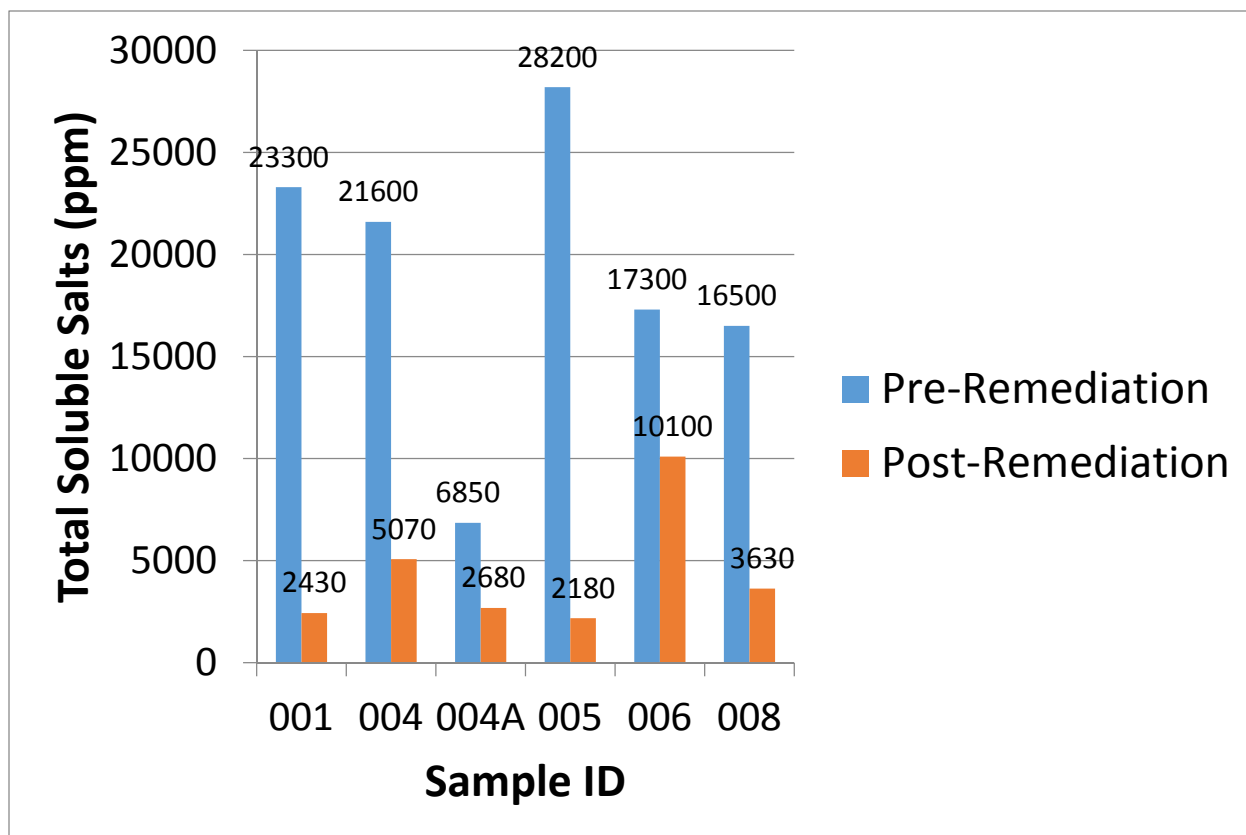
Comparison of Analytical Results from Pre and Post Remediation				
Sample ID	Depth (ft. bgs)	Pre-Remediation Total Soluble Salts Results (ppm)	Post-Remediation Total Soluble Salts Results (ppm)	Δ Total Soluble Salts Results (ppm)
001	0	23,300	2,430	-20,870
004	0	21,600	5,070	-16,530
004A	1	6,850	2,680	-4,170
005	0	28,200	2,180	-26,020
006	0	17,300	10,100	-7,200
008	0	16,500	3,630	-12,870

Figure 1: Comparison Graph of Pre and Post Remediation TSS Results

Results indicated significant reductions in TSS in Sample IDs 001, 004, 004A, 005, 006, 008.

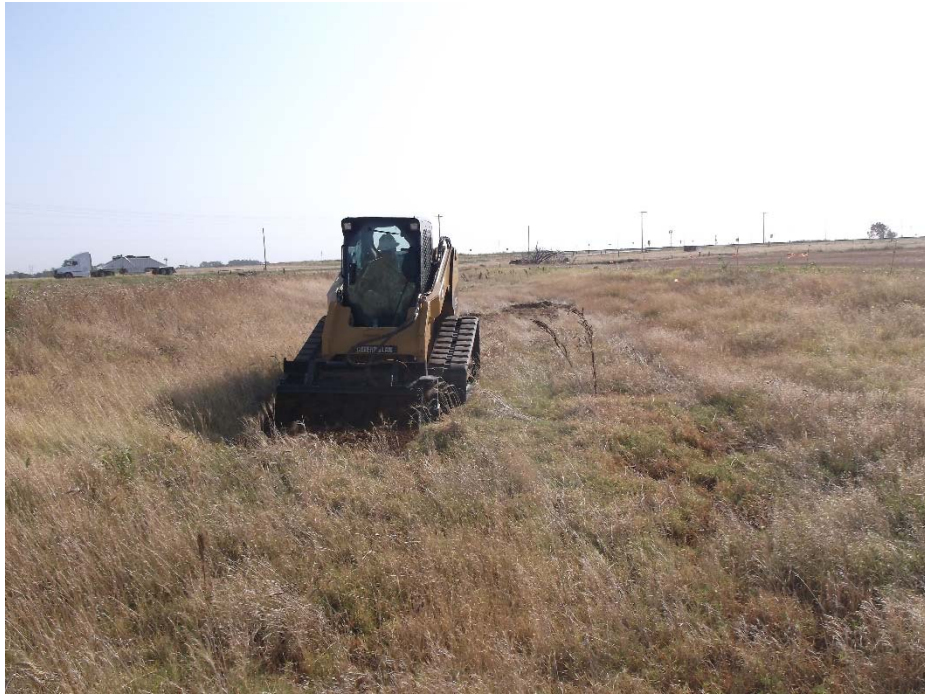
Photograph 1: Tilling drainage way

- Till impacted drainage way (southern portion)
- Treat impacted drainage way with a MicroBind solution
- Excavate remaining impacted area
- Incorporate gypsum and manure into the base of the excavation
- Treat the base of the excavation with a MicroBind solution
- Backfill with impacted soil
- Incorporate gypsum and manure into the backfilled area
- Treat the backfilled area with a MicroBind solution

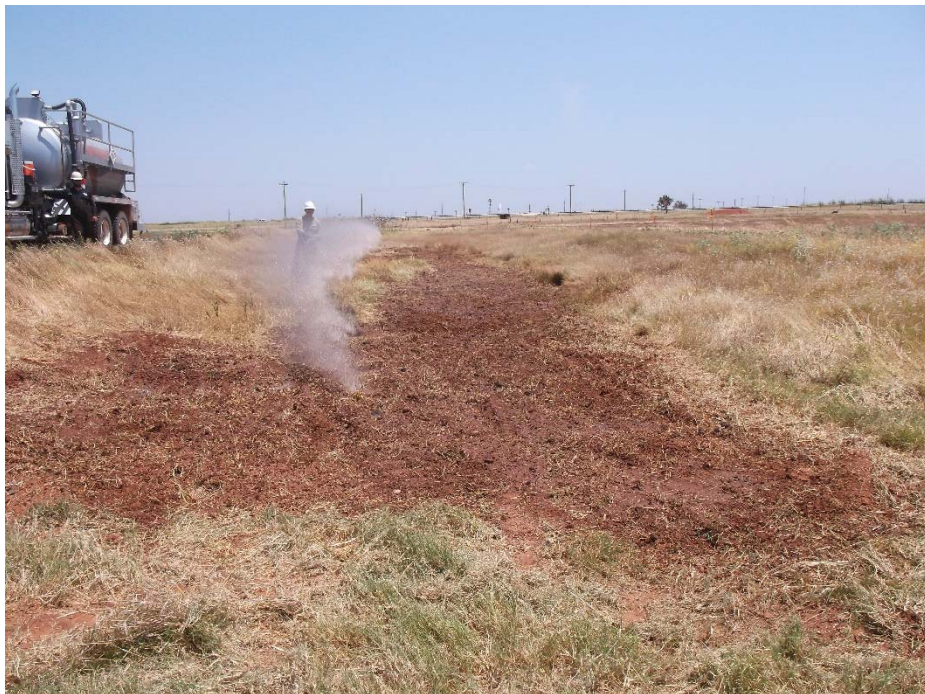
Photograph 2: Treating the tilled drainage way with a MicroBind solution

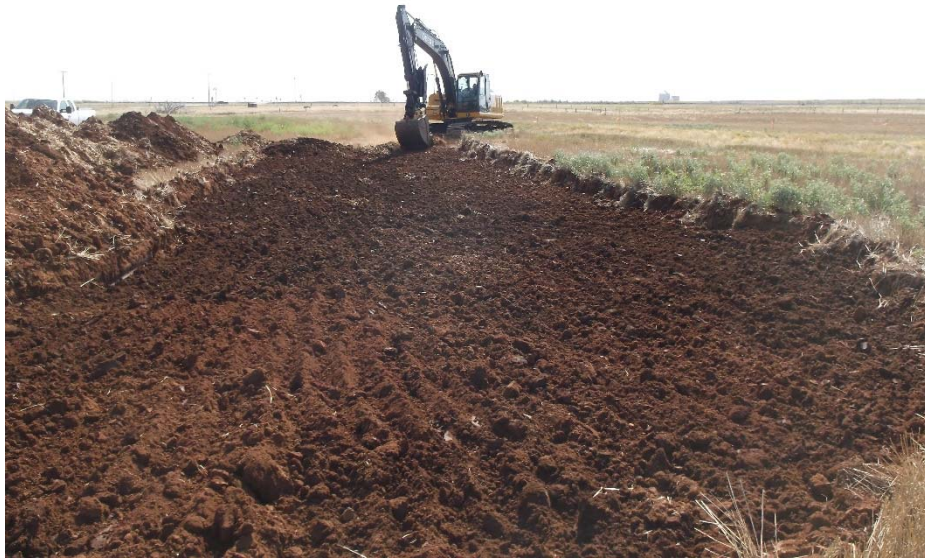
Photograph 3: Excavation of Impacted Area

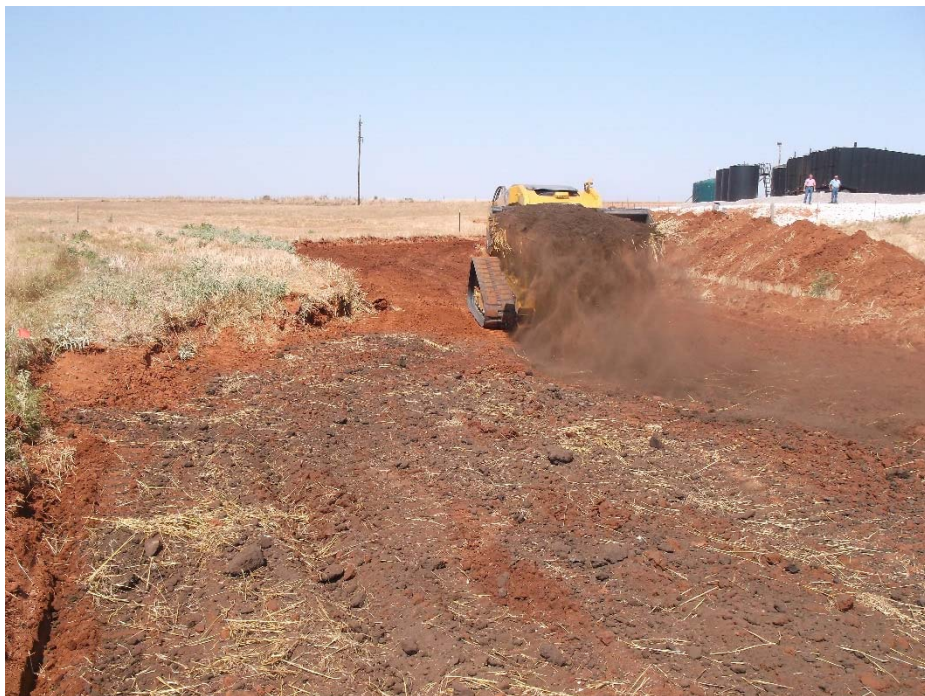
Photograph 4: Incorporating manure into base of the excavation

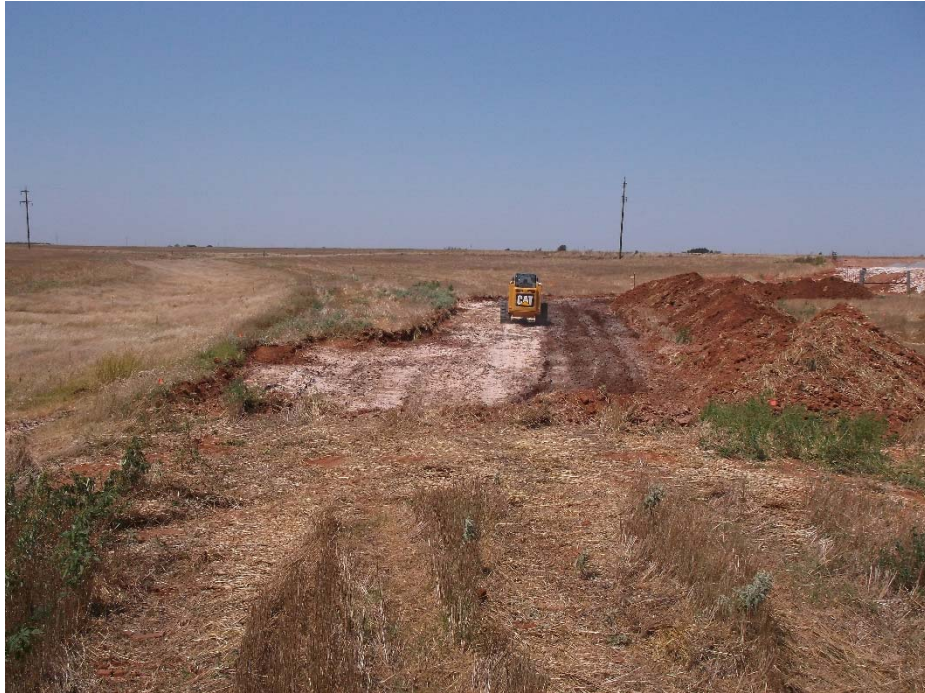
Photograph 5: Incorporating gypsum into base of the excavation

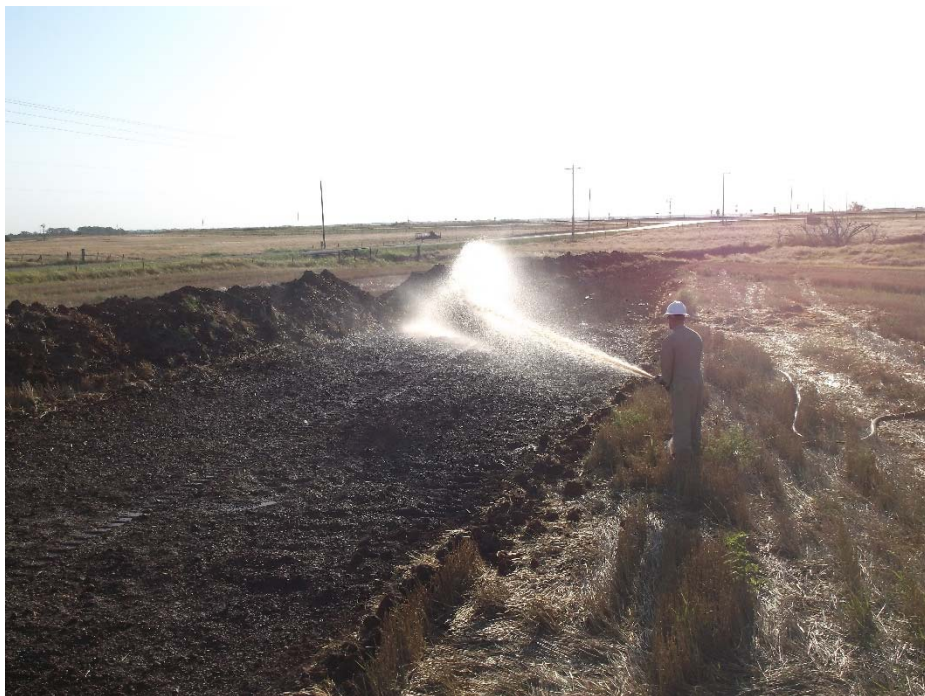
Photograph 6: Treating the base of the excavation with a MicroBind solution

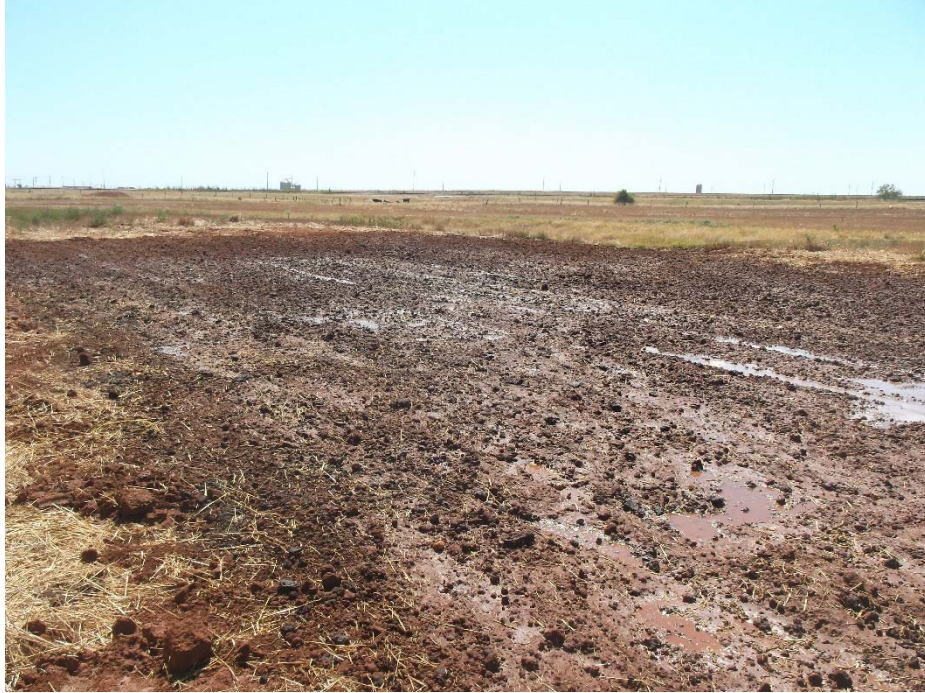
Photograph 7: Post Backfill Treatment with a MicroBind solution

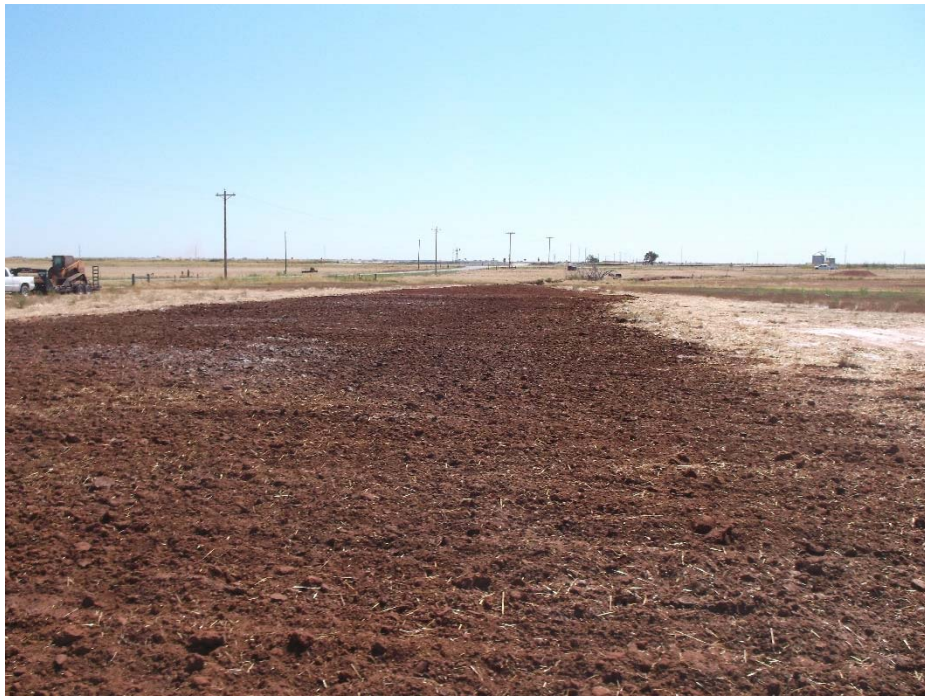
Photograph 8: Post Backfill Treatment with a MicroBind solution
