Closure Report

Site Name:	Conoco 10 State #1
Company:	Oxy Permian Ltd.
Legal Description:	U/L I, Section 10, T19S, R 29E
County:	Eddy County, NM
GPS Coordinates:	N 32.67332° W 104.05632°

Subject: **Soil Assessment and Remediation Work Plan**
Oxy USA, INC
Conoco 10 State #001
API #: 30-015-23066

Conoco 10 State #1
 Oxy - NM - North
 Eddy County, New Mexico
 Figure 1 - Site Plan

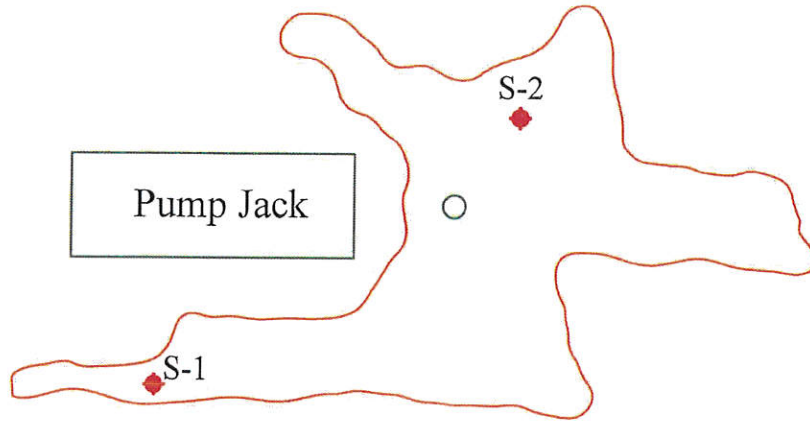
SITE PLAN

- The impacted area in the vicinity of sample location S-1 will be scrapped to remove any surface staining.
- The impacted area in the vicinity of sample location S-2 will be excavated to a depth of 1-foot bgs.
- All of the excavated material will be hauled to an NMOCD approved solid waste disposal facility.
- The excavation will be backfilled with caliche and contoured to match the surrounding location.
