To: Heather Patterson, New Mexico Oil Conservation Division, District II
Amber Groves, New Mexico State Land Office
Reference: Remediation Work Plan
Operator: Devon Energy Production Company
Location: Cottontail 16 St Com #1H
API: 30-015-42321
Legals: UL. O, Sec. 16, T25S, R29E
GPS: 32.1230 -103.9866
2RP-3554

Remediation Proposal

Release Notification and Corrective Action

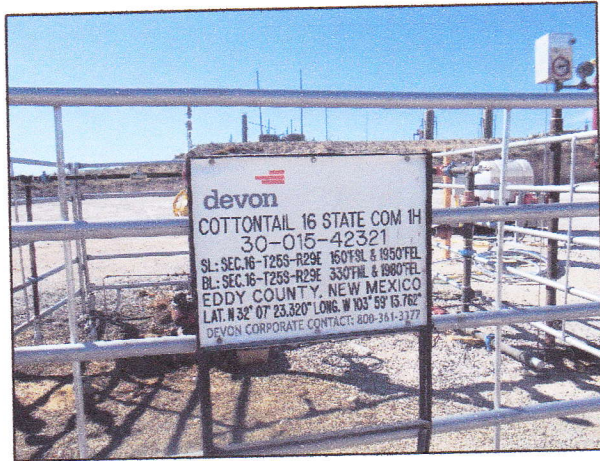
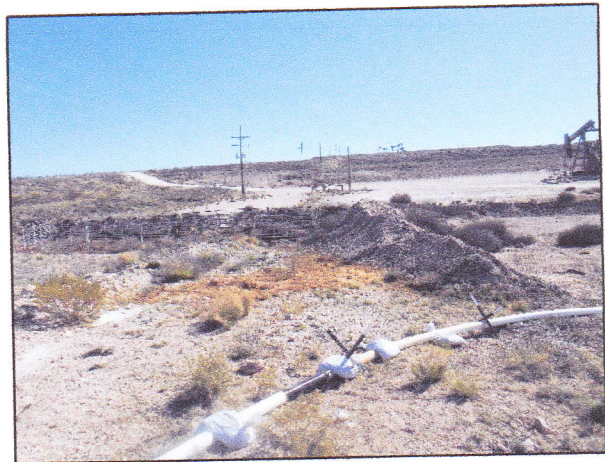
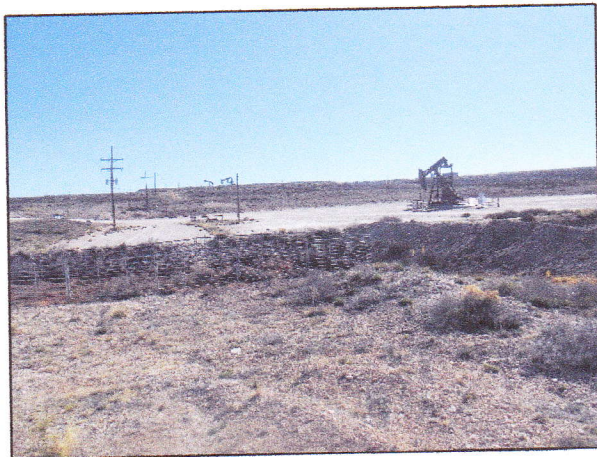
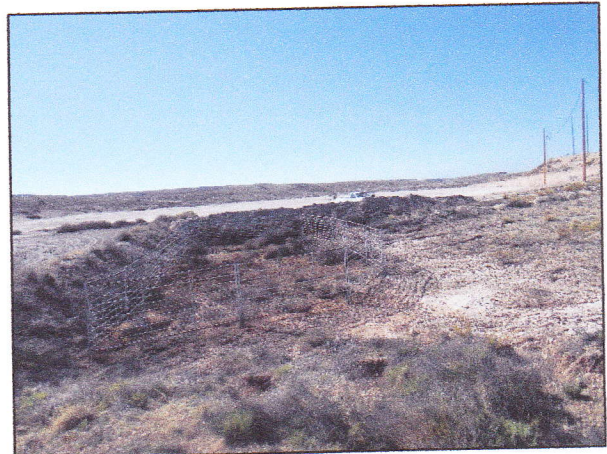
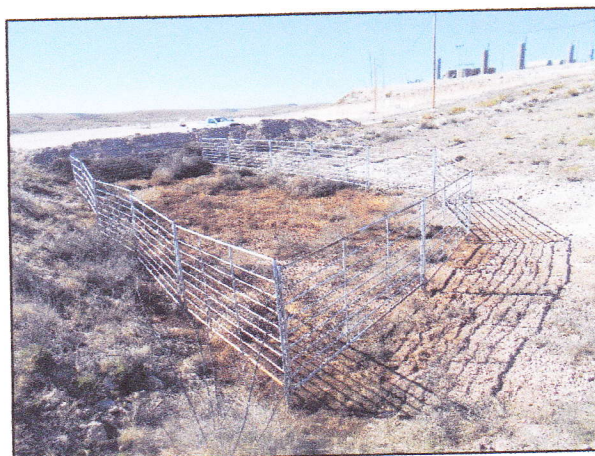
Devon Energy Production Company-Cottontail 16 St Comm #1H

This release of produced water and oil was due to a flow line rupture. The release was on a hillside and was contained by a "berm/wall" of the adjacent location to the east and to the south. The impacted area is an "L" shaped area off the edge of the caliche pad. The impacted area is roughly 80'x60'. A vacuum truck was used at the time of discovery to recover the free standing fluid.

With Chlorides being the primary contaminant of concern for this release, I propose to use the dig and haul method for the remediation. The impacted area at sample points #1 and #3 will be excavated to a depth of 1' BGS. The impacted area at sample point #4 will be excavated to a depth of 3' BGS. No work is required at sample point #2. Upon completion of the excavation, all impacted soil will be transported to a division approved facility for disposal. Fresh material will be used for backfill. The area will be brought back to grade and contoured to match the surrounding area.

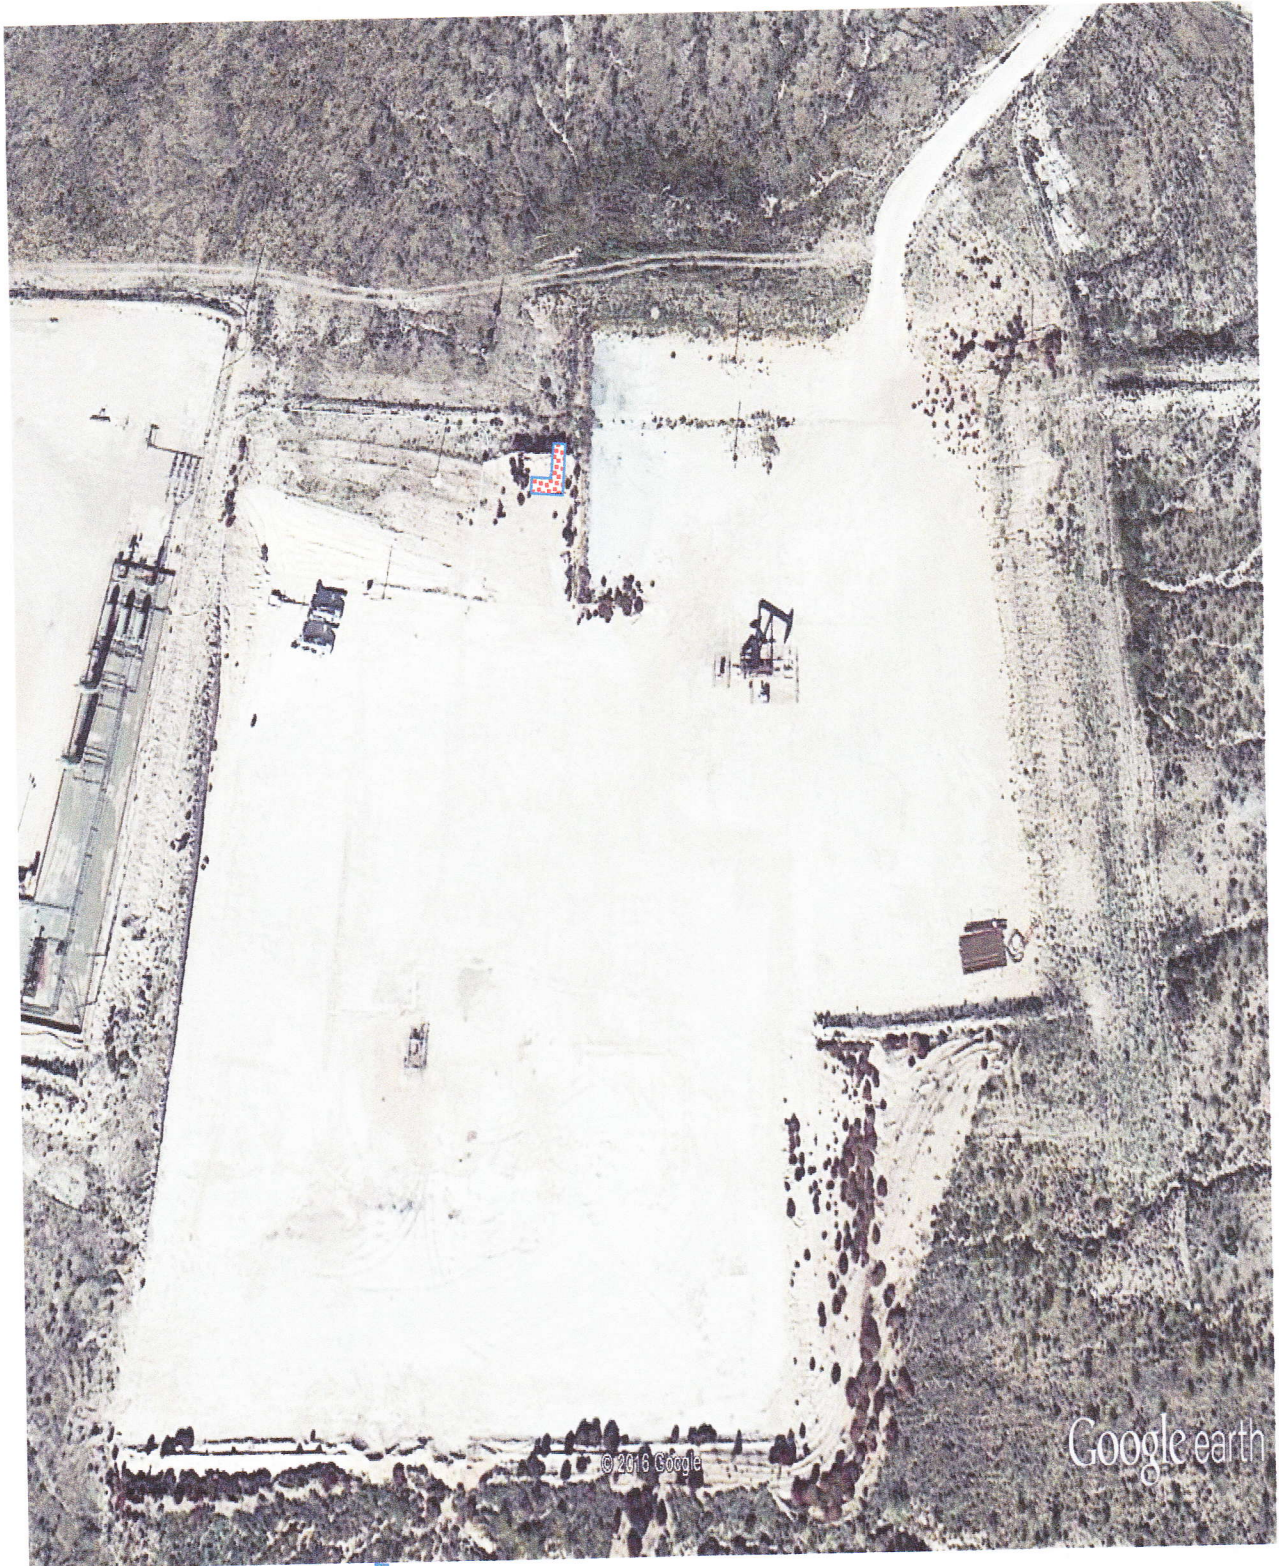
Devon Energy Production Company-Cottontail 16 St Com #1H

Impacted area noted with

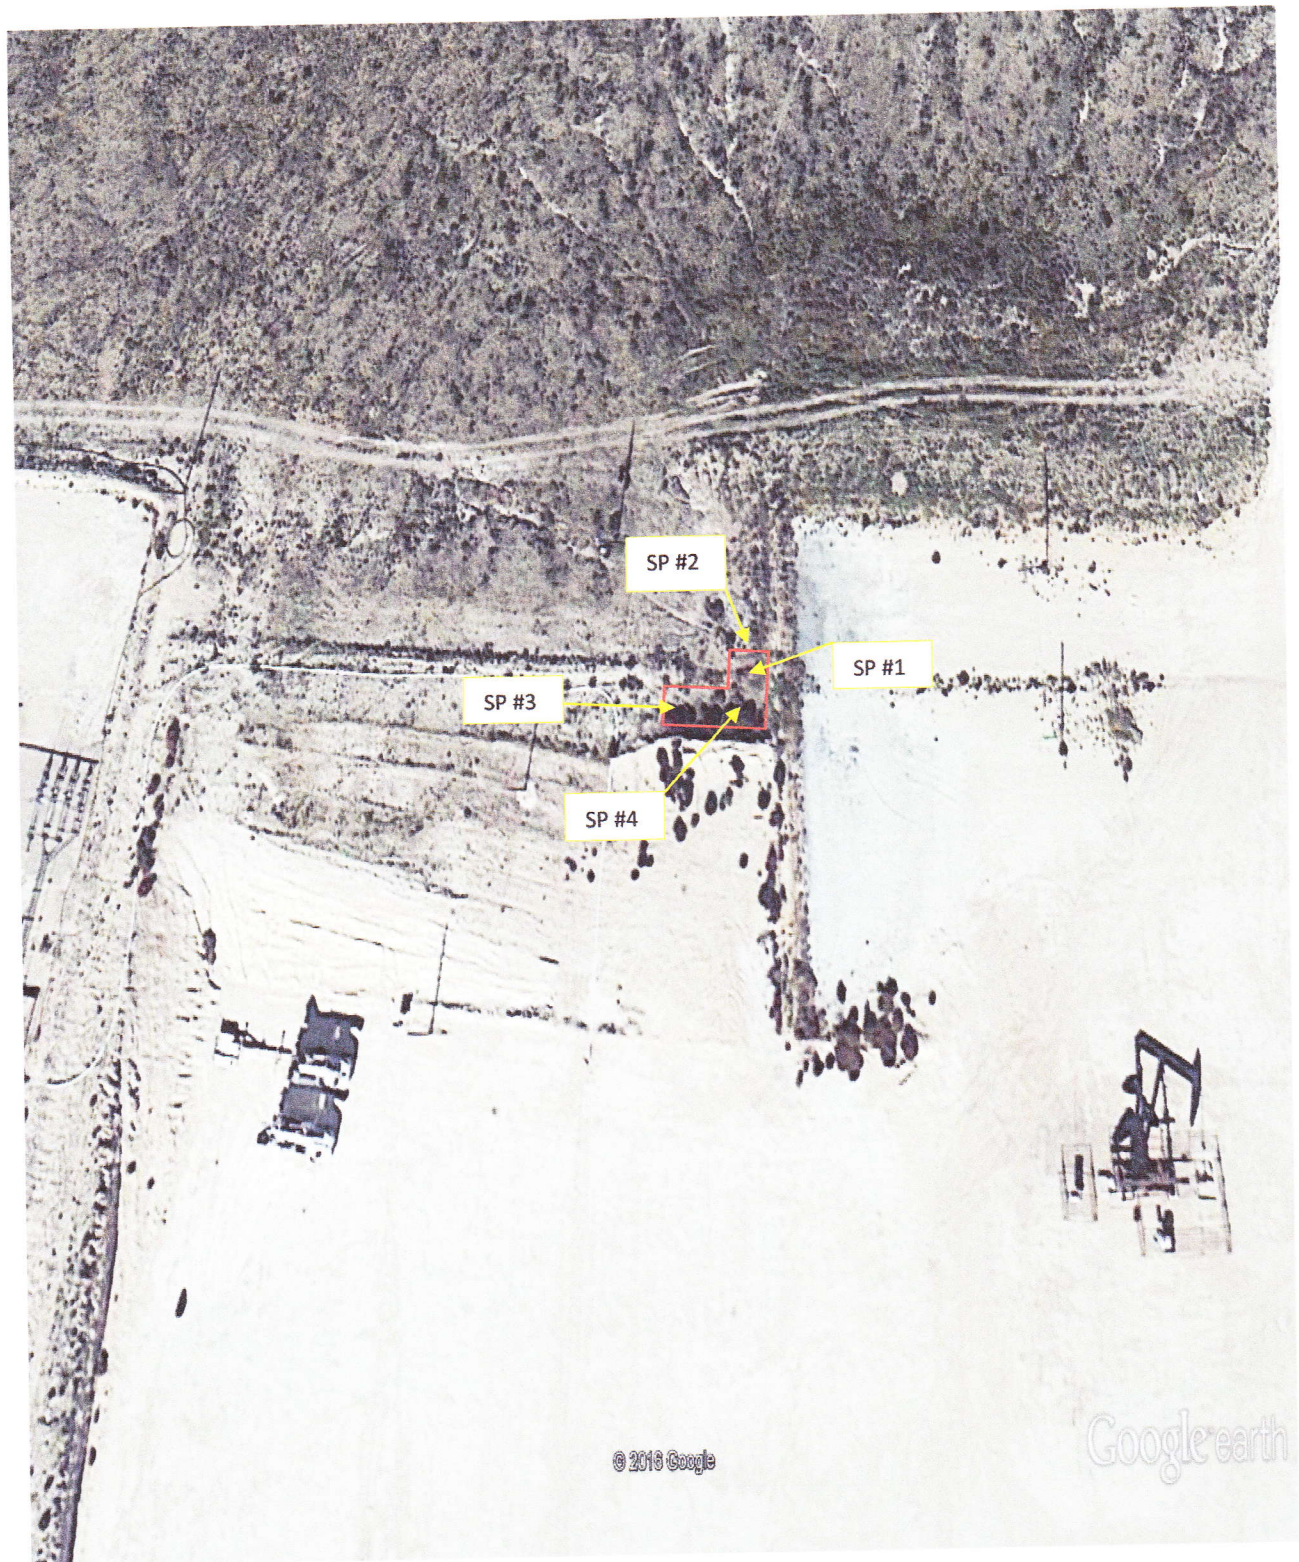
Devon Energy Production Company-Cottontail 16 St Comm #1H

A delineation was conducted using a backhoe. Soil samples were obtained from four sample points. Laboratory analysis was conducted for Chlorides, TPH, and BTEX. (See attached spread sheet and lab report.) Both hydrocarbons and chlorides are contaminants of concern for this release. However, lab results and field test indicate the impact to be limited to the top three feet of soil.

Overhead with Sample Points
