Summary of Sampling at the Crossman 25-1 Well Location

Project Location: Eddy Co, NM
Project Name: Crossman 25 State #1
Project Number: ENVO15.0002.1

Site Characterization Report of Oil and Gas-Related Spills in Red Bluff Draw, New Mexico

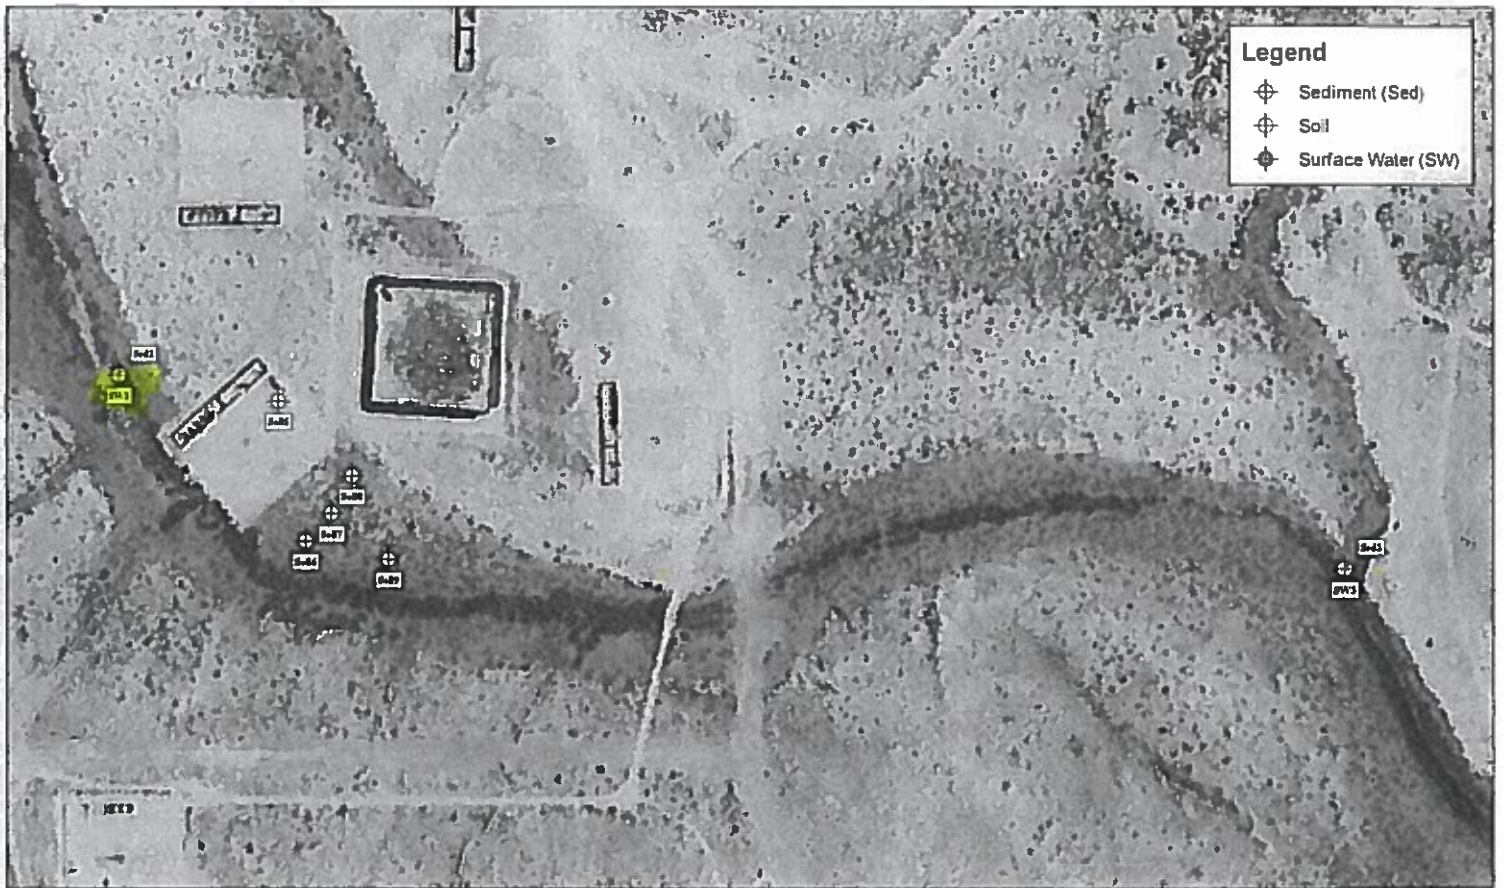
Red Bluff Draw - Map 2
COG Operating Pad Sample Area

A surface water and sediment sample (SW 2 and Sed 2) were collected from the pool immediately west (up-gradient) of the well pad. A surface water sample and sediment sample (SW 3 and Sed 3) were also collected at the nearest downstream surface water location, approximately 3,500ft to the east of the well pad (Map 2. Red Bluff Draw – COG Operating Well Pad Sample Area).

A small body of open water, present within the channel immediately west (upstream) of the well pad, was sampled as well as the nearest downstream surface water location, which is approximately 3,500ft to the east of the pad. Chlorides within the surface water and sediment samples to the west of the pad (SW 2 and Sed 2) were 1,800 mg/l and 410 mg/kg respectively. Chlorides within the surface water and sediments at the downstream surface water location (SW 3 and Sed 3) were 760 mg/l and 240 mg/kg respectively. No DRO was detected in the surface water or channel sediments in the pad area.
