CLOSURE REPORT

**BOPCO, L.P.
PLU #411H
Eddy County, New Mexico
Unit Letter "B", Section 28, Township 24 South, Range 31 East
Latitude 32.192796 North, Longitude 103.780195 West
NMOCD Reference #2RP-3107**

RE: Final Closure Report
Bopco, L.P. – PLU #411H
UL-B, Section 28, Township 24 South, Range 31 East
Eddy County, New Mexico
NMOCD Reference #2RP 3107

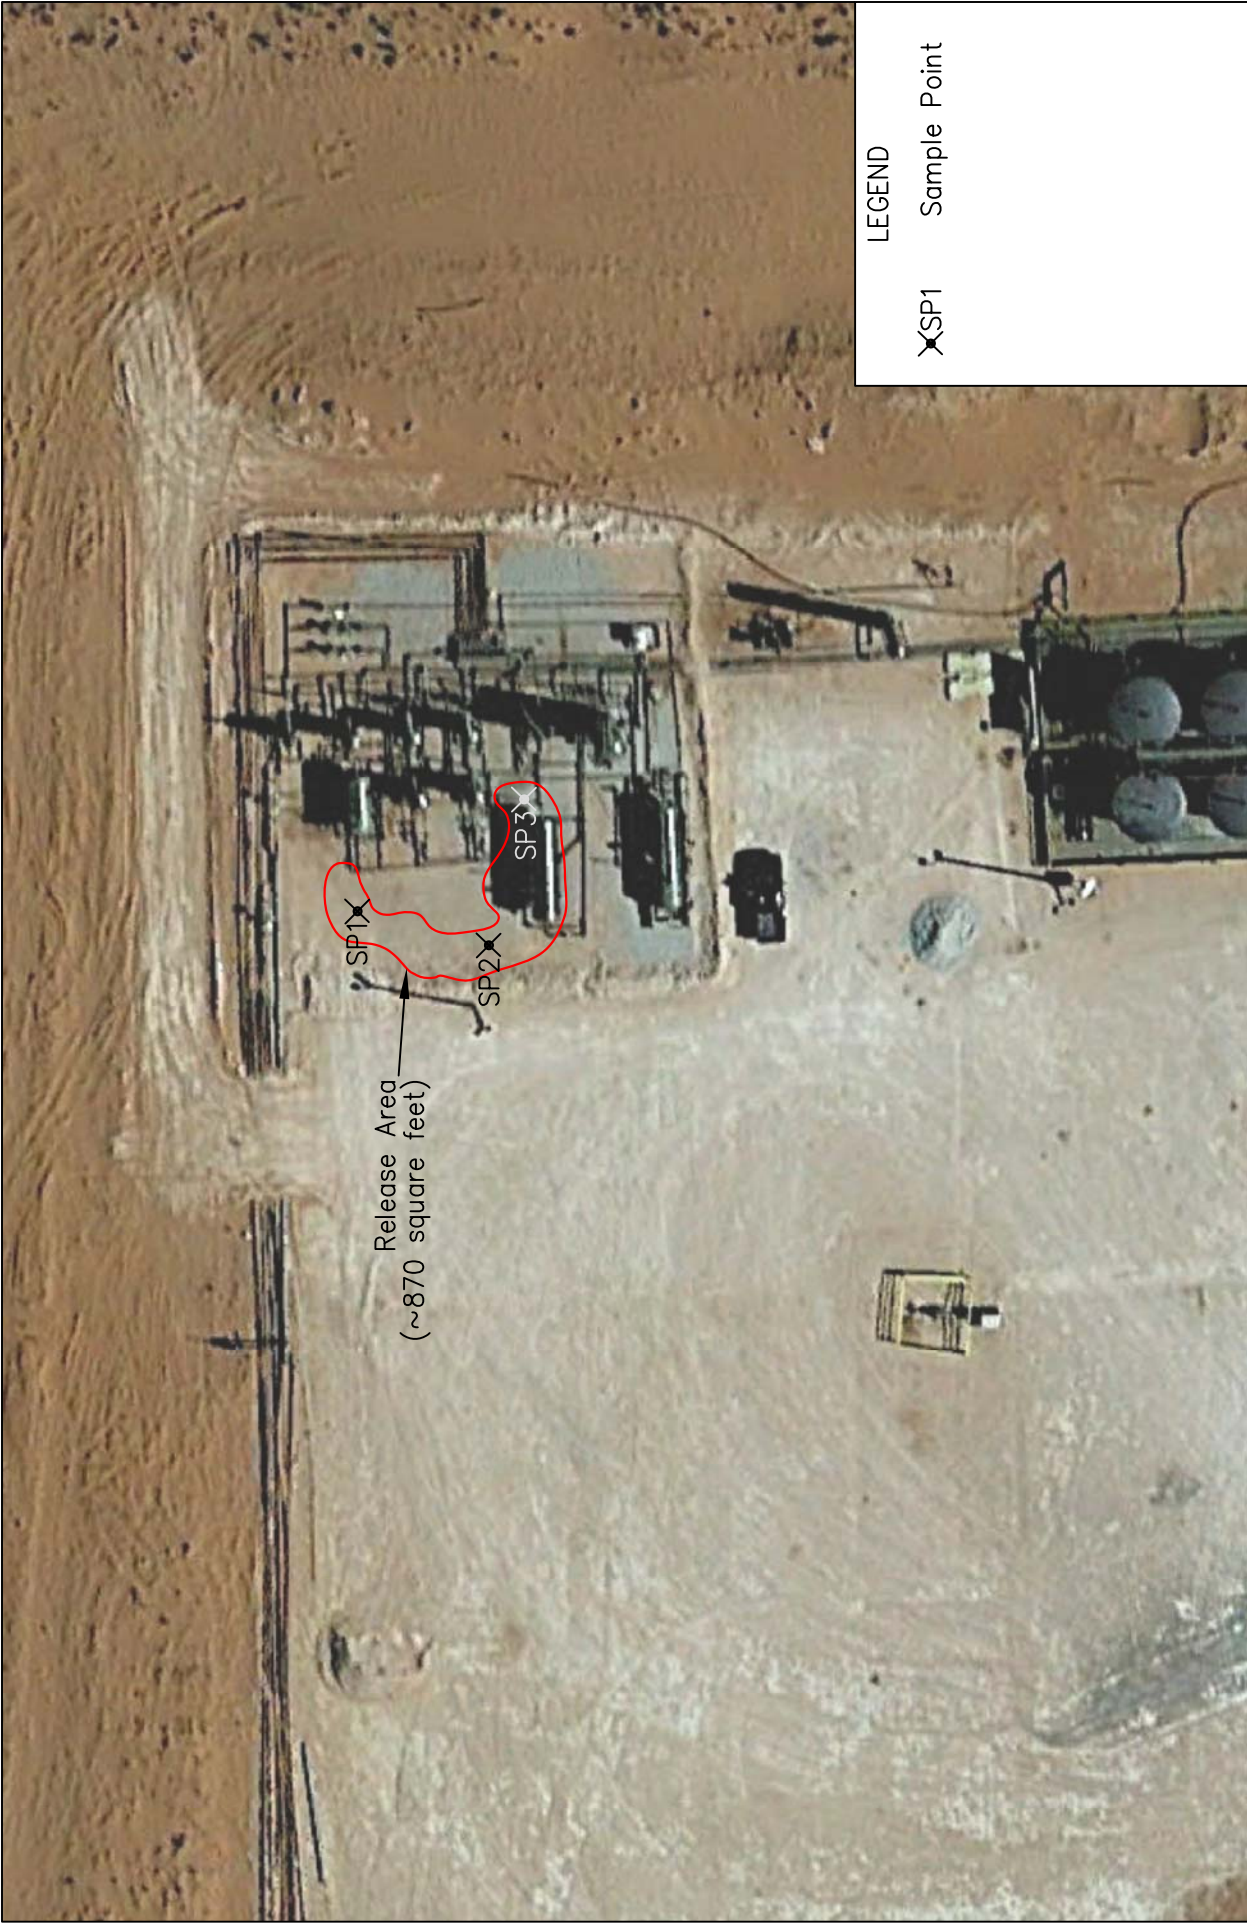
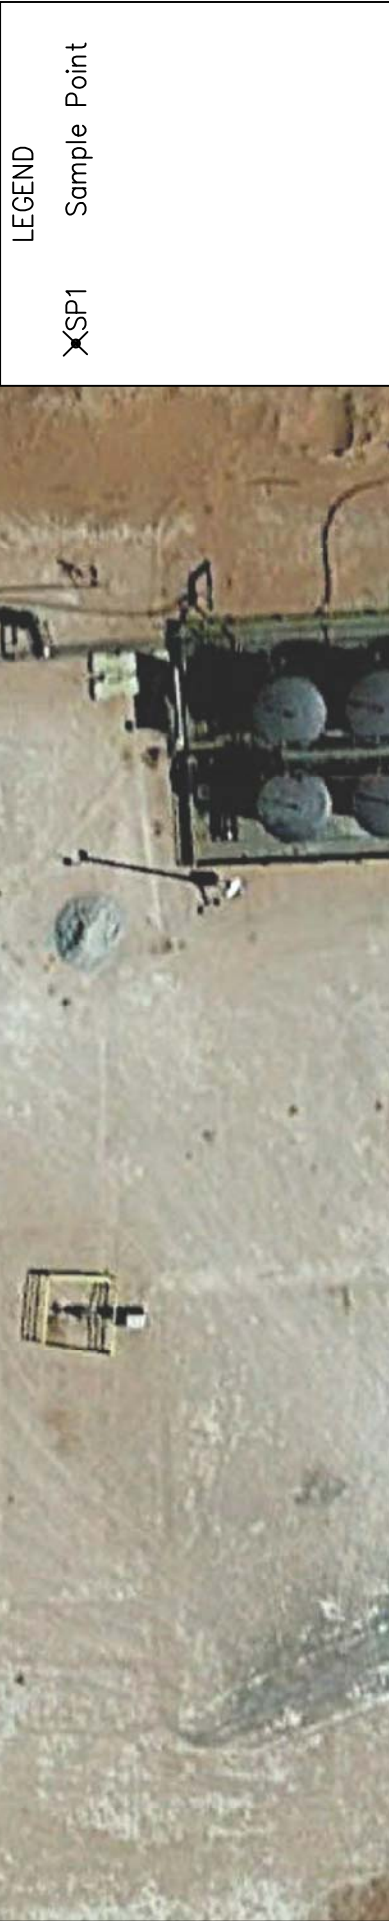
<p>Figure 3 Site/Sample Map Bopco, L.P. PLU #411H</p>				<p>0 40 80 Feet</p>		<p>SHEET 1 of 1</p>

EPI personnel mobilized on the site on July 14, 2015 to collect soil samples to determine the vertical extent of contamination. A total of ten (10) soil samples were collected from three (3) sample locations; SP1 – SP3. Seven (7) representative samples were sent to Cardinal Labs in Hobbs, New Mexico, for testing. Laboratory analytical results indicate that below surface level, the release area is void of Benzene, BTEX, TPH, and Chloride concentrations in excess of NMOCD Recommended Remedial Action Levels (RRALs) of 10 mg/Kg, 50 mg/Kg, 5,000 mg/Kg, and 1,000 mg/Kg, respectively (reference *Figure 3* and *Table 2*).

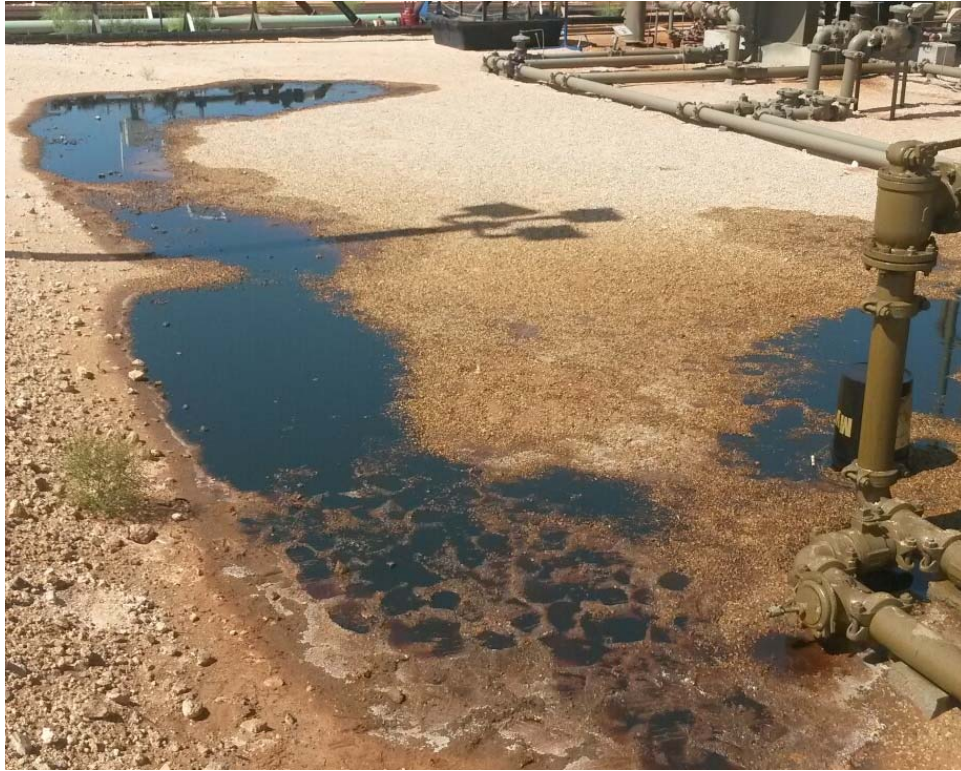
Release of oil and produced water occurred at the FWKO due to a failed sight glass. Affected well pad around production equipment, all fluid was contained within earth berm. A vacuum truck was called to the location and was able to recover 1 barrel of oil.

Photograph #1 – Northern view across release area

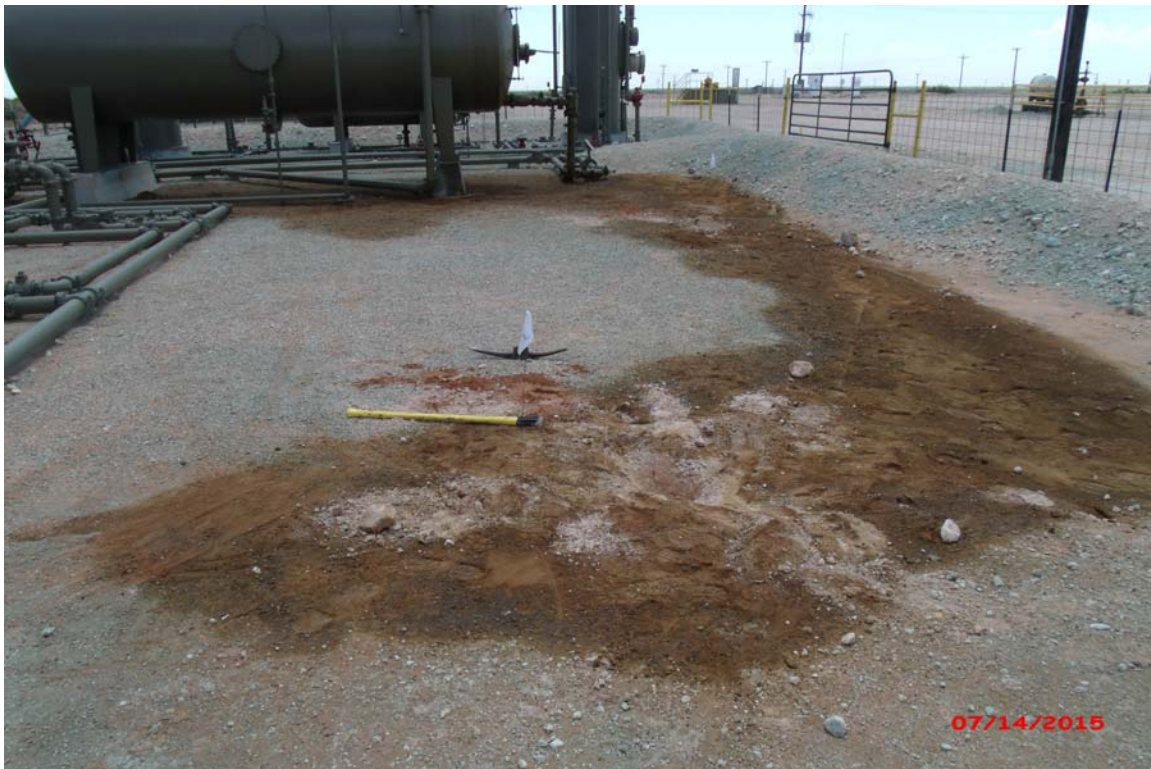
Photograph #2 – Southern view across release area

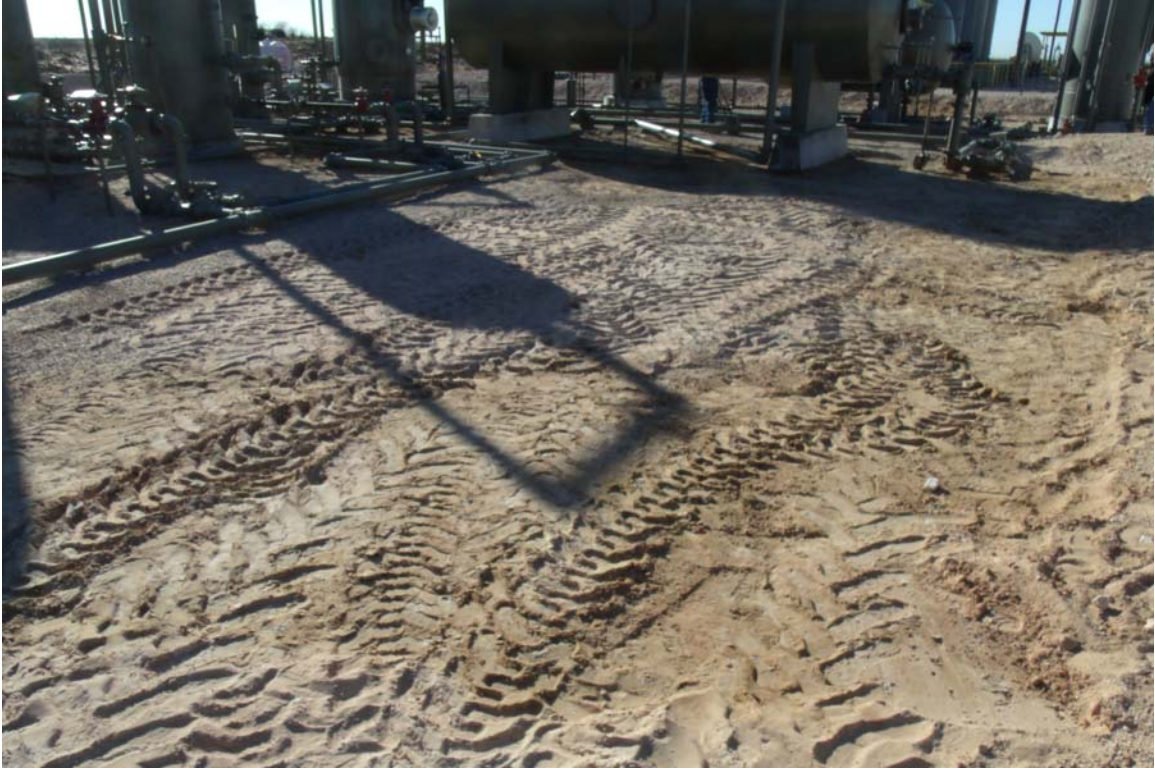
Photograph #3 – Surface scraped

The release area was surface scraped approximately three (3) – four (4) inches deep. Approximately 28 yards of contaminated soil was excavated and hauled to a state approved facility for disposal.

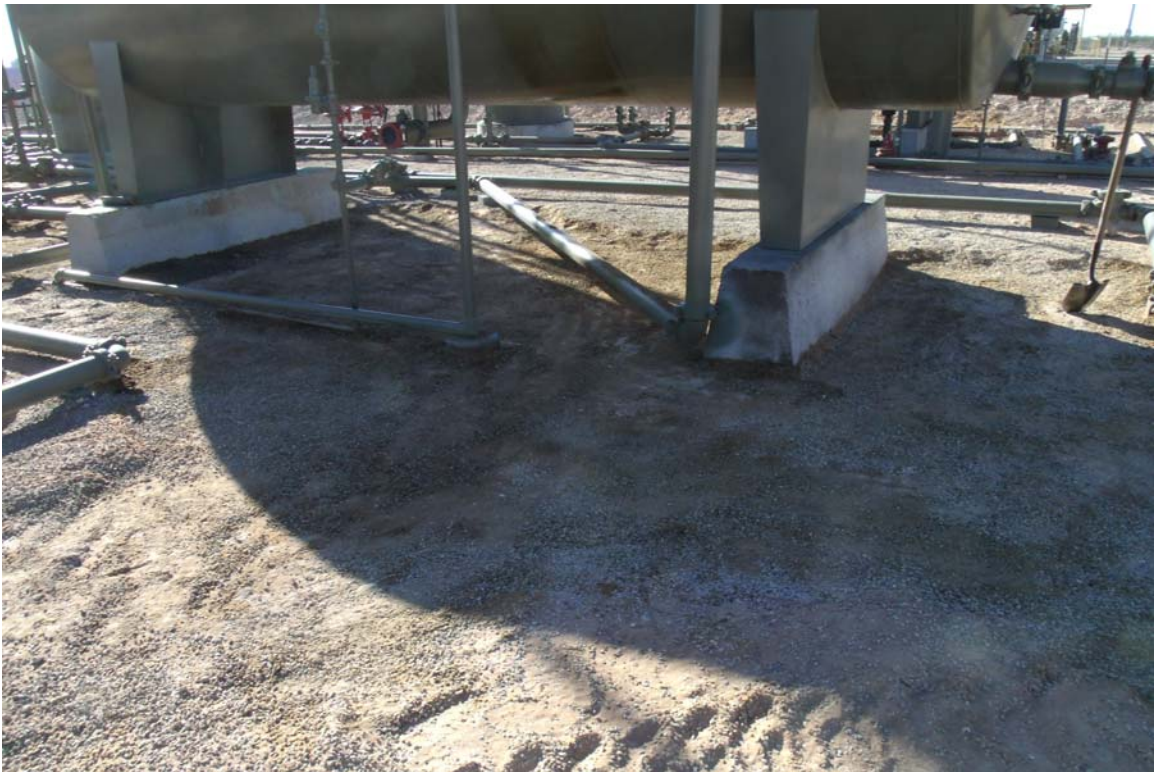
Photograph #4 – Surface scraped

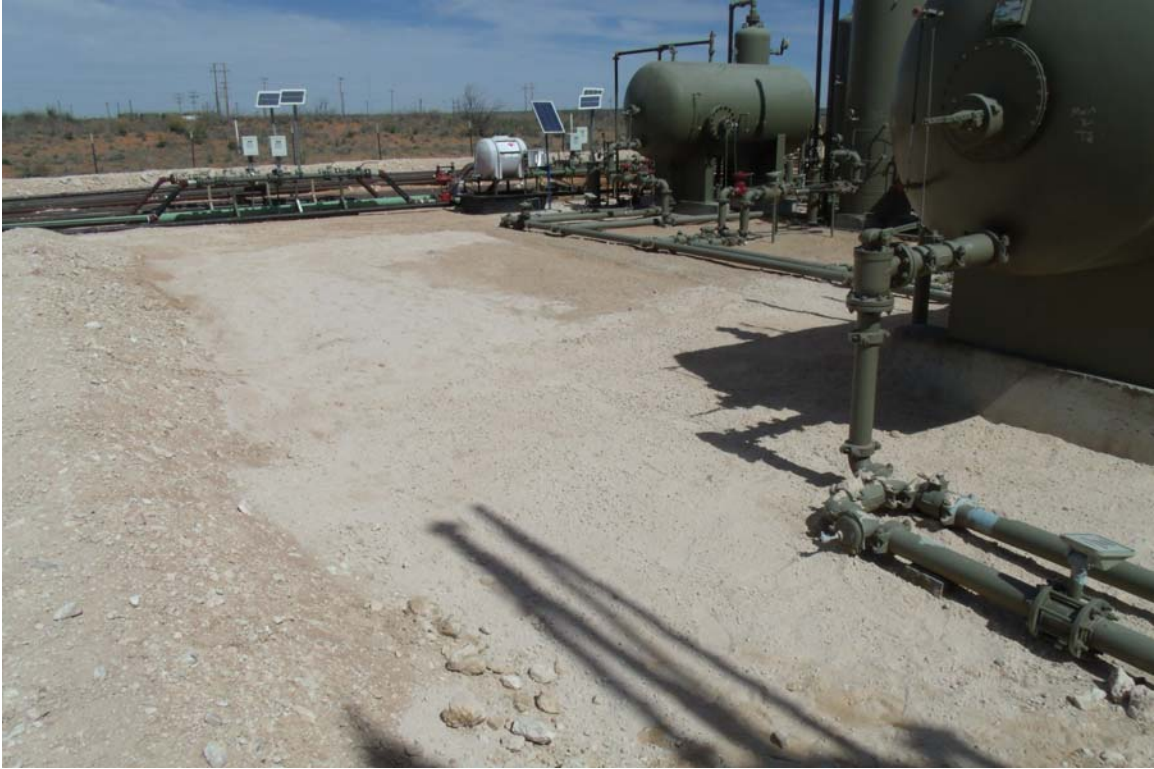
Photograph #5 – Backfilled

Based on laboratory analytical data and NMOCD approval, the excavation was backfilled with approximately 28 yards of clean soil. The entire disturbed area was then contoured to blend with existing pad area and protected against wind/water erosion.

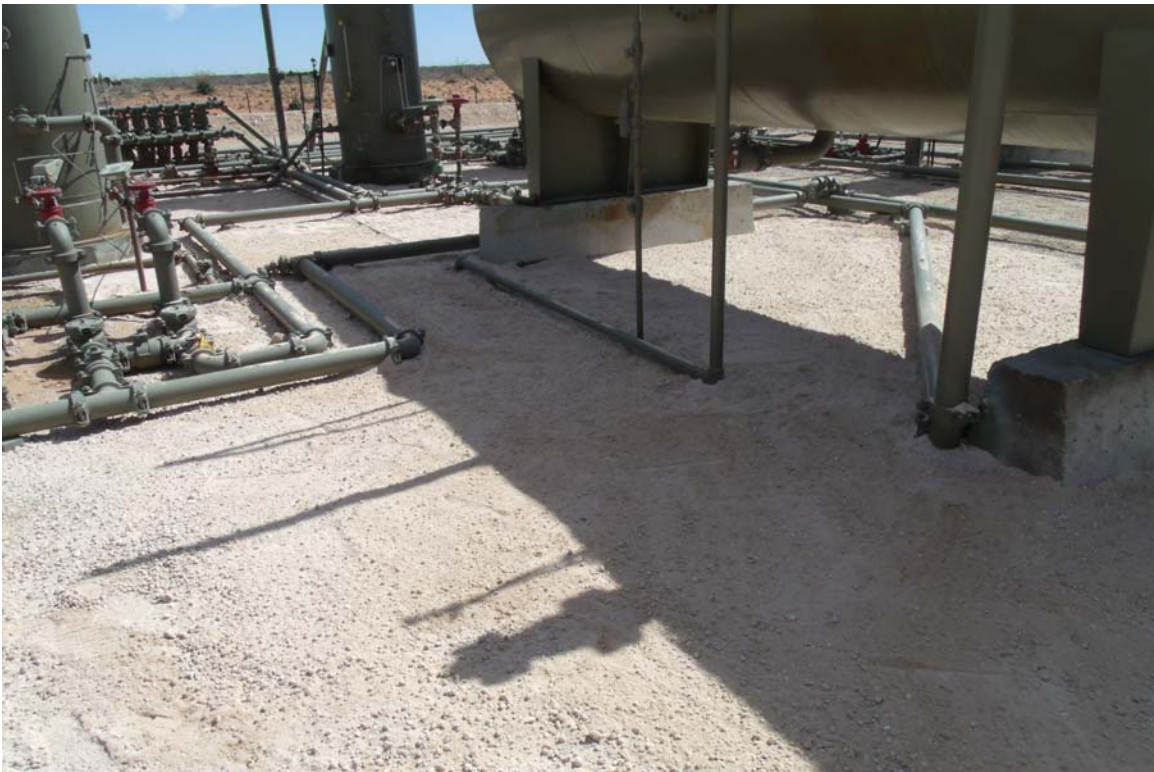
Photograph #6 – Backfilled
