SUBJECT: SOIL REMEDIATION WORK PLAN FOR INCIDENT 2RP-1167 Solt State, API# 30-015-25277, EDDY COUNTY, NEW MEXICO

# SOIL REMEDIATION WORK PLAN FOR INCIDENT 2RP-1167

ALAMO PERMIAN RESOURCES  
SOLT STATE  
API# 30-015-25277  
UL O SECTION 5, T18S R28E, NMPM  
EDDY COUNTY, NM

March 1, 2016  
SMA Reference  
5B24270 BG7

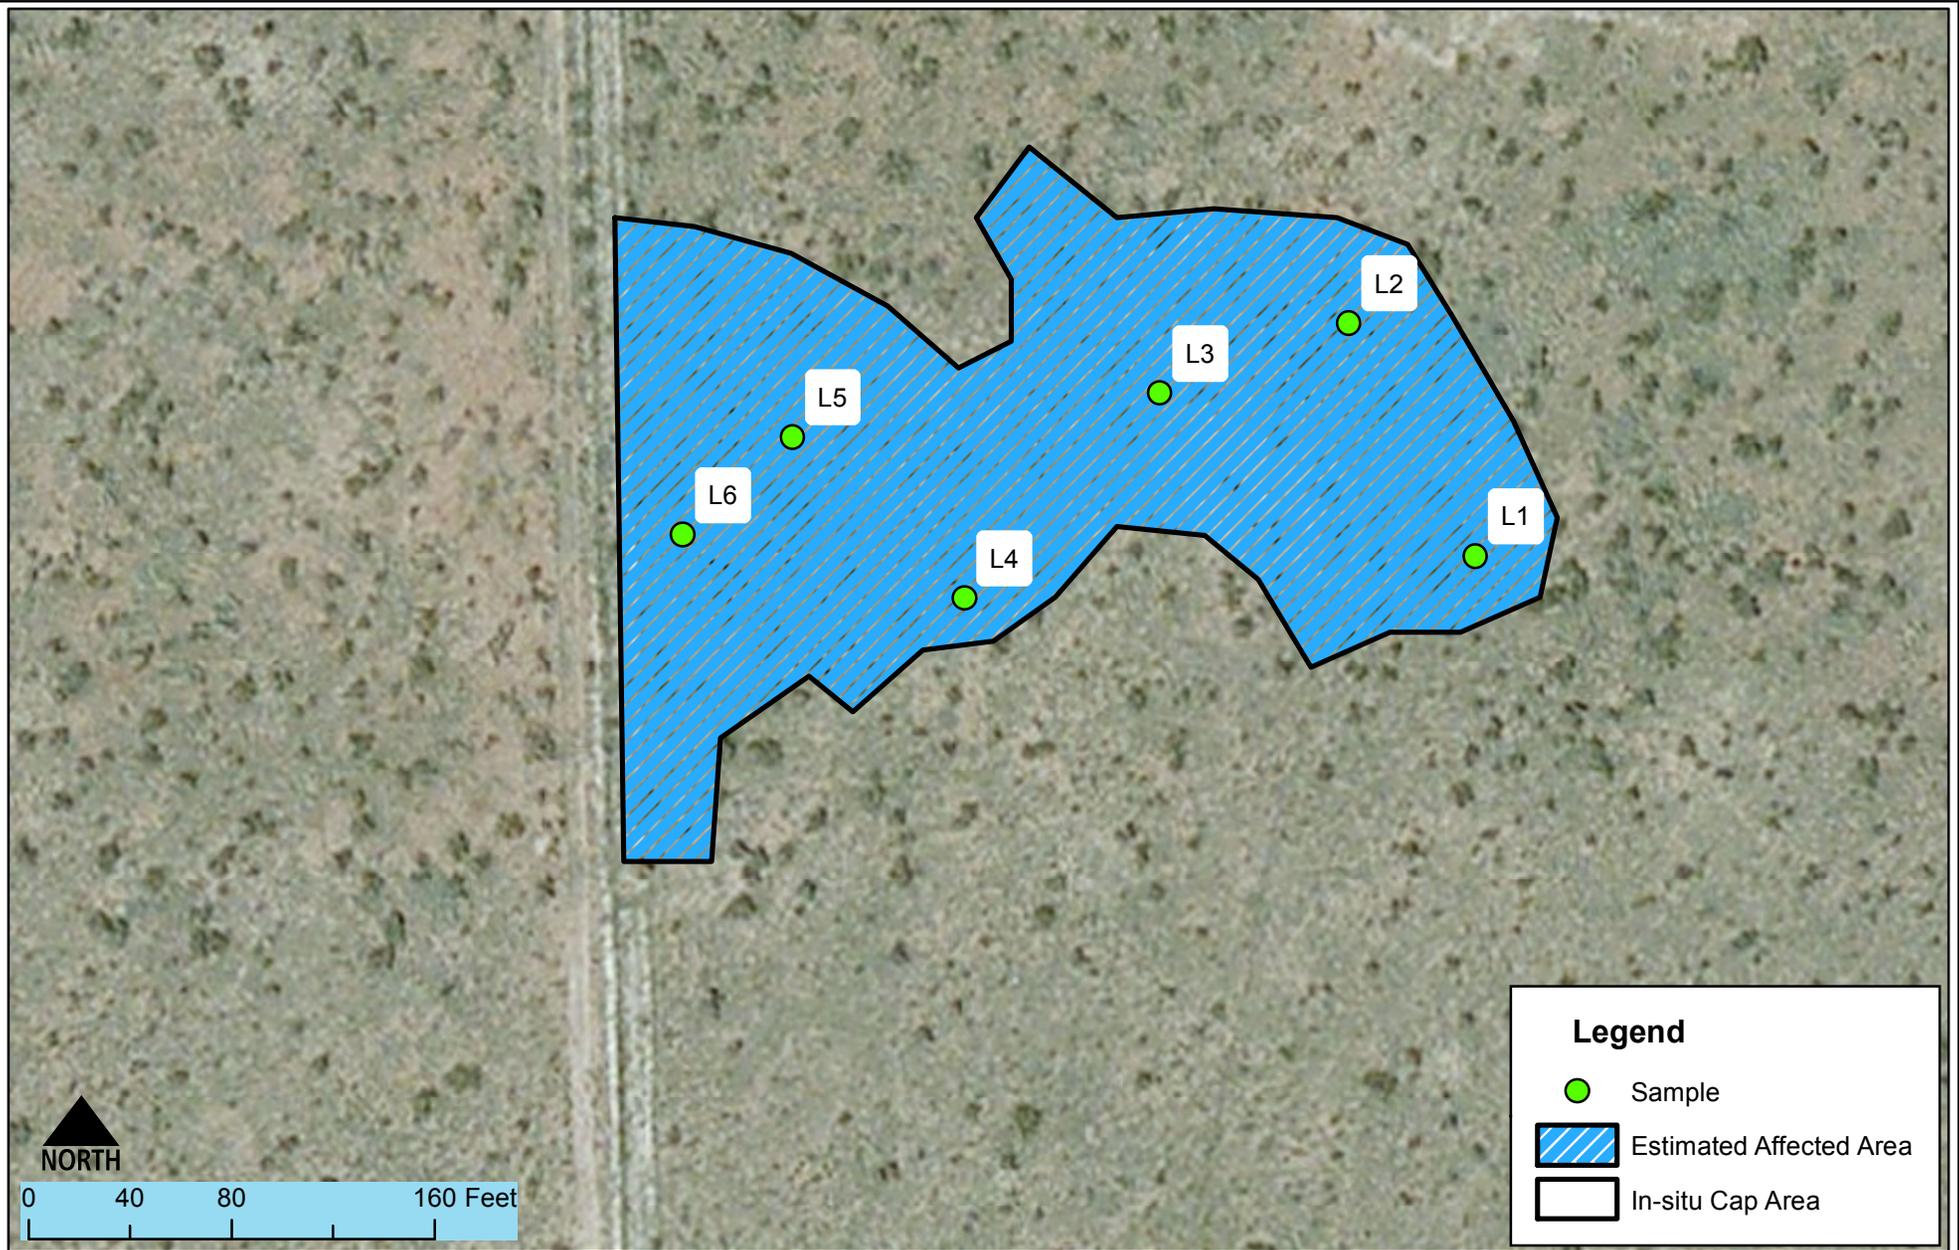
## SITE DETAILS AND SAMPLE LOCATIONS MAP

Site Detail and Sample Locations  
 Alamo Permin Resources -Solt State  
 Artesia, New Mexico

The Solt State #1 release site is located approximately 7 miles (> 1,000 feet) east of Pecos River, in an area administered by New Mexico State Land Office with an elevation of approximately 3,640 feet above sea level. After evaluation of the site using aerial photography and topographic maps, depth to groundwater is estimated to be less than 100 feet but greater than 50 feet below ground surface (bgs). Figure 1 depicts the site vicinity and Figure 2 depicts the site details and sample locations.

Soil contaminant concentrations found during the initial delineation are illustrated in Figure 2. A summary of the laboratory analyses is included in Table 2. Laboratory reports are included in Appendix A.

Analytical Report-1602A13	Sample Number on Figure 2 Map	Sample Date	Depth	BTEX ppm	Benzene mg/Kg	GRO mg/Kg	DRO mg/Kg	Cl- mg/Kg
1602A13-001	L1	2/17/2016	1'	BDL	BDL	BDL	BDL	1,100
1602A13-002	L1	2/17/2016	6'	N/A	N/A	N/A	N/A	14,000
1602A13-003	L4	2/17/2016	3'	N/A	N/A	N/A	N/A	470
1602A13-004	L4	2/17/2016	6'	N/A	N/A	N/A	N/A	440
1602A13-005	L5	2/17/2016	2'	BDL	BDL	BDL	BDL	1,200
1602A13-006	L5	2/17/2016	6'	N/A	N/A	N/A	N/A	7,200
1602A13-007	L6	2/17/2016	3'	N/A	N/A	N/A	N/A	49

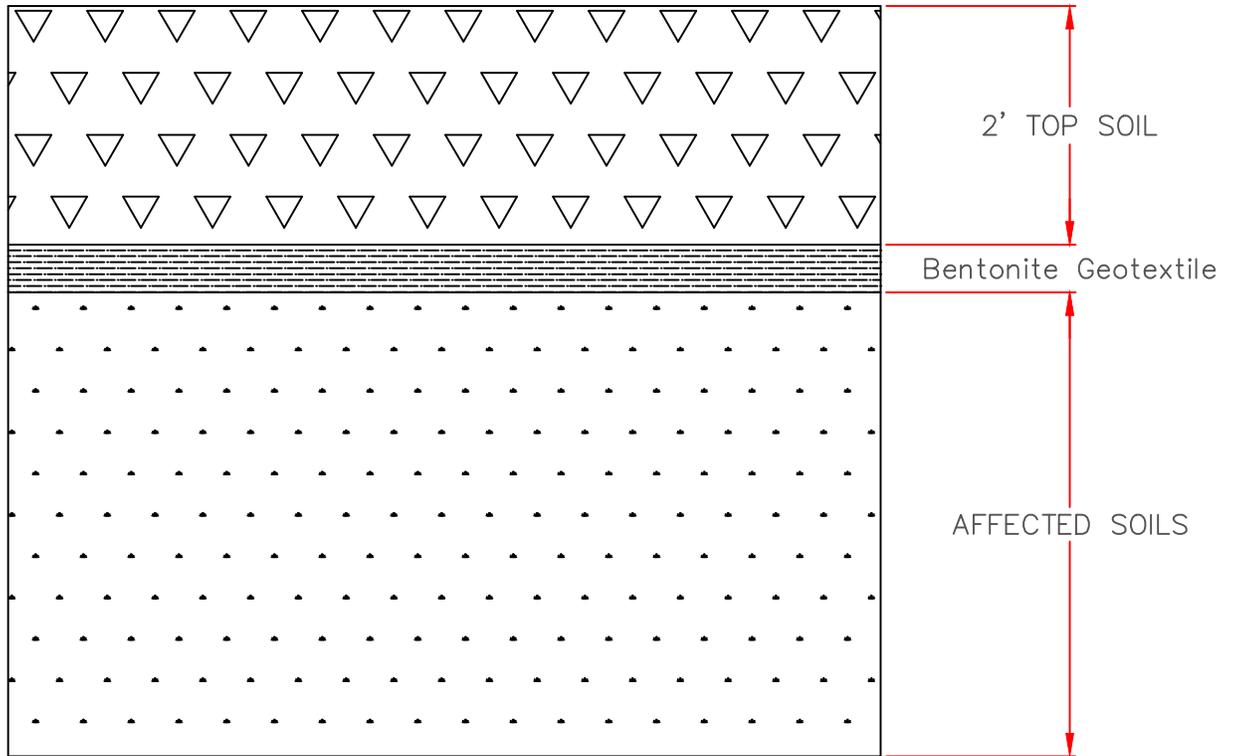
Designed LM	Drawn GJF	Checked KT
Date: February 2016		
Scale: Horiz: NA Vert: NA		
Project No: 5B24270		
<b>Figure 3</b>

## IN-SITU CAP AND BIO BARRIER DESIGN

**IN-SITU CAP  
 AND BIOBARRIER DESIGN**  
 Alamo Premian Resources- Solt State

SMA has determined that the impacted area was previously excavated to approximately one foot bgs during initial response activities. SMA proposes to mobilize a hollow stem auger HSA to the location to continue vertical delineation, final samples well be collected delimiting the impacted area. The in-situ cap will be placed over the delineated impacted area to encompass the horizontal extent of the impact. The cap will consist of bentonite and geotextile layer and two feet of soil. The construction of the in-situ cap (Figure #3) has been designed to prevent both capillary and leaching movement of the brine affected soils. Starting at surface grade the affected soils will be compacted and amended with a bentonite impregnated geotextile liner to act as a capillary break

between the affected soils and the proposed caliche cap. Then 2 feet of top soil will be added above the geotextile liner. The geotextile liner on the bottom of the top soil will effectively break the communication of precipitation through the cap. The imported topsoil will be added as overburden to help with contouring to prevent ponding and pooling on the cap area. Any contaminated soil will be transported to Lea Land, near Carlsbad, NM.

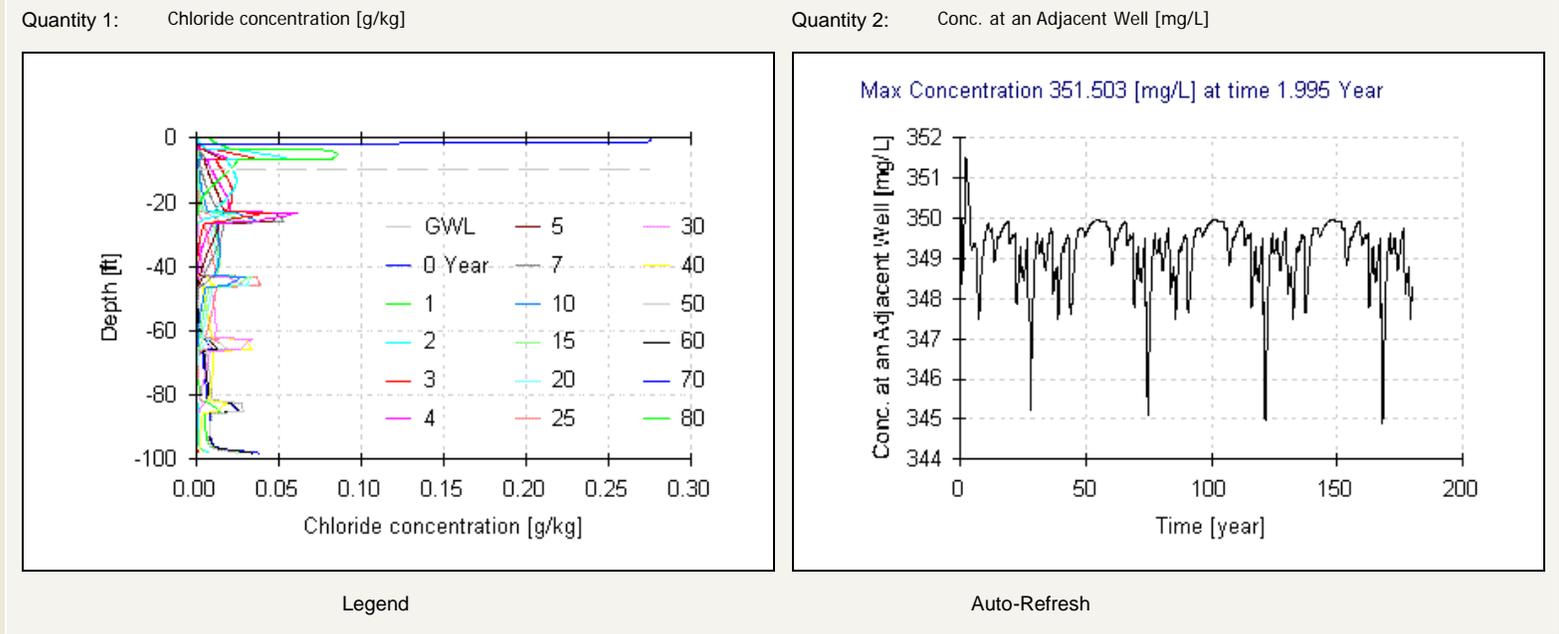
**Output Charts**

P4 - Caliche (1) + Medium Sand (5)
