Sampling Summary Report and Remediation Plan
North Brushy Draw 35-12 Produced Water Spill
Unit D, Section 2, Township 25S, Range 29E, Eddy County, NM
Spill Incident # NAB1613135790

Figure 1: Site Map
WPX Energy, Inc.
North Brushy Draw 35-12 Produced Water Spill
 Eddy County, New Mexico

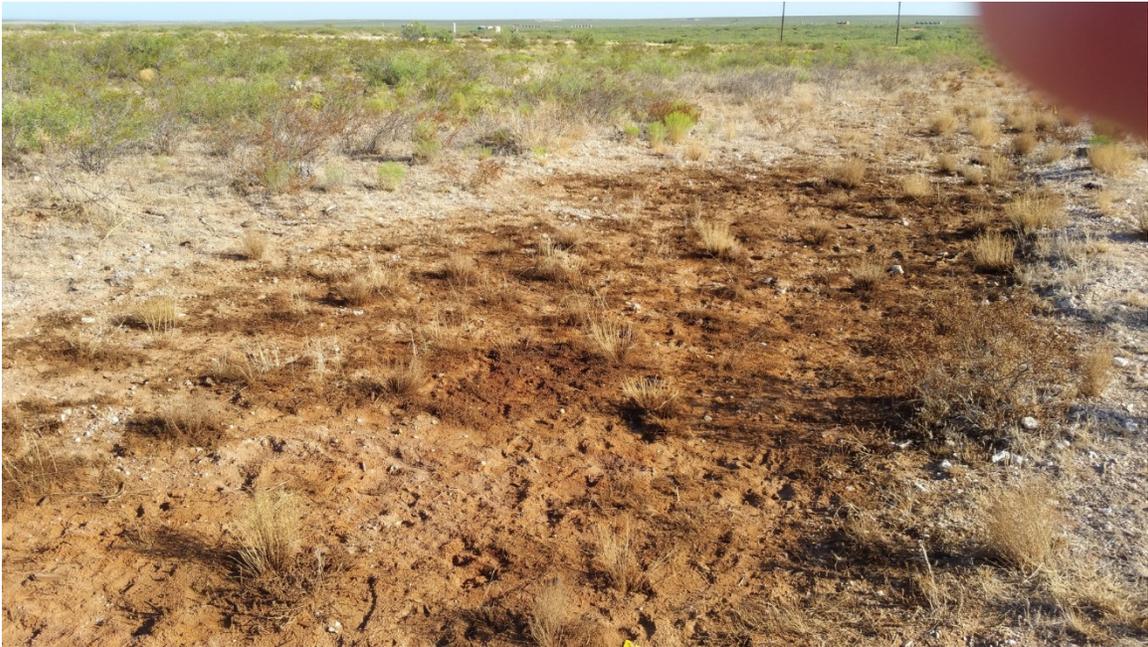
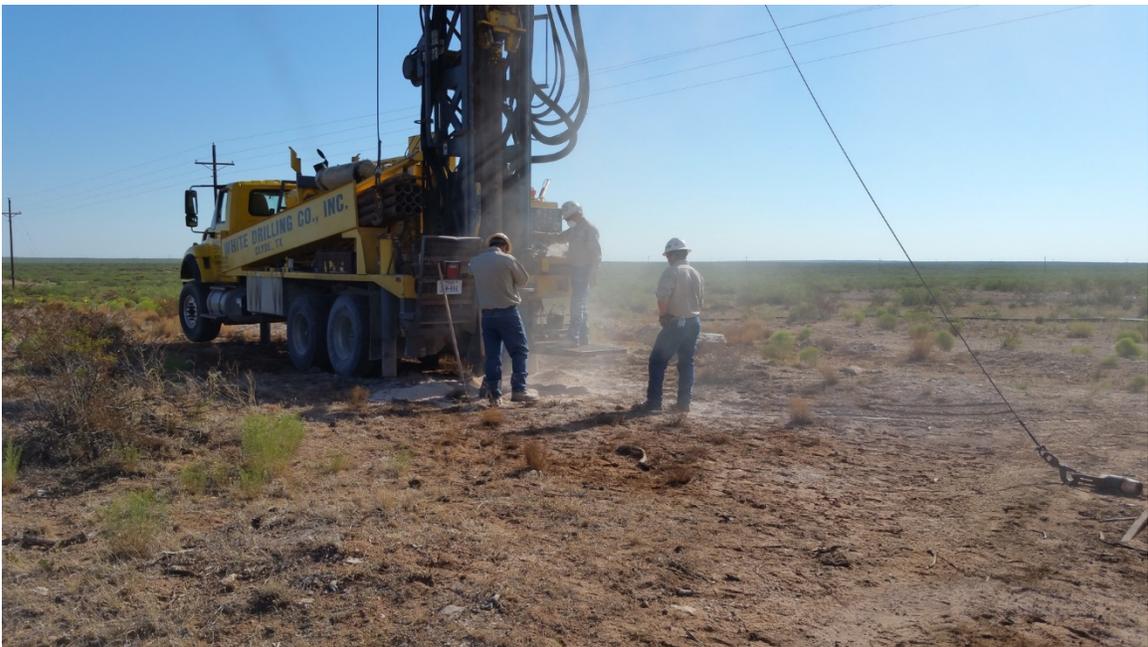
On June 29, 2016, one soil boring was installed in the area of apparent pooling and as close to the pipelines as safety allows. The soil boring was drilled with an air rotary rig by White Drilling Company (WDC), of Clyde, Texas. A right of entry permit was acquired by WPX from the NMSLO for soil investigation.

Drill cuttings were described according to the Unified Soil Classification System (USCS). Cuttings were collected every 2-feet to a depth of 20 feet, then every 5-feet from 20 to 40 feet bgs for field and laboratory analyses. Laboratory samples were collected in 4-ounce glass jars and transferred to XENCO. Samples were analyzed for Chlorides per EPA Method 300.0. A summary of the analytical results is provided in **Table 2**. Copies of the laboratory report and chain of custody documentation are provided in **Appendix D**. Soil boring log is provided in **Appendix F**.

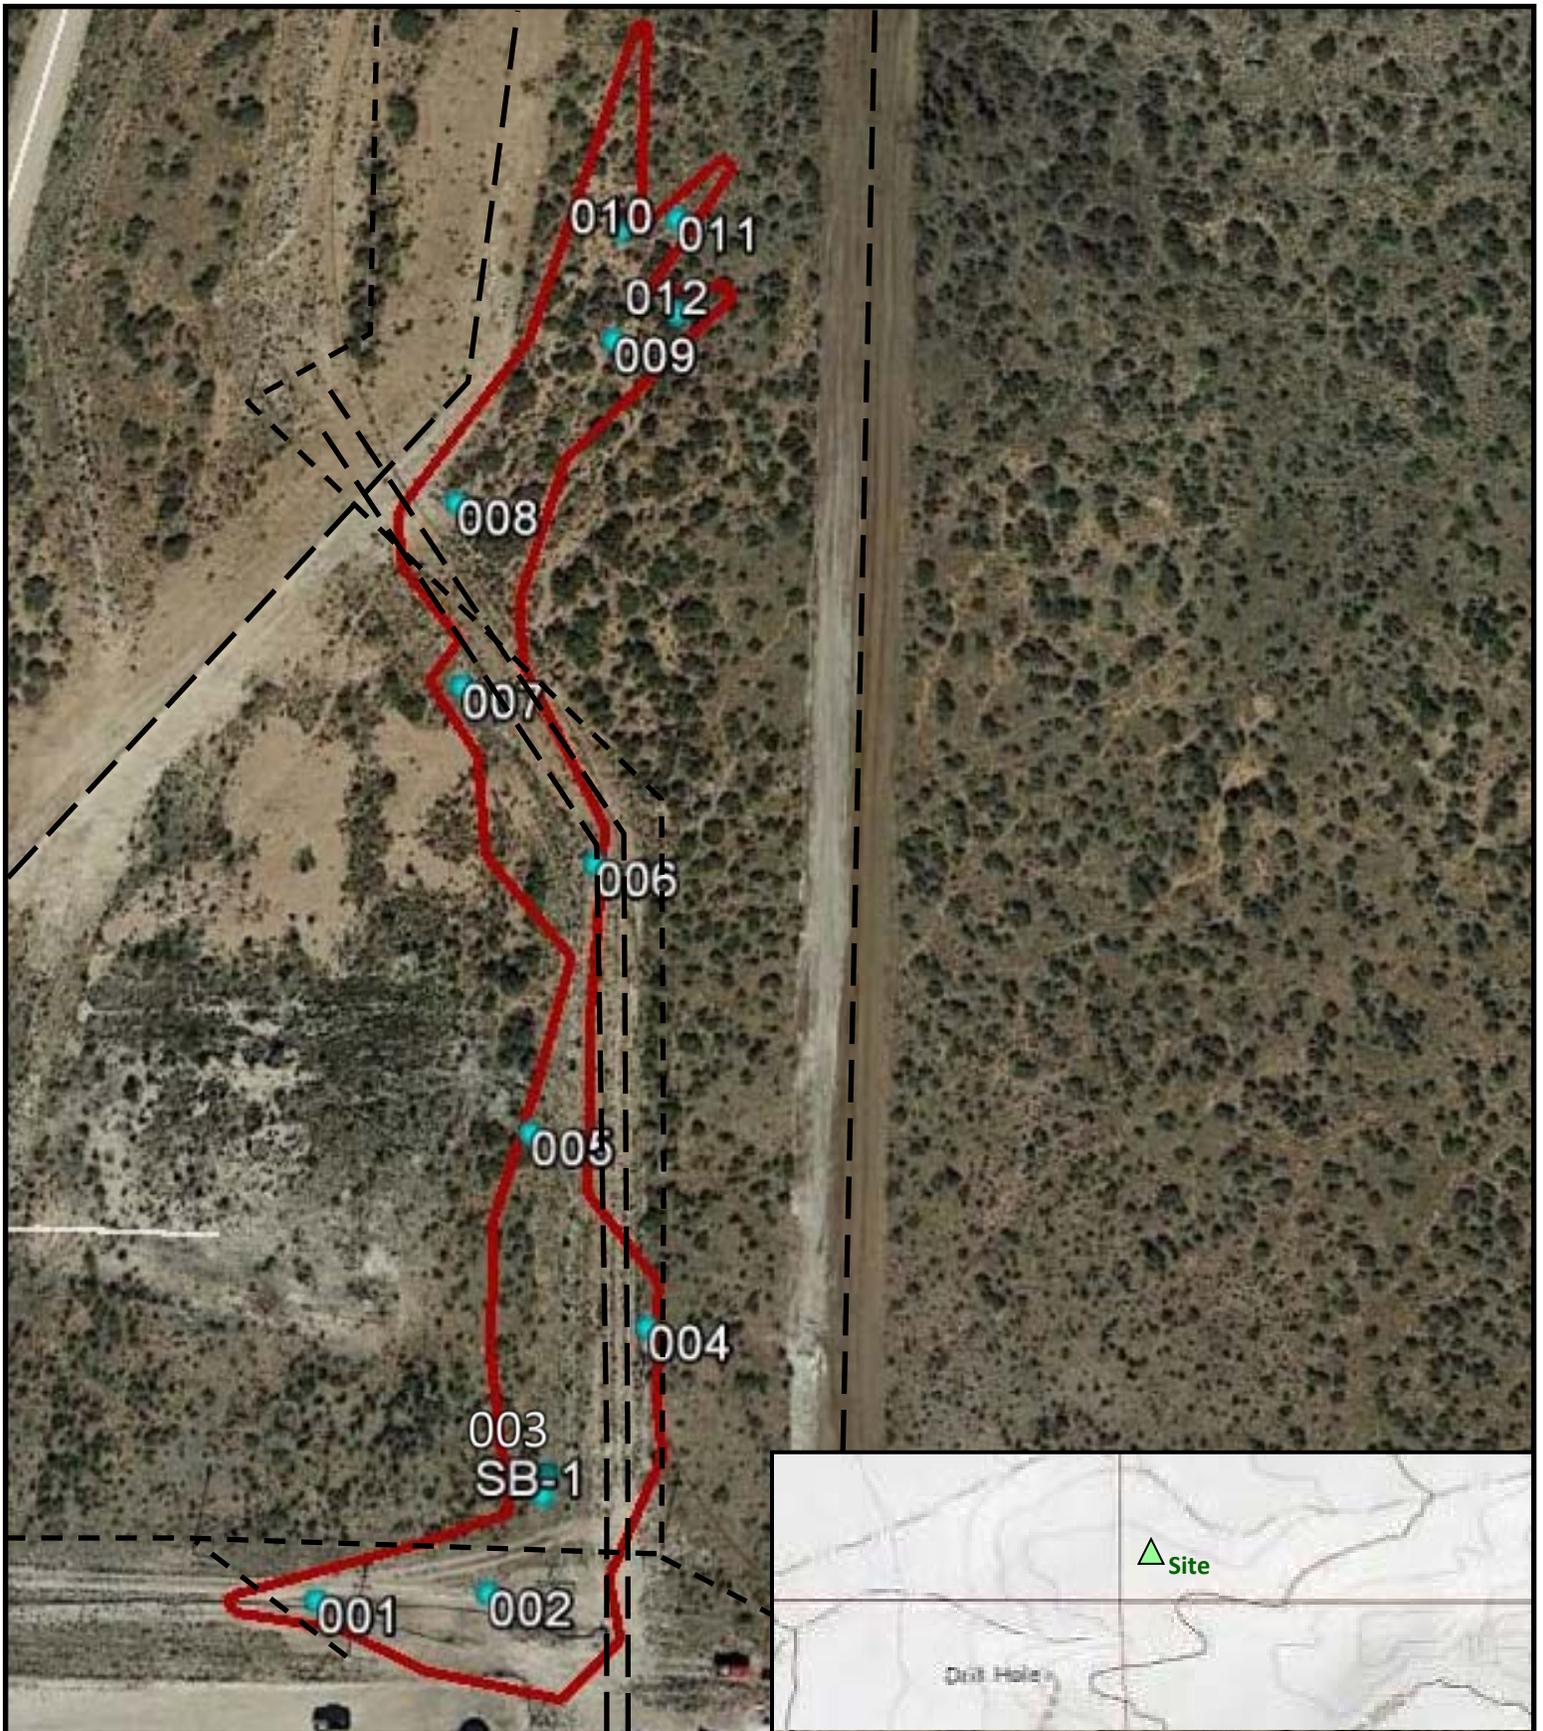
The North Brushy Draw 35-12 is located on New Mexico State Land (NMSLO) 12 miles southeast of Malaga in Eddy County, New Mexico. The legal description is: Unit D, Section 2, Township 25S, Range 29E, with the GPS coordinates of 32.07898°N, 103.94493°W. A Site Map is provided in **Appendix B**.

- Approximate Spill Area, May 16, 2016
- Approximate Soil Sample Locations
- Pipeline
- Overhead Powerline
