2RP-3637

Investigation Summary and Work Plan

Cedar 32 State Com #1

April 29, 2016

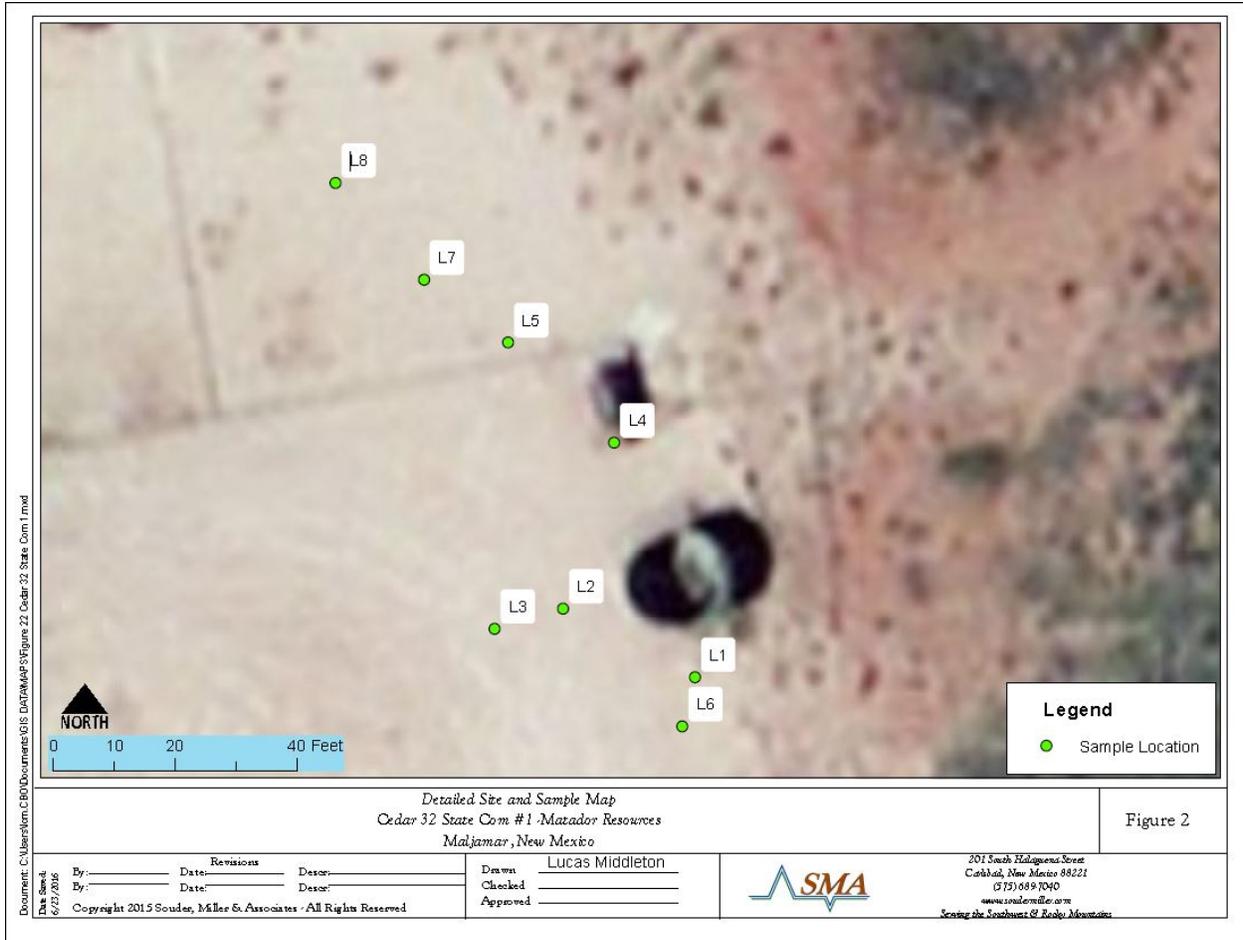
Soil samples were collected as shown on the attached plat at the surface.

As can be seen by the table above, the chlorides at location point 4 that is 3 feet below ground surface are 1700 mg/kg. As this is above the acceptable limit, Matador proposes to excavate 4 feet below surface to remove the chlorides, and replace with 'fresh' soil.
