Termination Report

Re: Apache State SWD # 3
API# 30-015-38978
Case 2RP-2923

Apache State SWD #3

Path Forward

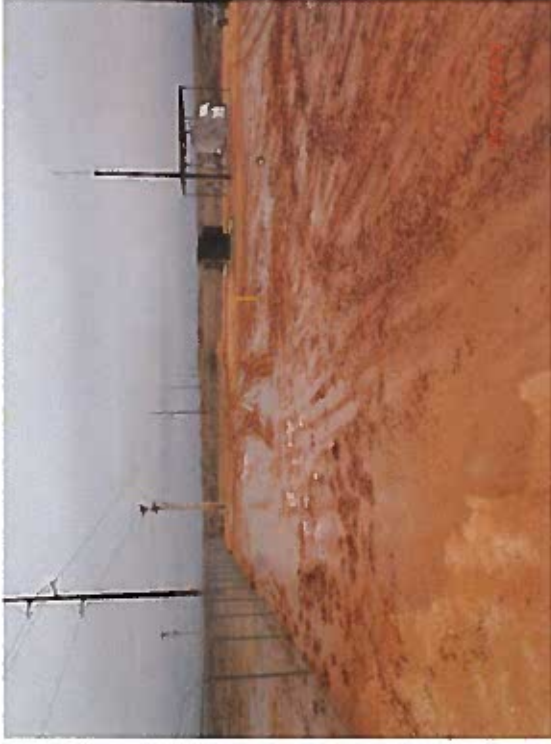
Initial release area, facing west

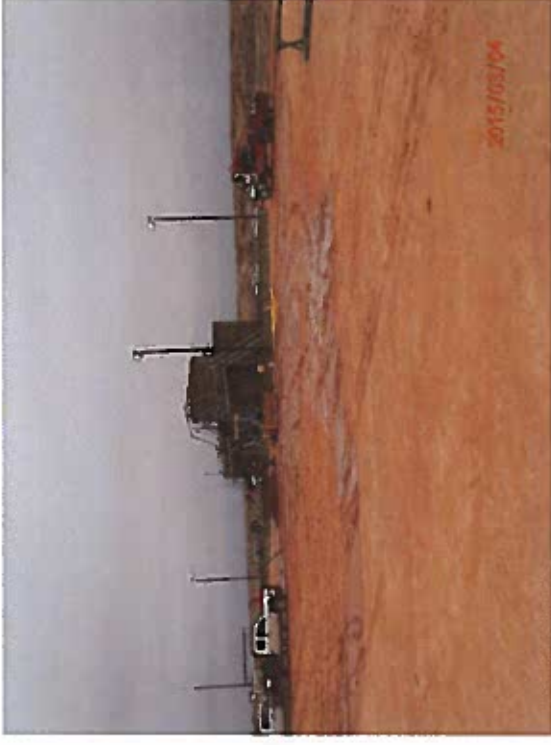
Initial release area, facing northwest

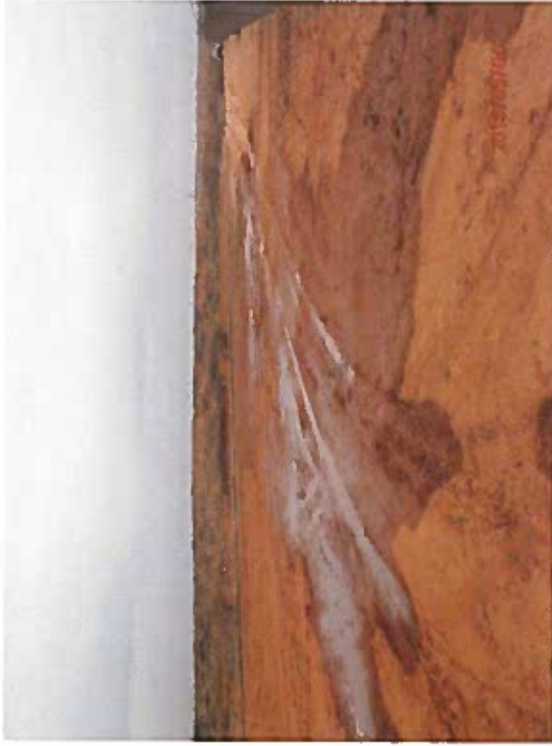
Initial release area, facing northwest

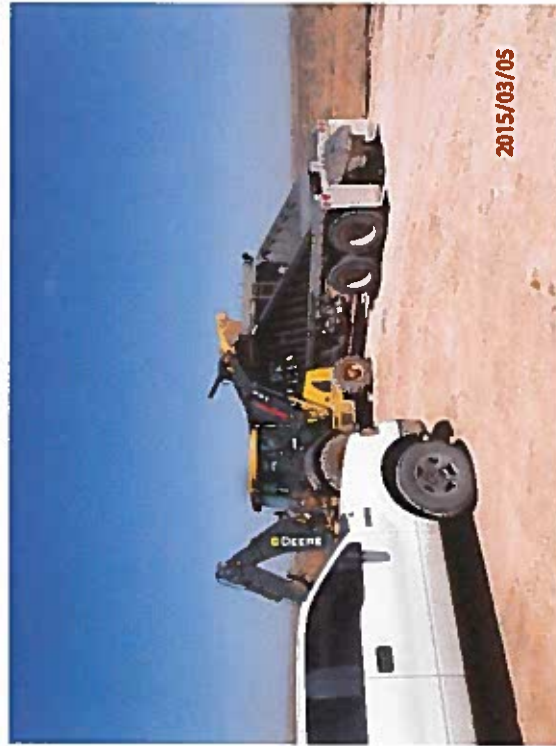
Moving contaminated soil to spoil pile, facing southeast

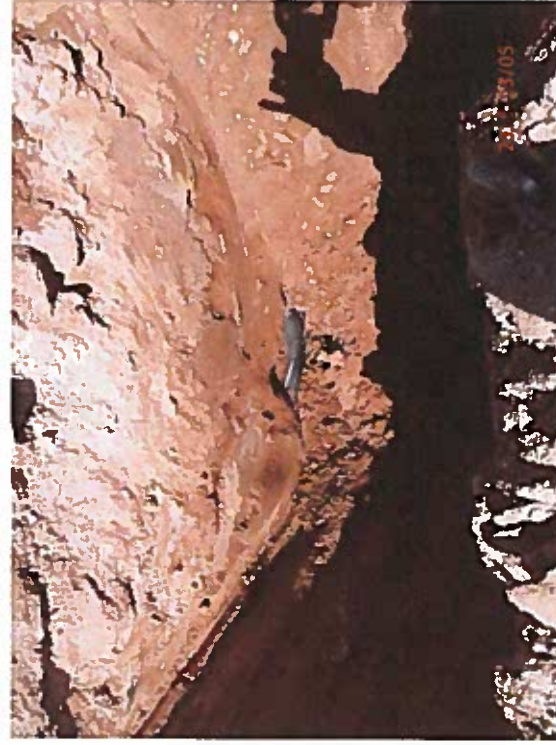
Facility liner discovered in Vertical 2

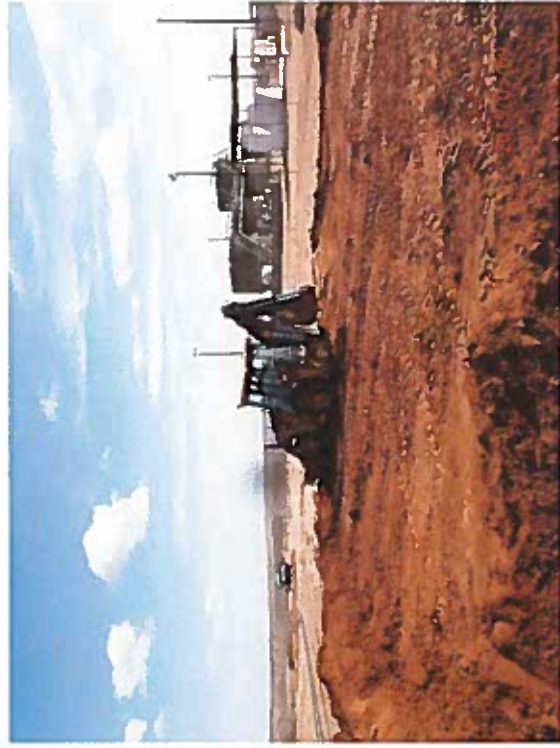
Scraping west of battery, facing east 3/9/15

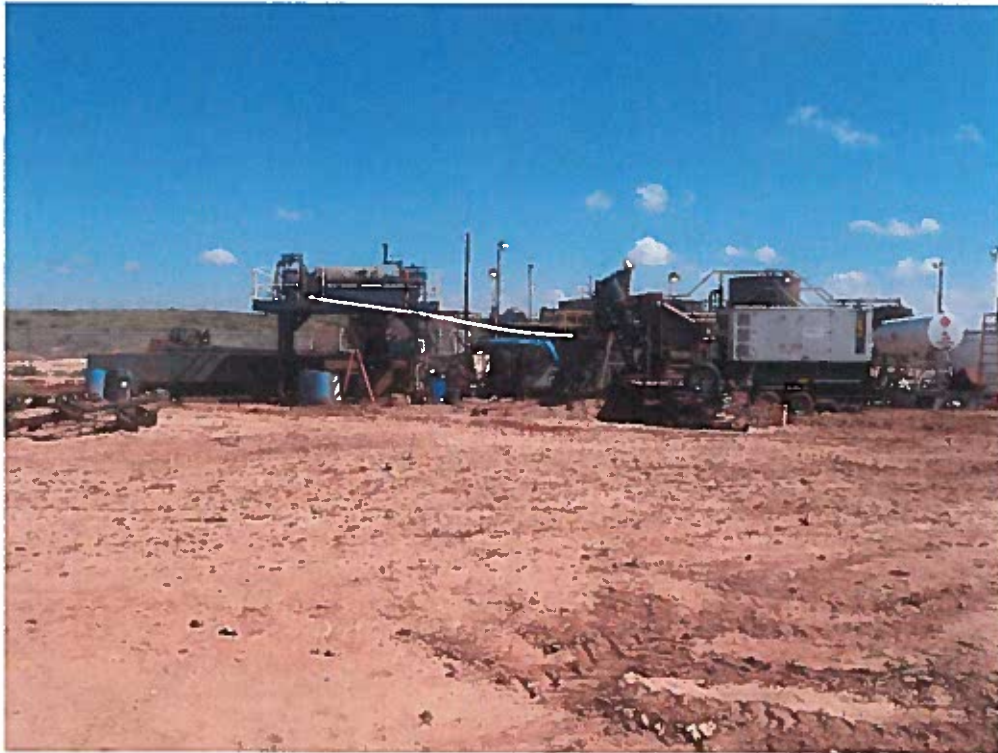
Photo of Soil Washing Set-Up Facing North

Beginning on May 11, 2015 through August, 2015 a total of 2,595 yards of contaminated soil was washed using 9,310 barrels of fresh water. The contaminated water however could not be used in oilfield activities due to fine soil particles in the water. All contaminated water was disposed of at a NMOCD approved SWD. All the washed material was placed into 7 cells and 5 point composite samples of each cell were taken to a commercial laboratory for analysis. Cells 2, 4, and 5 laboratory results showed elevated chlorides over the 1,000 chloride threshold.

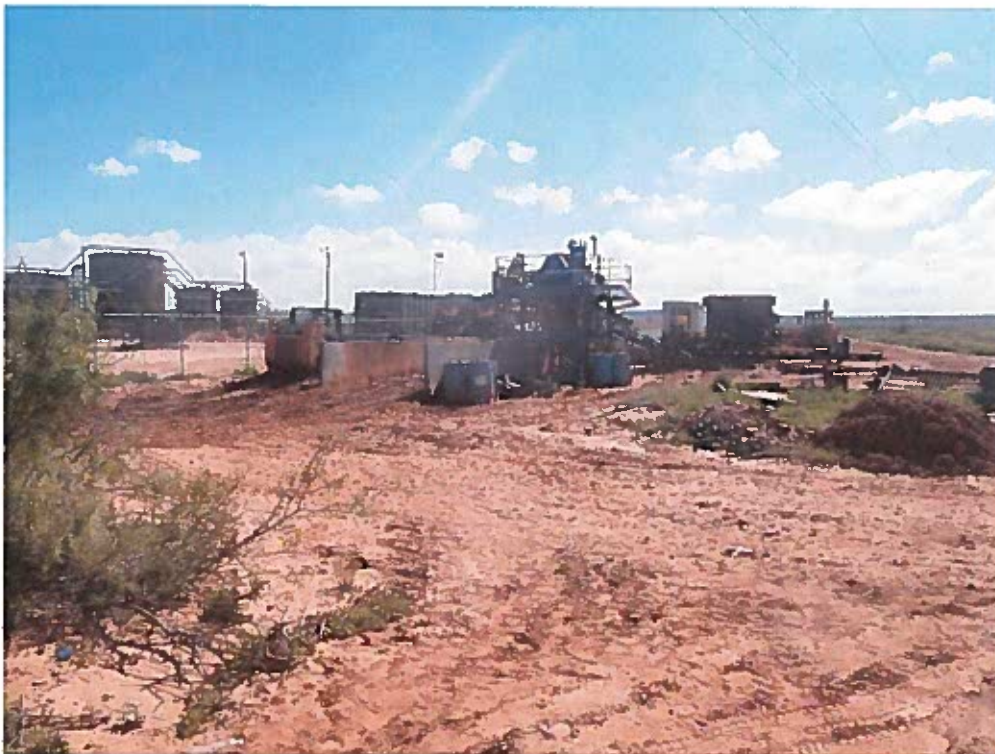
Photo of Soil Washing Facing North-East

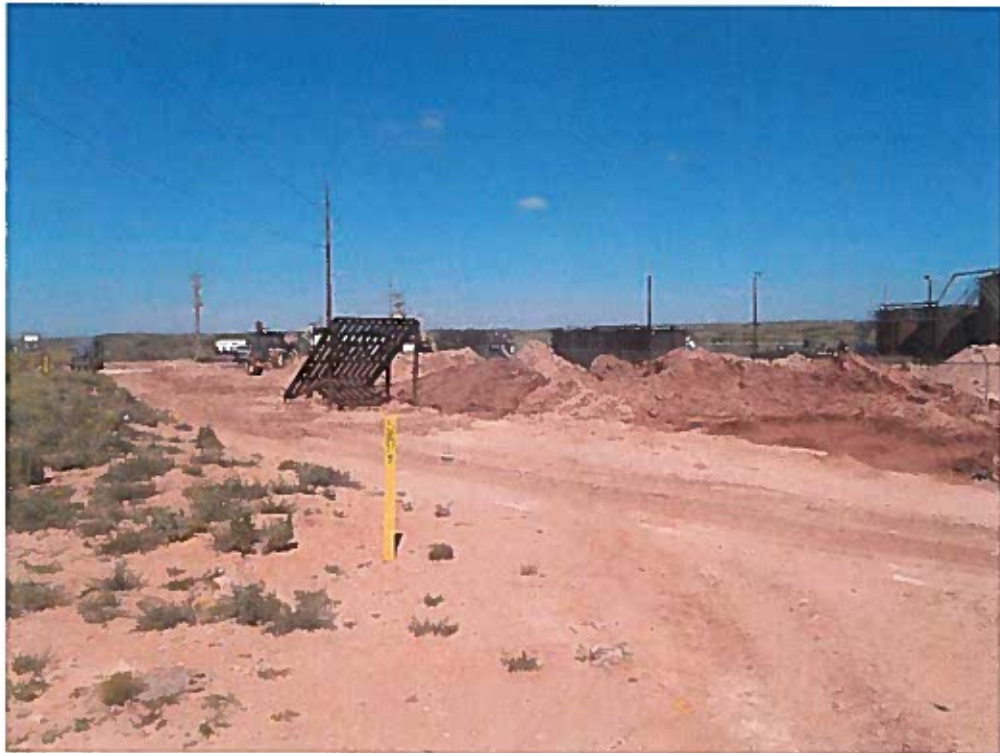
Photo of Stock Pile Facing North-West

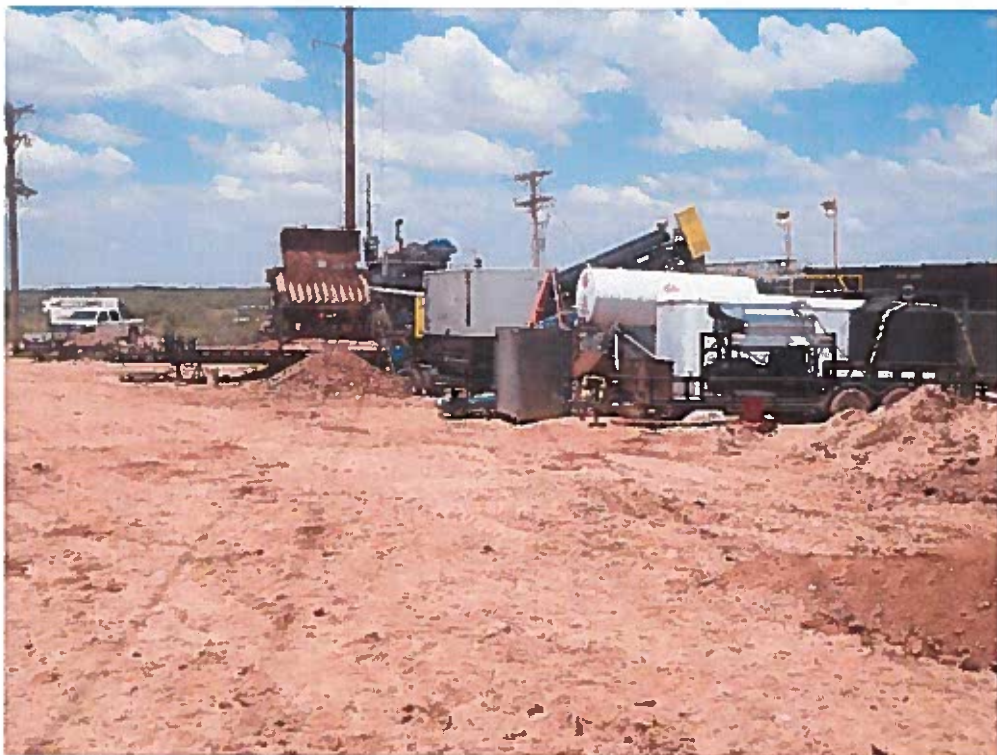
Photo of Soil Washing Facing West

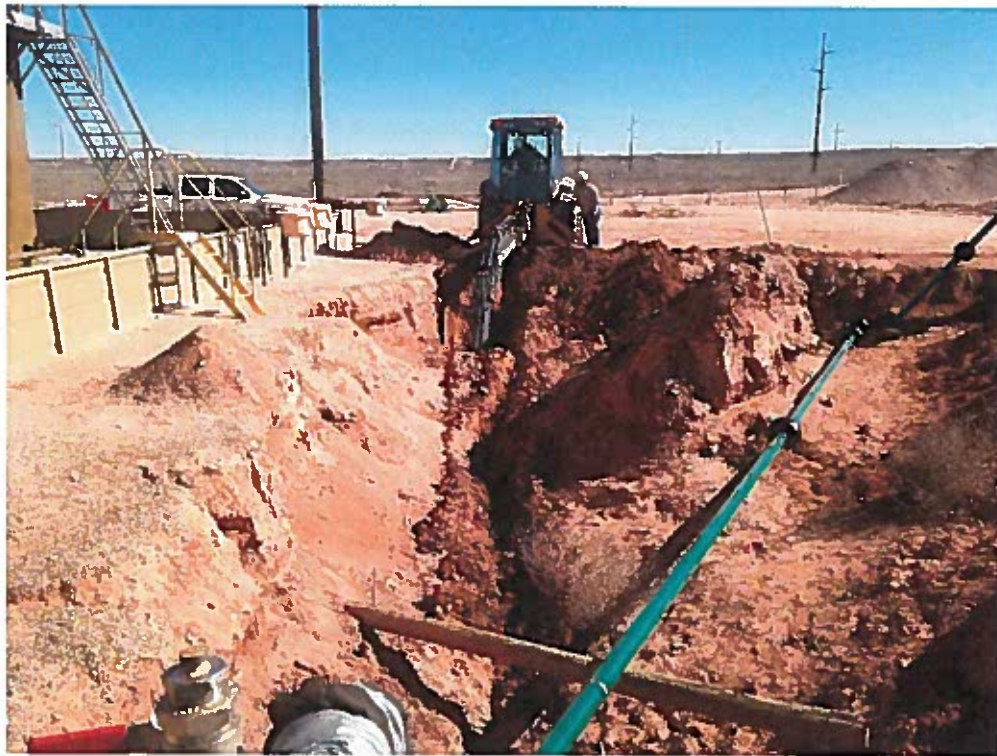
Photo of Vertical Delineation Facing East

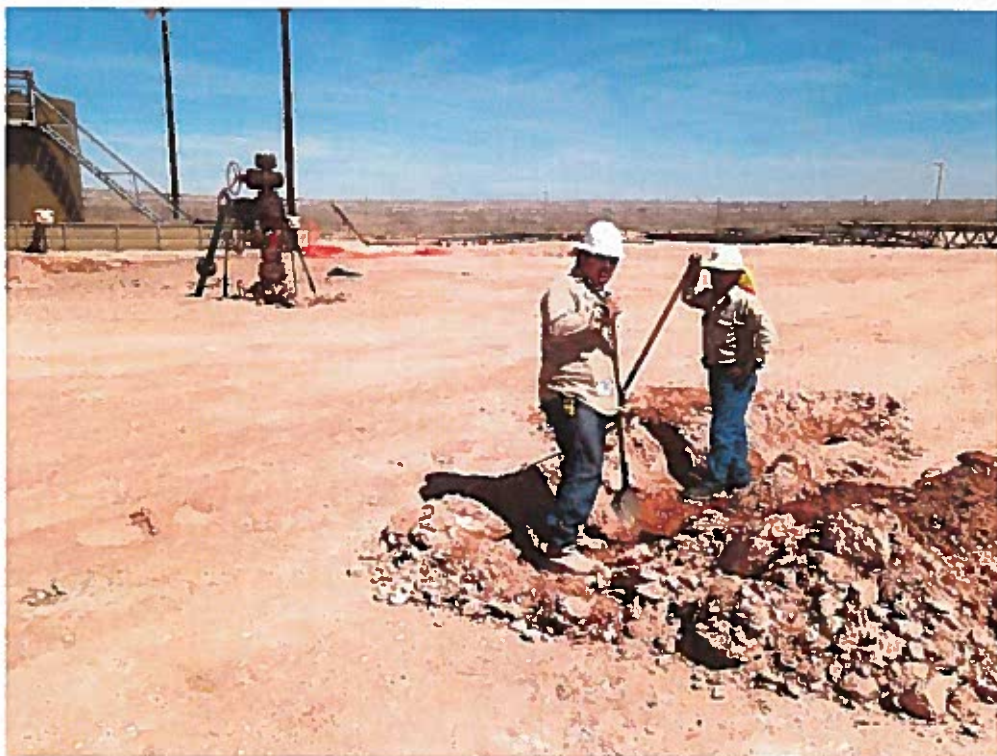
Photo of Spotting Edge of Liner Facing North-East

The area inside the facility was scraped down to levels less than 1,000 chlorides except above the liner which the highest concentration were removed to a depth that would not jeopardize the integrity of the buried liner. The area around the source of the release was delineated to a depth of 10 feet and ceased delineation when clay was encounter and the 9 foot sample was taken to a commercial laboratory for analysis for chloride. The area around the pipeline was excavated were possible to a depth of the natural occurring clay barrier.

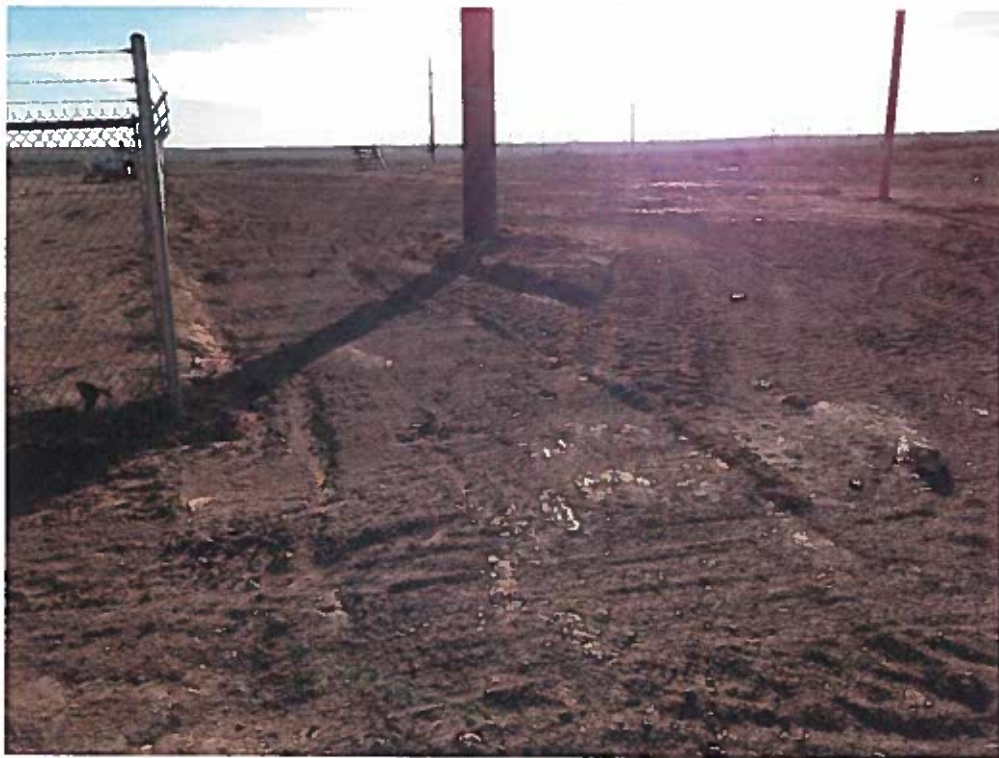
Photo of Pasture Backfilled Facing East

Beginning on December 3, 2015 the pasture was backfilled utilizing washed top soil and clean imported top soil and contoured to the surrounding area. The facility was backfilled with clean imported caliche and caliche was also utilized to build berms around the facility.

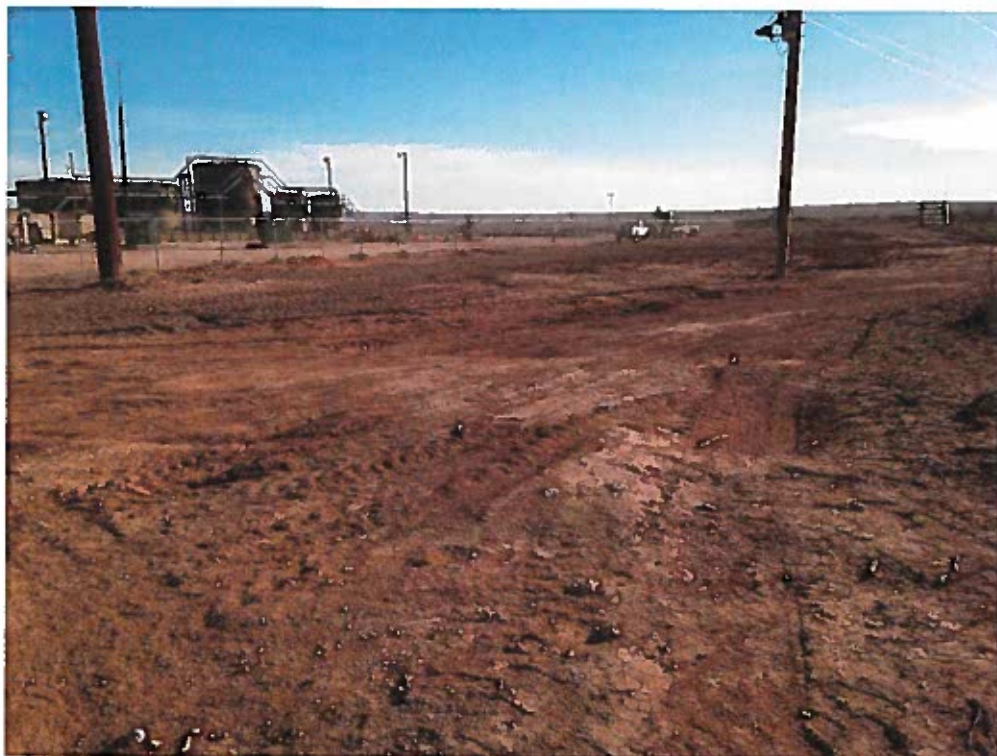
Photo of Pasture Backfilled Facing North-East
