Report Type: Closure Report 2RP-4024

Site:	Firefox 4 Fed Com 5H Battery					
Company:	COG Operating LLC					
Section, Township and Range	Unit M	Sec. 04	T 19S	R 31E		
Lease Number:	API No. 30-015-41423					
County:	Eddy County					
GPS:	32.683605° N			103.882709° W		
Surface Owner:	Federal					
Mineral Owner:						
Directions:	From the intersection of 126A (Maljamar Rd) and Lusk Plant Rd. in rural Eddy County, turn west on Lusk Rd for approximately 6.20 mi, turn west onto lease road for 0.4 miles, turn south for 0.6 mi , turn west onto lease road for 0.15 mi to location on north side of lease road.

Re: Closure Report for the COG Operating LLC., Firefox 4 Fed Com 5H Battery, Unit M, Section 04, Township 19 South, Range 31 East, Eddy County, New Mexico. 2RP-4024

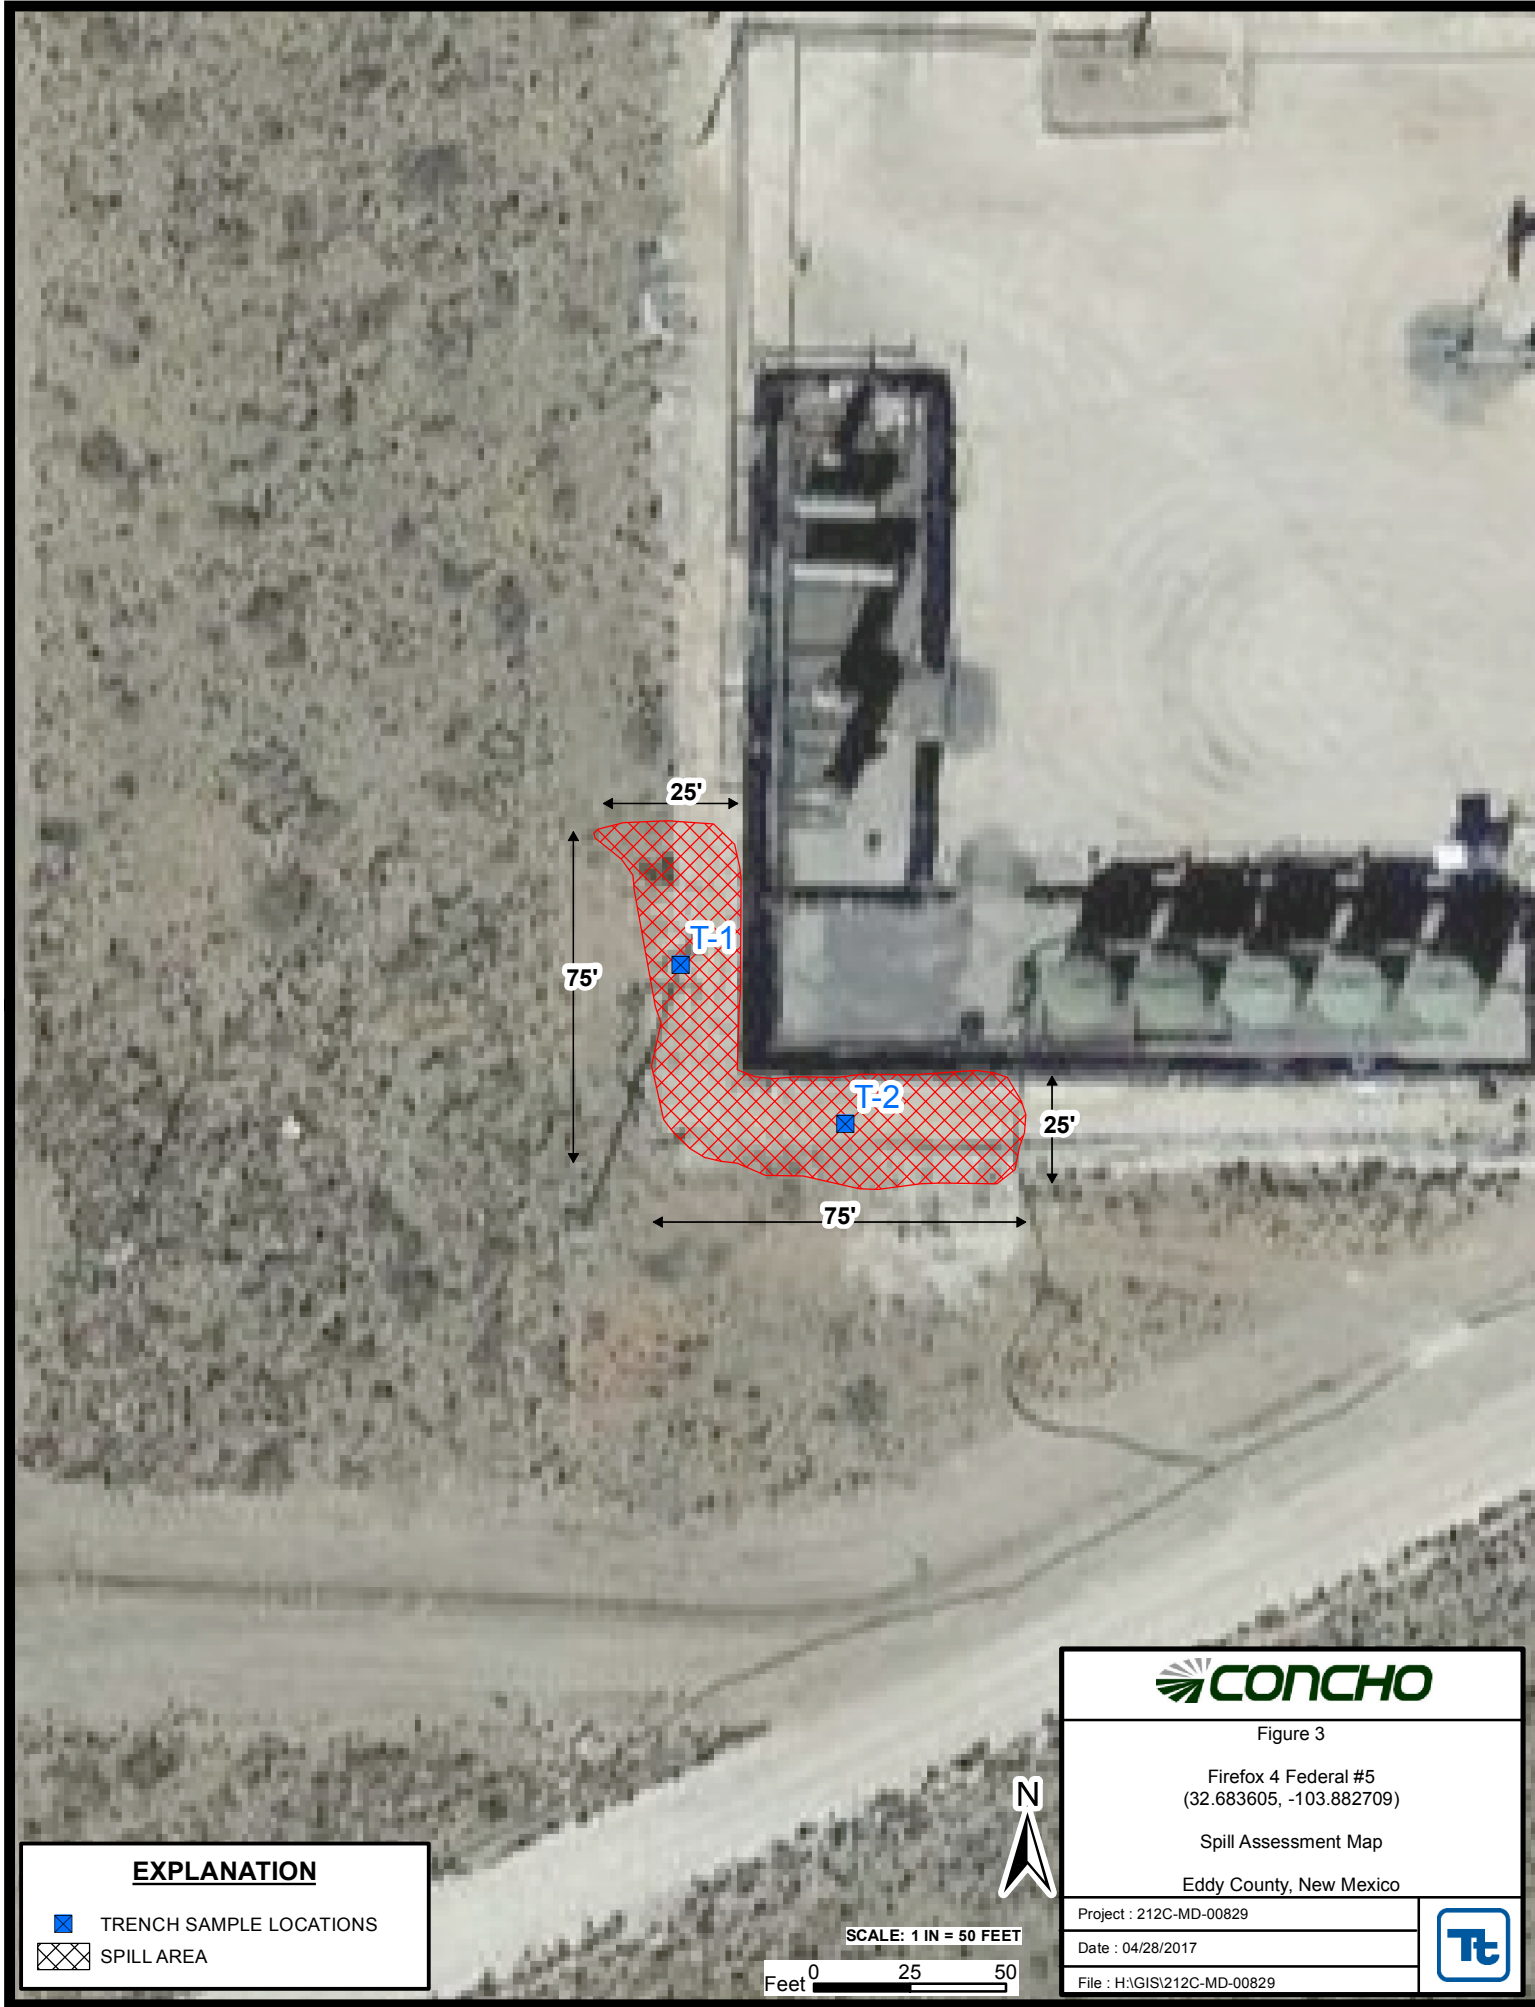
Figure 3

On December 19, 2016, COG personnel was onsite to evaluate and sample the release area. Using a backhoe, two (2) sample trenches (T-1 and T-2) were installed to total depths of 8.0' and 10.0' below surface to evaluate the impact to the soils. Selected samples were analyzed for TPH analysis by EPA method 8015 modified, BTEX by EPA Method 8021B, and chloride by EPA method 300.0. Copies of the laboratory analysis and chain-of-custody documentation are included in Appendix C. The results of the sampling are summarized in Table 1. The trench location is shown in Figure 3.

Spill Assessment Map

Referring to Table 1, none of the samples collected at trenches (T-1 and T-2) showed total TPH, benzene, or total BTEX concentrations above the RRAL's. However, the area of trench (T-1) showed elevated chloride concentrations in the shallow soils with a chloride high of 8,000 mg/kg at 1.0' below surface, which then declined with depth and showed a bottom hole concentration of 208 mg/kg at 10.0' below surface. Additionally, the area of trench (T-2) showed a chloride high of 12,800 mg/kg at surface, which inconsistently declined with depth to 228 mg/kg at 6.0' below surface. A chloride spike of 3,480 mg/kg was detected at 7.0', before declining to 720 mg/kg at 8.0' below surface and the area was not vertically defined.

Based on the laboratory results, COG personnel returned to the site on March 16, 2017, to resample and assess the area of trench (T-2). One (1) backhoe trench (T-1) was installed in the area of trench (T-2) in order to vertically define the chloride impact. Selected samples were analyzed chloride by EPA method 300.0. Copies of the laboratory analysis and chain-of-custody documentation are included in Appendix C. The results of the sampling are summarized in Table 1.

Referring to Table 1, the area of T-1 (T-2) showed a chloride concentration of 7,970 mg/kg at surface. The chloride concentrations then steadily declined with depth to 307 mg/kg at 8.0' and showed a bottom hole concentration of <10.0 mg/kg at 14.0' below surface.

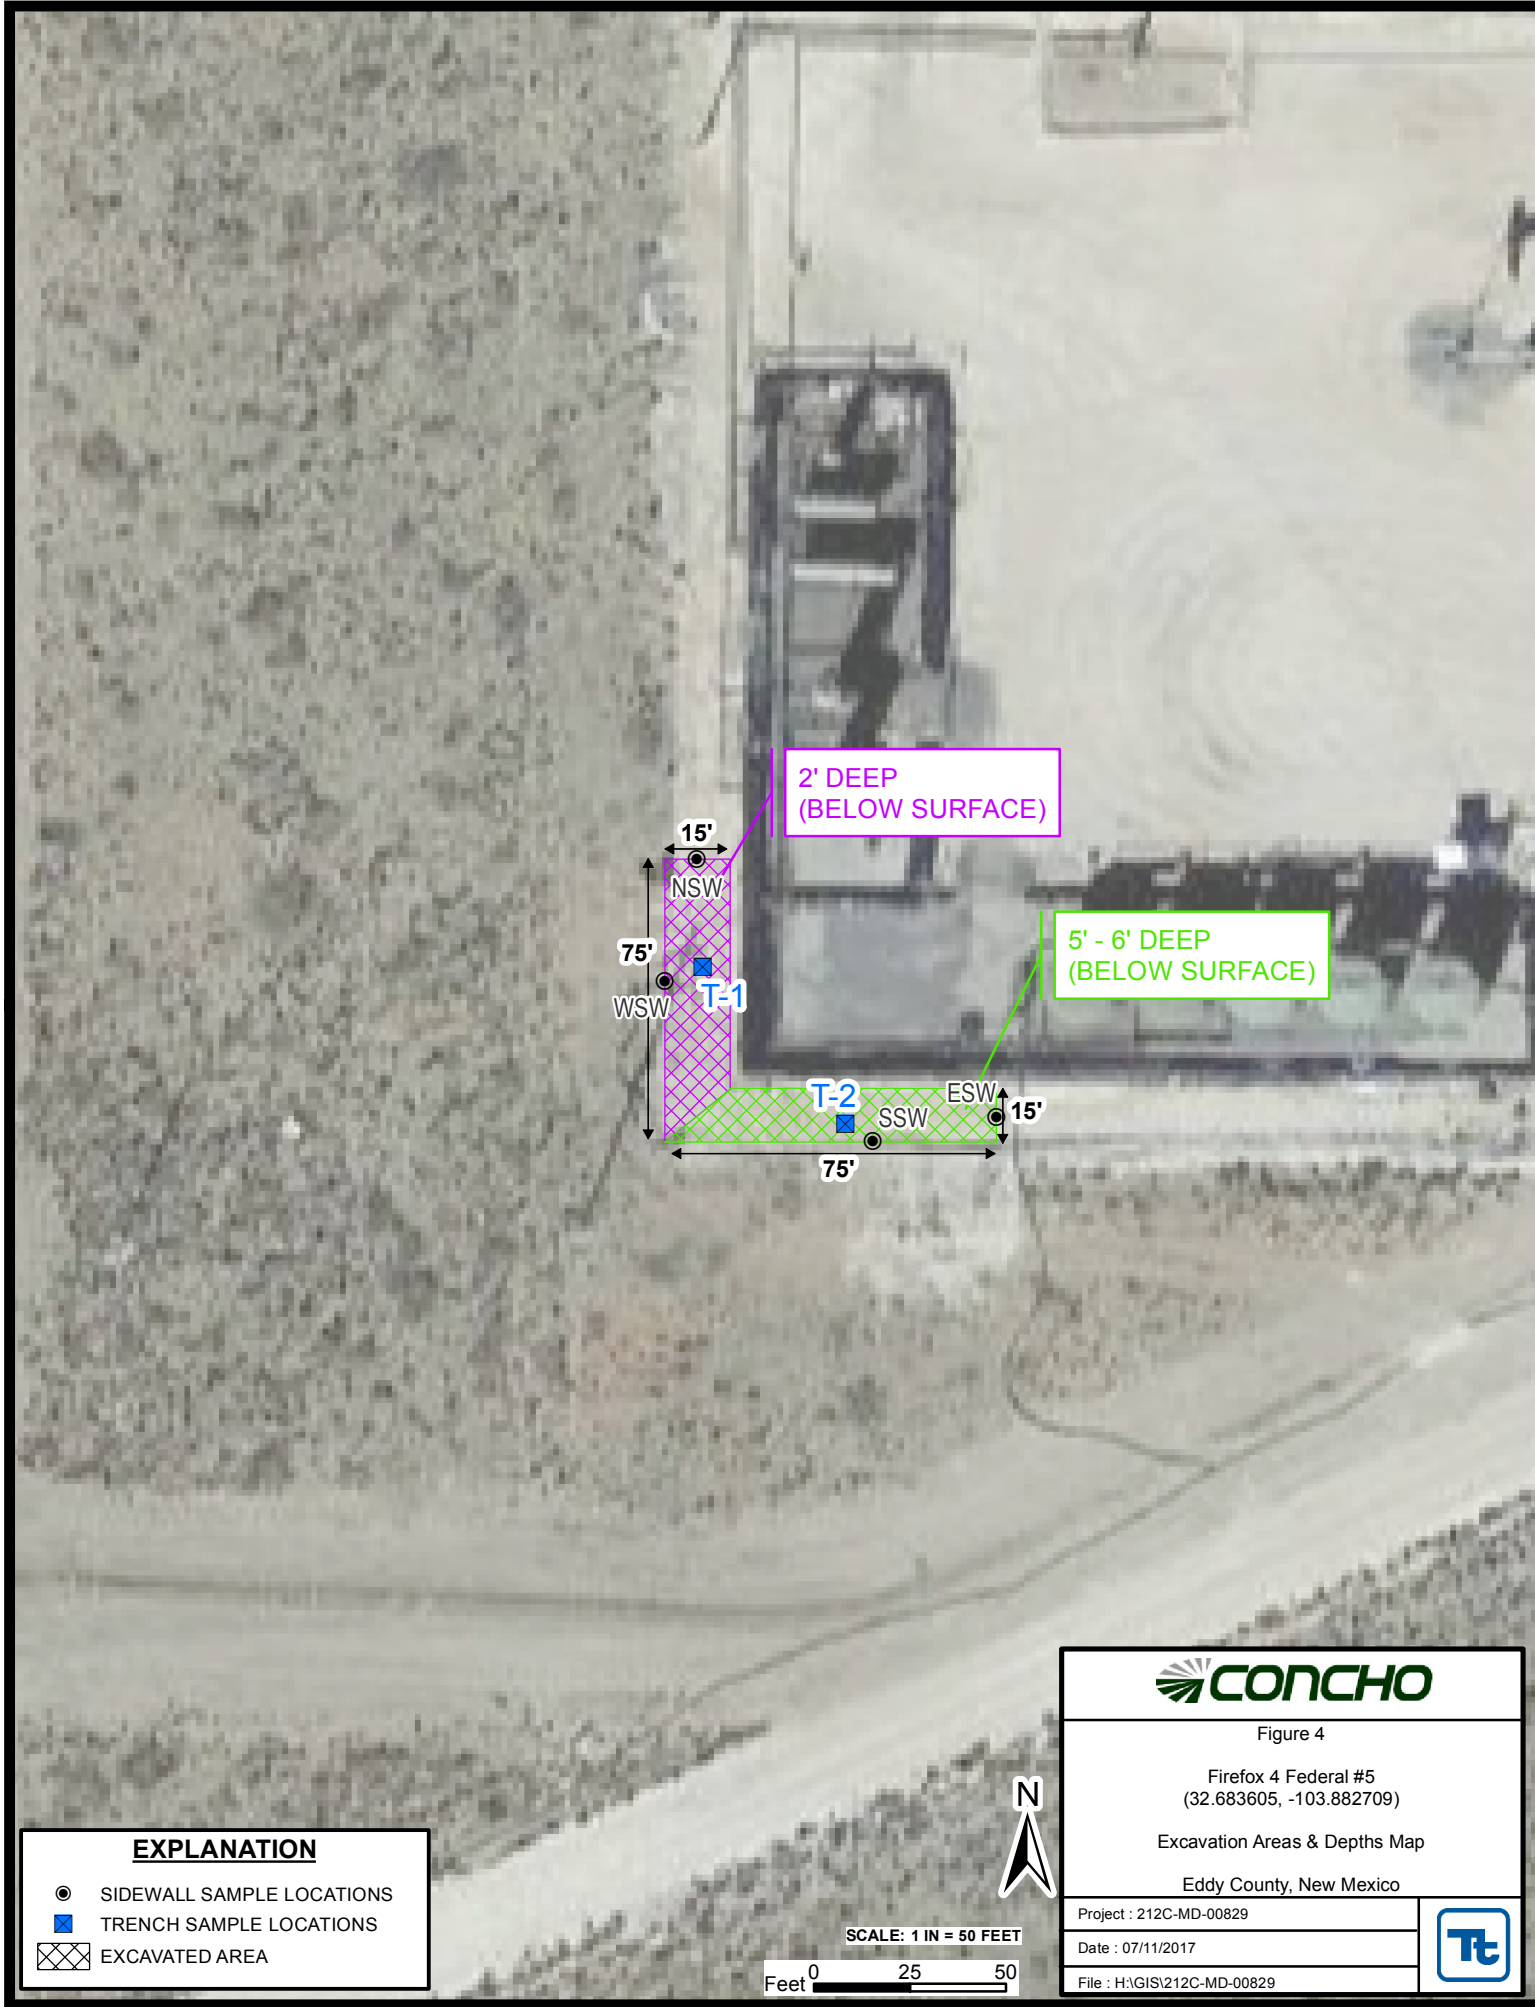
On June 22-26, 2017, Tetra Tech personnel were onsite to supervise the excavation and remediation activities. The excavated areas and depths are shown on Figure 4 and highlighted (green) in Table 1. The area of trench (T-1) was excavated to 2.0' and the area of trench (T-2) was excavated to 6.0' below surface. A total of four (4) sidewall samples (North Sidewall, West Sidewall, South Sidewall, and East Sidewall) were collected to ensure proper removal of the impacted material. Selected samples were analyzed for chloride by EPA method 300.0. Copies of the laboratory analysis and chain-of-custody documentation are included in Appendix C. The results of the sampling are summarized in Table 1. The sidewall sample locations are shown on Figure 4.

Excavation Areas & Depths Map

Referring to Table 1, none of the sidewall samples showed chloride concentrations above 600 mg/kg, with concentrations ranging between 17.4 mg/kg and 373 mg/kg. Once the excavation was completed, the areas of trenches (T-1 and T-2) were backfilled with clean material to surface grade. Approximately 400 cubic yards of excavated material was transported offsite for proper disposal.

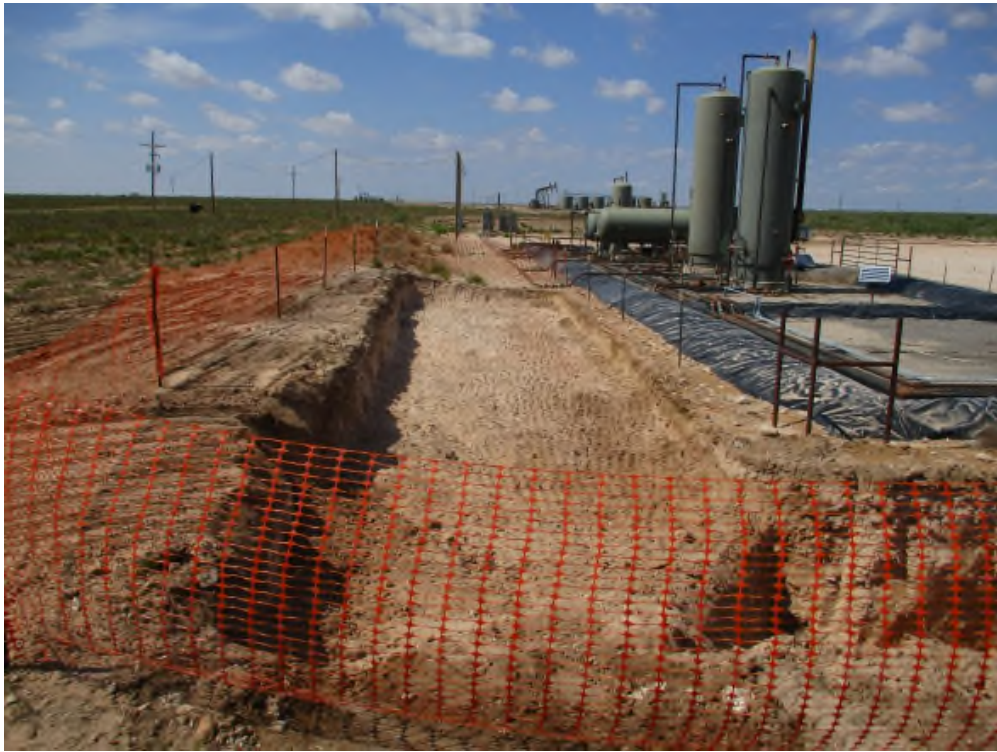
View North – Excavated area of T-1

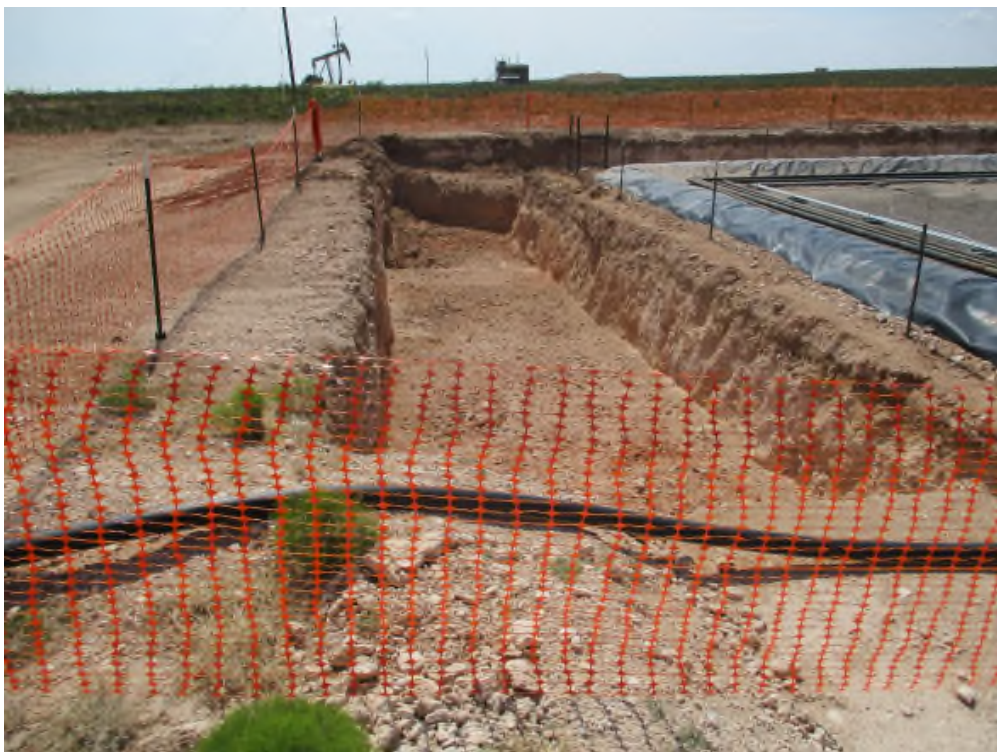
View West- Excavated Area of T-2

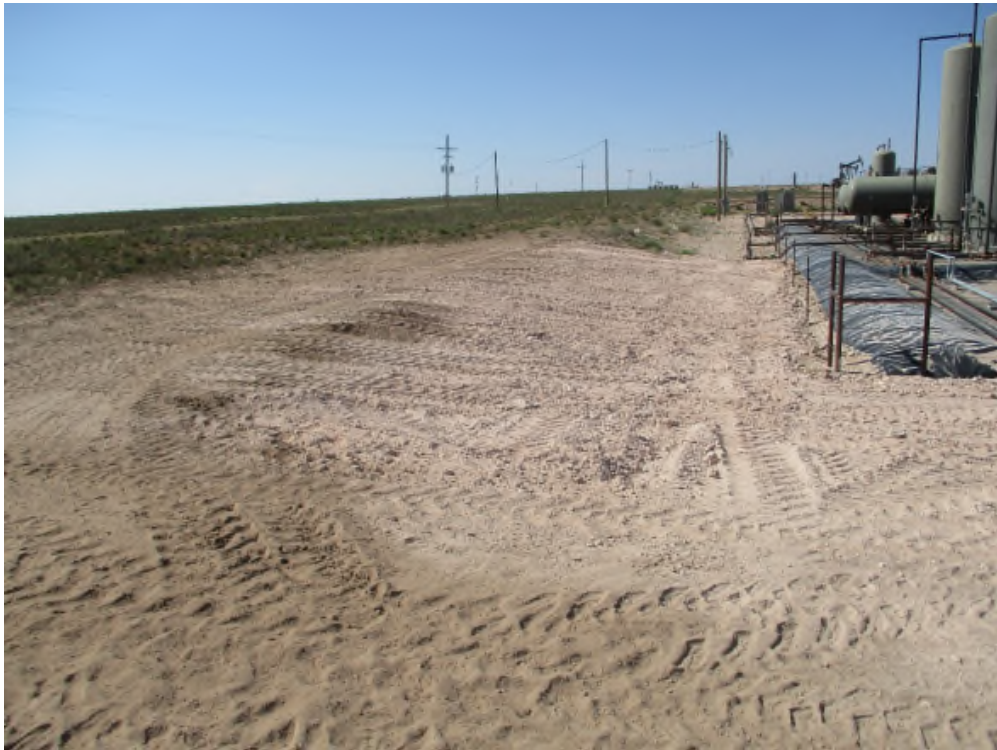
View North – Backfilled Area of T-1

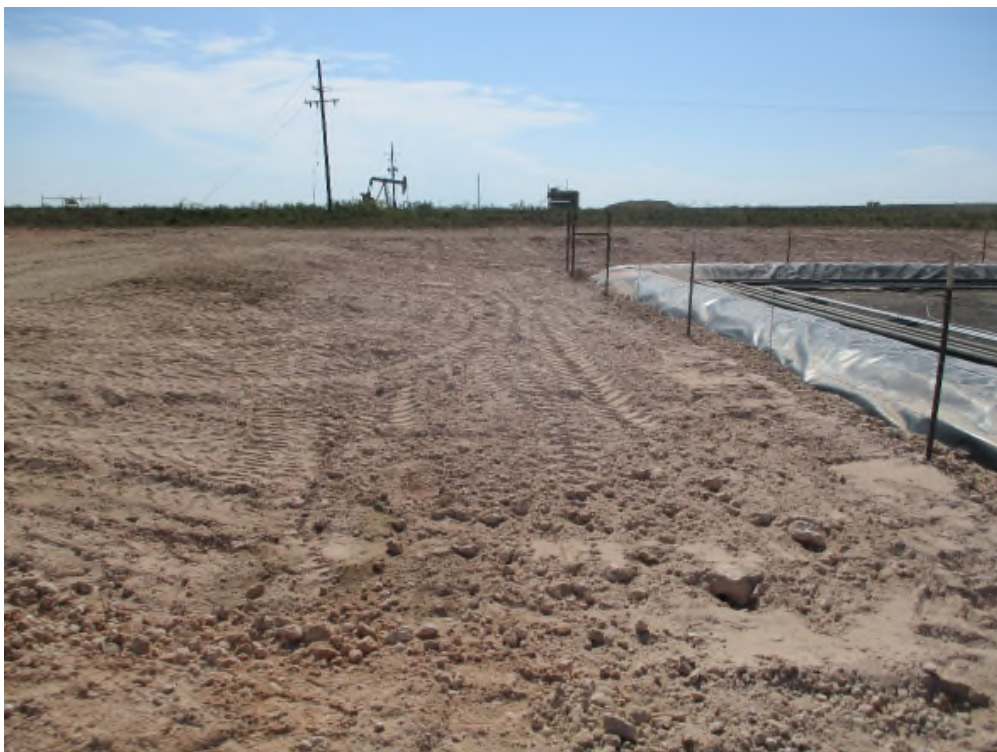
View West – Backfilled Area of T-2
