**Re: Work Plan
Dump Yard 2 State #002H
API #: 30-015-42518
RP#: 2RP-4424
Unit Letter N Section 02, Township 21S, Range 28E
Eddy County, NM**

COG Operating, LLC (COG) is pleased to submit for your consideration the following remediation work plan for the Dump Yard 2 State #002H. This plan is in response to an oil release that occurred on September 29, 2017. Subsequent to the release a C-141 initial report was submitted to the New Mexico Oil Conservation Division (NMOCD) on October 4, 2017.

APPENDIX I

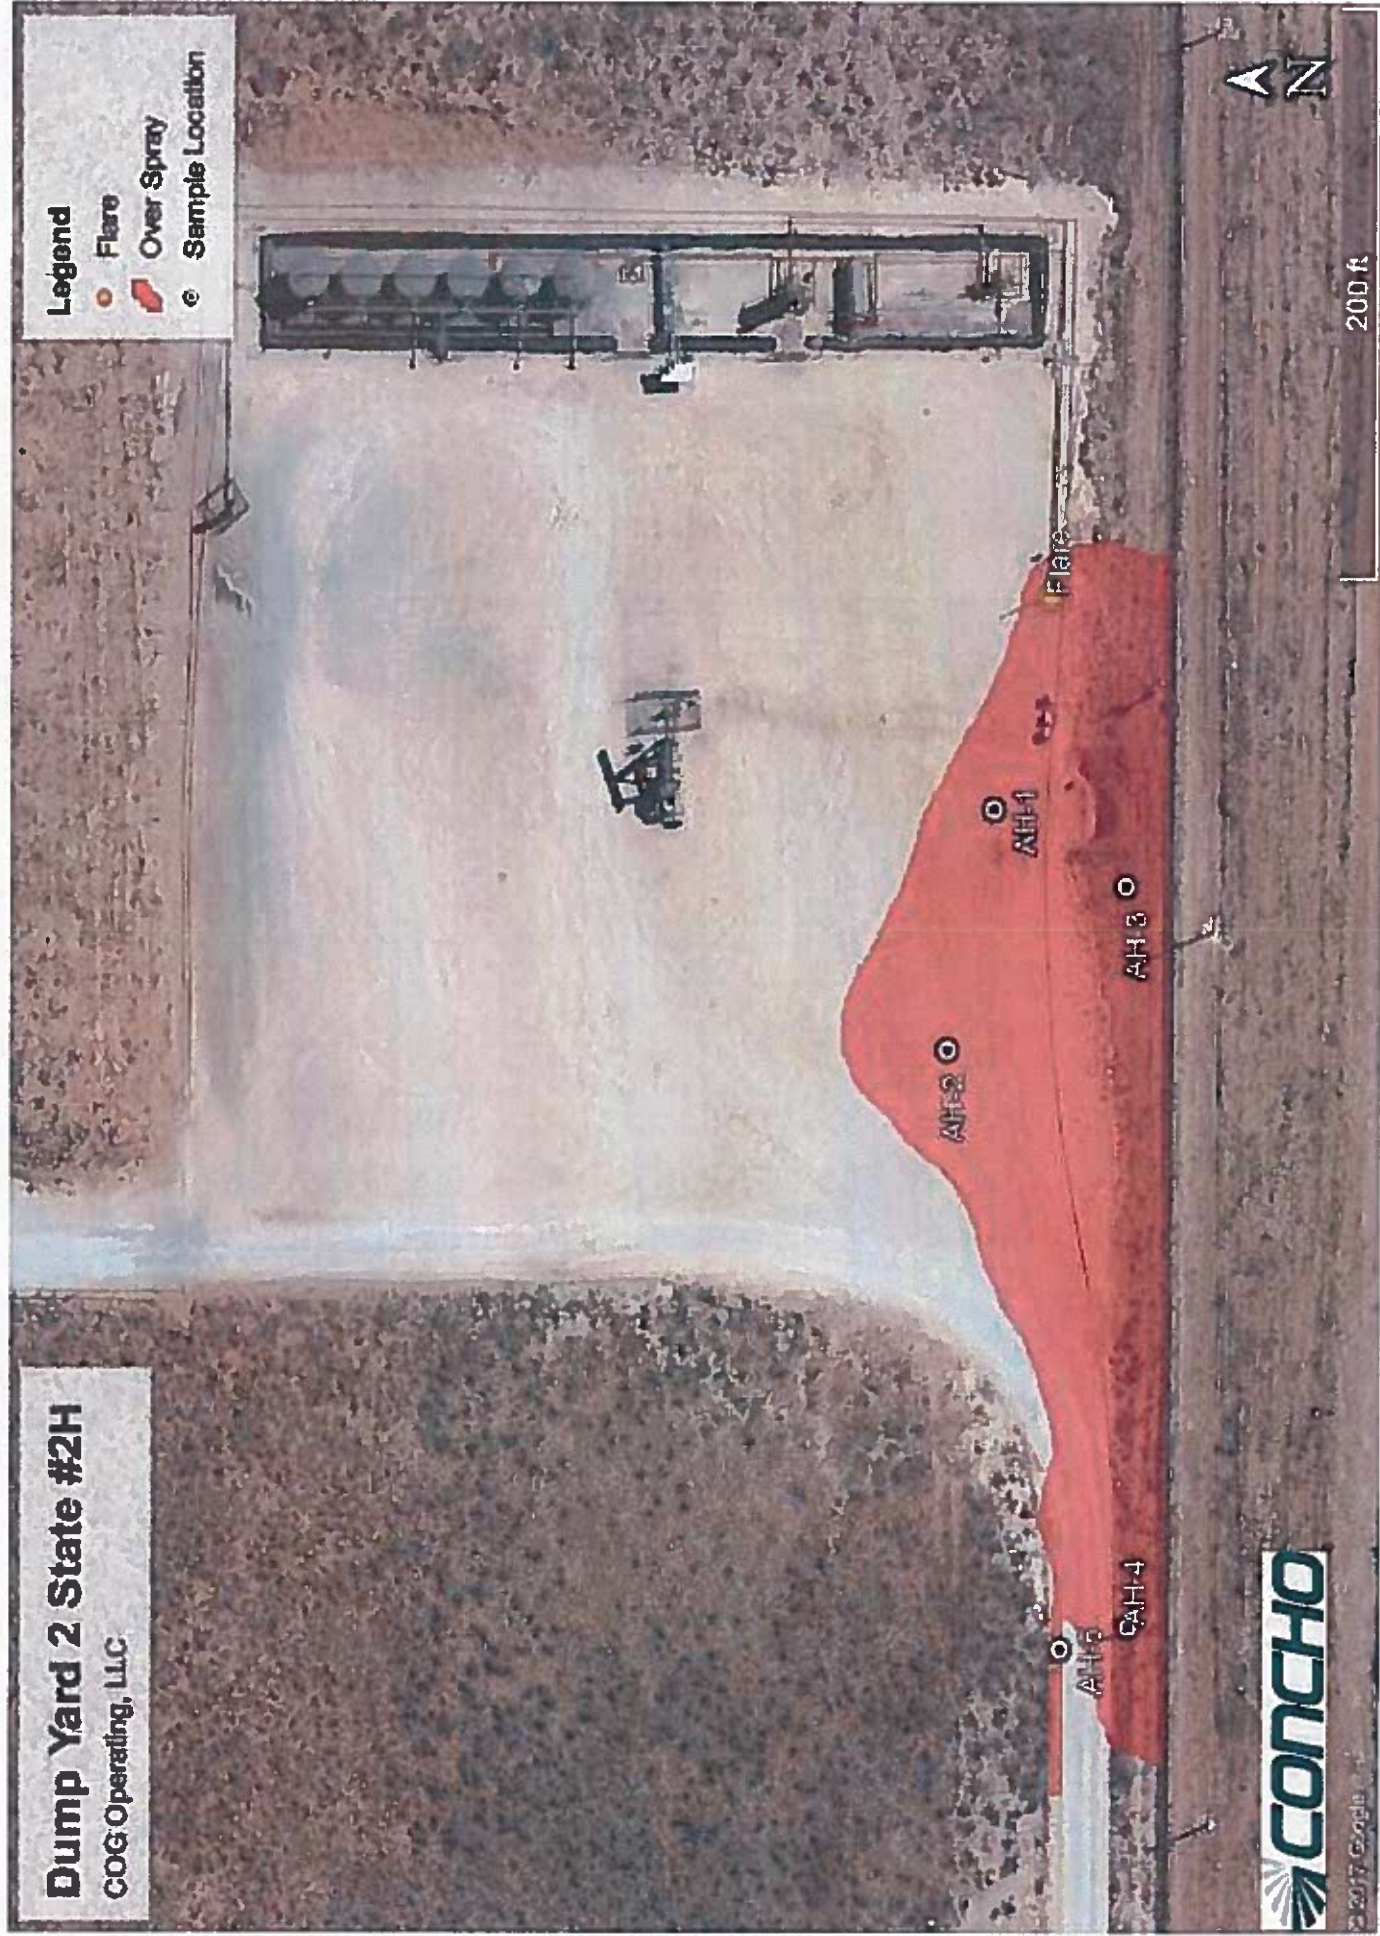
Dump Yard 2 State #2H

On October 4, 2017, a site assessment was conducted in order to vertically and horizontally define the impacted area. A site diagram is included in Appendix I. The analytical results from the site assessment activities are summarized in the table below.

- The overspray that resulted from the flare release was treated with Micro-Blaze on November 14, 2017 as part of the initial remedial actions.
- 90-days from the date of the above mentioned Micro-Blaze event a surface soil sample will be collected from sample location AH-1 and analyzed for Total Petroleum Hydrocarbons (TPH) to determine if TPH concentrations have attenuated below NMOCD Recommended Remedial Action Levels (RRAL's).
- If TPH levels remain elevated above NMOCD RRAL's the area in the vicinity of sample location AH-1 will be excavated to a depth of 0.5-feet BGS and hauled to an NMOCD approved disposal facility. The excavation will then be backfilled with caliche.
