## **Soil Assessment and Remediation Work Plan**

Bridger-Sunoco Pecos River Unloading Station  
Facility #5593400000 \* 2RP-4435-0  
Talon Project No: 702231.004.01

Subject: **Soil Assessment and Remediation Work Plan**  
Sunoco Pecos River Station Unloading Station  
Facility #5593400000 \* 2RP-4435-0

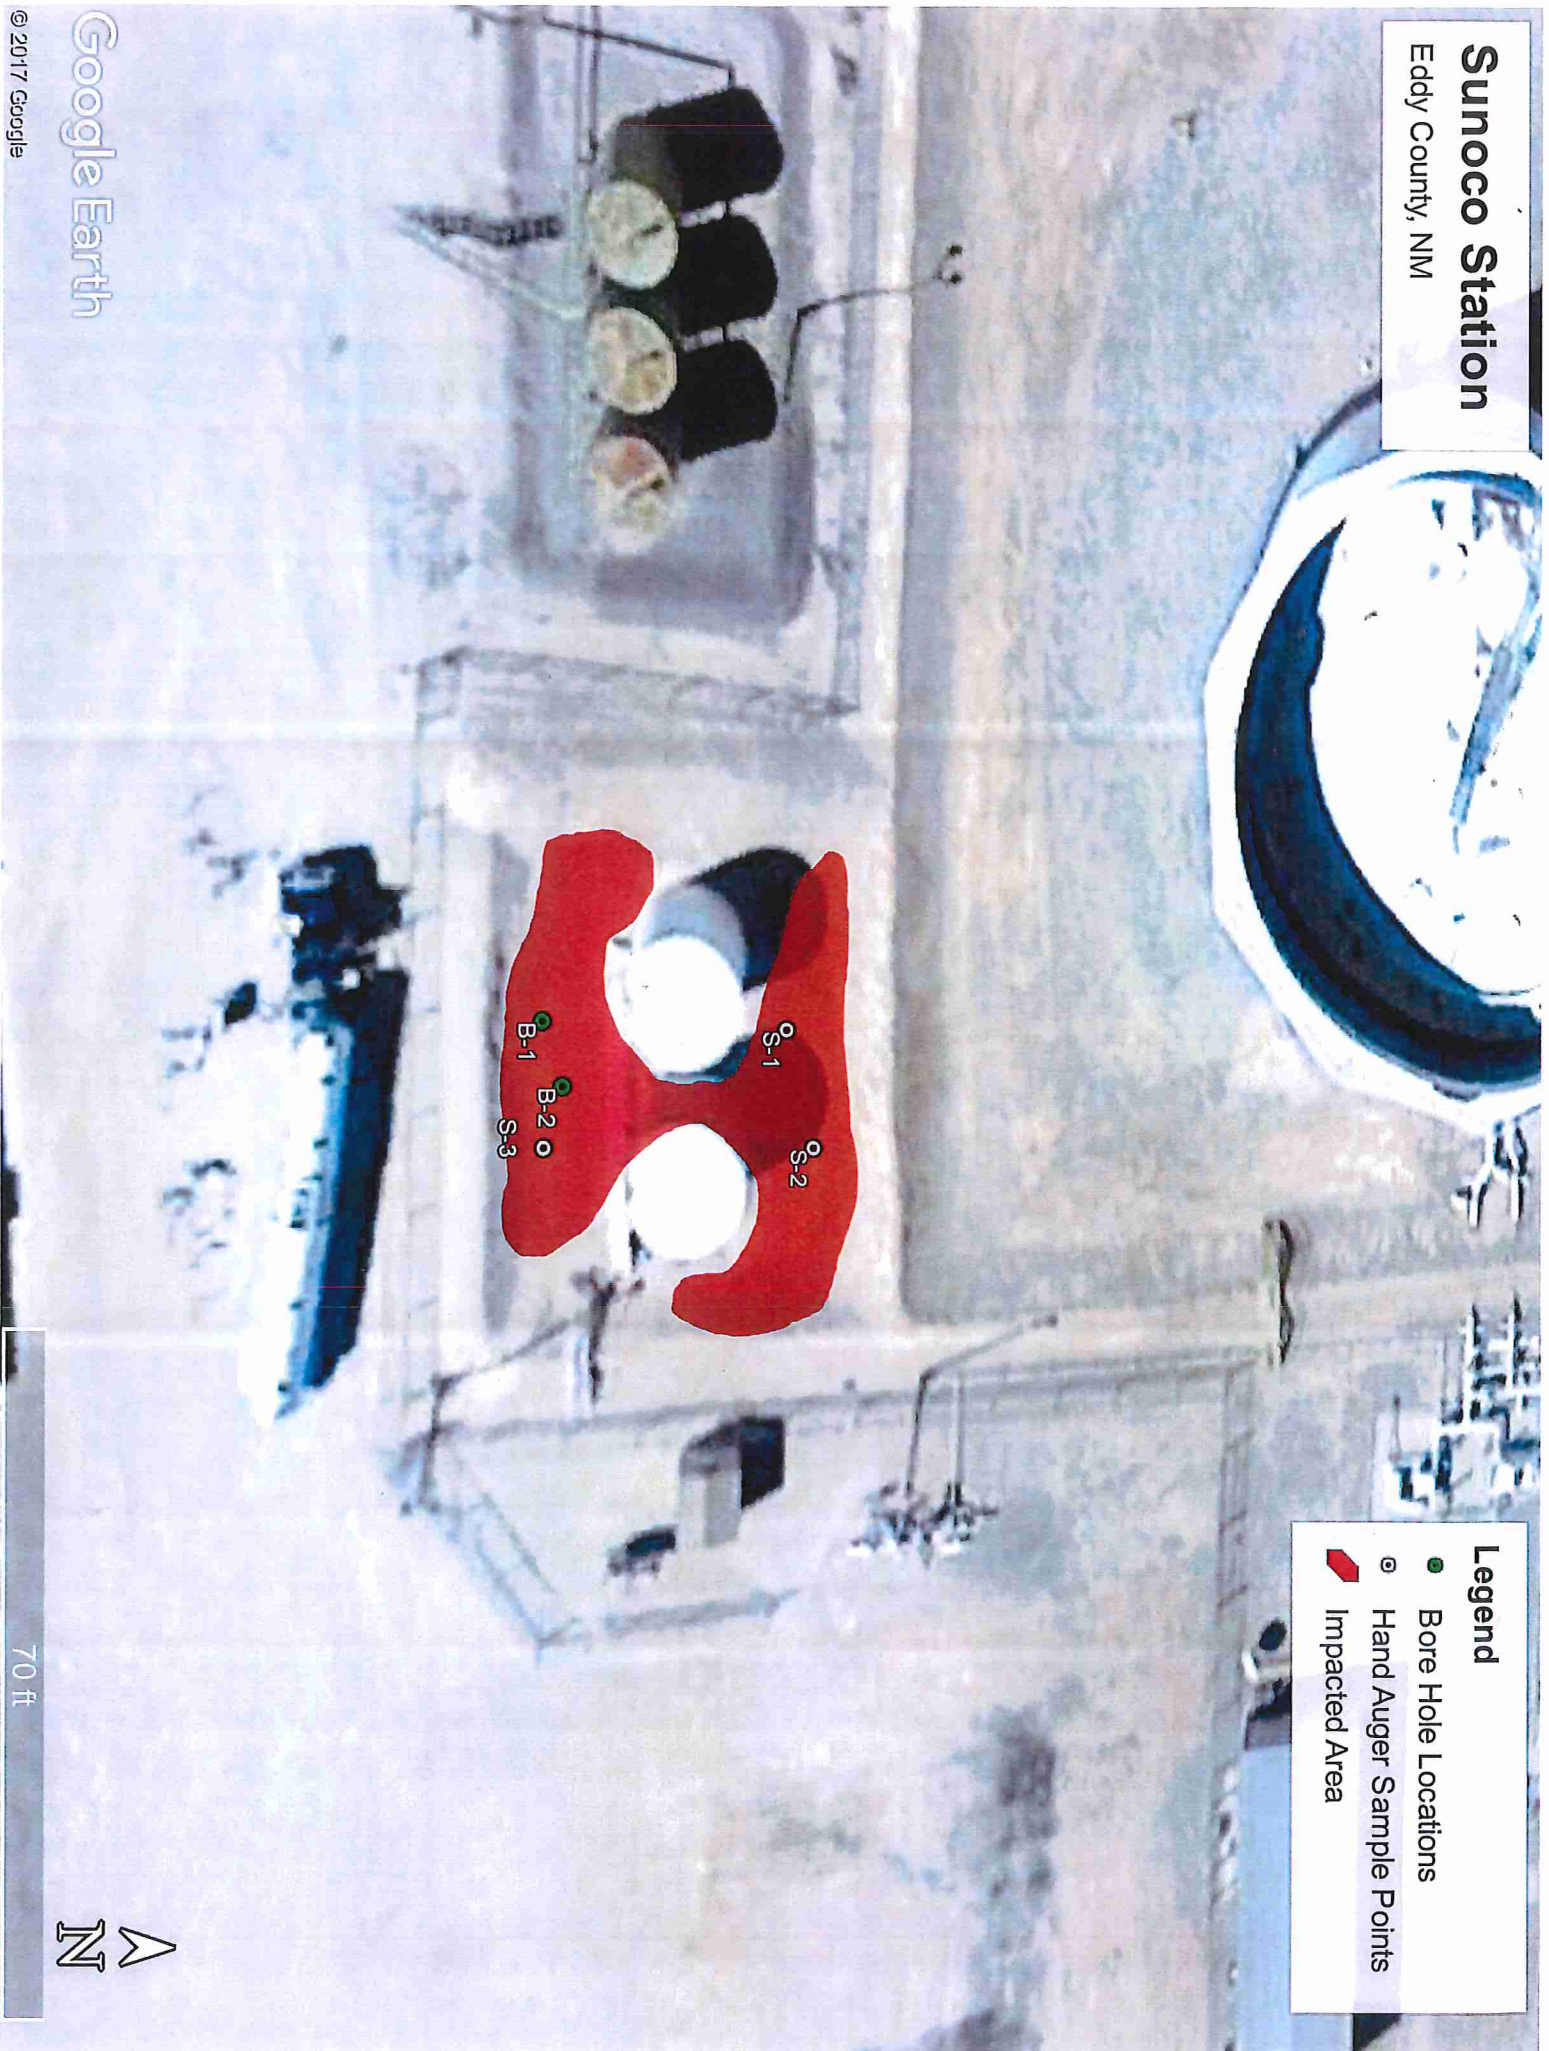
# Sunoco Station

On Saturday evening September 16, 2017, a tank at the Sunoco Pecos River Station was overfilled releasing approximately five (5) barrels of crude oil into an unlined earthen tank battery. All fluids were contained within the berms. There were no fluids recovered. A site plan illustrating the impacted area can be located in [Appendix I](#).

- Bore Hole Locations
- Hand Auger Sample Points
- Impacted Area

- All remaining hydrocarbon-impacted soil within the bermed, unlined containment (to a depth of 2-feet deep) will be hand-excavated to the best extent reasonable, feasible and as safely as possible around the tanks and steel flow lines in the battery to protect the safety of field personnel and structural integrity of the equipment within the battery.

- The excavated soil will be transported to Lea Land, LLC, a NMOCD approved solid waste disposal facility.
- A 20-mil liner will be installed at the bottom of the excavated area at a minimum of 2-feet below land surface to encapsulate the remaining impacted soil and insure that further downward migration of contaminants cannot occur.

- The excavated area will be backfilled with new caliche, machine compacted and contoured to match the surrounding location. The berms will be reconstructed.

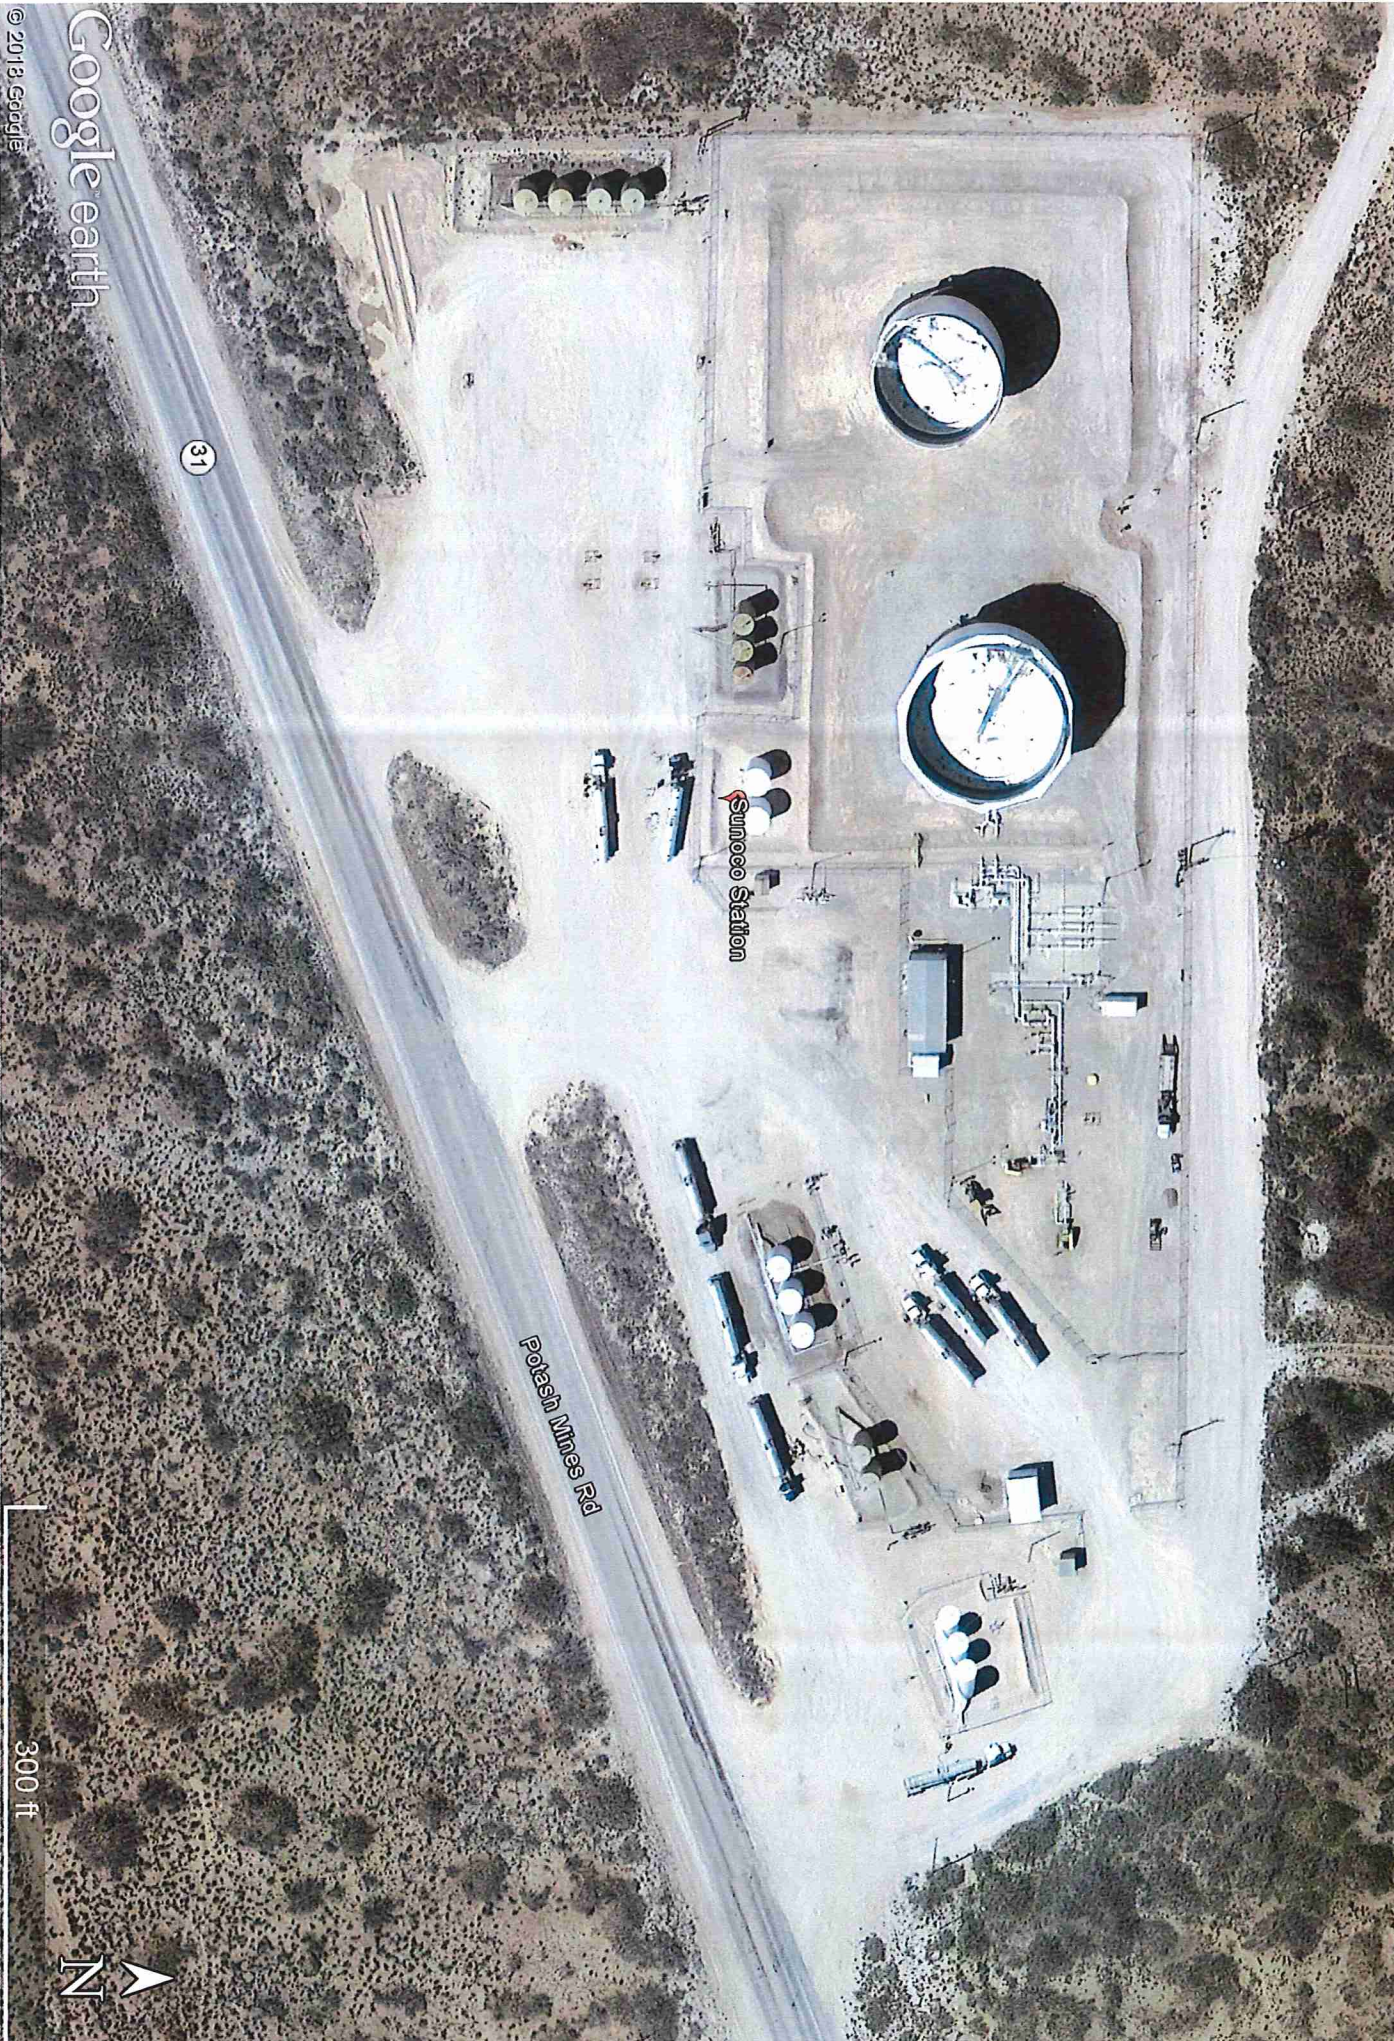
# Pecos River Unloading Station

The Sunoco Pecos River Unloading Station is located approximately fifteen (15) miles southeast of Carlsbad, New Mexico. The legal location for this release is Unit Letter L, Section 12, Township 28 South and Range 23 East in Eddy County, New Mexico. More specifically the latitude and longitude for the release are 32.315733 North and -104.050077 West. A site plan is presented in [Appendix I](#).
