# Closure Report

Site Name:	Sterling Silver 3 Federal #6 CTB
Company:	Oxy USA Inc.
Legal Description:	U/L F, Section 3, T24S, R31E
County:	Eddy County, NM
GPS Coordinates:	N 32.24825 W-103.76642

Date of Release:	06/15/2017
Type of Release:	Produced water
Source of Release:	Compromised poly line
Volume of Release:	25 bbls
Volume Recovered:	0 bbls

Remediation Parameters:	Excavated the areas of SP1-SP5 to a depth of 1 foot. Excavated the areas of SP6 & SP7 to a depth of 3 feet. Excavated the areas of SP8-SP10 to a depth of 4 feet and placed a liner in this excavation. Backfilled the site with clean soil.	
Remediation Activities:	06/28/2018 to 08/07/2018	
Plan Sent to OCD:	11/25/2017	Email from Cliff Brunson to Mike Bratcher
OCD Approval of Plan:	03/05/2018	Email from Mike Bratcher to Cliff Brunson
Plan Sent to BLM:	11/25/2017	Email from Cliff Brunson to Shelly Tucker
BLM Approval of Plan:	12/27/2017	Email from Shelly Tucker to Cliff Brunson

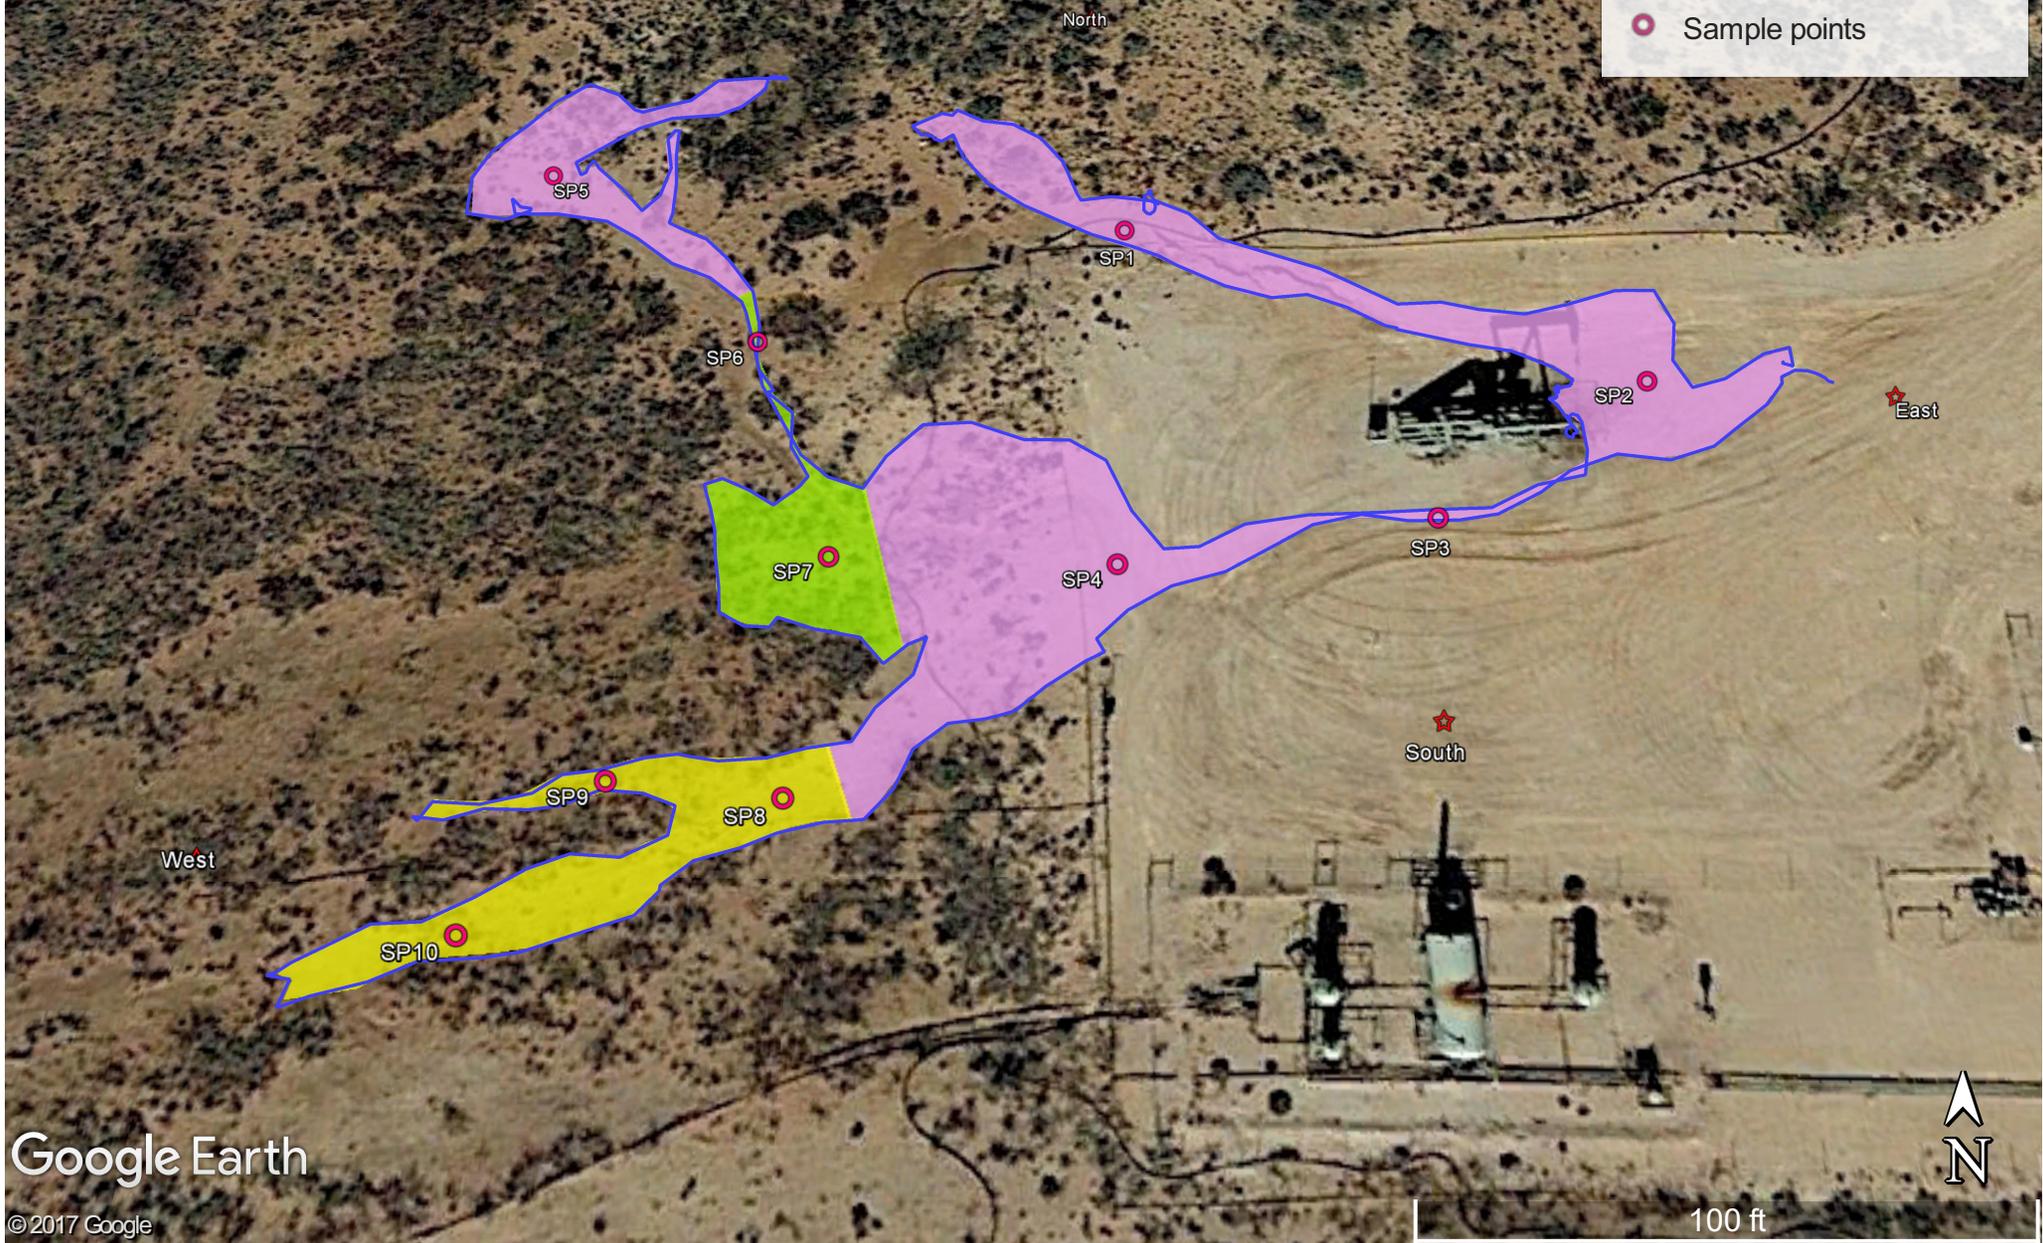
Leak date: 06/15/2017  
Eddy County, NM  
API# 30-015-27638  
2RP-4261

- 1 ft Excavation
- 3 ft Excavation
- 4 ft Excavation with liner
- Cardinal sample points
- Leak Area
- Sample points
