Re: Closure Report

XTO – Poker Lake Unit 078

NMOCD Reference #: 2RP-3980

RXSoil, Inc. is pleased to submit the Closure Report summarizing the on-site soil remediation of produced water and crude oil impacted soil at the Poker Lake Unit (“PLU”) 078 site located in Eddy County, New Mexico.

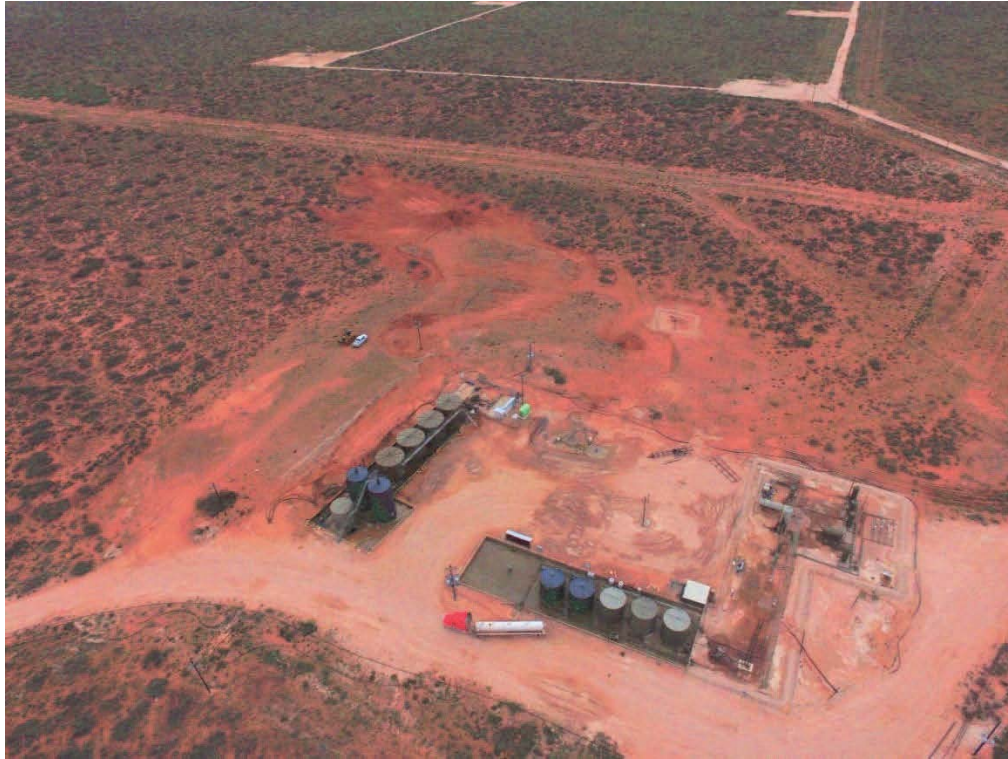
Nov. 14<sup>th</sup>, 2016 – Drone shot overview

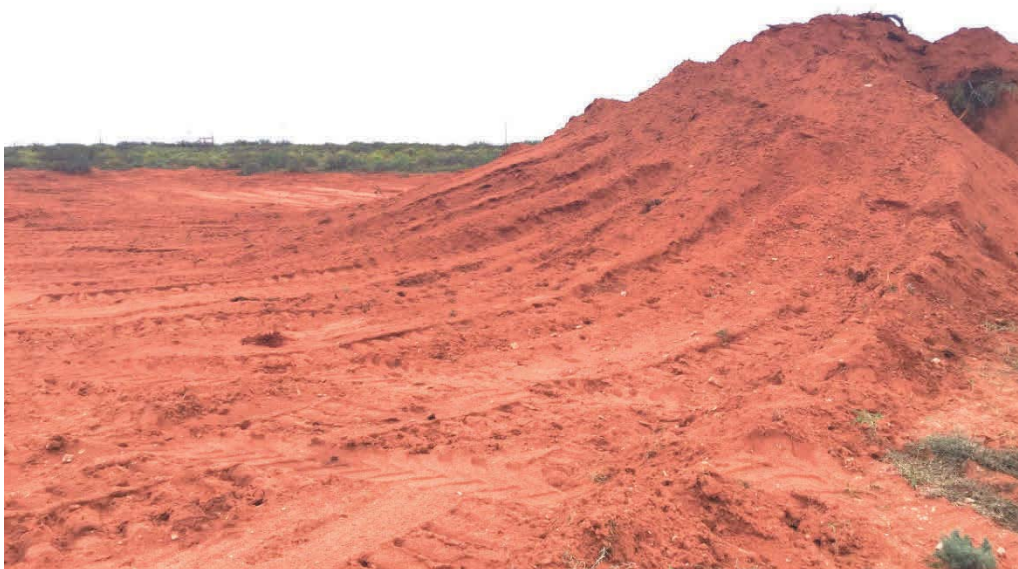
Nov. 14<sup>th</sup>, 2016 – Pile of dozed impacted material

During the initial response to the release, a pile of contaminated material was contained to one area near the flare stack. A small area around this pile was determined to be above threshold for chlorides. Excavation occurred in this area to a depth of 4' until all sidewalls tested below limit. Two bottom samples were collected from this area as well. All final samples were field screened for chlorides and sent on ice to Cardinal Laboratories in Hobbs, NM for chloride, TPH and BTEX testing.

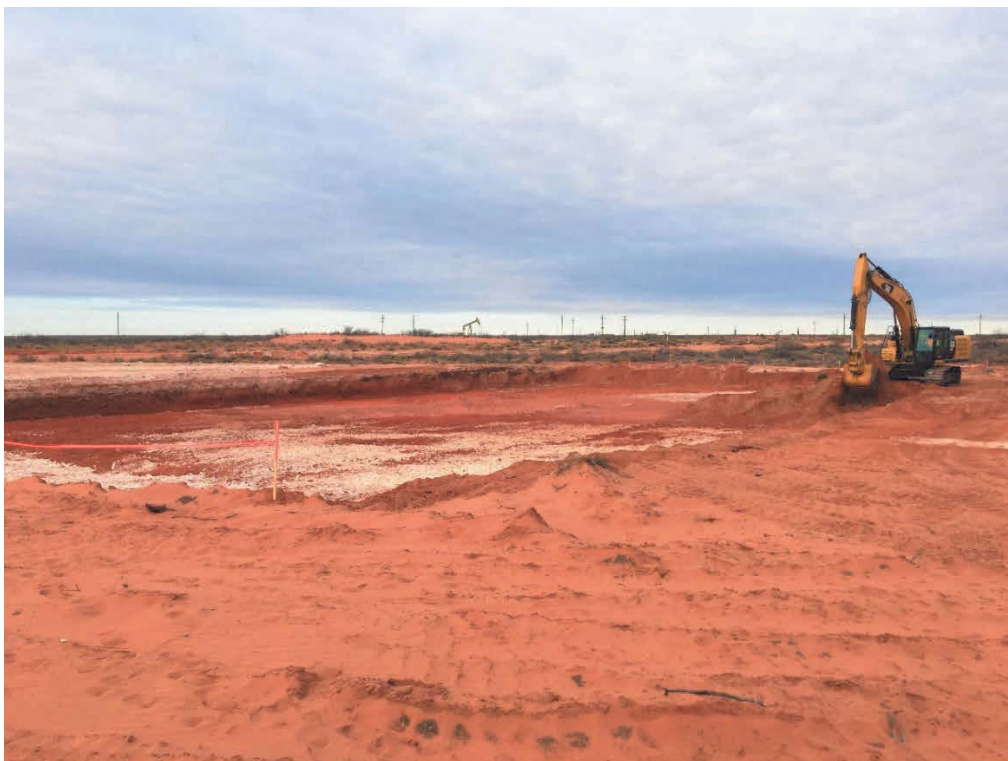
Jan. 16<sup>th</sup>, 2018 – Excavation to 4'

RXSoil excavated four treatment cells with a depth of 4' at PLU 078 for in-situ remediation of soil impacted by produced water and crude oil. Sidewall samples were collected along the outer edges of treatment cells to guide excavation. Excavation occurred until field screenings tested below threshold for chlorides. Bottom samples were also collected throughout the excavation area. Sidewall and bottom samples were transferred on ice and tested by Cardinal Laboratories.

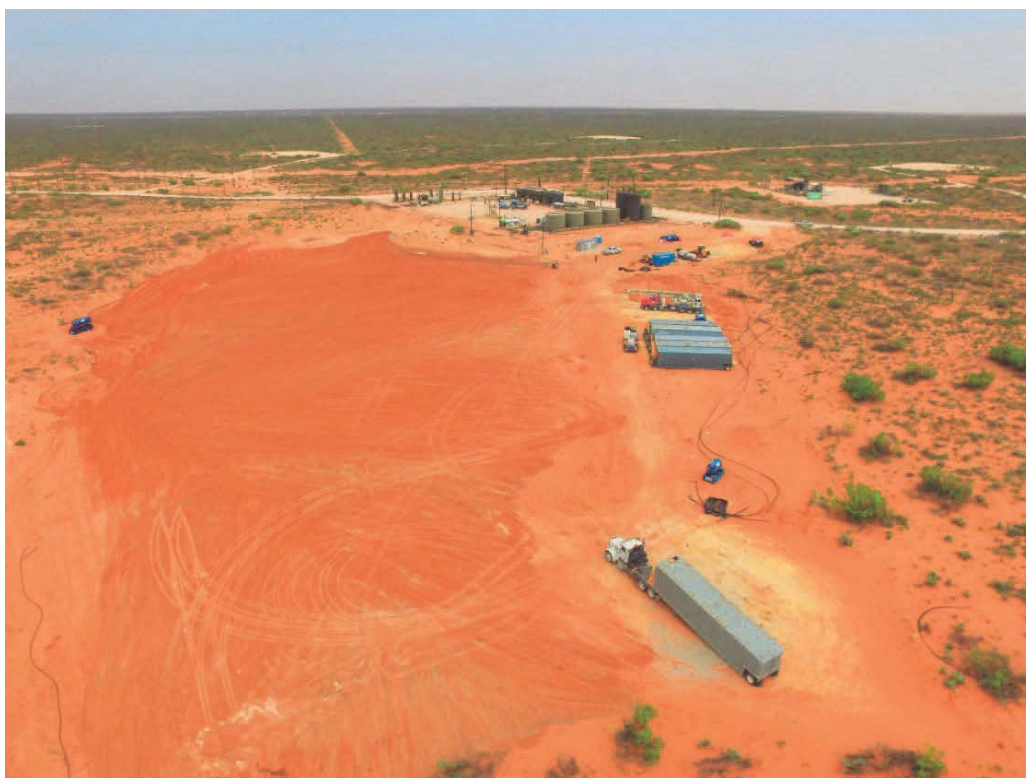
June 25<sup>th</sup>, 2018 – Post-remediation

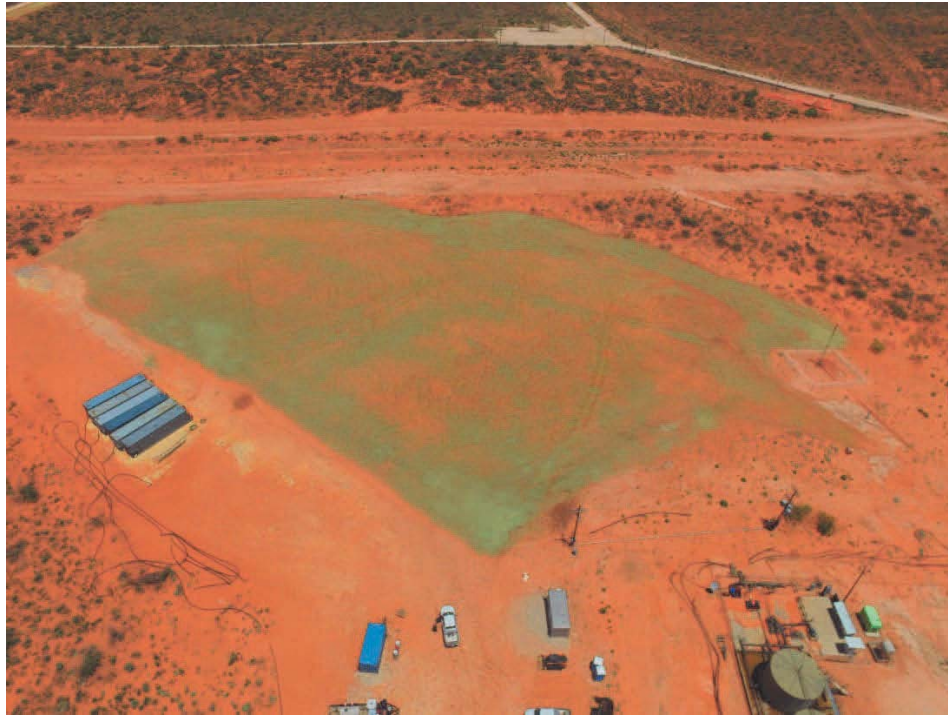
June 26<sup>th</sup>, 2018 – Post-hydroseeding

The area was contoured to the surrounding surface landscape and hydroseeded with BLM #2 seed mix as directed by the New Mexico Bureau of Land Management (“BLM”).

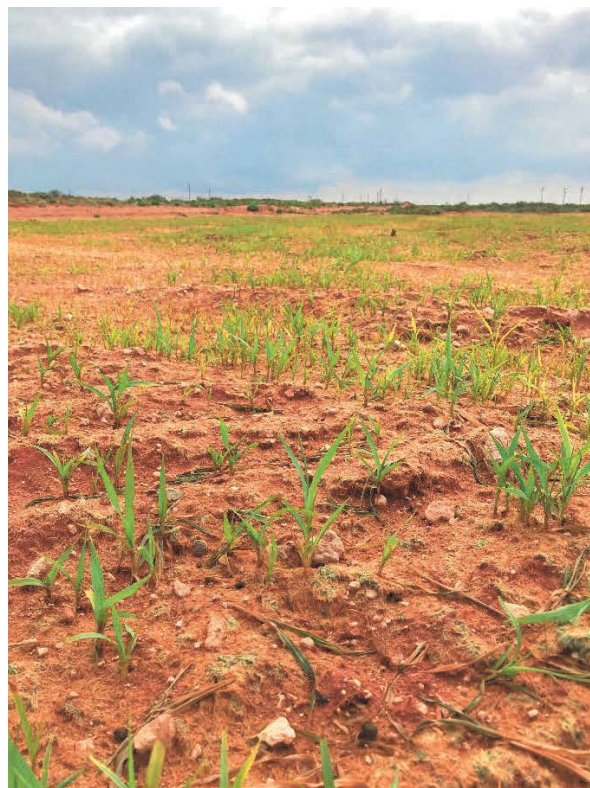
July 31<sup>st</sup>, 2018 – Growth present
