Re: Work Plan  
Ghostrider 25/36 WODM Fed Com #2H  
NMOCD Reference #: 2RP-4781

RXSoil, Inc. is pleased to submit the work plan summarizing the on-site remediation of produced water impacted soil at the Mewbourne Ghostrider 25/36 WODM Fed Com #2H site located in Eddy County, New Mexico. Remediation work plan follows in the attached report.

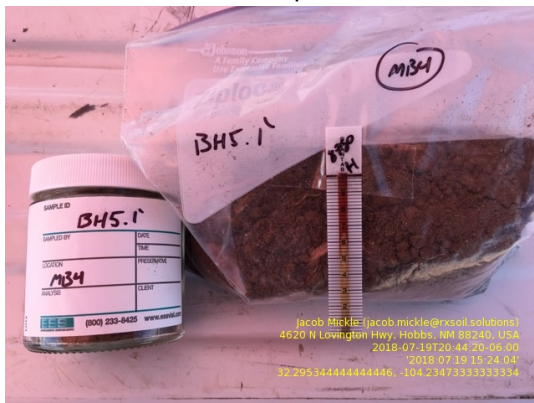
**Type of Field Test** Soil  
**Method of Testing** Chloride Strips  
**Method of Sample Collecting** Bore Hole BH  
**Name of Sample Point** BH5.1'  
**Depth (feet)** 1  
**Chloride Strip Reading** 6.1  
**Strip Type** High  
**Chloride Level (ppm)** 8780  
**Comments** 07/18  
 1700-1900

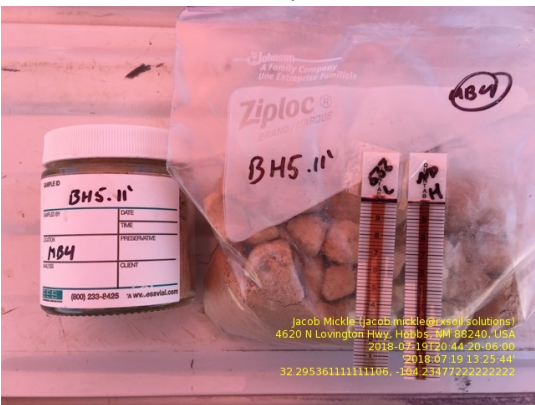
| Comments | REJECTION - COBBLE |

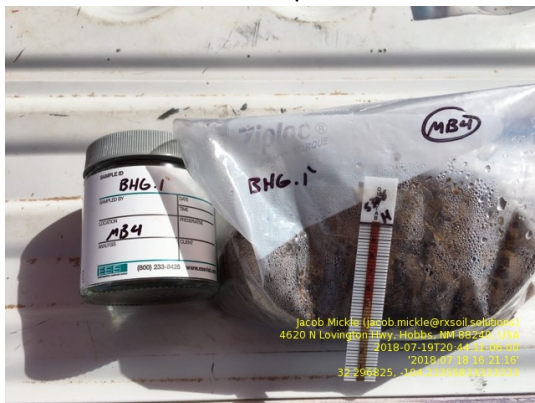
**Type of Field Test** Soil  
**Method of Testing** Chloride Strips  
**Method of Sample Collecting** Bore Hole BH  
**Name of Sample Point** BH6.1'  
**Depth (feet)** 1  
**Chloride Strip Reading** 5.4  
**Strip Type** High  
**Chloride Level (ppm)** 5368  
**Comments** 07/18  
 1330-1630

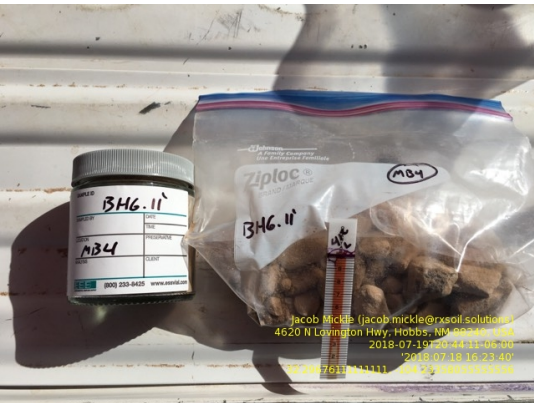
CommentsREJECTION - COBBLE

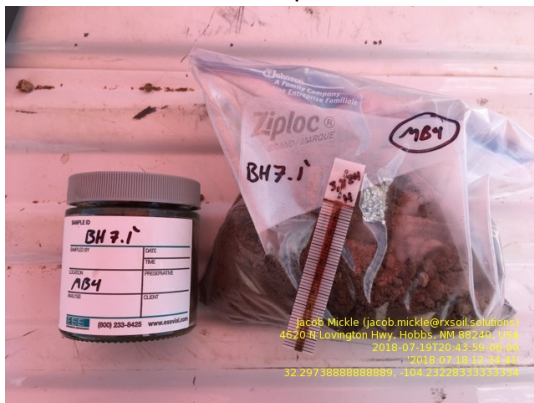
**Type of Field Test** Soil  
**Method of Testing** Chloride Strips  
**Method of Sample Collecting** Bore Hole BH  
**Name of Sample Point** BH7.1'  
**Depth (feet)** 1  
**Chloride Strip Reading** 4.6  
**Strip Type** High  
**Chloride Level (ppm)** 3824  
**Comments** 07/18  
 1120-1300

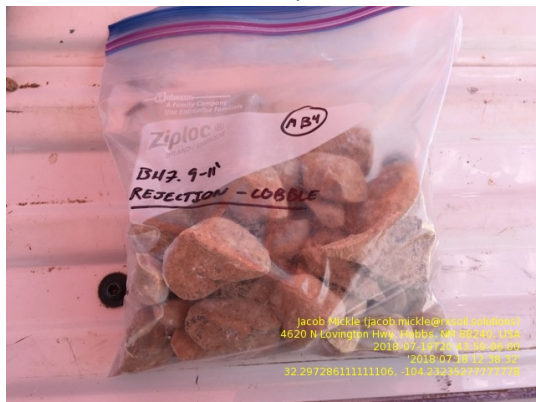
| Comments | REJECTION - COBBLE BROKE 2ND SPOON CAP |

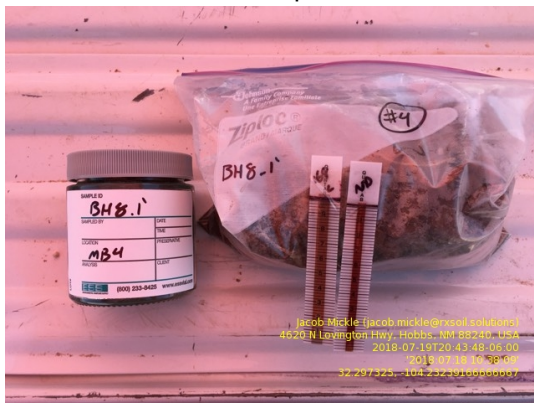
**Type of Field Test** Soil  
**Method of Testing** Chloride Strips  
**Method of Sample Collecting** Bore Hole BH  
**Name of Sample Point** BH8.1'  
**Depth (feet)** 1  
**Chloride Strip Reading** 2.0  
**Strip Type** Low  
**Chloride Level (ppm)** 168  
**Comments** 07/18  
 0900-1100

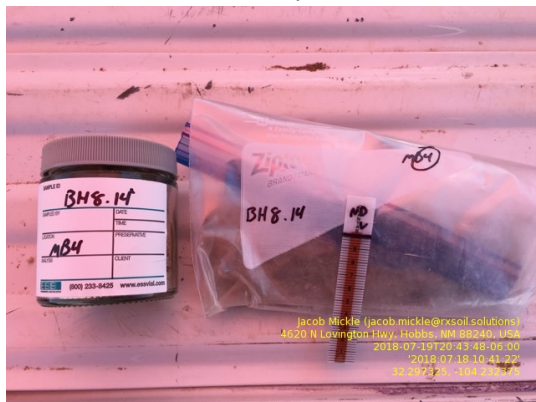
| Comments | REJECTION - Broke tooling at 14'. Stopped drilling. |
