**EOG Resources, Inc.**  
Artesia Division Office  
104 S. 4<sup>th</sup> Street  
Artesia, N. M. 88210

Re: Jackson B #57  
30-015-41003  
L-1-17S-30E  
Eddy County, NM  
2RP-5149

EOG Y Resources, Inc. is submitting the enclosed remediation work plan for the above referenced site. The plan is being submitted in reference to the C-141 report dated on December 13, 2018.

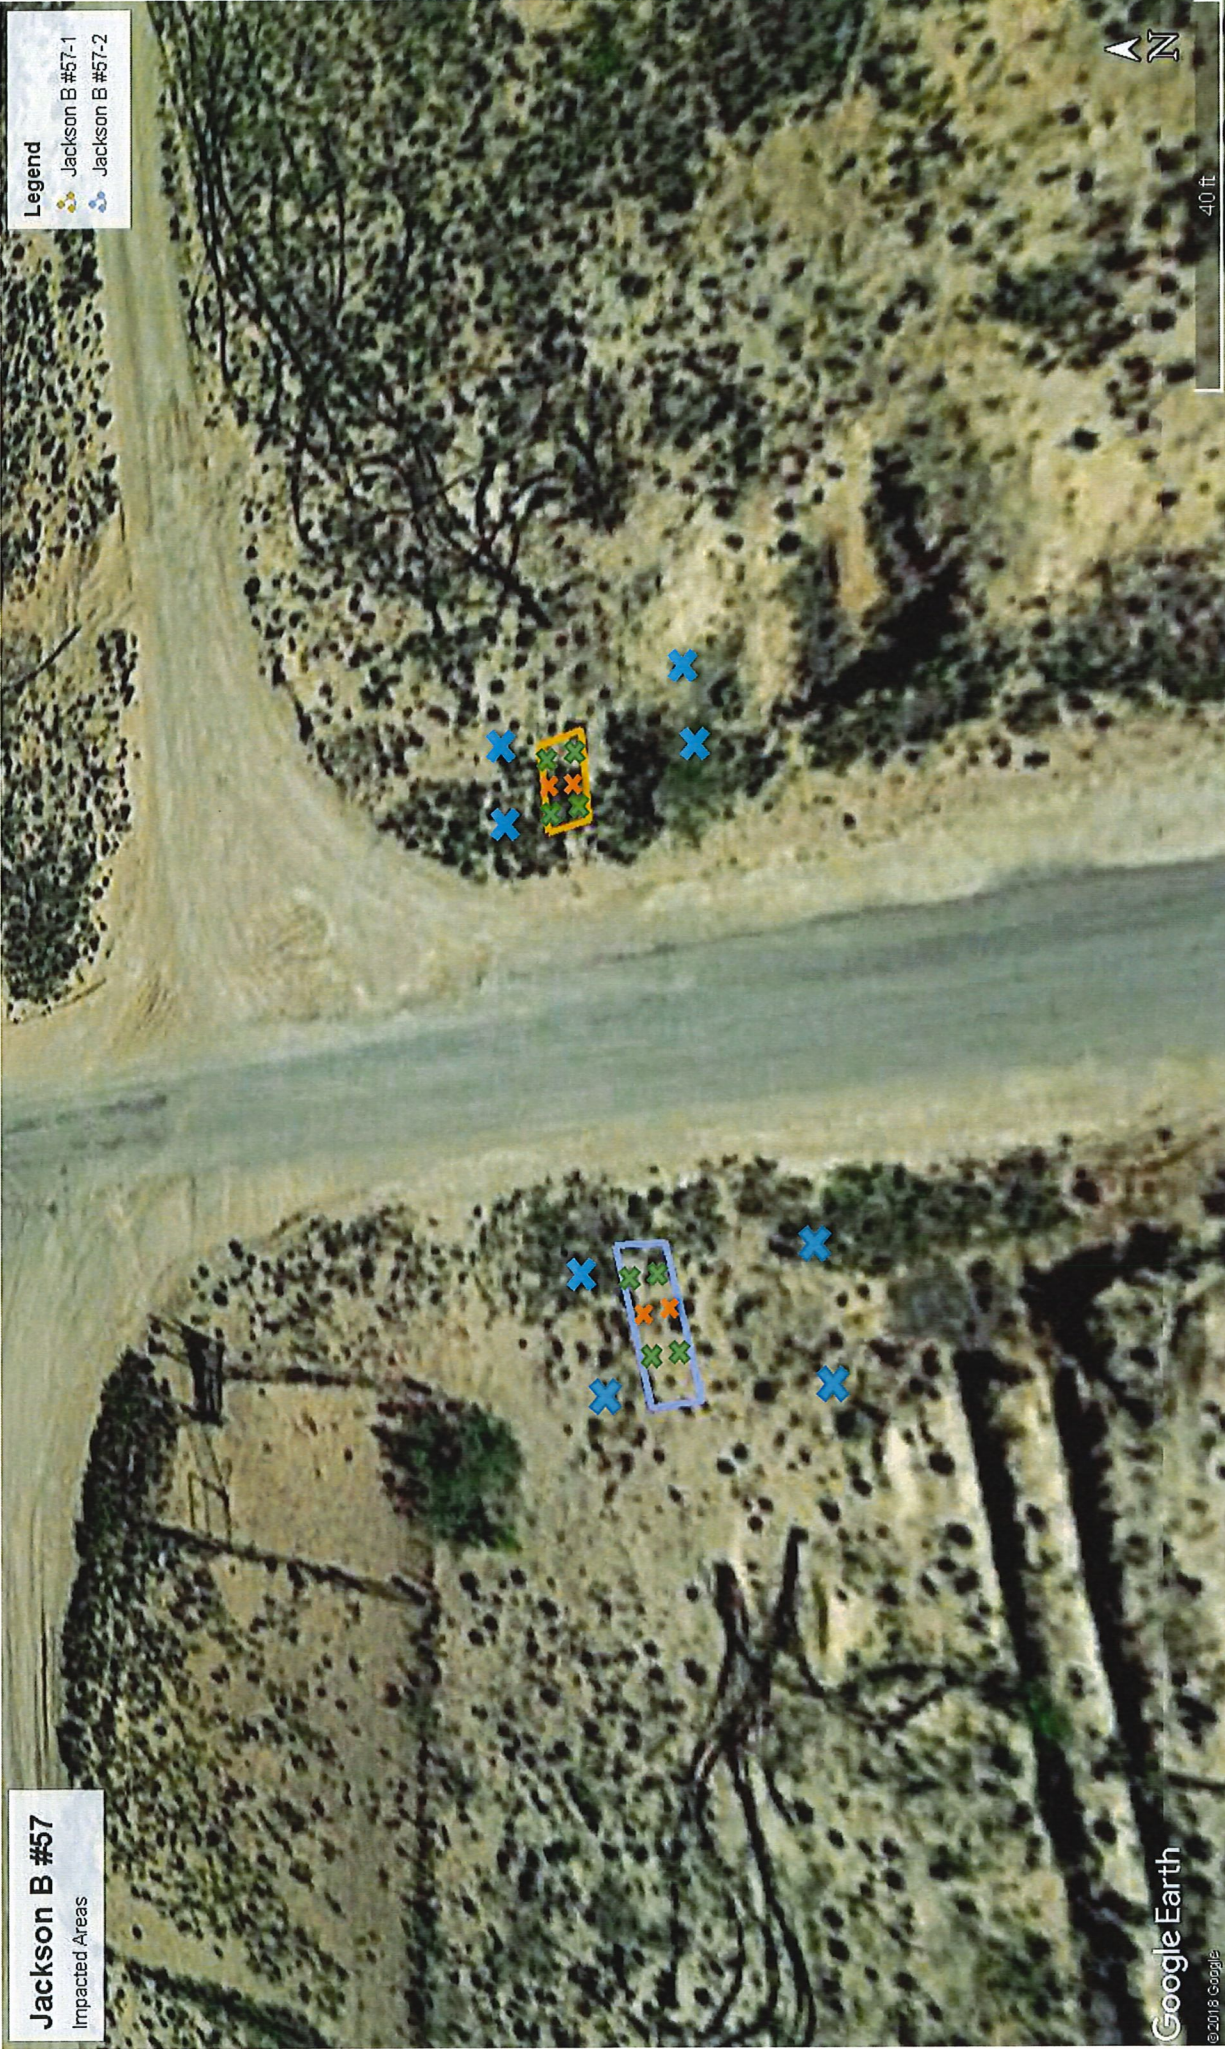
# Figure 1

## Site Map with Sample and Treatment Points

✕ -Represents an initial soil testing bore hole and soil treatment bore hole

✕ -Represents a confirmation soil testing bore hole

✕ -Represents a horizontal soil testing bore hole and possible treatment bore hole (note: these will be placed as close to lines as SAFELY possible)

Due to the presence of active flow lines, the asphalt county road, and the area consisting of sand soils, we are unable to sample any further vertically at this time. In order to fully delineate the sites, EOG Resources, Inc. proposes to install a Geosynthetic Clay Liner (GCL) under the flow lines and road sleeve that are already excavated at six (6) feet bgs. This would prevent any further vertical movement of contaminants and address the chloride issues identified in the #2 excavation area. Then the two excavated areas (#1 and #2) would be backfilled with caliche to grade in order to create a flat, stable surface with the ability to support an Air Rotary Core Rig. With the flow line positions clearly marked from previously being excavated, EOG will be able to safely complete vertical and horizontal delineation of the release areas. Once the bottom of the contamination has been determined, slotted PVC pipe (three inch if possible) will be installed into the bore holes, and these will serve to gravity flow a microbial bioremediation product (Liquid Remediact) into the impacted areas to perform in situ remediation. Approximately one (1) gallon of the mixed product will be used for every three feet of PVC pipe installed. The bioremediation product will be administered for five (5) consecutive days during each treatment cycle, with treatment cycles to occur every thirty (30) days for the anticipated 90-day remediation project. The initial design will have a minimum of four (4) treatment holes at each excavation site (#1 and #2), two (2) treatment holes on either side (north and south) of the road sleeve and flow lines (Figure 2). Treatment bore holes will be spaced enough that at the completion of the treatment process a confirmation bore hole can be completed between the two bore holes on each side of the sleeve used to apply the bioremediation product. Confirmation samples will be collected from each bore hole beginning at ten (10) feet bgs and to consist of sample collection every five (5) feet thereafter to a depth ten (10) feet past the known contamination depth. To identify horizontal extents, sample bore holes will be completed outside of the known impacted areas, with two bore holes to the north and two bore holes to the south at both the #1 and #2 excavation areas (Figure 1). Samples collected at these bore holes will begin a five (5) feet bgs, with sampling to occur every five (5) feet thereafter, and extend to the known uncontaminated depth of the bore holes completed in the excavation areas. Based on these analytical sample results, treatment area could be increased with more bore holes installed to meet the bioremediation needs of the site. Once the soils have completed bioremediation, EOG will use bentonite to plug the treatment and sample holes from eight (8) feet bgs to five (5) feet bgs. This will allow the GCL previously installed to bond to the plugs and create a seal to prevent any further chloride migration, but will also prevent any future releases that may occur from re-impacting this area.

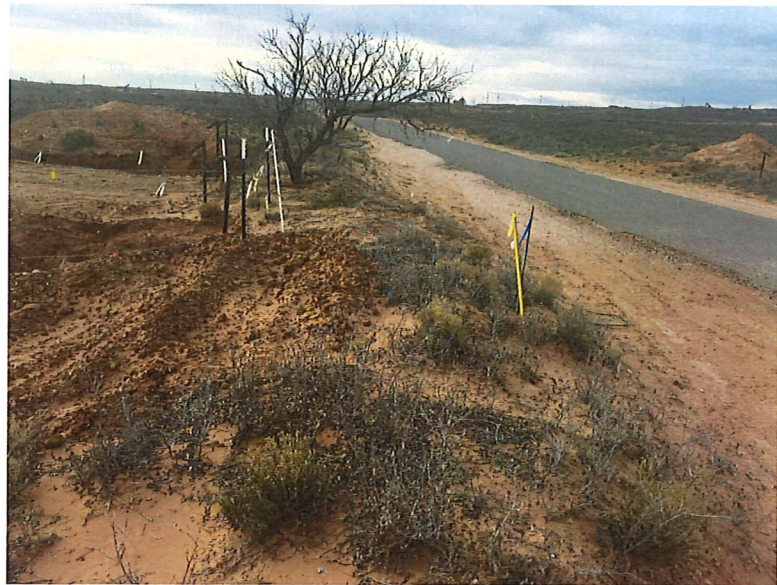
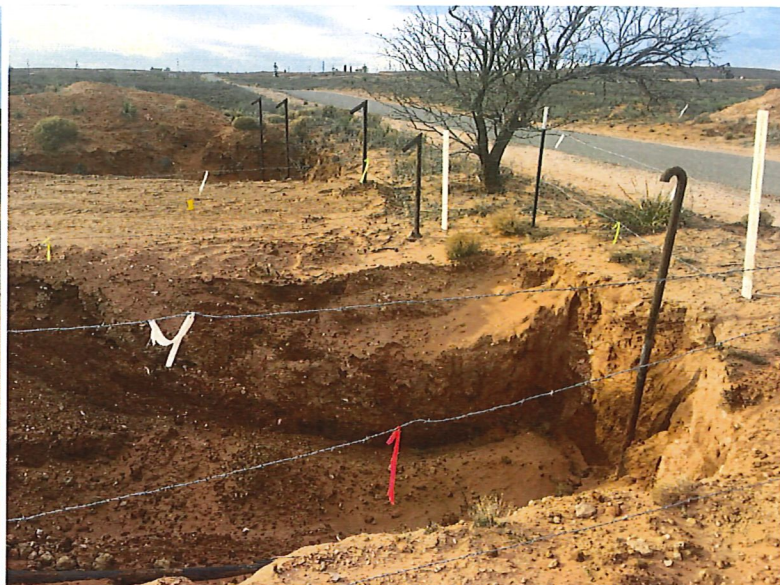
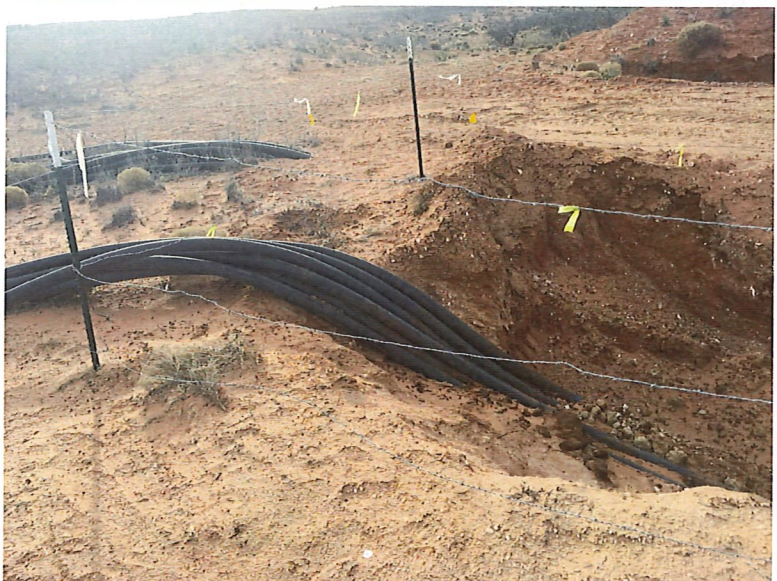
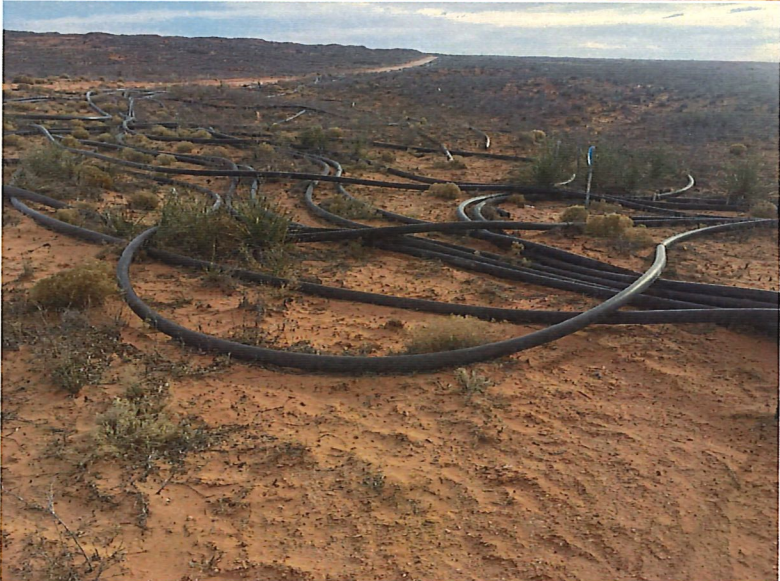
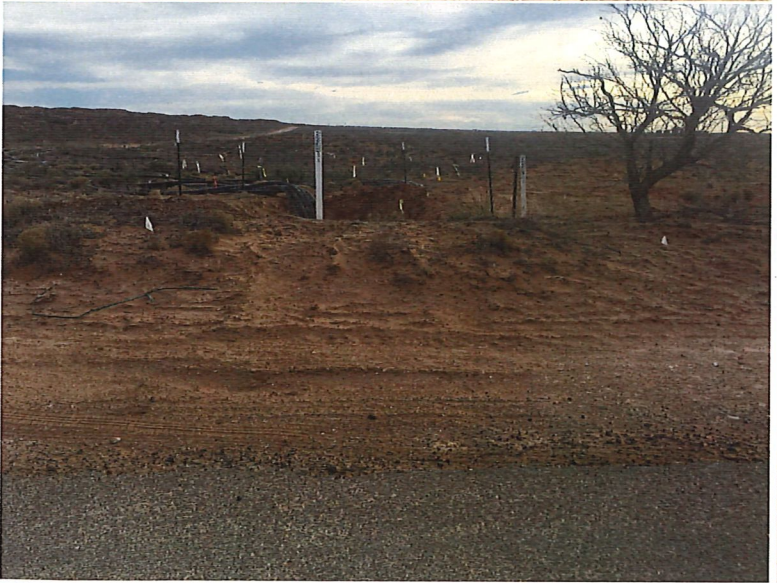
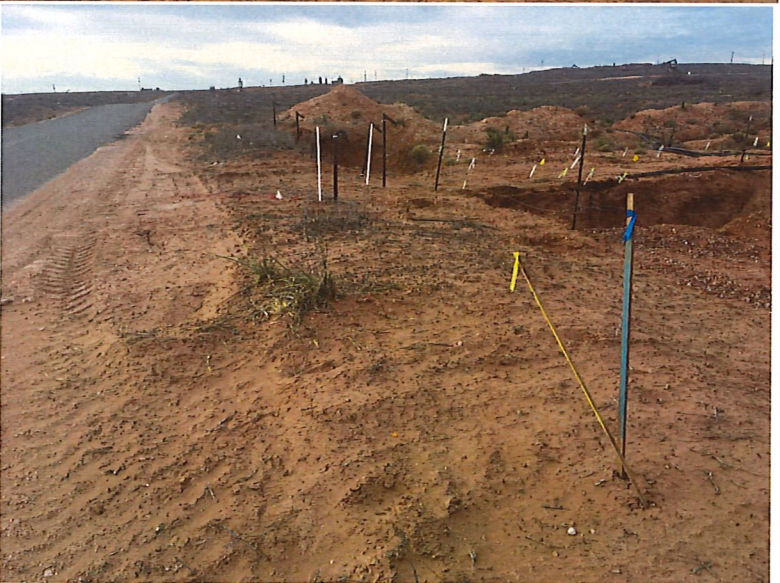
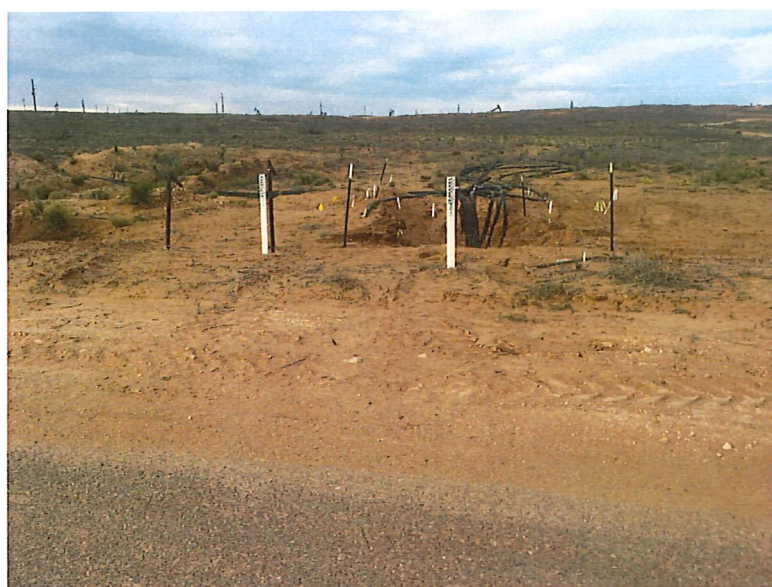
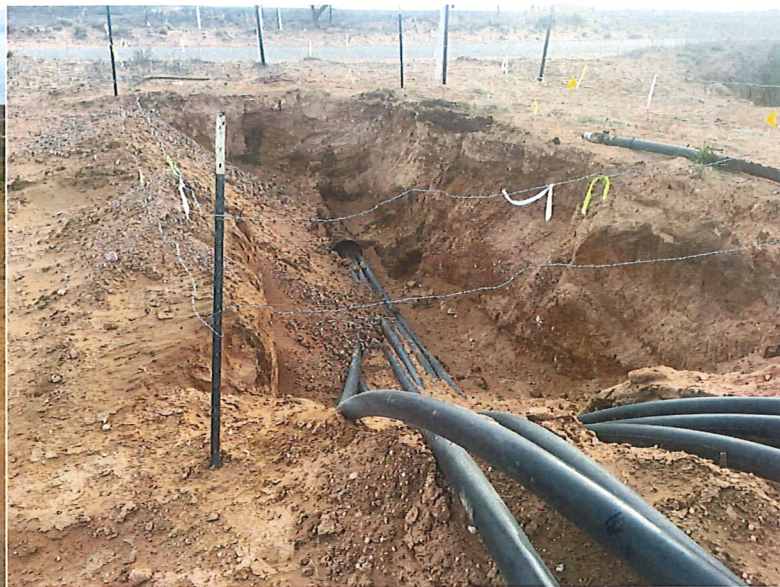
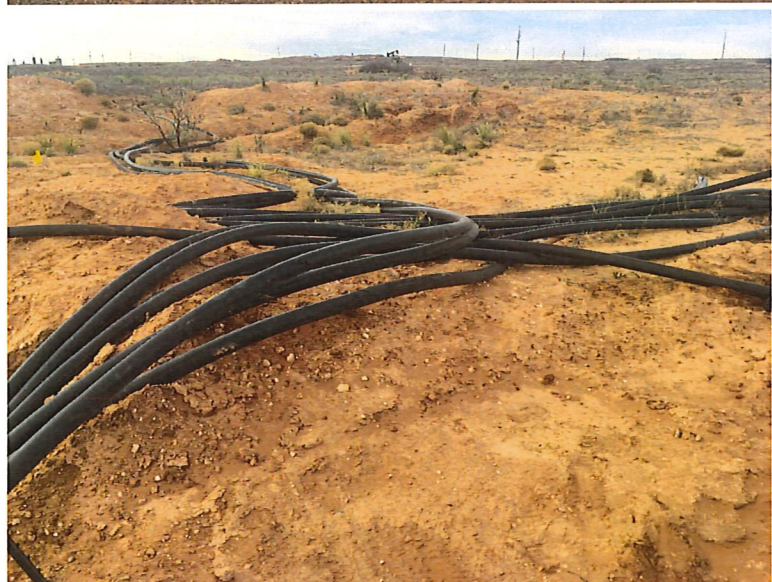
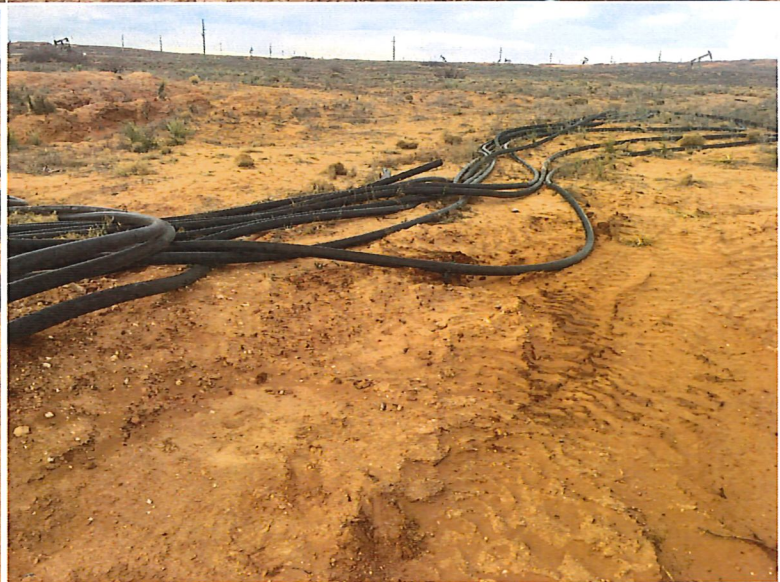
# Photos

A release was discovered on December 1, 2018, from the Jackson B #57 poly flow line that runs through a sleeve under Square Lake Road (CR 220) to the gathering facility. The release consisted of 2 B/CO and 6 B/PW with 2 B/CO and 5 B/PW recovered. A contractor was obtained to excavate soils that were impacted by the release. Approximately 67 cubic yards of soil were excavated, 22 cubic yards from the excavation named #1 on the east side of Square Lake Road and 45 cubic yards from the excavation named #2 on the west side of Square Lake Road, leaving both sites excavated to approximately six (6) feet below grade surface (bgs). All excavated soil was sent to a NMOCD approved disposal facility. The affected area in #1 is approximately ten (10) feet by ten (10) feet and in #2 is approximately twenty (20) feet by ten (10) feet. Initial vertical and horizontal soil sampling was conducted at the location with use of a backhoe on January 29, 2019.
