Closure Report

Re: Crow Federal Mega Battery
Case # 2RP-5032

Crow Federal Mega Battery Sample Data

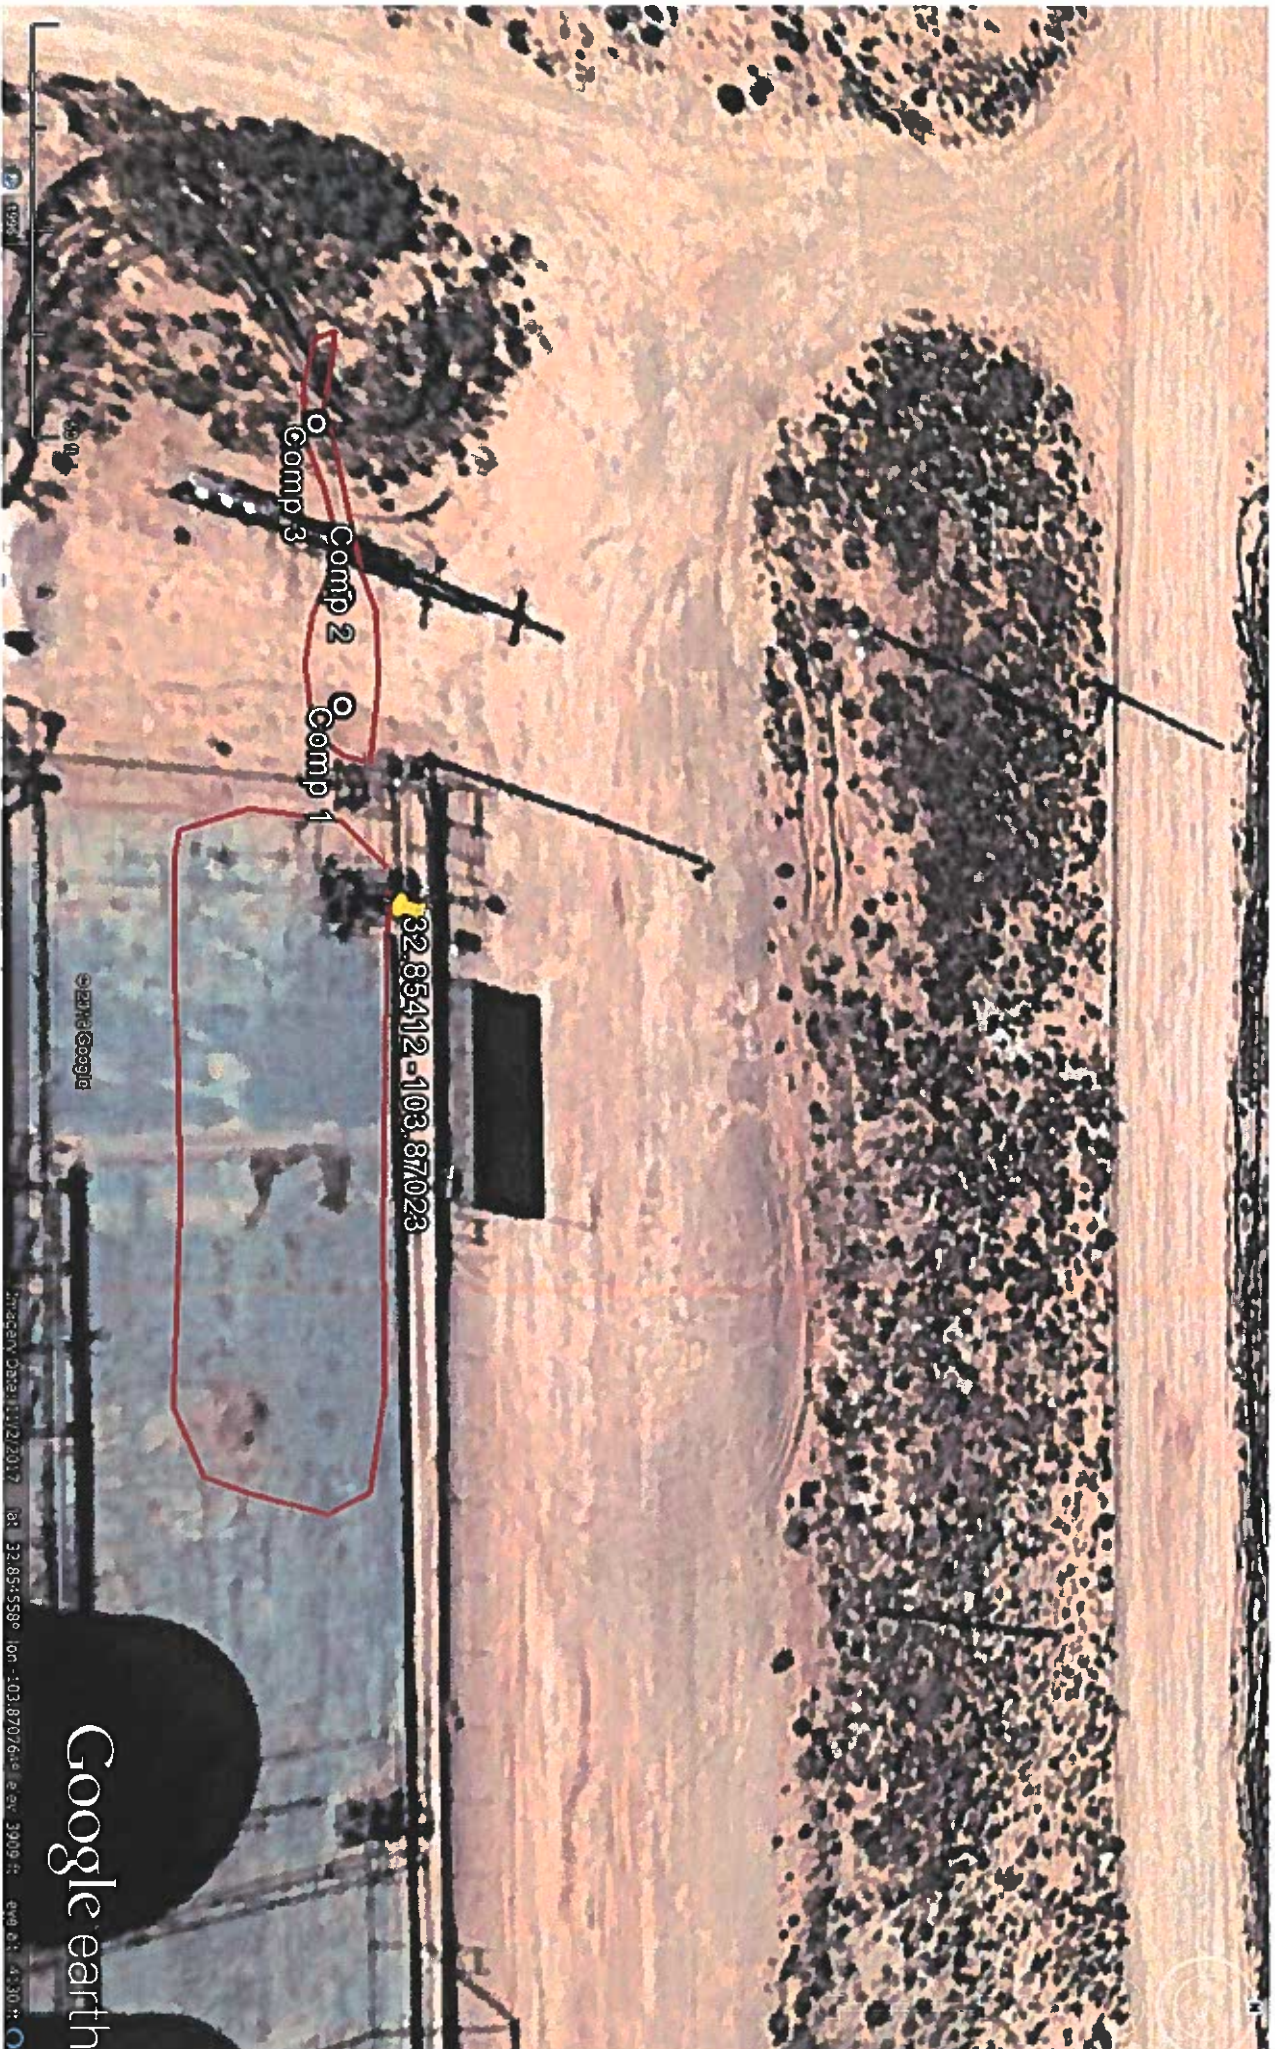
Comp 3

Comp 2

Comp 1

32.85412-103.87023

Sample Pt.	Chloride	Benzene	Toluene	Ethylbenzene	Total Xylenes	Total BTEX	GRO	DRO	EXT DRO
COM 1	32	<0.050	<0.050	<0.050	<0.150	<0.300	<10.0	30.1	<10.0
COM 2	16	<0.050	<0.050	0.315	0.898	1.21	25.5	375	61.6
COMP 3 @ 6"	32	<0.050	<0.050	0.292	0.748	1.04	20.9	255	21
E Wall	16	<0.050	<0.050	<0.050	<0.150	<0.300	<10.0	121	27
N Wall	32	<0.050	<0.050	<0.050	<0.150	<0.300	<10.0	<10.0	<10.0
S Wall	32	<0.050	<0.050	<0.050	<0.150	<0.300	<10.0	<10.0	<10.0
W Wall	32	<0.050	<0.050	<0.050	<0.150	<0.300	<10.0	<10.0	<10.0

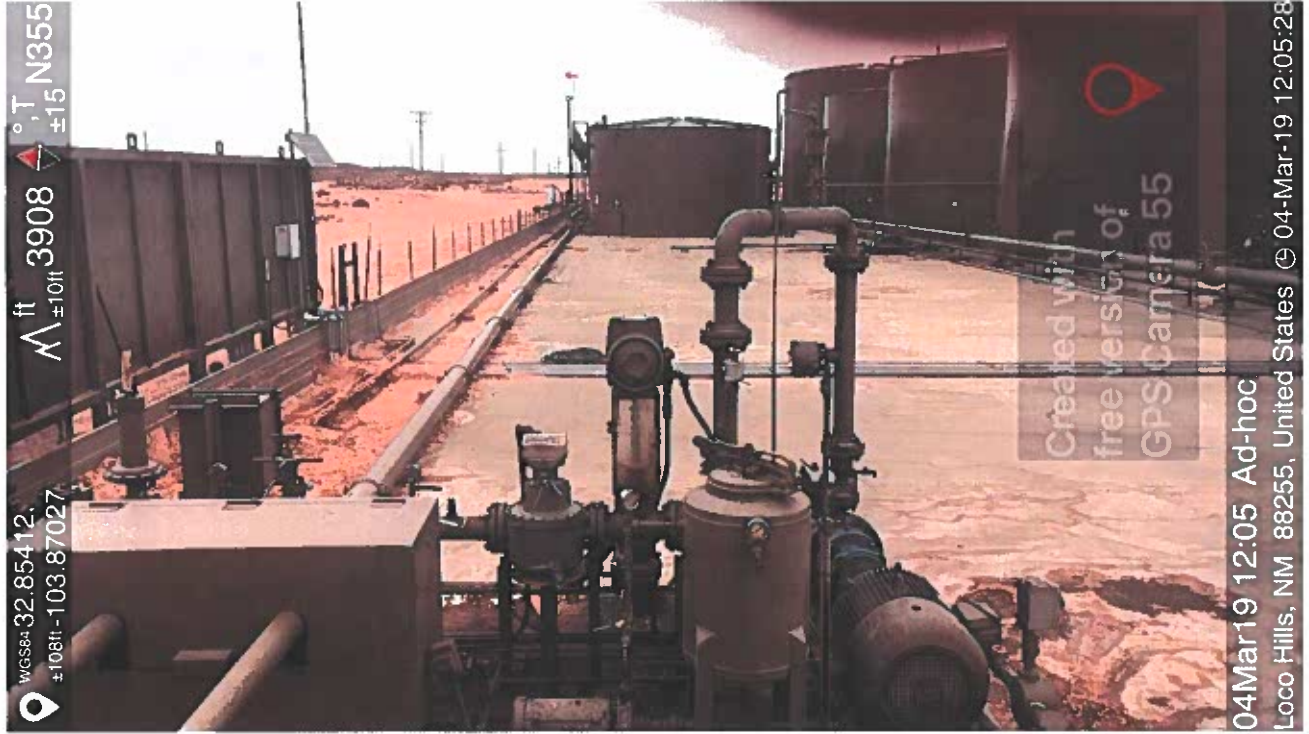
Photo of Liner

The majority of the release was contained inside a lined facility except for approximately a barrel of fluid was sprayed outside the liner to the west. The standing fluid inside the lined containment was picked up with a vacuum truck. The stained area outside the containment area was hand shoveled down to 6 inches below surface. Once the hand excavation was complete bottom five point composite samples were collect not to exceed 200 square feet. Five point composite samples were collected on the north and south walls and grab samples were collected on the east and west walls. All samples collected were submitted to a commercial laboratory for analysis of chloride, TPH, and BTEX. All the laboratory results were below table 1 standards for releases that occur with depth to groundwater greater than 100 feet. The excavated material 12 yards was disposed of at an NMOCD approved facility.

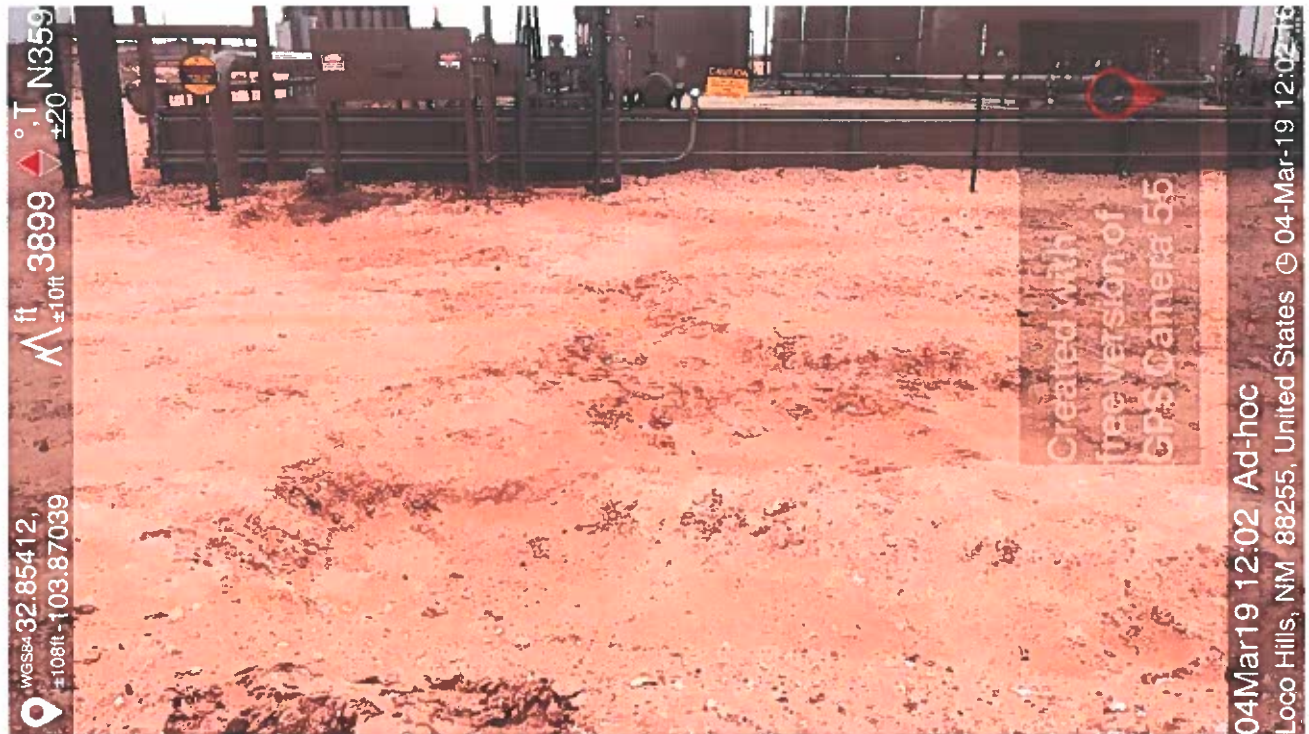
Photo of excavation

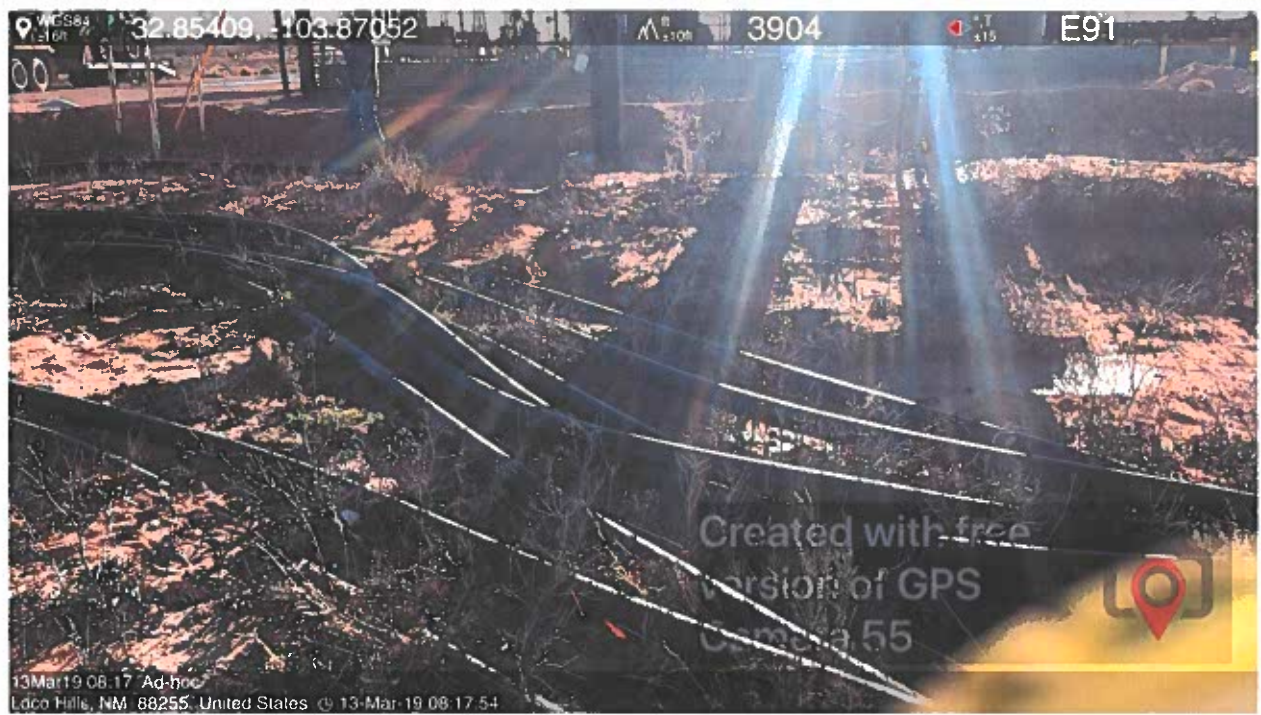
Photo of excavation
