April 23, 2019

**RE: Closure Request  
Hasta La Vista 1 DI Federal Battery  
Remediation Permit Number 2RP-5231  
Eddy County, New Mexico**

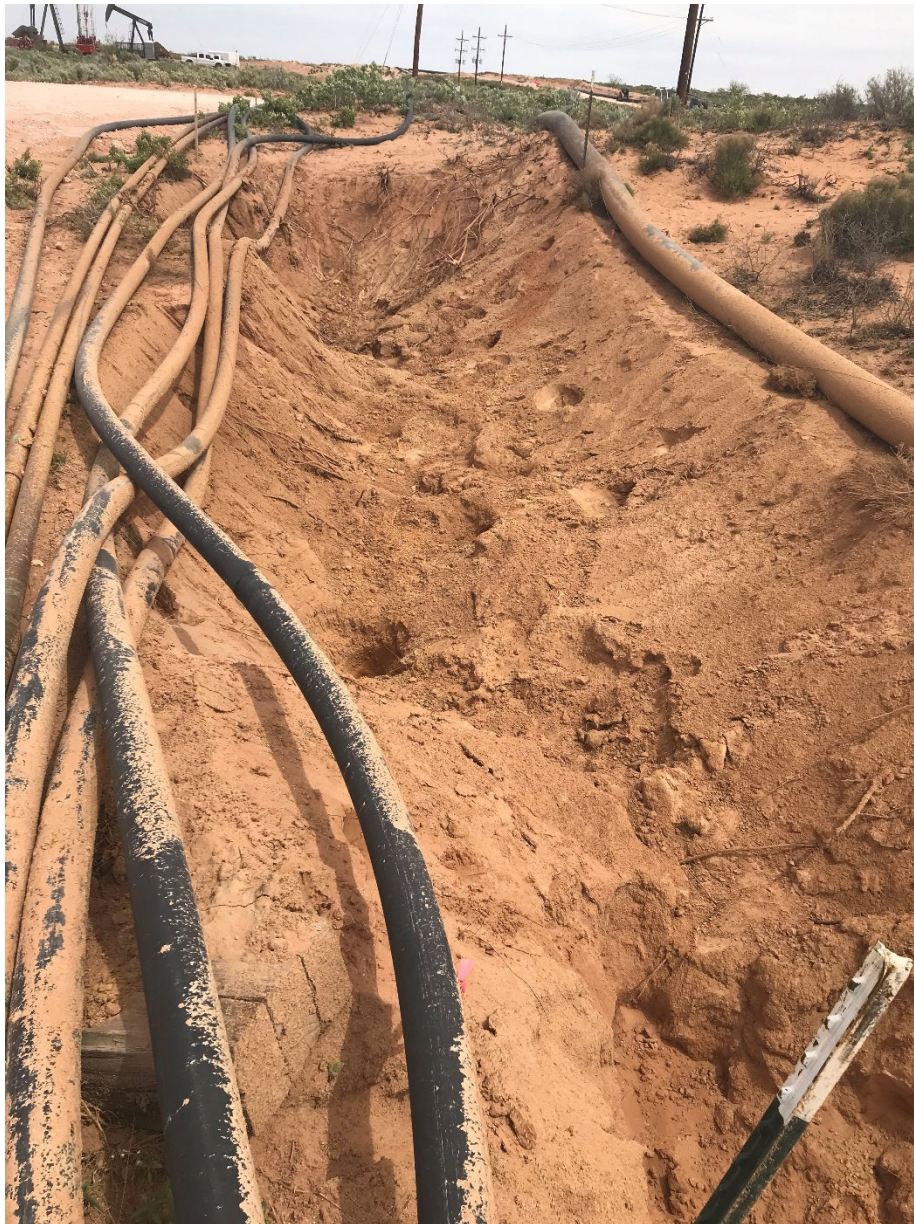
**View facing east of the excavation area (2RP-5231).**

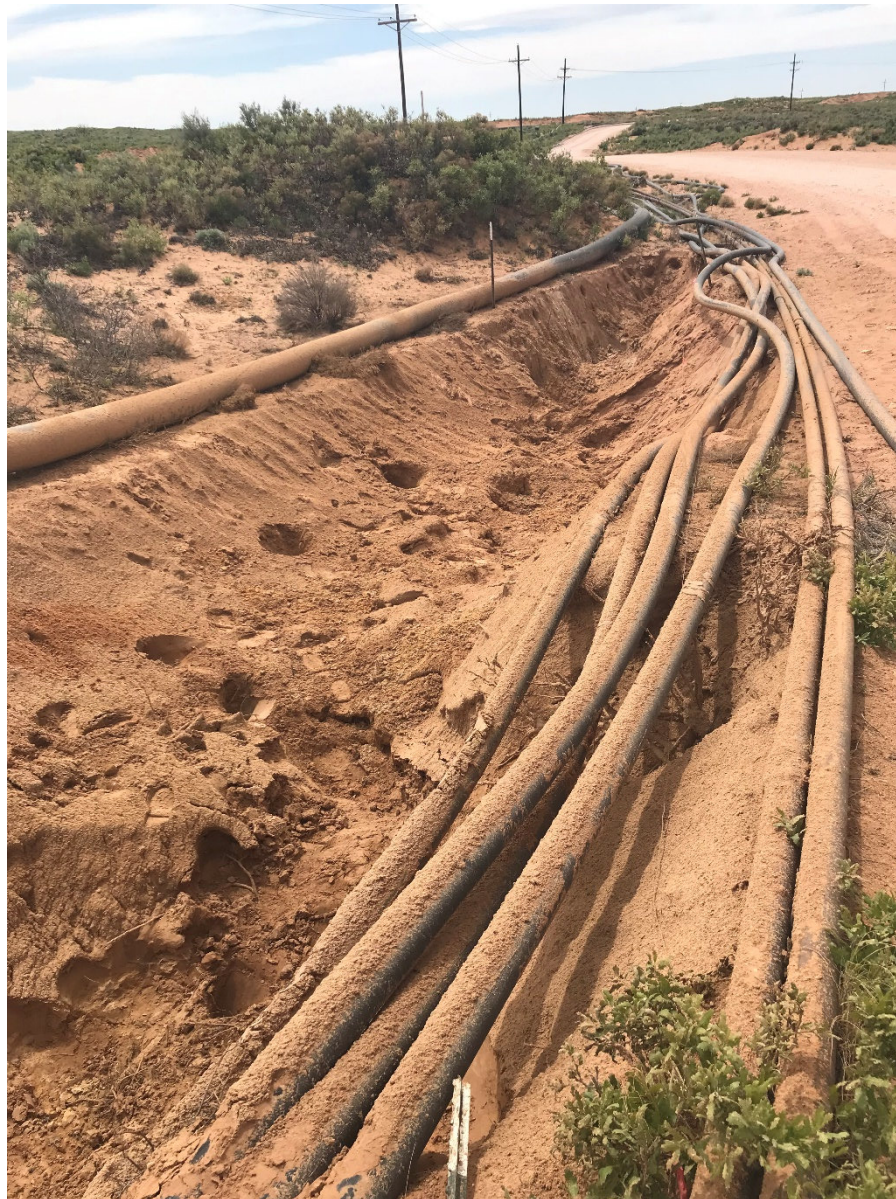
**View facing west of the excavation area (2RP-5231).**
