State of New Mexico  
Energy Minerals and Natural  
Resources DepartmentOil Conservation Division  
1220 South St. Francis Dr.  
Santa Fe, NM 87505Form C-141  
Revised August 24, 2018  
Submit to appropriate OCD District office

**Release Notification****5URIB-190808-C-1410****Responsible Party**

| Site Name Big Eddy Unit DI#4 (at COG Birdseye 32 St 1H) | Site Type Multiple Production Well Facility |

On April 22, 2019, a poly flow line was damaged by vehicles passing over it, which resulted in the release of 8.2 barrels (bbls) of produced water. The release affected the Site access road and the ROW on the west and east side of the access road. The flow line was clamped and repaired; no fluid was recovered. XTO reported the release to the New Mexico Oil Conservation Division (NMOCD) on a Release Notification and Corrective Action Form C-141 (Form C-141) on May 2, 2019, and was subsequently assigned Remediation Permit (RP) Number 2RP-5423 (Attachment 1).

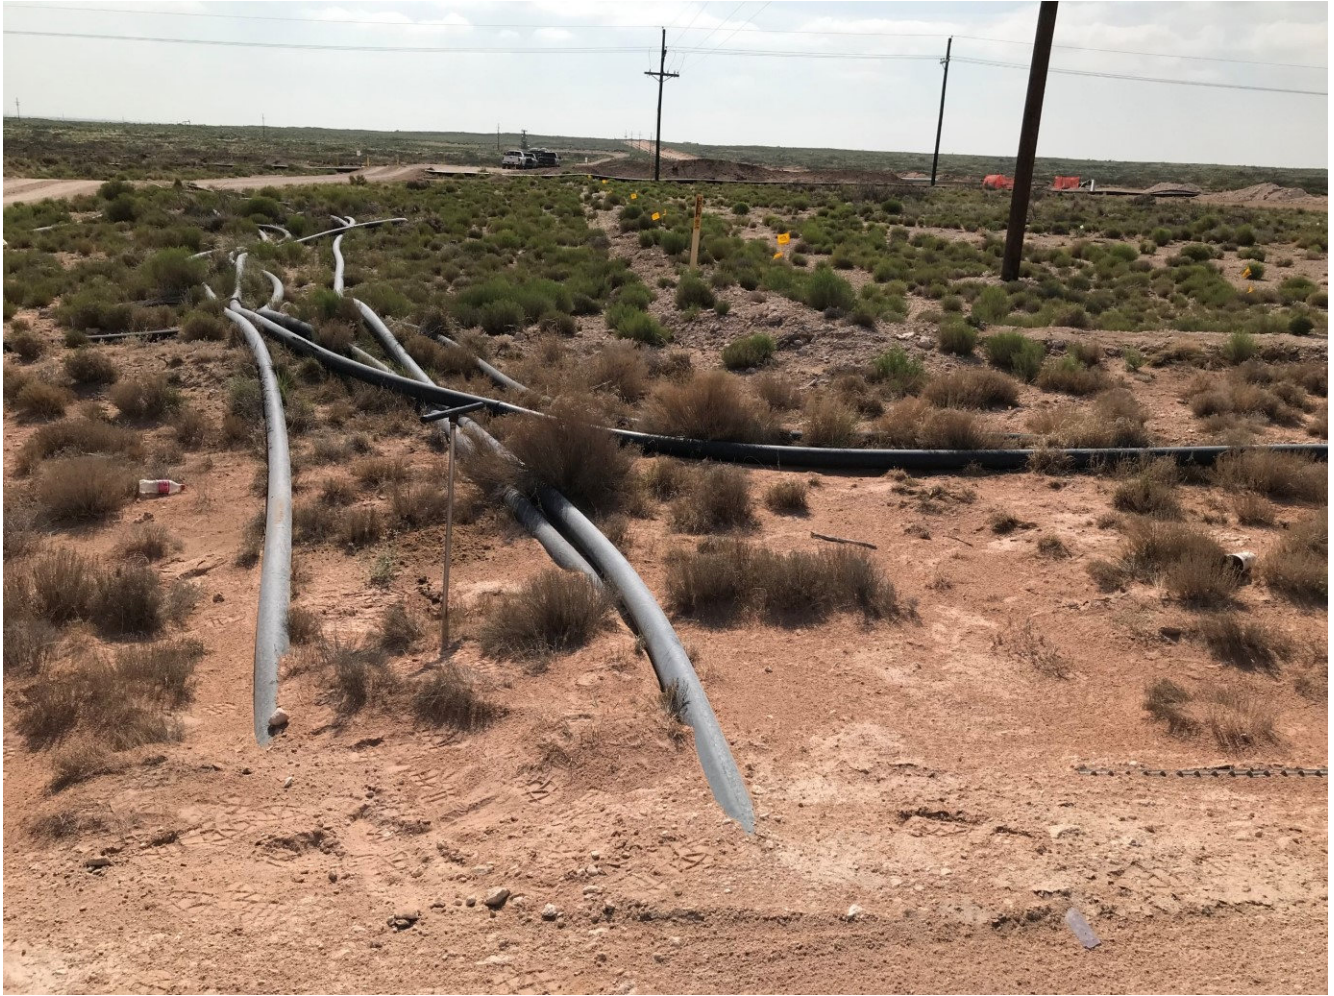
**Eastern view of point of release identified on flow line during site assessment.**

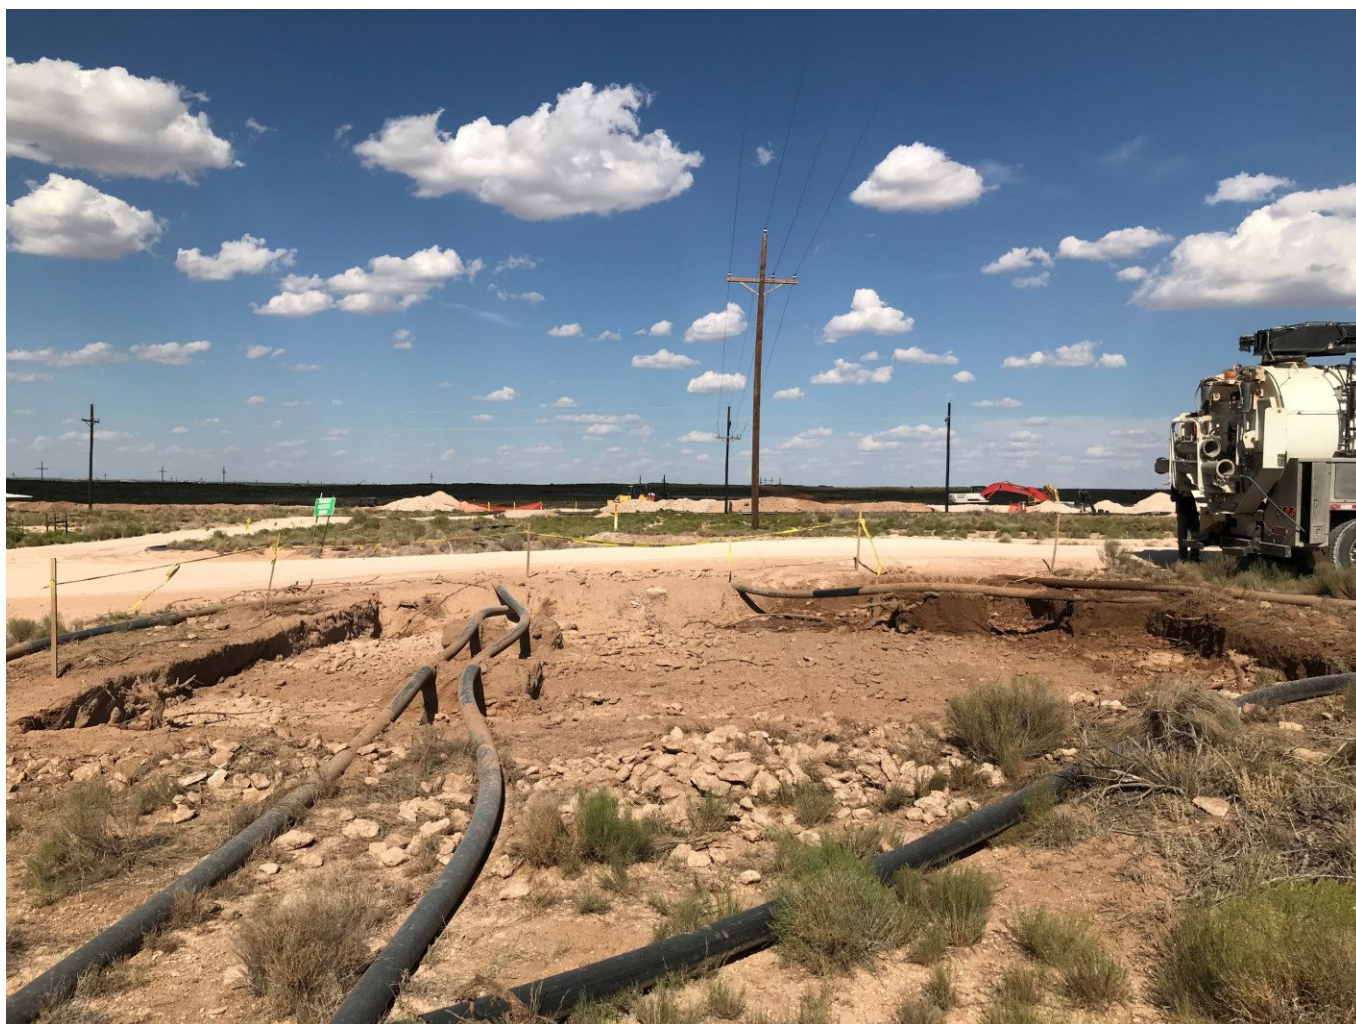
**Eastern view of final excavation extent to the west of the lease road.**

Initial response efforts and excavation of chloride-containing soil have mitigated adverse effects at this Site. XTO requests no further action for RP Number 2RP-5423. Upon approval of this closure request, XTO will backfill the excavation with material purchased locally and recontour the Site to match pre-existing site conditions. An updated NMOCD Form C-141 is included as Attachment 1.
