Re: Mimosa Federal SWD #3Y  
30-015-29123  
P-4-20S-24E  
Eddy County, NM  
2RP-5426

**Mimosa Federal SWD #3Y**

**Closure Report**

**September 24, 2019**

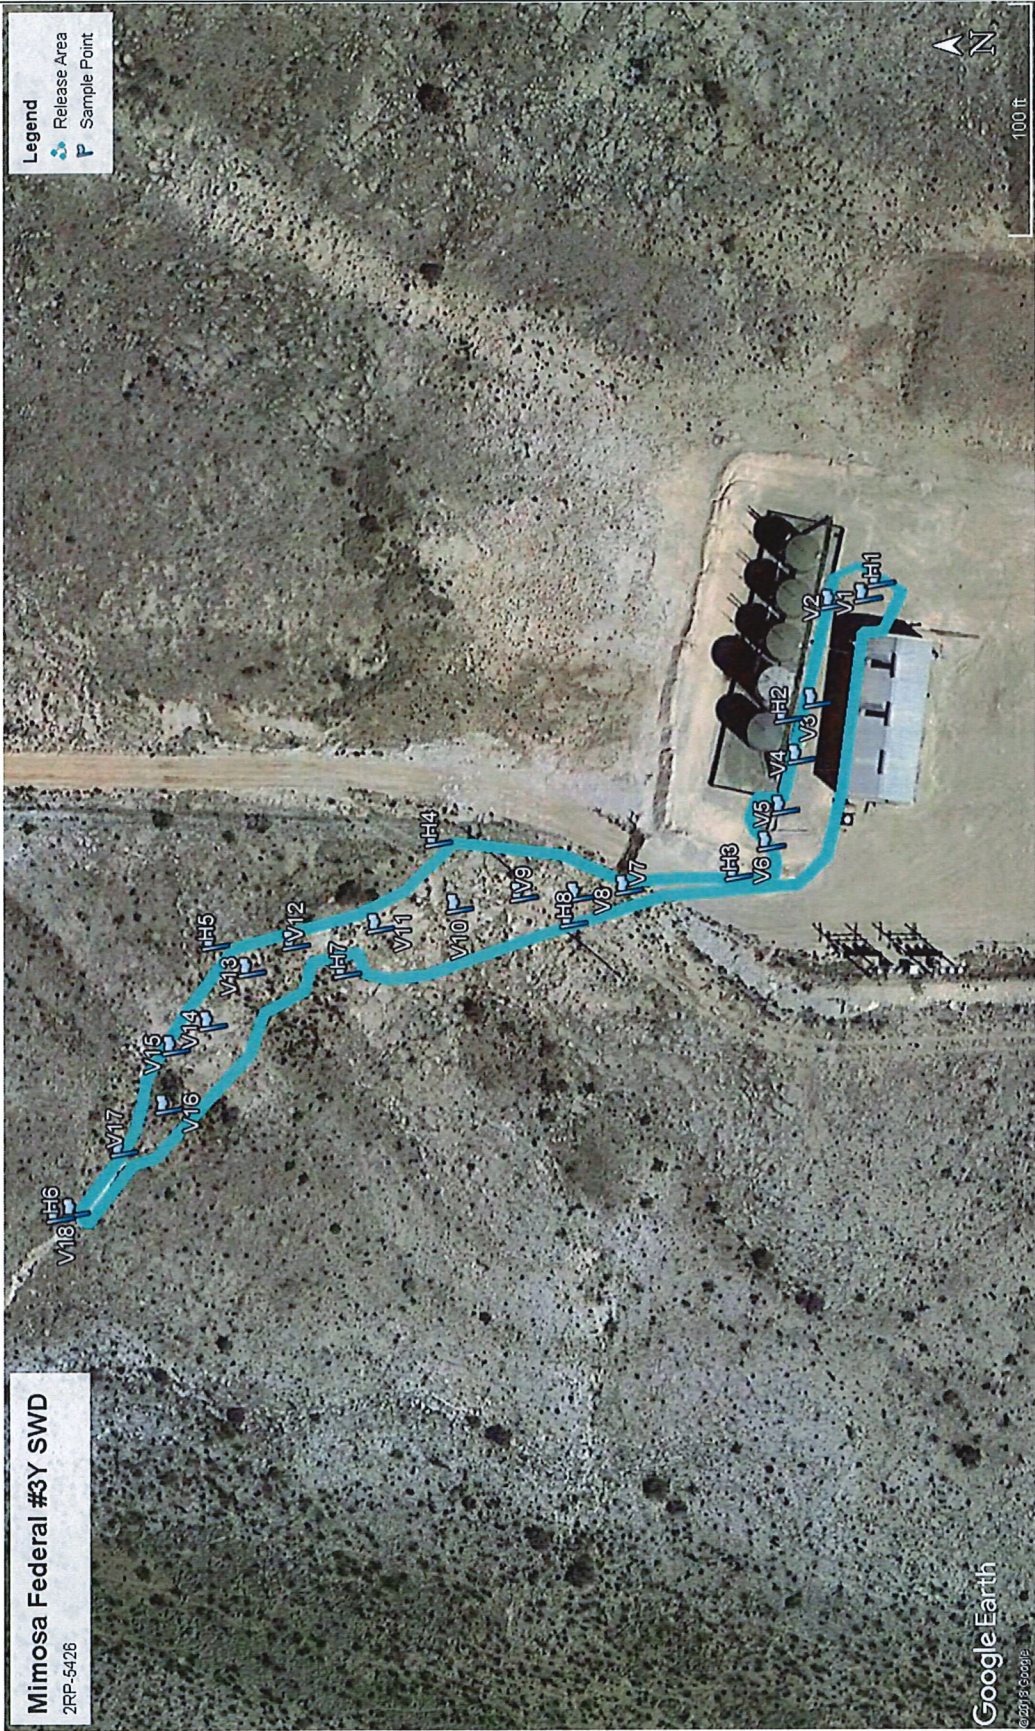
# Figure 1

## Site Map with Sample Points

After the initial sample results were received, EOG Resources, Inc. furthered the excavation depth in all areas except V6, V13, V14, V15, V16, and V17. Confirmation samples taken on May 30, 2019, after notification was provided to NMOCD and BLM on May 28, showed that the V1, V2, V5, V11, V12, and V18 areas had been excavated to depths which the soil impacts were below Table 1 requirements (6/10/19 enclosed). Further excavation was then conducted in the V4, V7, V8, V9, and V10 areas with confirmation sampling occurring on July 18, 2019, after notification was provided to NMOCD and BLM on July 16, 2019. Horizontal extents were also sampled on this date for the initial results (7/22/19 enclosed). Results of the sampling activity showed that further excavation was still needed in all vertical areas (V4, V8, V9, & V10), however, the horizontal areas H4-H8 showed to be below Table 1 standards and also to meet the reclamation requirements of 19.15.29.13. The excavation was enhanced horizontally in the H1, H2, and H3 areas and vertically in the V4, V8, V9, and V10 areas. The H1, H2, and H3 areas were extended out an additional six (6) inches to one (1) foot, with the V4 area excavated to a depth of three (3) feet, and the V8-V10 areas excavated to four (4) feet bgs. An initial sampling notification was sent to NMOCD and BLM on August 5, 2019, but had to be resent on August 8, 2019, after the desired excavation depth was not reached due to the extremely hard rock that was encountered in the four vertical sample areas. Once excavation was complete, sampling occurred on August 14, 2019, with results (8/15/19 enclosed) confirming that all vertical areas had been excavated to depths which remaining soil was under Table 1 standards, and also met the reclamation guidelines for 19.15.29.13. Horizontal samples indicated further boundary expansion was still required for the H1-H3 areas, so the extents of the excavation were increased to two (2) to three (3) feet from the initial excavation boundary. On August 20, 2019, notification was submitted to NMOCD and BLM for sampling that would be conducted on August 22, 2019. Those results (8/26/19) confirmed that the remaining horizontal samples were under Table 1 standards and below the reclamation standards required in 19.15.29.13. All horizontal samples were collected by way of 5-point composite samples, with each composite sample representing less than 200 square feet of sidewall.

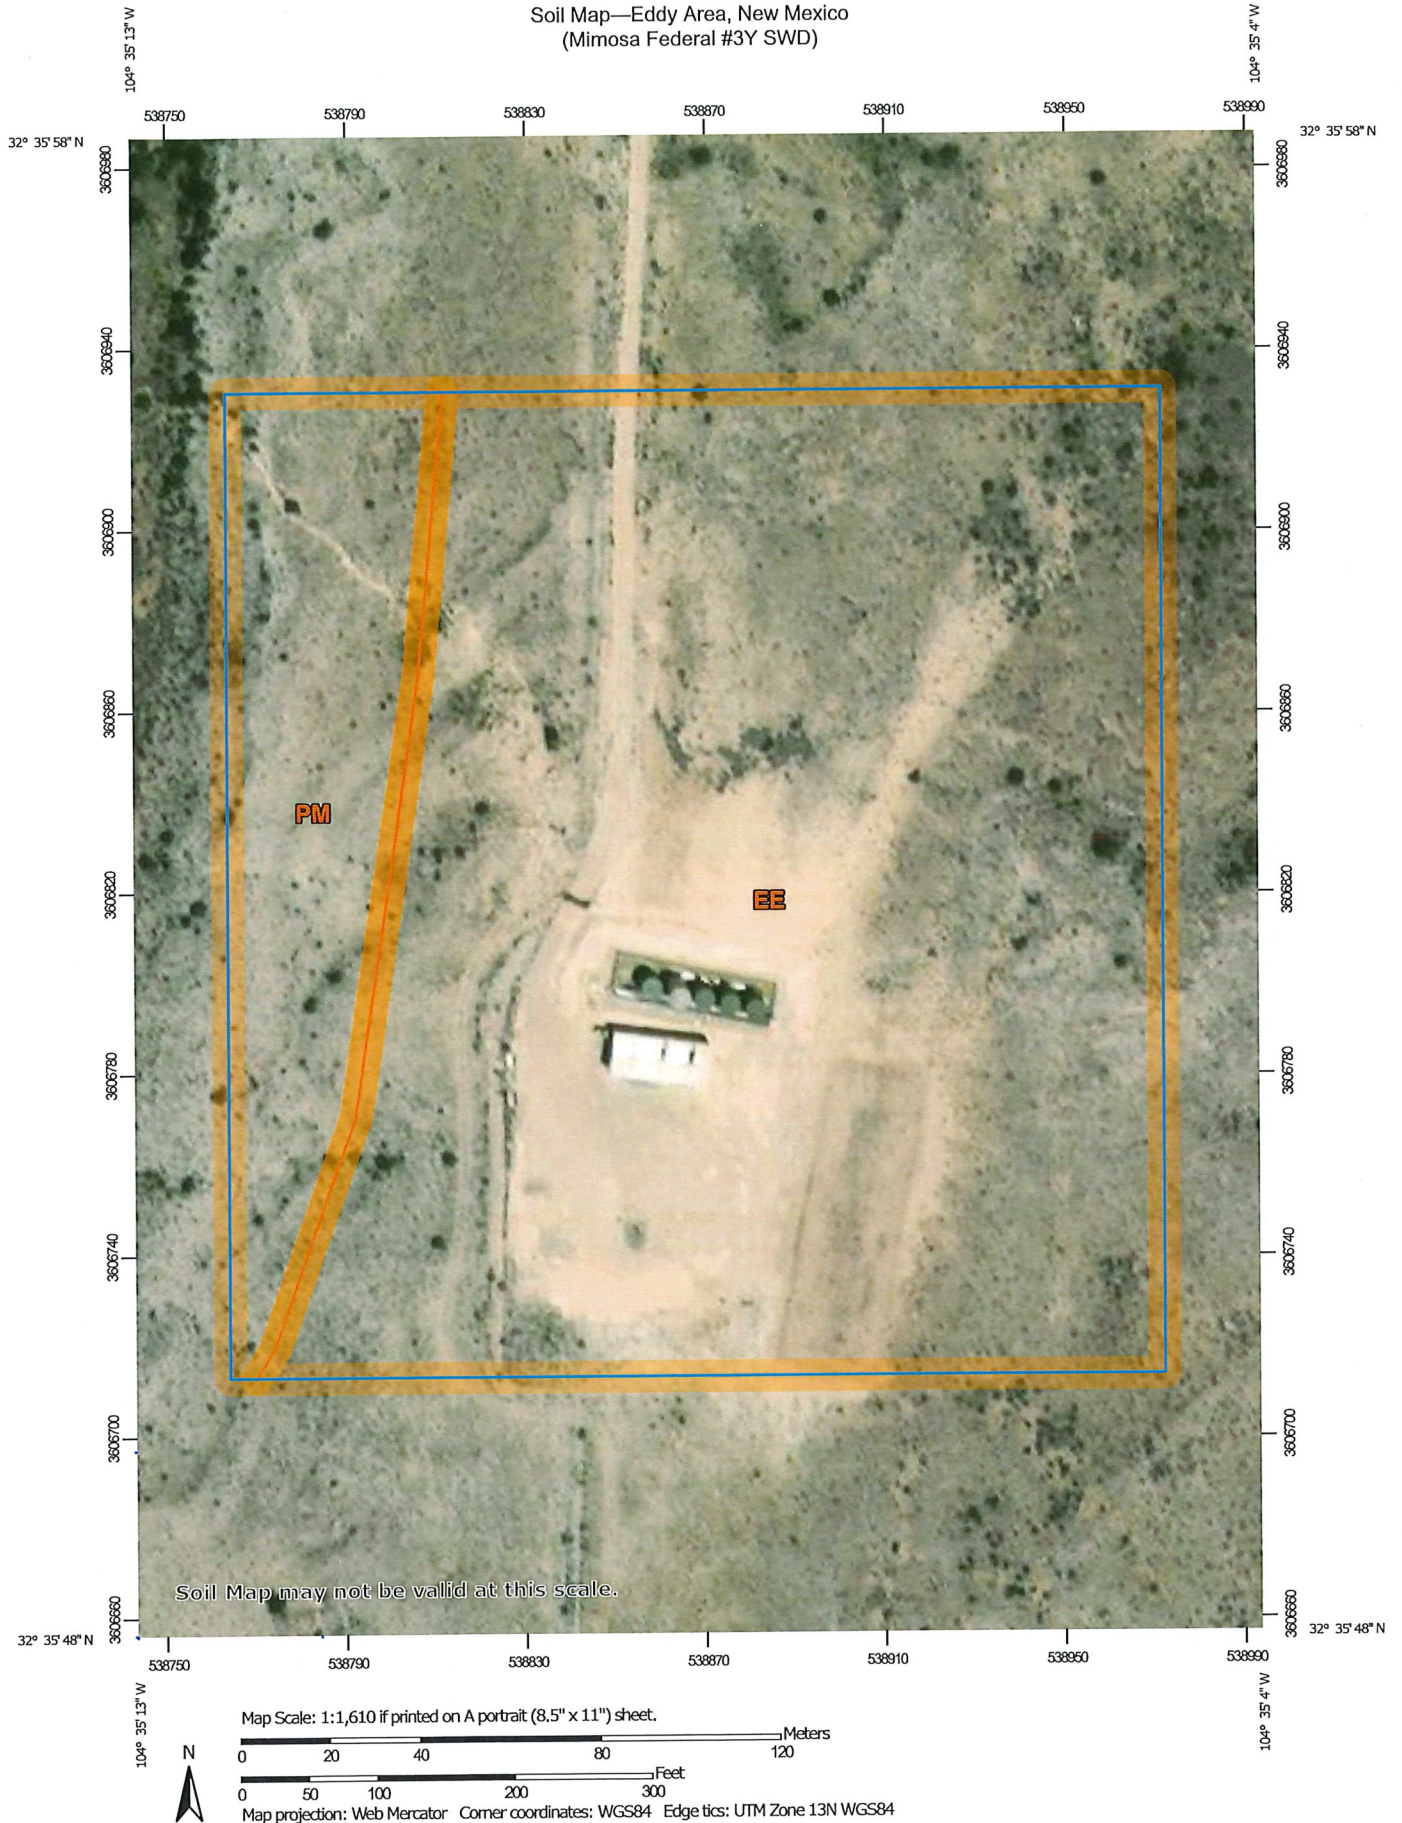
Soil Map—Eddy Area, New Mexico  
(Mimosa Federal #3Y SWD)

USDA Natural Resources Conservation Service (NRCS) classifies soil in the area as Ector extremely rocky loam, with 9-25% slopes, and Pima silt loam, with 0-1% slope.

Map Unit Symbol	Map Unit Name	Acres in AOI	Percent of AOI
EE	Ector extremely rocky loam, 9 to 25 percent slopes	9.4	83.8%
PM	Pima silt loam, 0 to 1 percent slopes	1.8	16.2%
Totals for Area of Interest		11.2	100.0%
