DELINEATION WORKPLAN

OXY – SOLOMON STATE COM #1H (Leak Date: 9/24/18)

RP # 2RP-5019

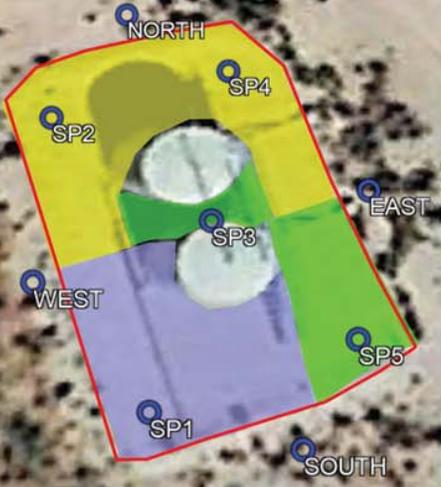
Leak date: 9/24/18
Eddy County, NM
2RP-5019
NMAP1829562807

- 1 ft Excavation
- 2 ft Excavation
- 5 ft Excavation
- Leak Area (red outline)
- Sample points

OXY will excavate the spill area as depicted on the following site diagram. The leak area near SP1 (PURPLE shade on diagram) will be excavated to a depth of 1 foot. The leak area near SP2 and SP4 (YELLOW shade on diagram) will be excavated to a depth of 2 feet. The leak area near SP3 and SP5 (GREEN shade on diagram) will be excavated to a depth of 5 feet.

A confirmation sample at the bottom of SP3 will be taken and analyzed for all four constituents as per the spill rule.

Bottom confirmation samples will be collected at no greater than 50 ft. intervals. Estimated volume of material to be removed is 156 cubic yards. The remediation will be completed within 90 days of plan approval.

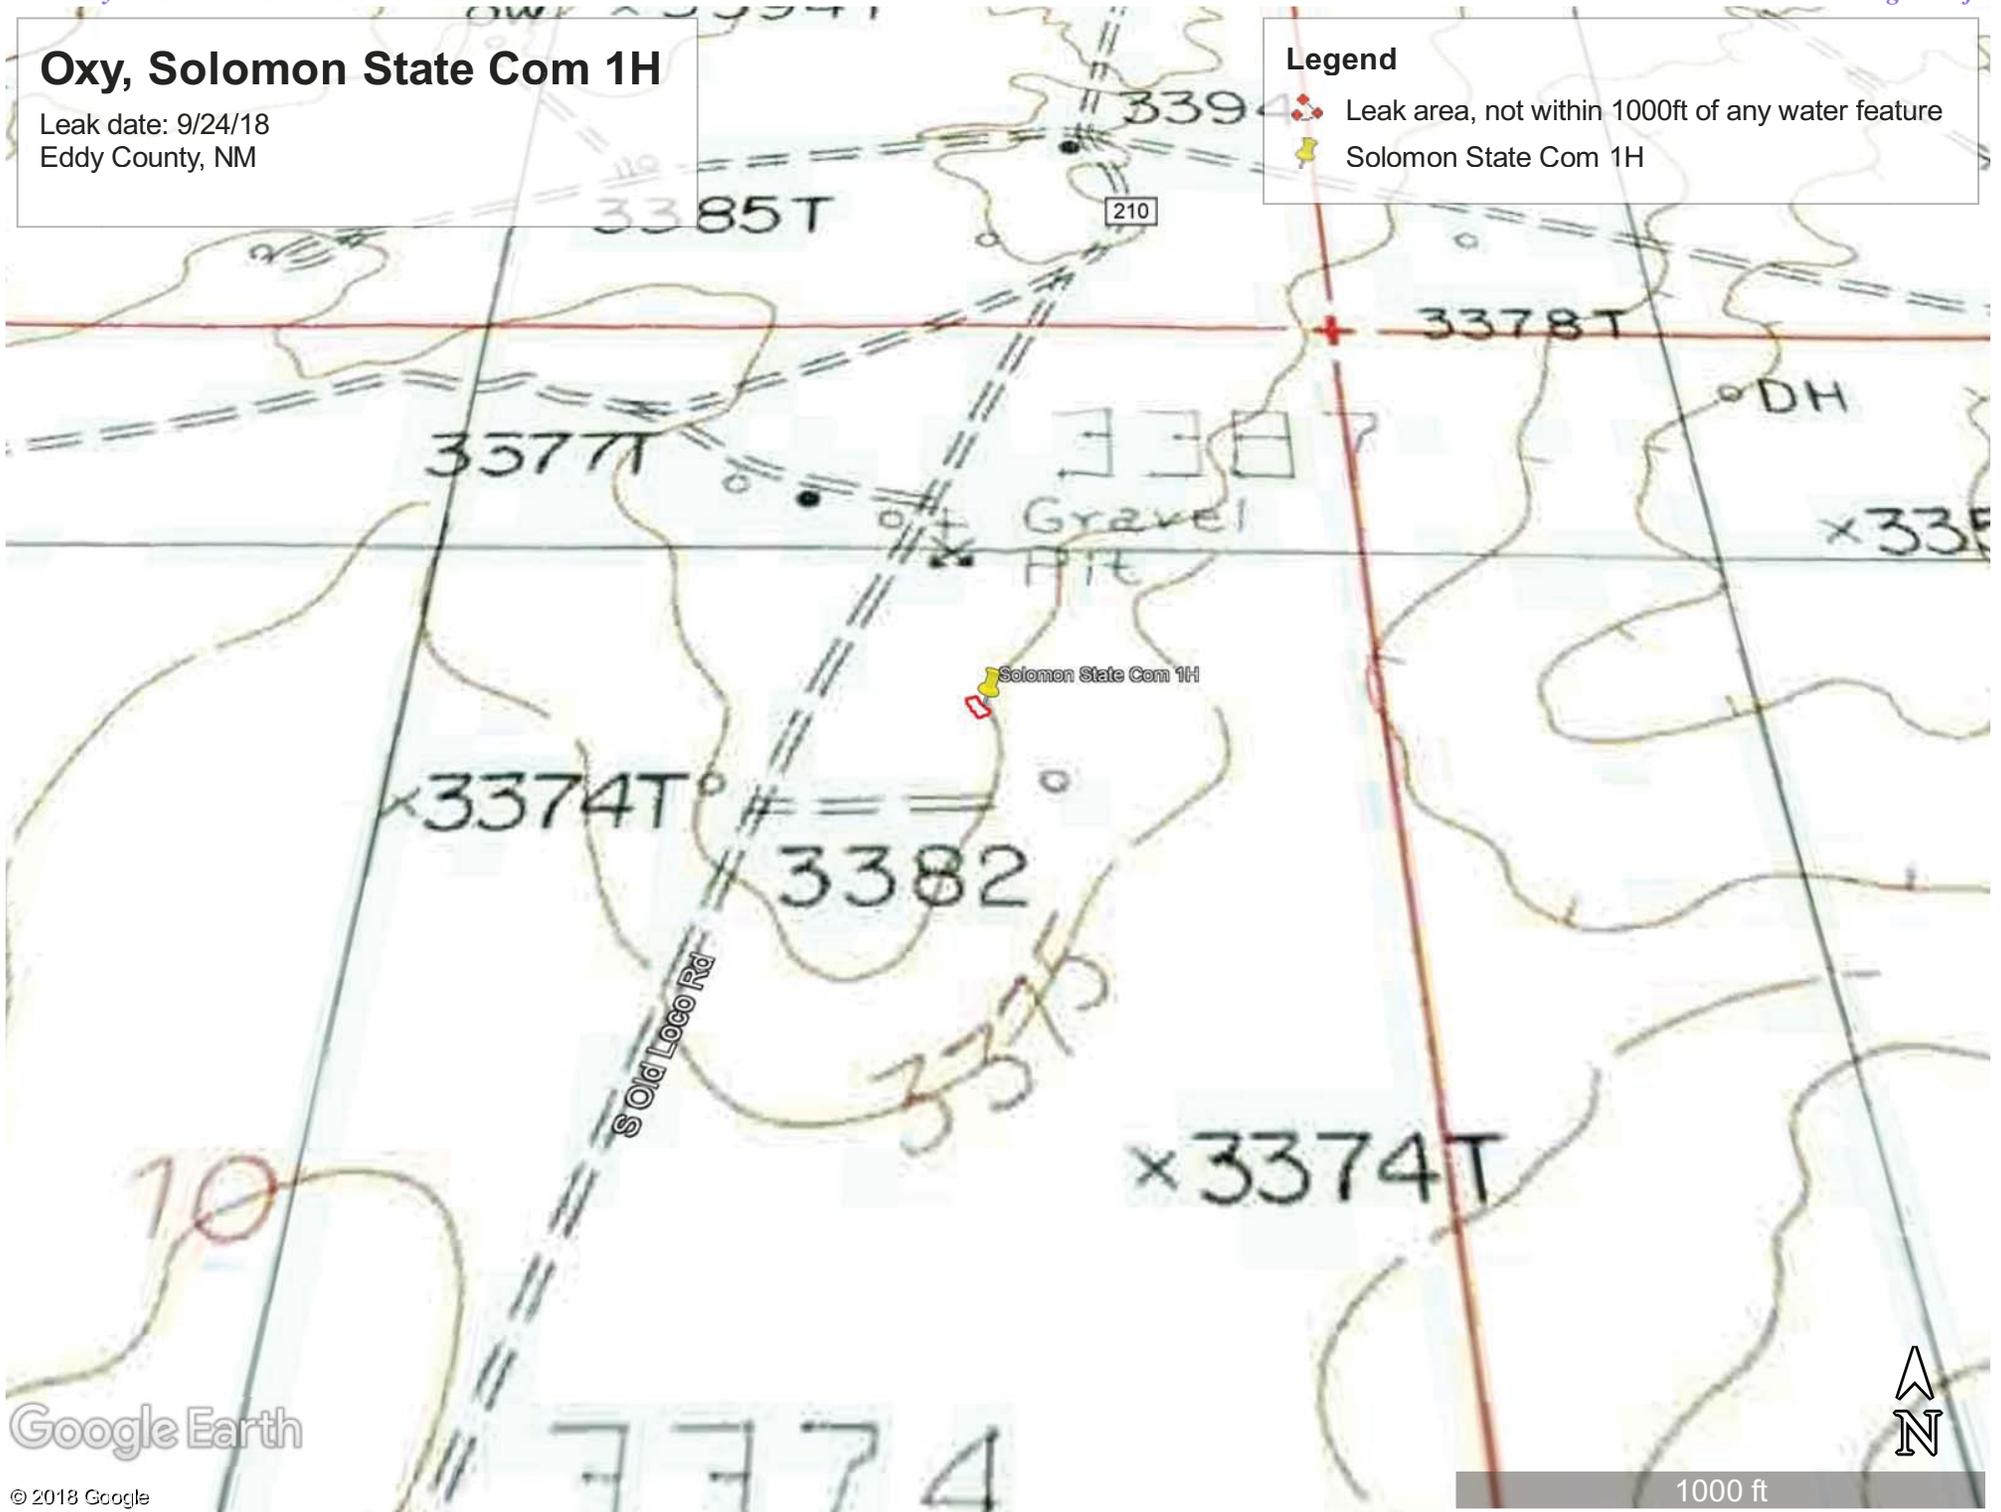
Solomon State Com 1H

Leak area, not within 1000ft of any water feature
-
