Remediation and Closure Report

Stratojet 31 State Com #007H
API# 30-025-43792, 1RP-5146, 1RP-5278
Talon Project # 700778.135.01

Subject: **Remediation and Closure Report**
Stratojet 31 State Com #007H
API# 30-025-43792, 1RP-5146, 1RP-5278

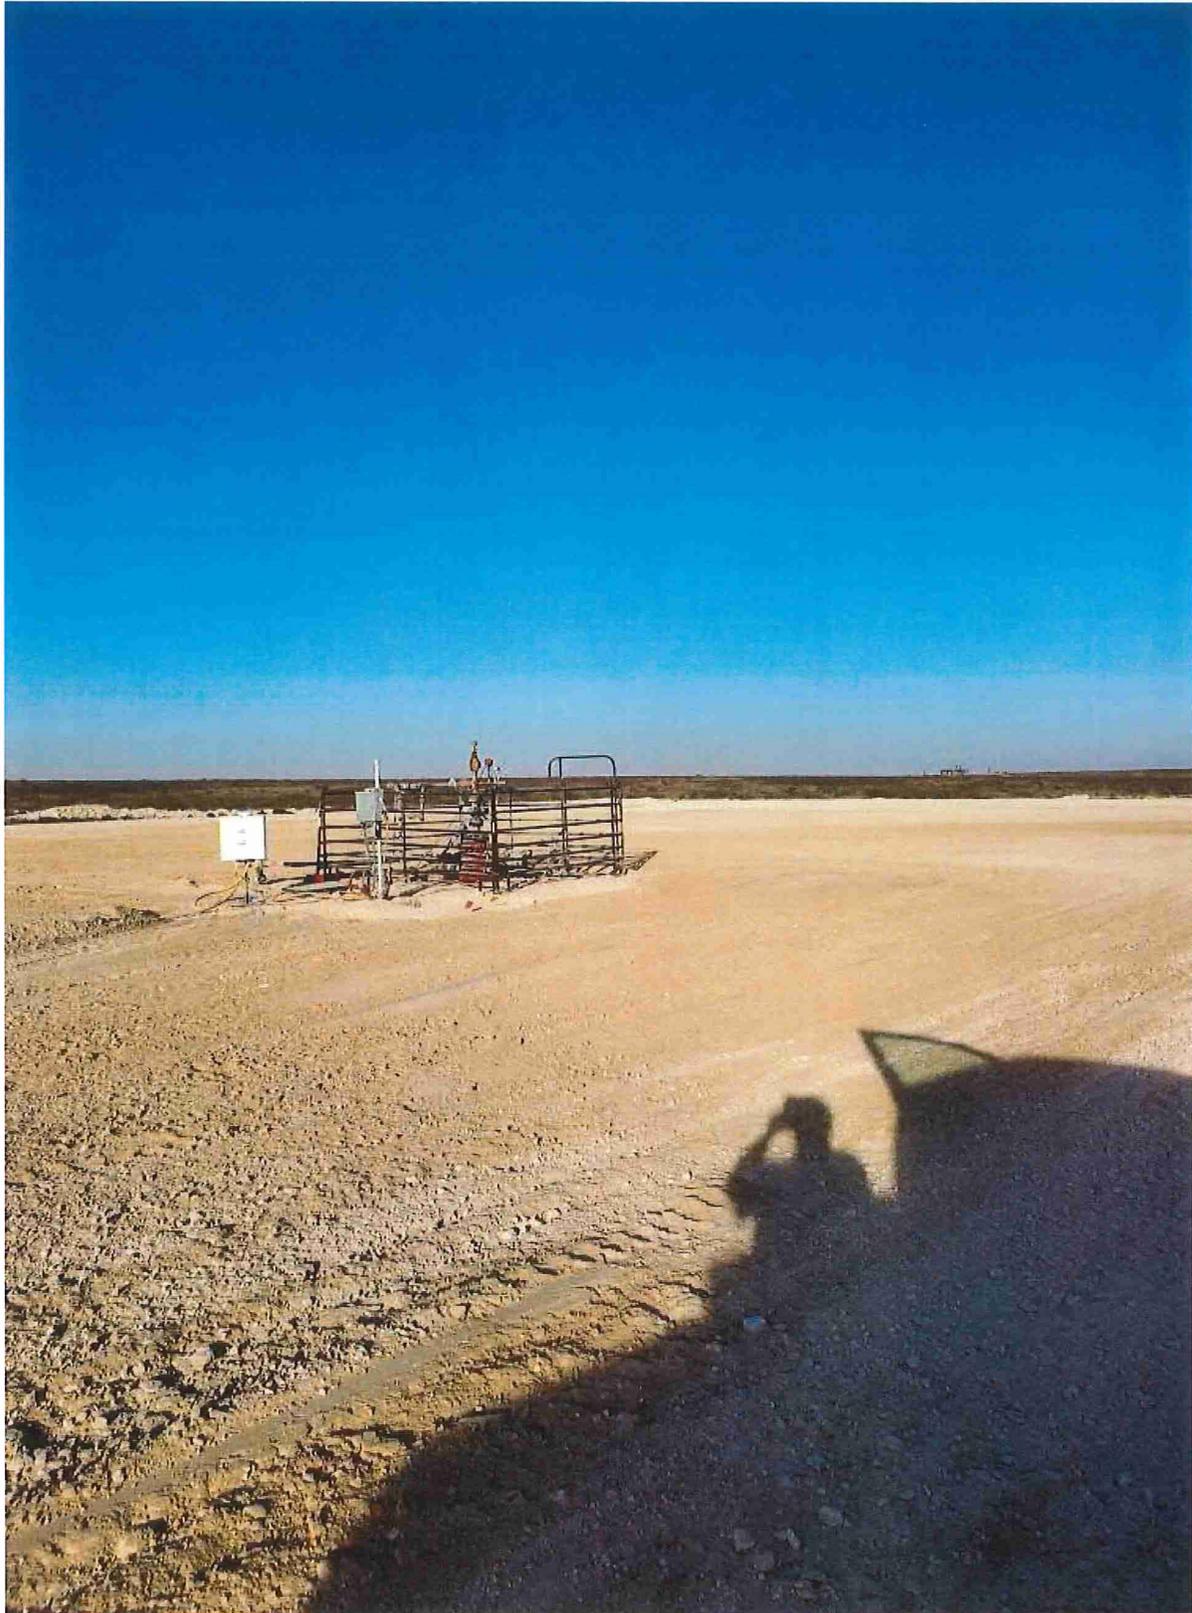
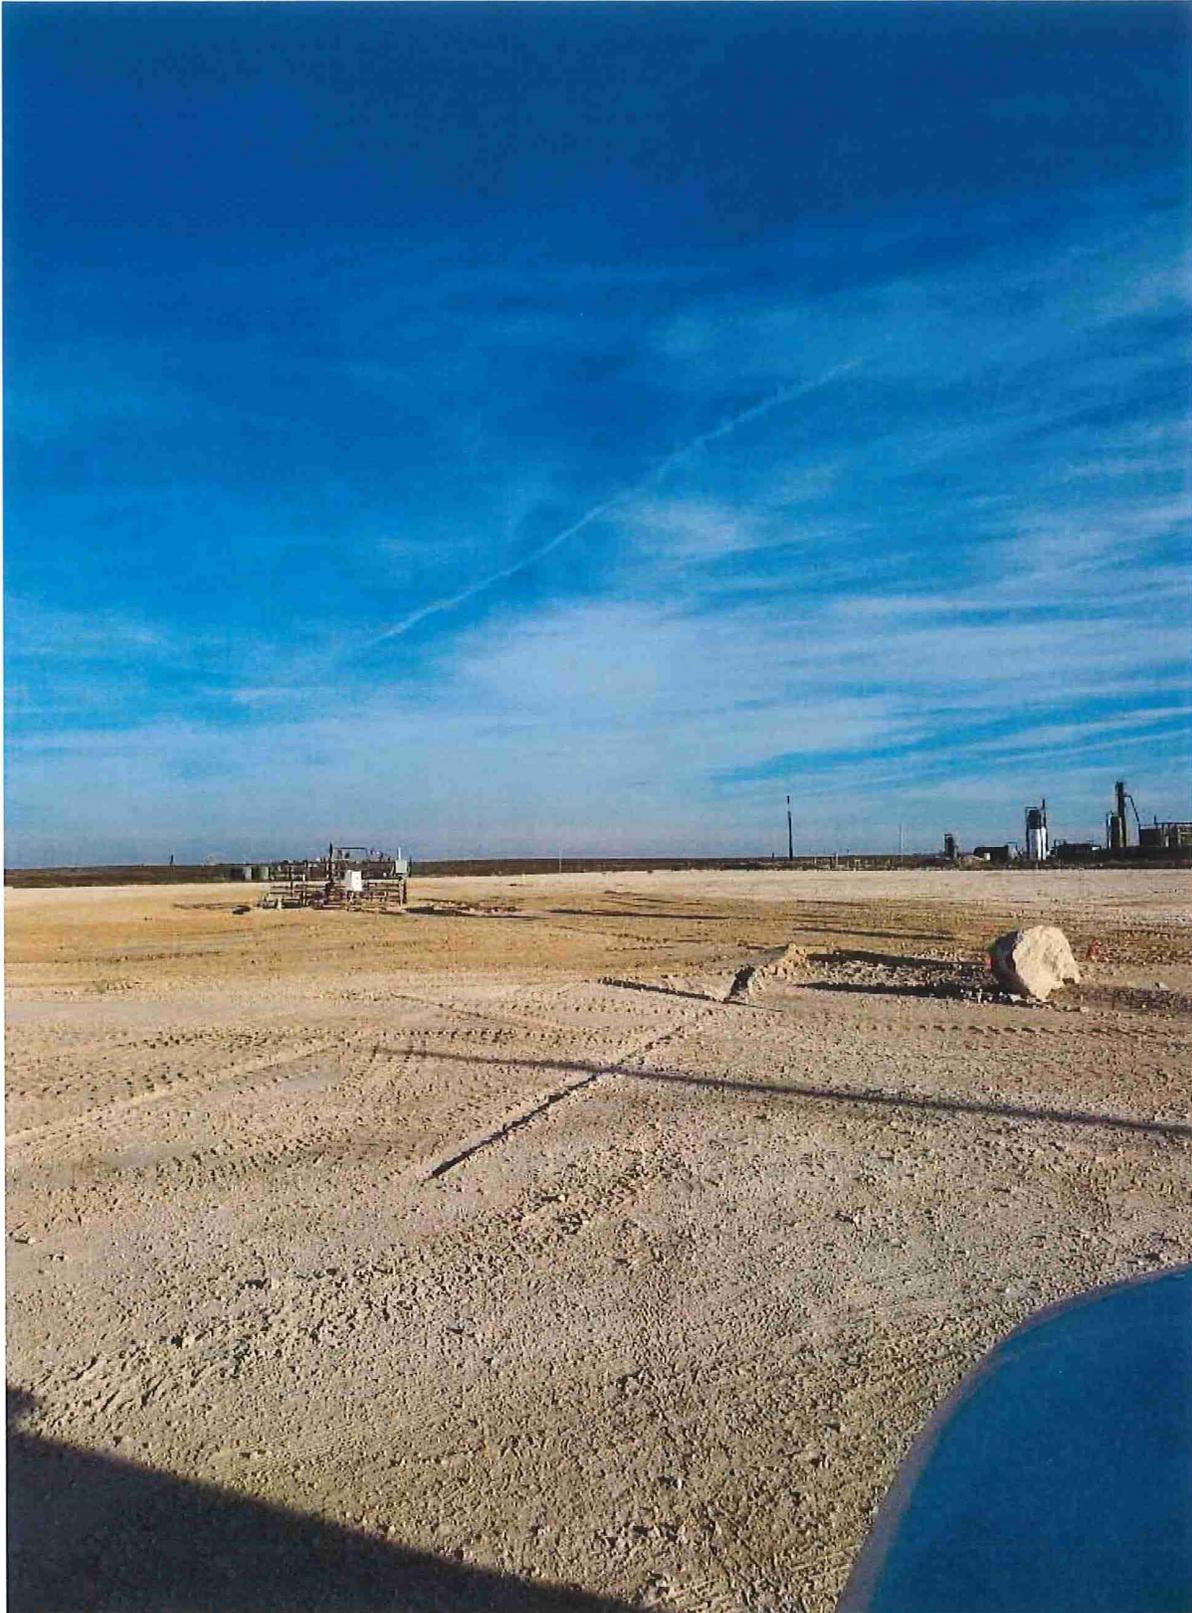
Pre-excavation photographs

According to the C-141 as it was filed with the NMOCD: On August 4, 2018, 10 barrels (bbls) of crude oil, and 7 bbls of produced water leaked from the union off of the pump tee, of which 7 bbls of crude and 3 bbls of produced water respectively were recovered. The C-141 was received by the NMOCD on August 06, 2018 and issued Remediation Permit No. 1RP-5146.

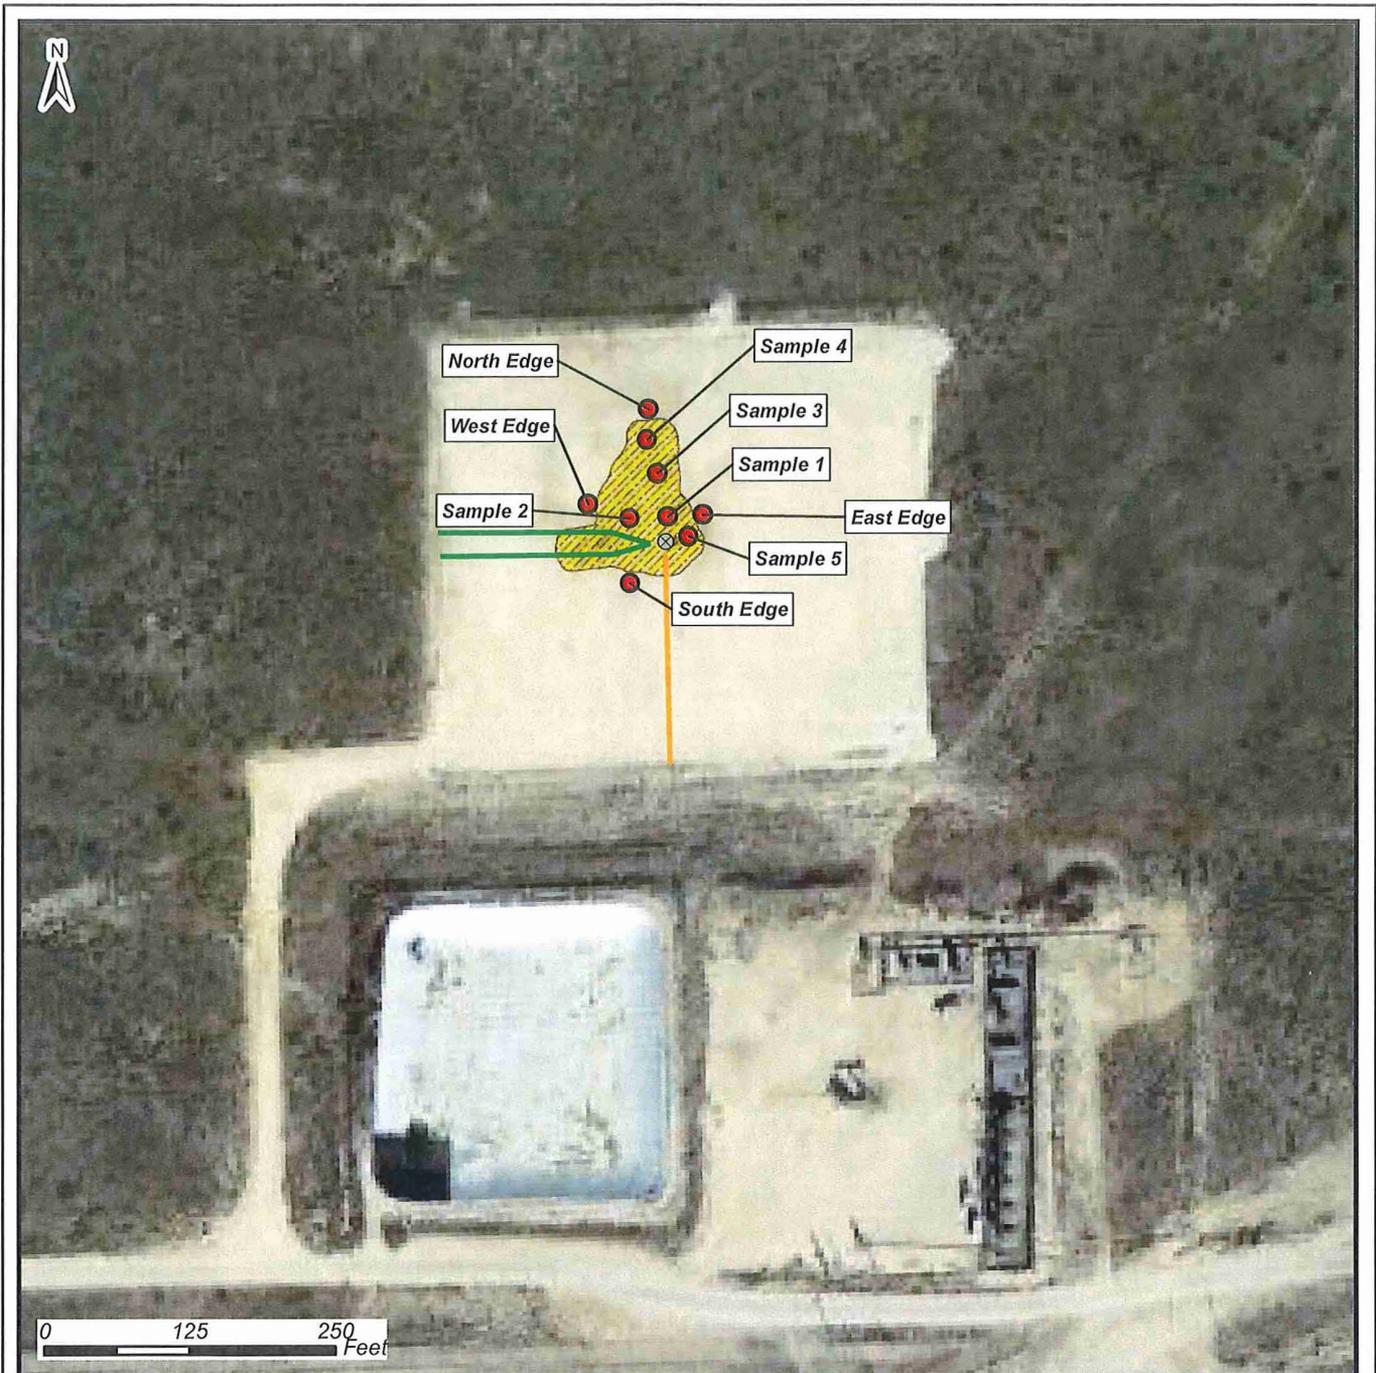
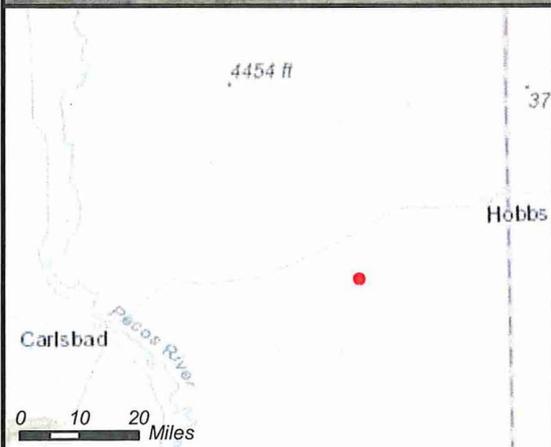
Sample Location Map
 Stratojet 31 State Com #007H
 32.524537 -103.499301
 Section 31, Township 20 South, Range 35 East

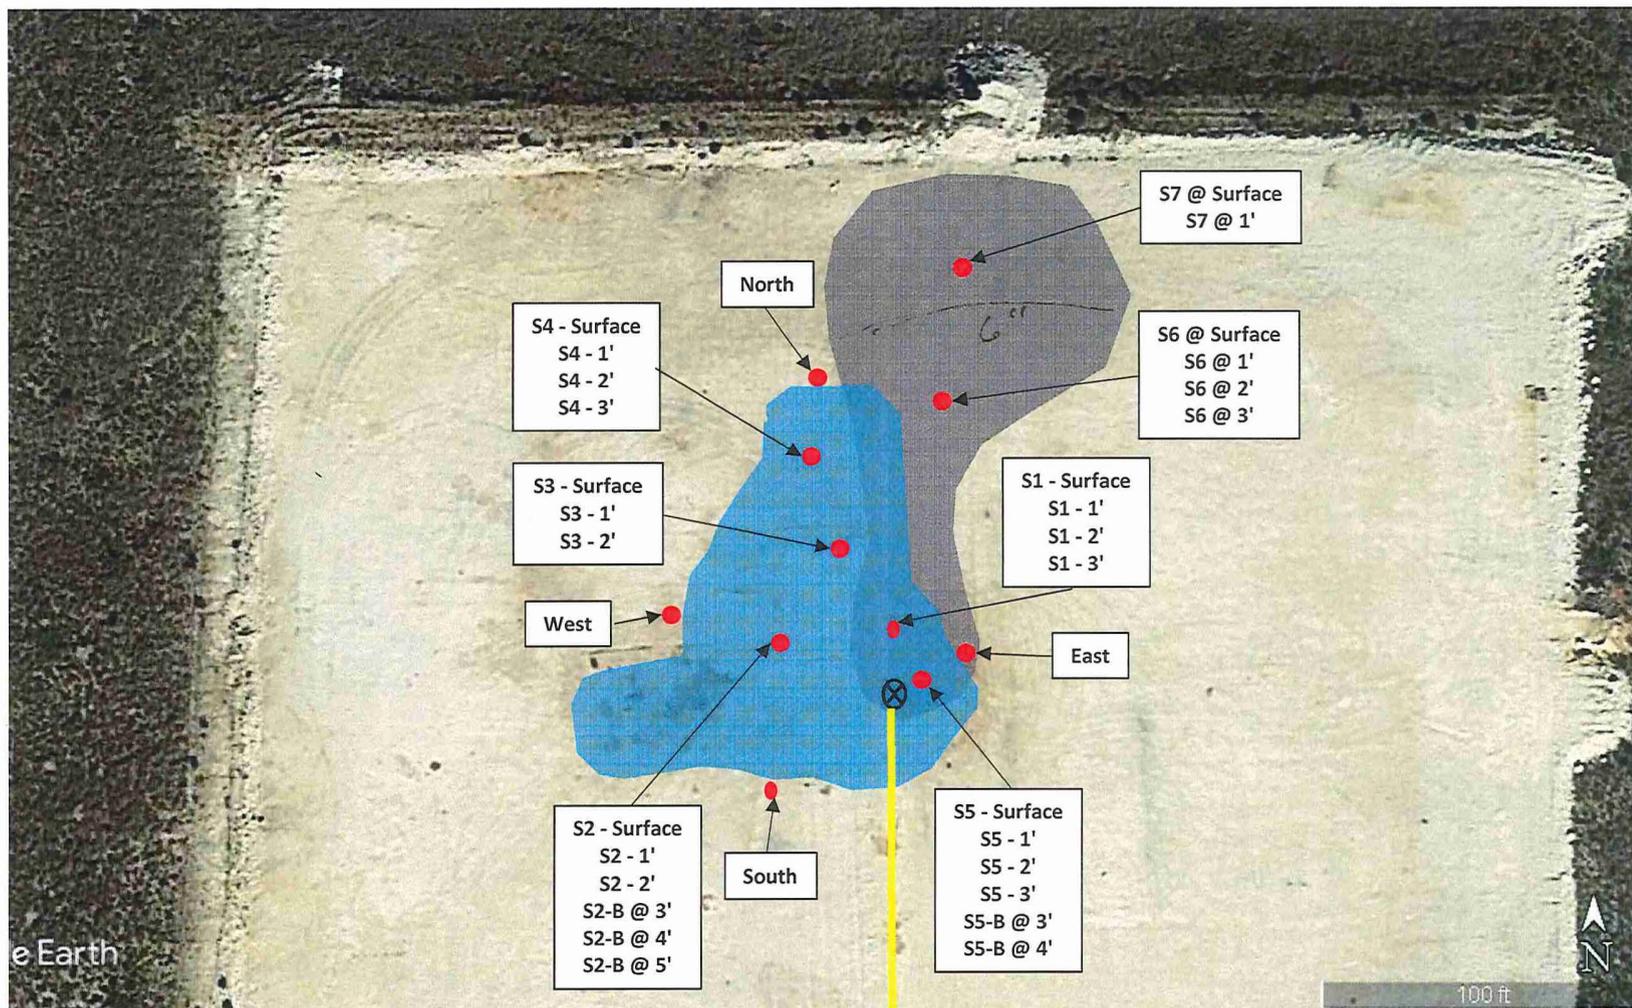
Inferred Release Margins (8/04/18)
	Inferred Release Margins (11/05/18)
	Sample Point Location
	Wellhead
	Underground Pipeline
