Re: Replacement Closure Report – 1RP-2770
Legacy Reserves Jalmat Yates Unit #17
Legal: Unit C, Sec 18, T25S R37E, 660' FNL, 1,980' FWL, Lea County, NM
Latitude/Longitude: 32.135787/ -103.203931
Etech Proj. Number: 164-2830-000
Depth to Groundwater: 115 feet - Chevron/Texaco Lea County Depth to Groundwater Map
Value provided by NMOCD, District 1

Attachment B
Site Diagram and Sample Location Map

**Attachment C
Photograph Log**

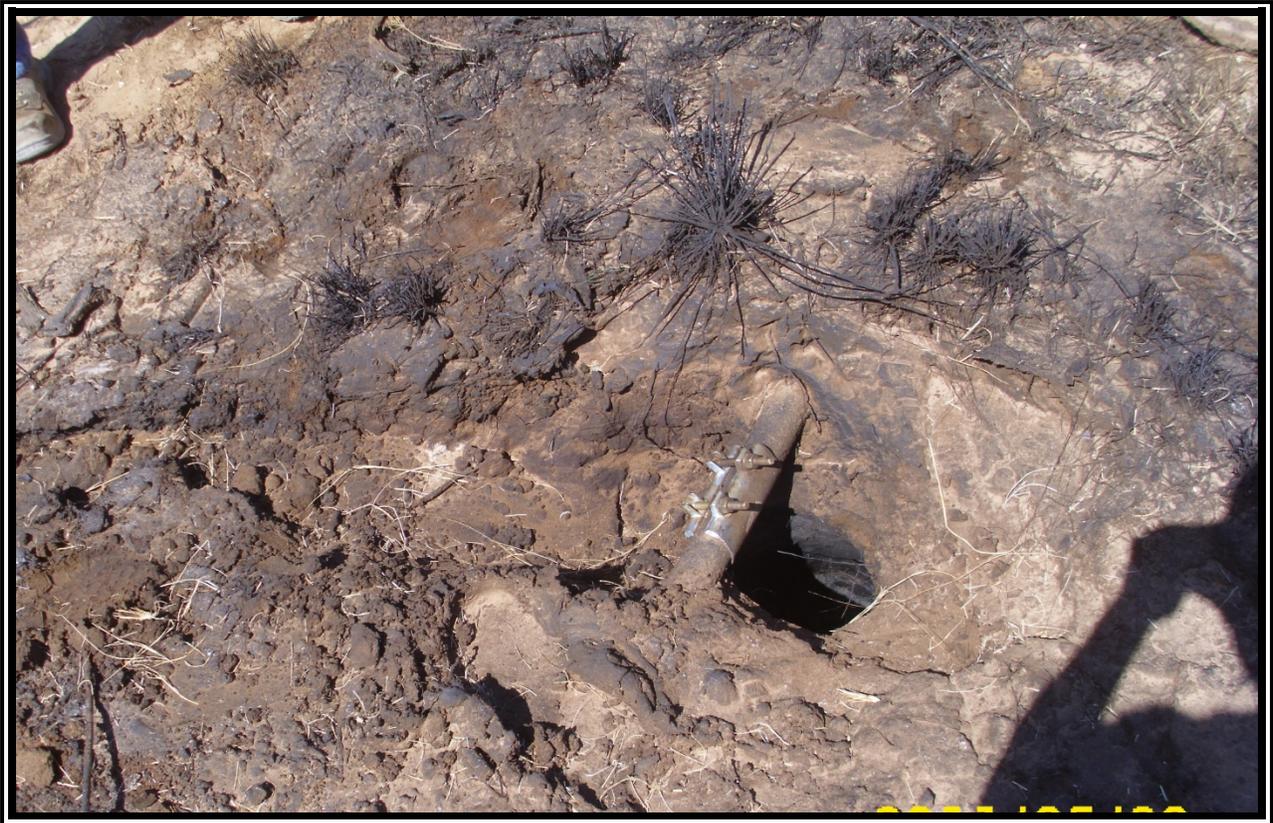
On May 19, 2011, a release of crude oil and produced water was discovered in the pasture land approximately three hundred (300) feet north of the Legacy Reserves, Jalmat Yates Unit #17. The source of the release was a hole in a two (2) inch steel flowline. The fluid flowed north from the release point following the lease road, then flowed eastward and pooled in the pasture.

View of release point at west terminus of release prior to excavation.

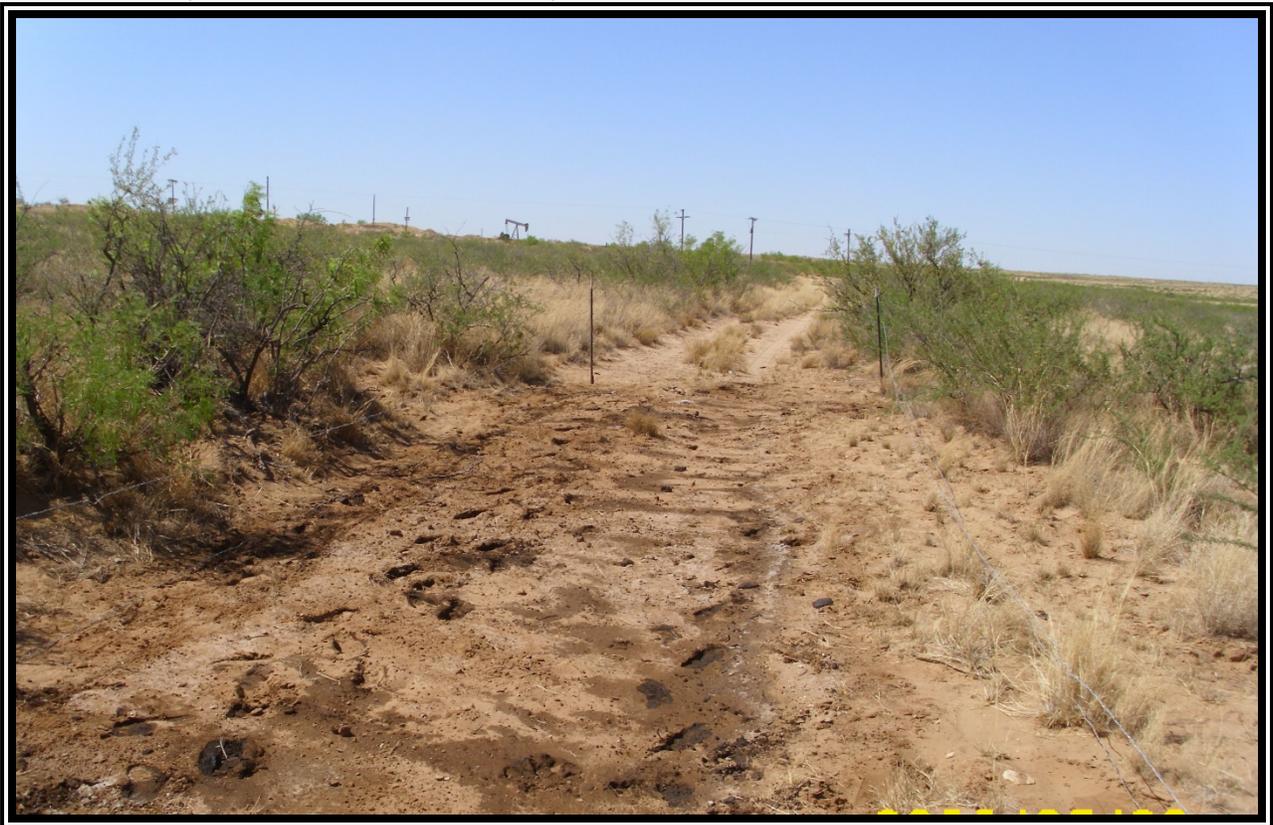
View of release following the lease road to the north prior to excavation.

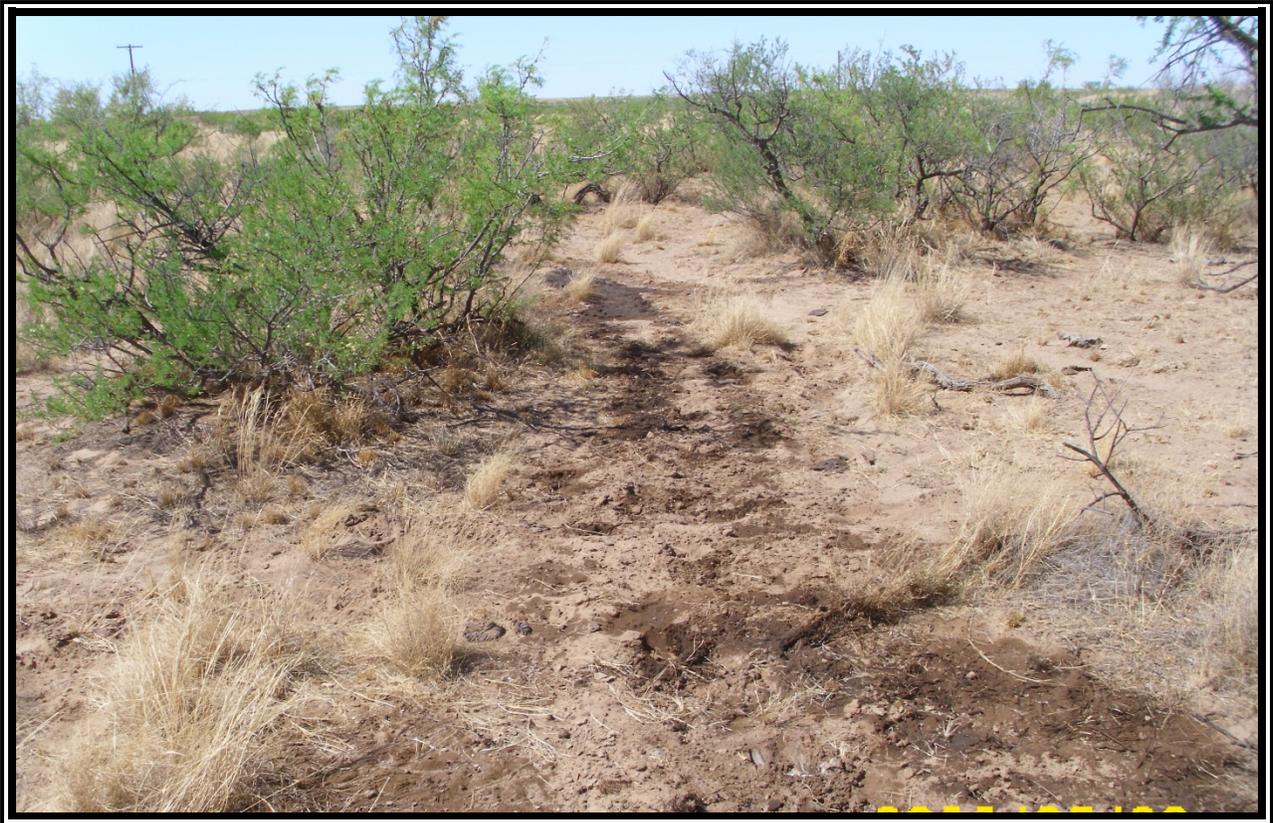
View of the release flow path in the pasture prior to excavation.

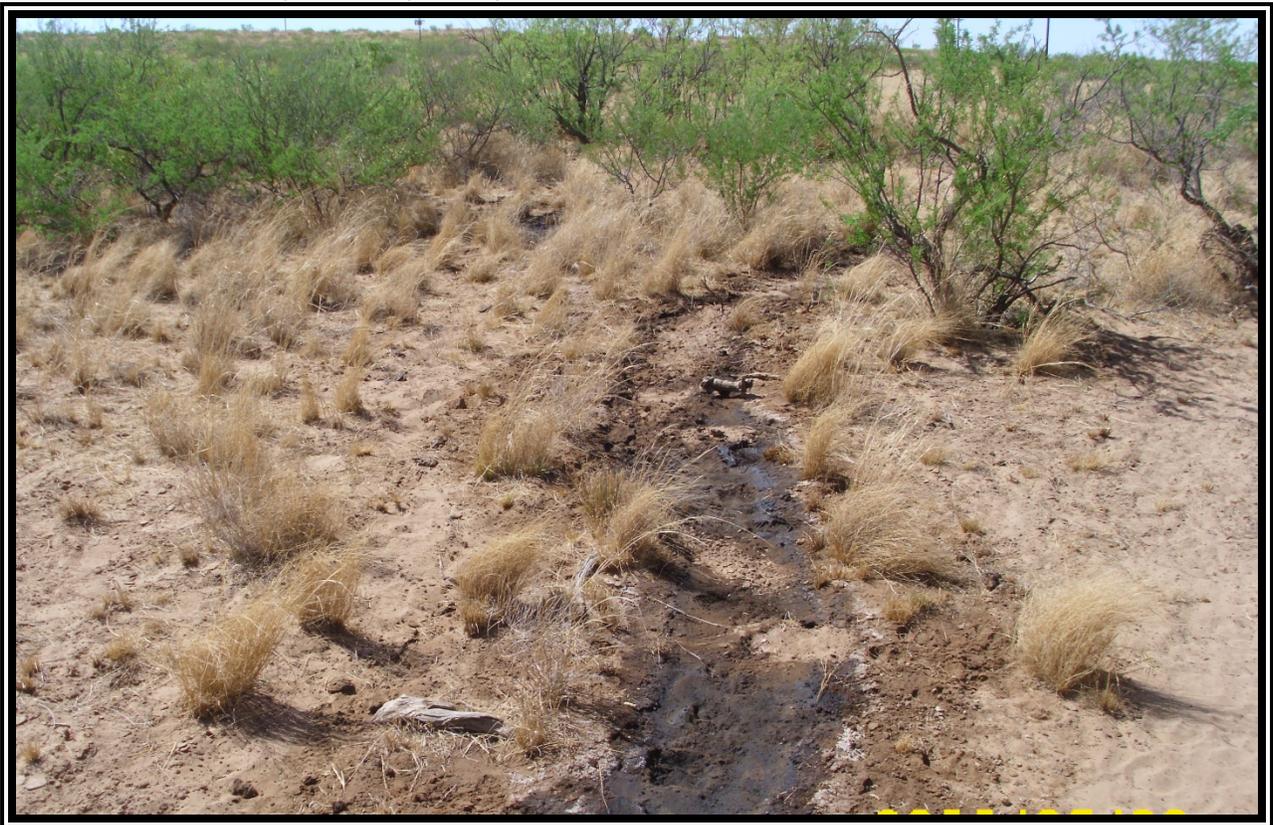
View of east terminus of the release prior to excavation.

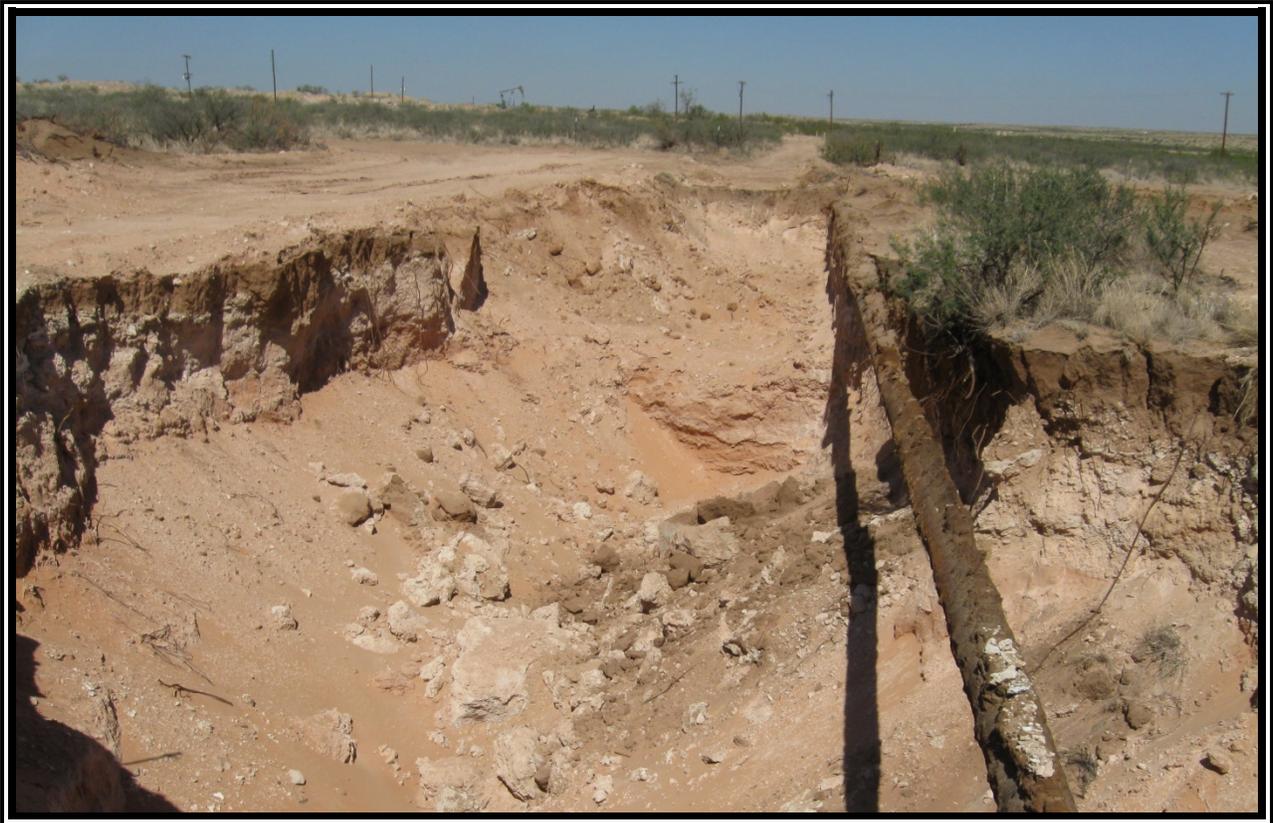
View of the west terminus of the release after excavation.

The pooled area at the release point at the west terminus of the release, the flow path (north and east), and the pooled area at the east terminus of the release were excavated. Field testing for chloride concentrations indicated that chloride concentrations were steadily reducing from surface to approximately twelve (12) feet below ground surface ((bgs), approximately 800 mg/kg at 12 feet bgs). At this point the chloride concentrations began to elevate. Excavation of the pooled areas continued until the limits of our ability to excavate were reached. The pooled areas at this point were approximately twenty-two (22) feet bgs. Soil samples collected from the bottom of the excavation ranged in chloride concentration from 1,200 to 2,000 mg/kg. Remediation limits were excavate to 500 mg/kg and delineate to 250 mg/kg.

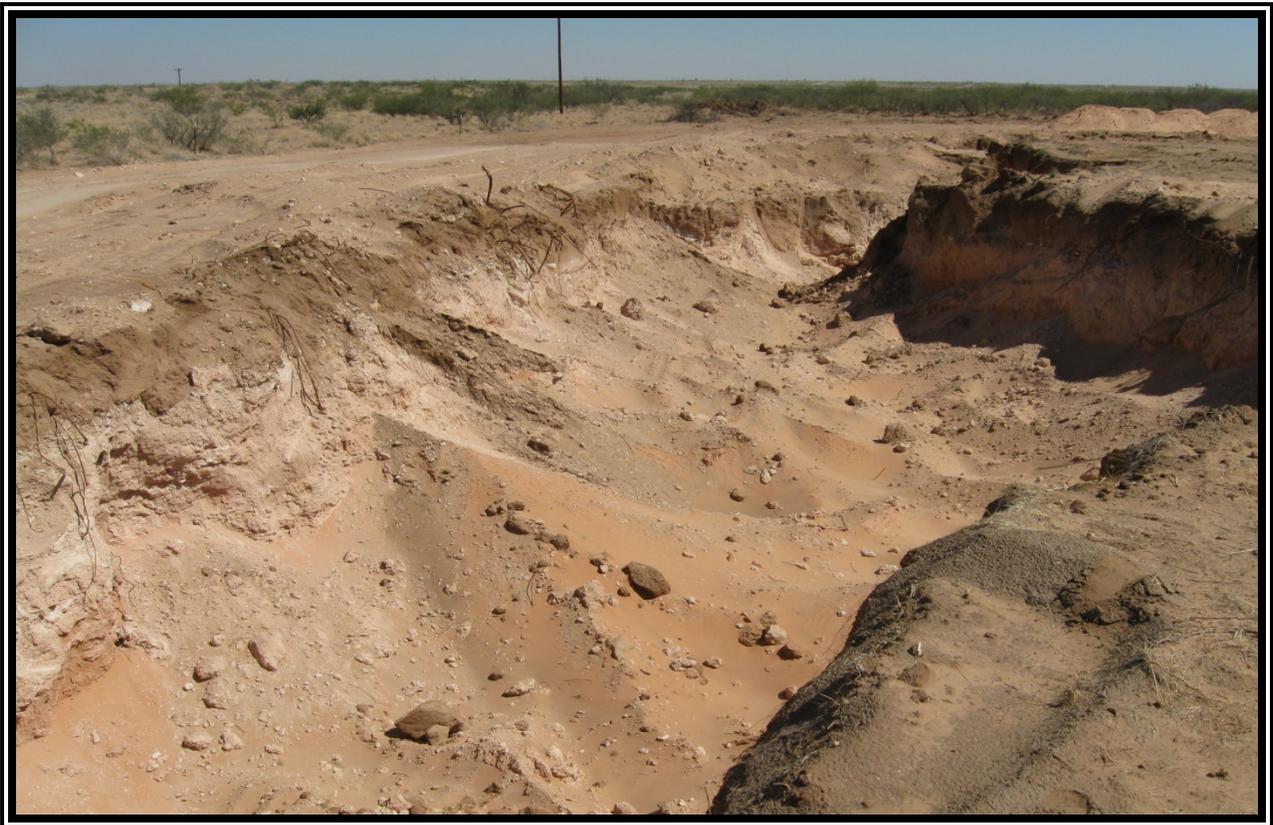
View of release following the lease road north after excavation.

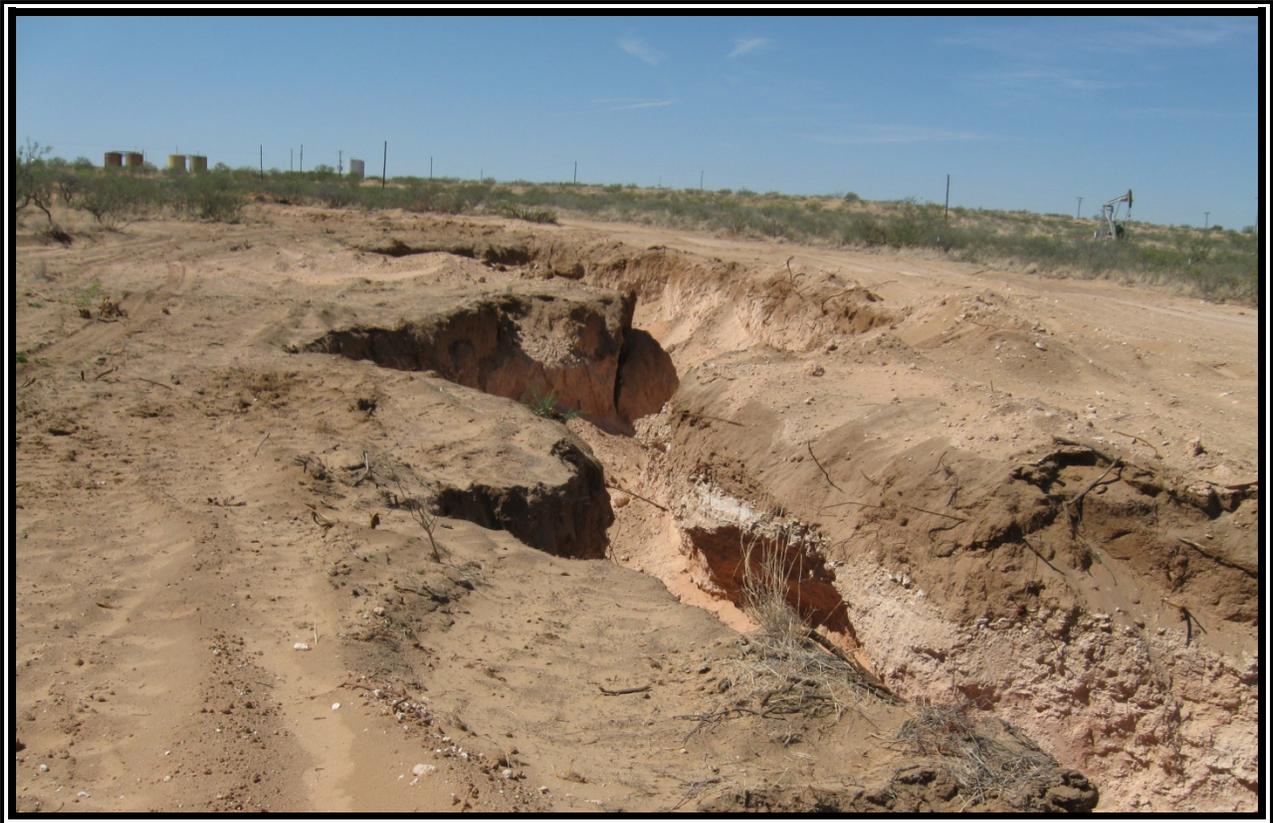
View of release flow path in the pasture after excavation.

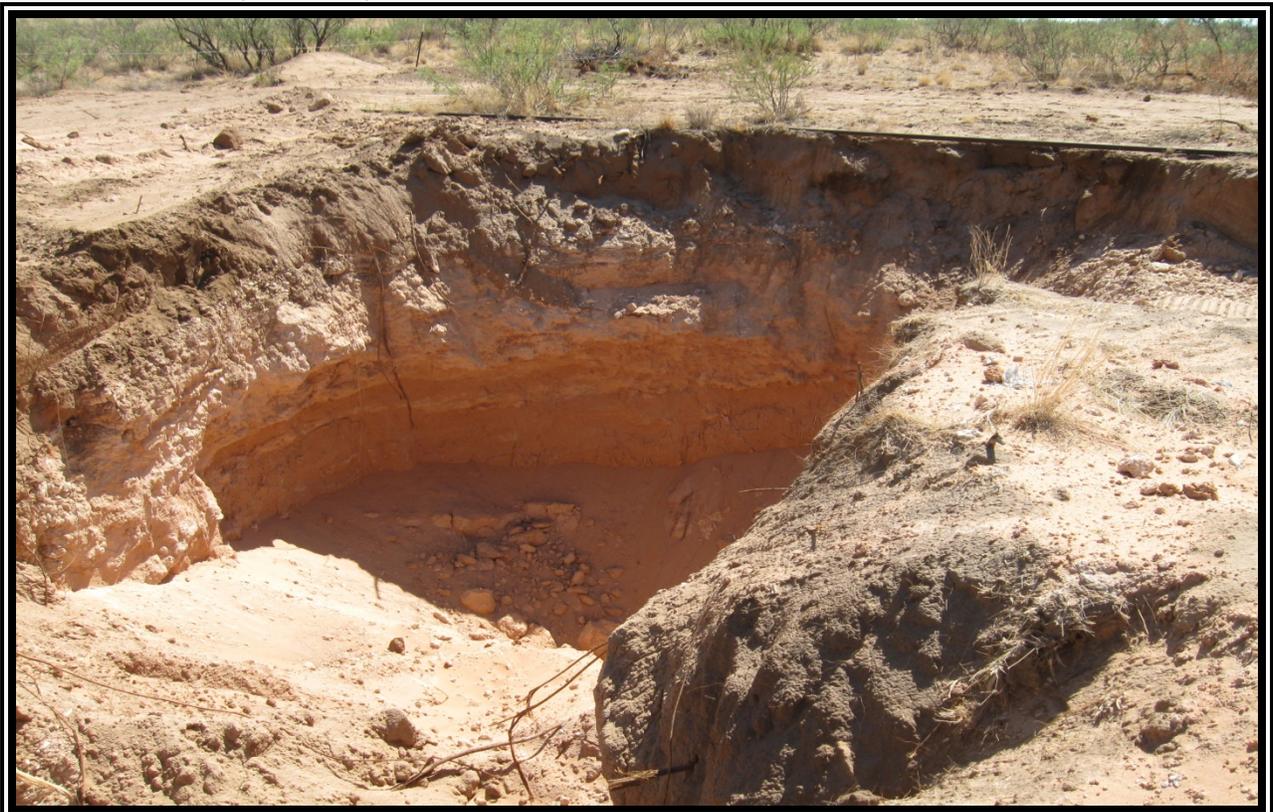
View of east terminus of the release after excavation.

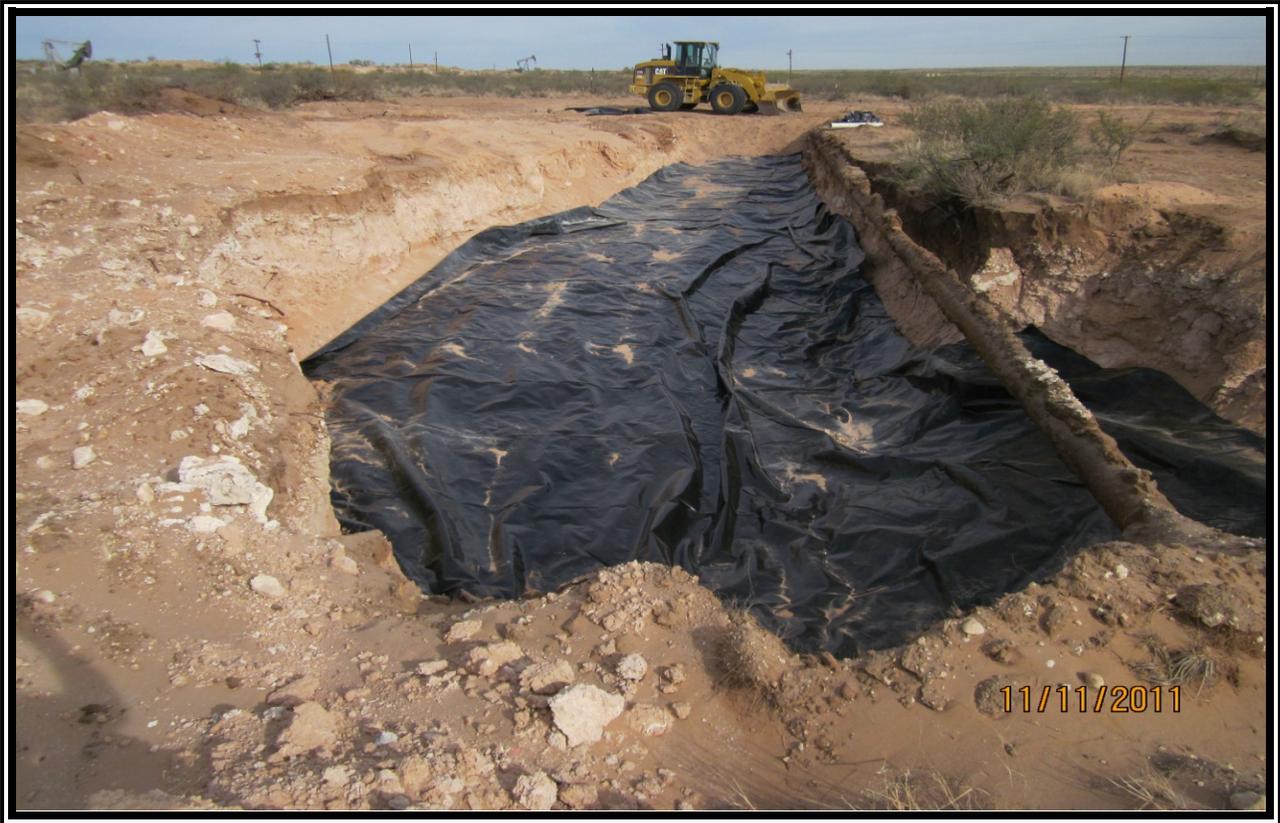
View of the west terminus of the release after installation of liner.

All impacted soils (4,780 cubic yards) were removed from the site, transported, and disposed of at Sundance Services. Per NMOCD approval of October 5, 2011, and based upon the analytical data and the site conditions, the pooled areas at the site were backfilled with clean fill material to a depth of ten (10) feet bgs where a twenty (20) mil poly liner was installed and the areas backfilled to surface and contoured. The spill flow path was backfilled to surface.

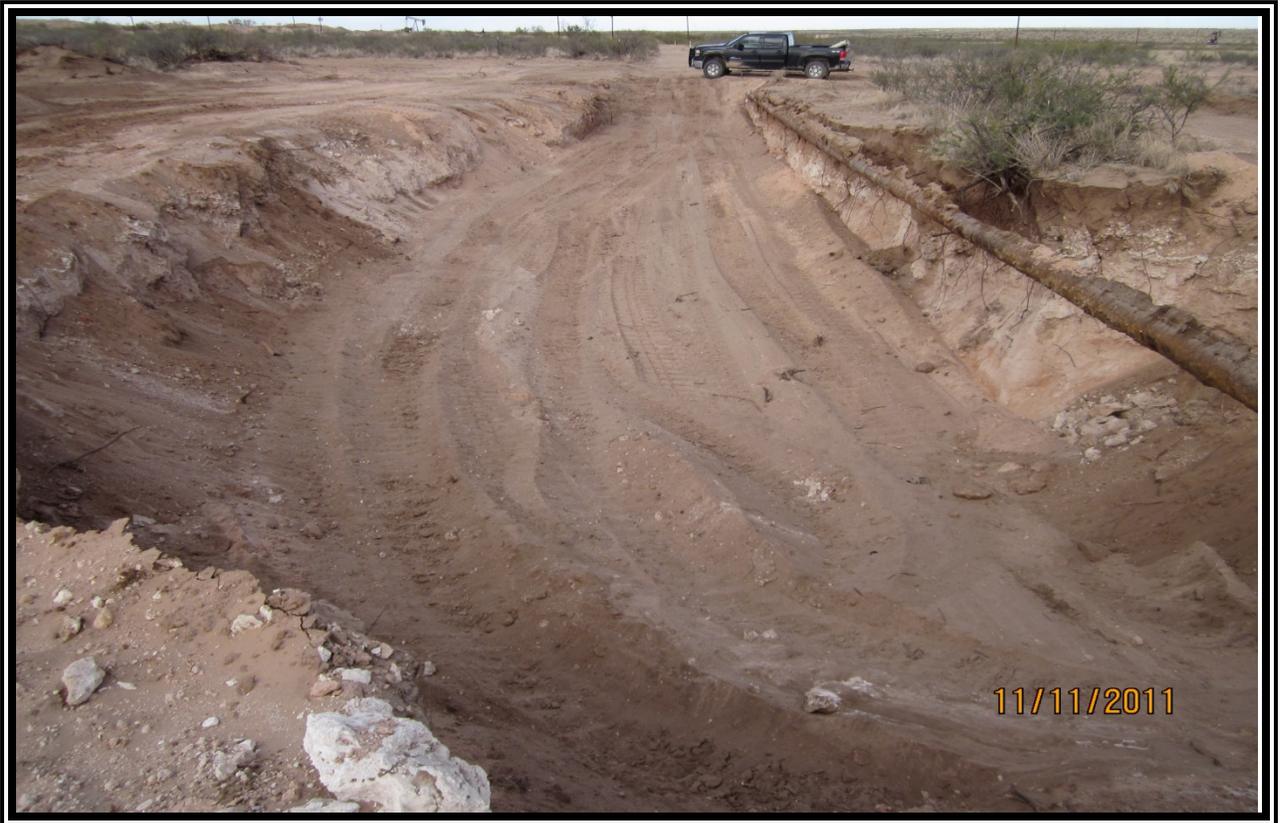
View of the west terminus of the release after backfill emplaced over liner.

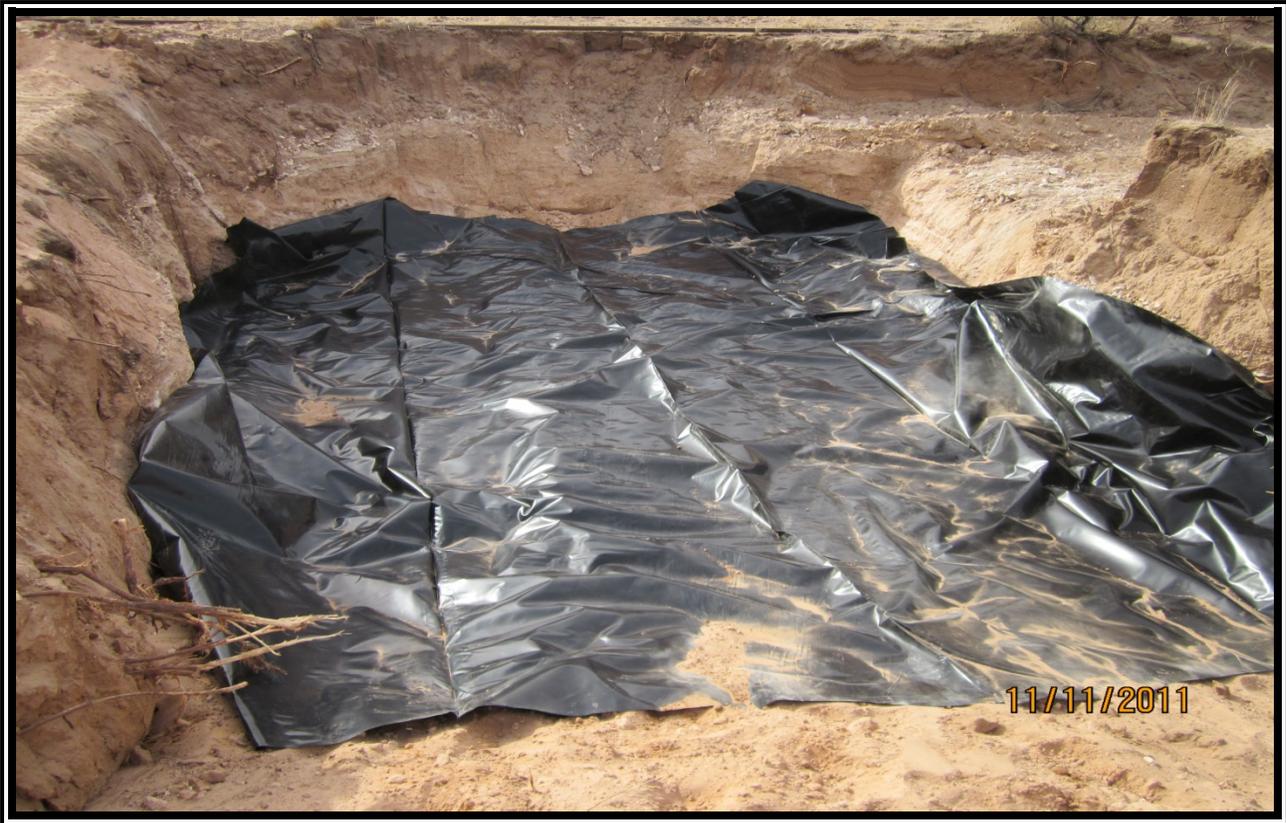
View of east terminus of the release after installation of liner.

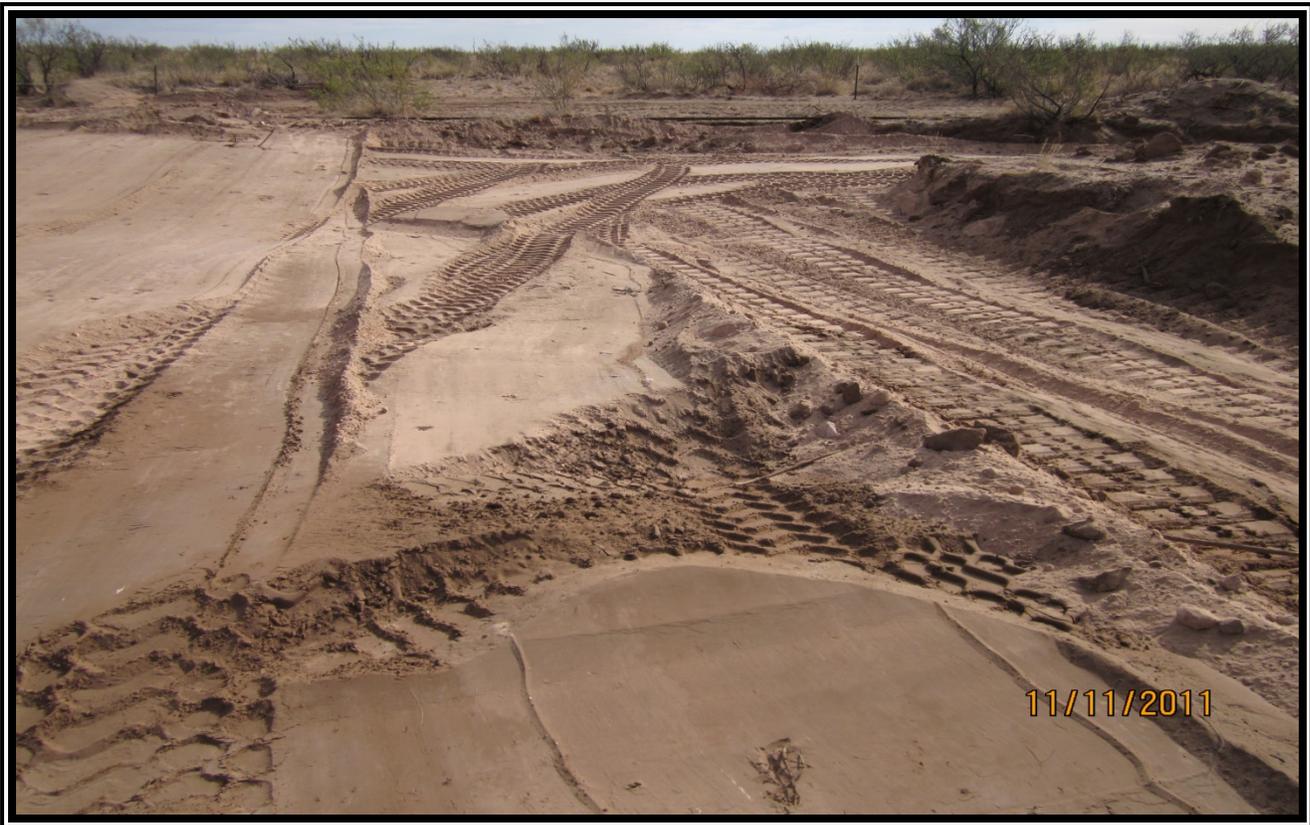
View of east terminus of the release after backfill emplaced over liner.
