Closure Report

Copperhead 31 Federal Com #001H
API#: 30-015-38532
RP#: 2RP-4763
DOR: May 20, 2018
GPS: 32.000366 -104.016256
Unit Letter H, Section 31, Township 26 South, Range 29 East
Eddy County, New Mexico

Re: Work Plan for the COG Operating, LLC, Copperhead 31 Federal Com #001H, Unit H, Section 31, Township 26 South, Range 29 East, Eddy County, New Mexico. 2RP-4763

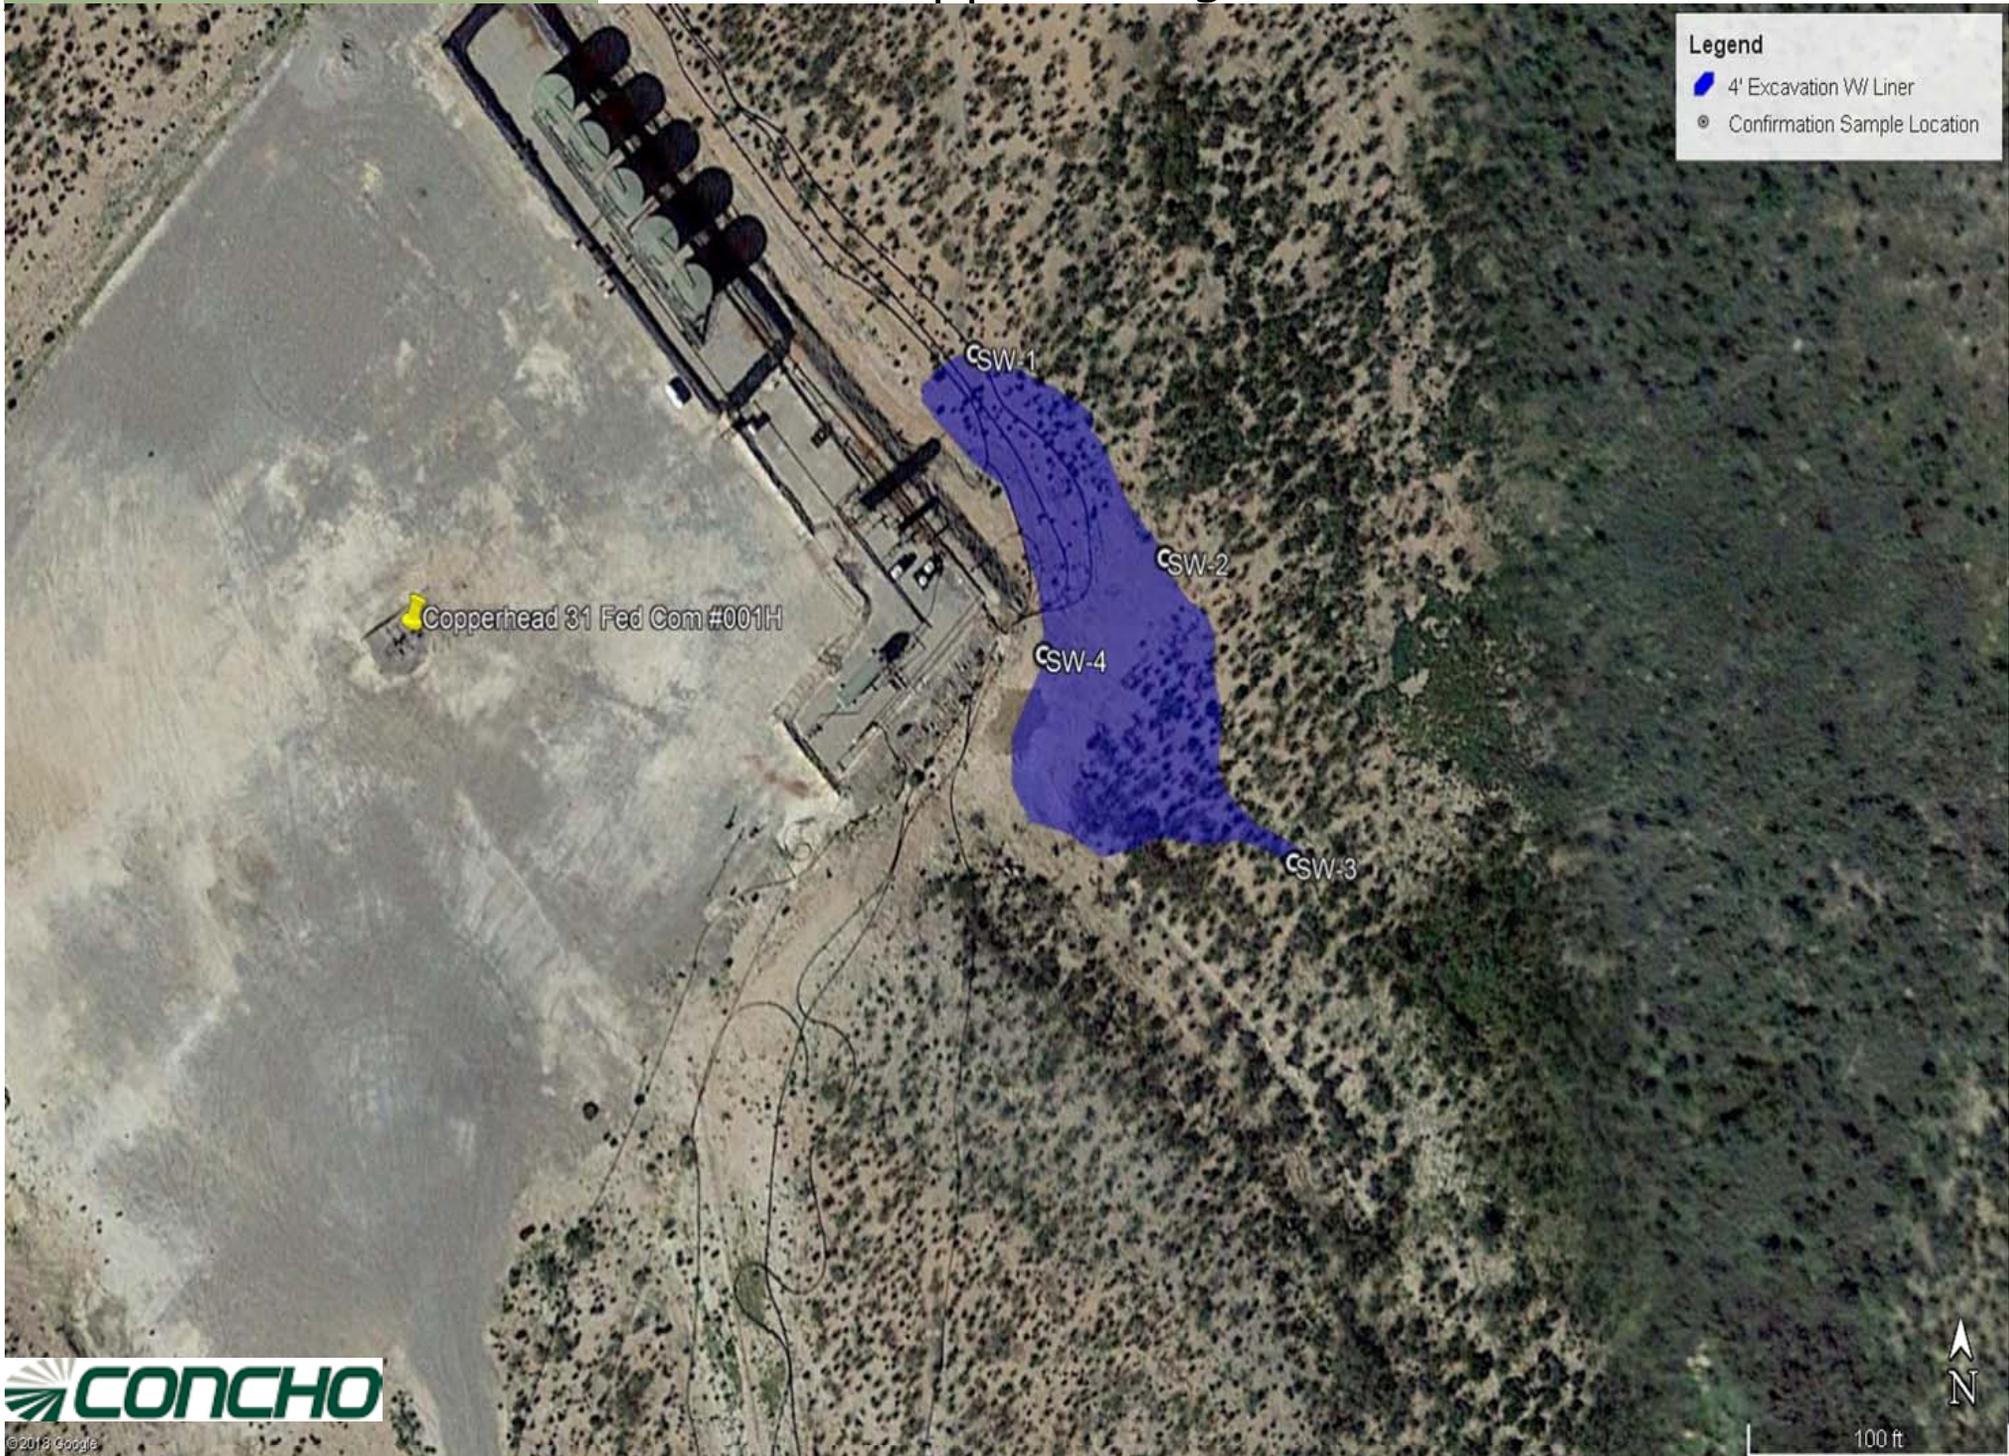
FIGURES

- The impacted area was excavated to a depth of four (4) feet BGS.
- All of the excavated material was hauled to an NMOCD approved solid waste disposal facility.
- Confirmation soil samples were taken from the sidewalls of the excavation per the approved sampling plan.
- A 20-mil poly liner was installed in the bottom of the four (4) foot excavation in order to encapsulate the remaining chloride impacts at depth.

- 4' Excavation W/ Liner
- Confirmation Sample Location

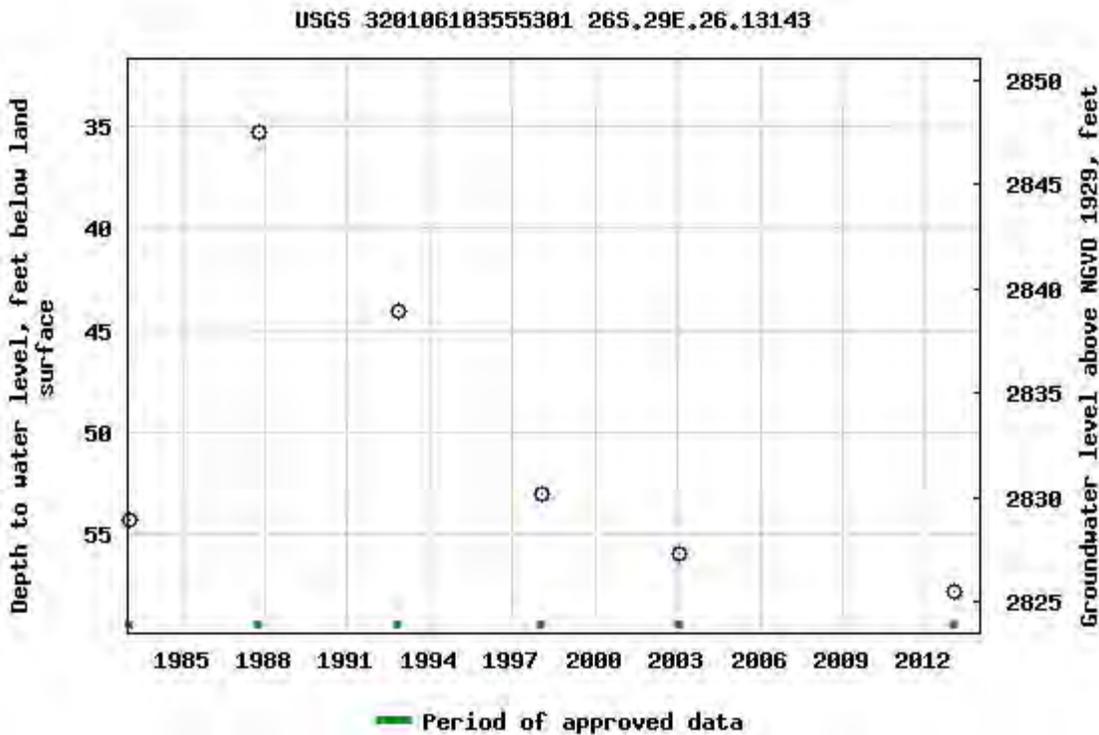
This well is completed in the Rustler Formation (312RSLR) local aquifer.

Breaks in the plot represent a gap of at least one year between field measurements.

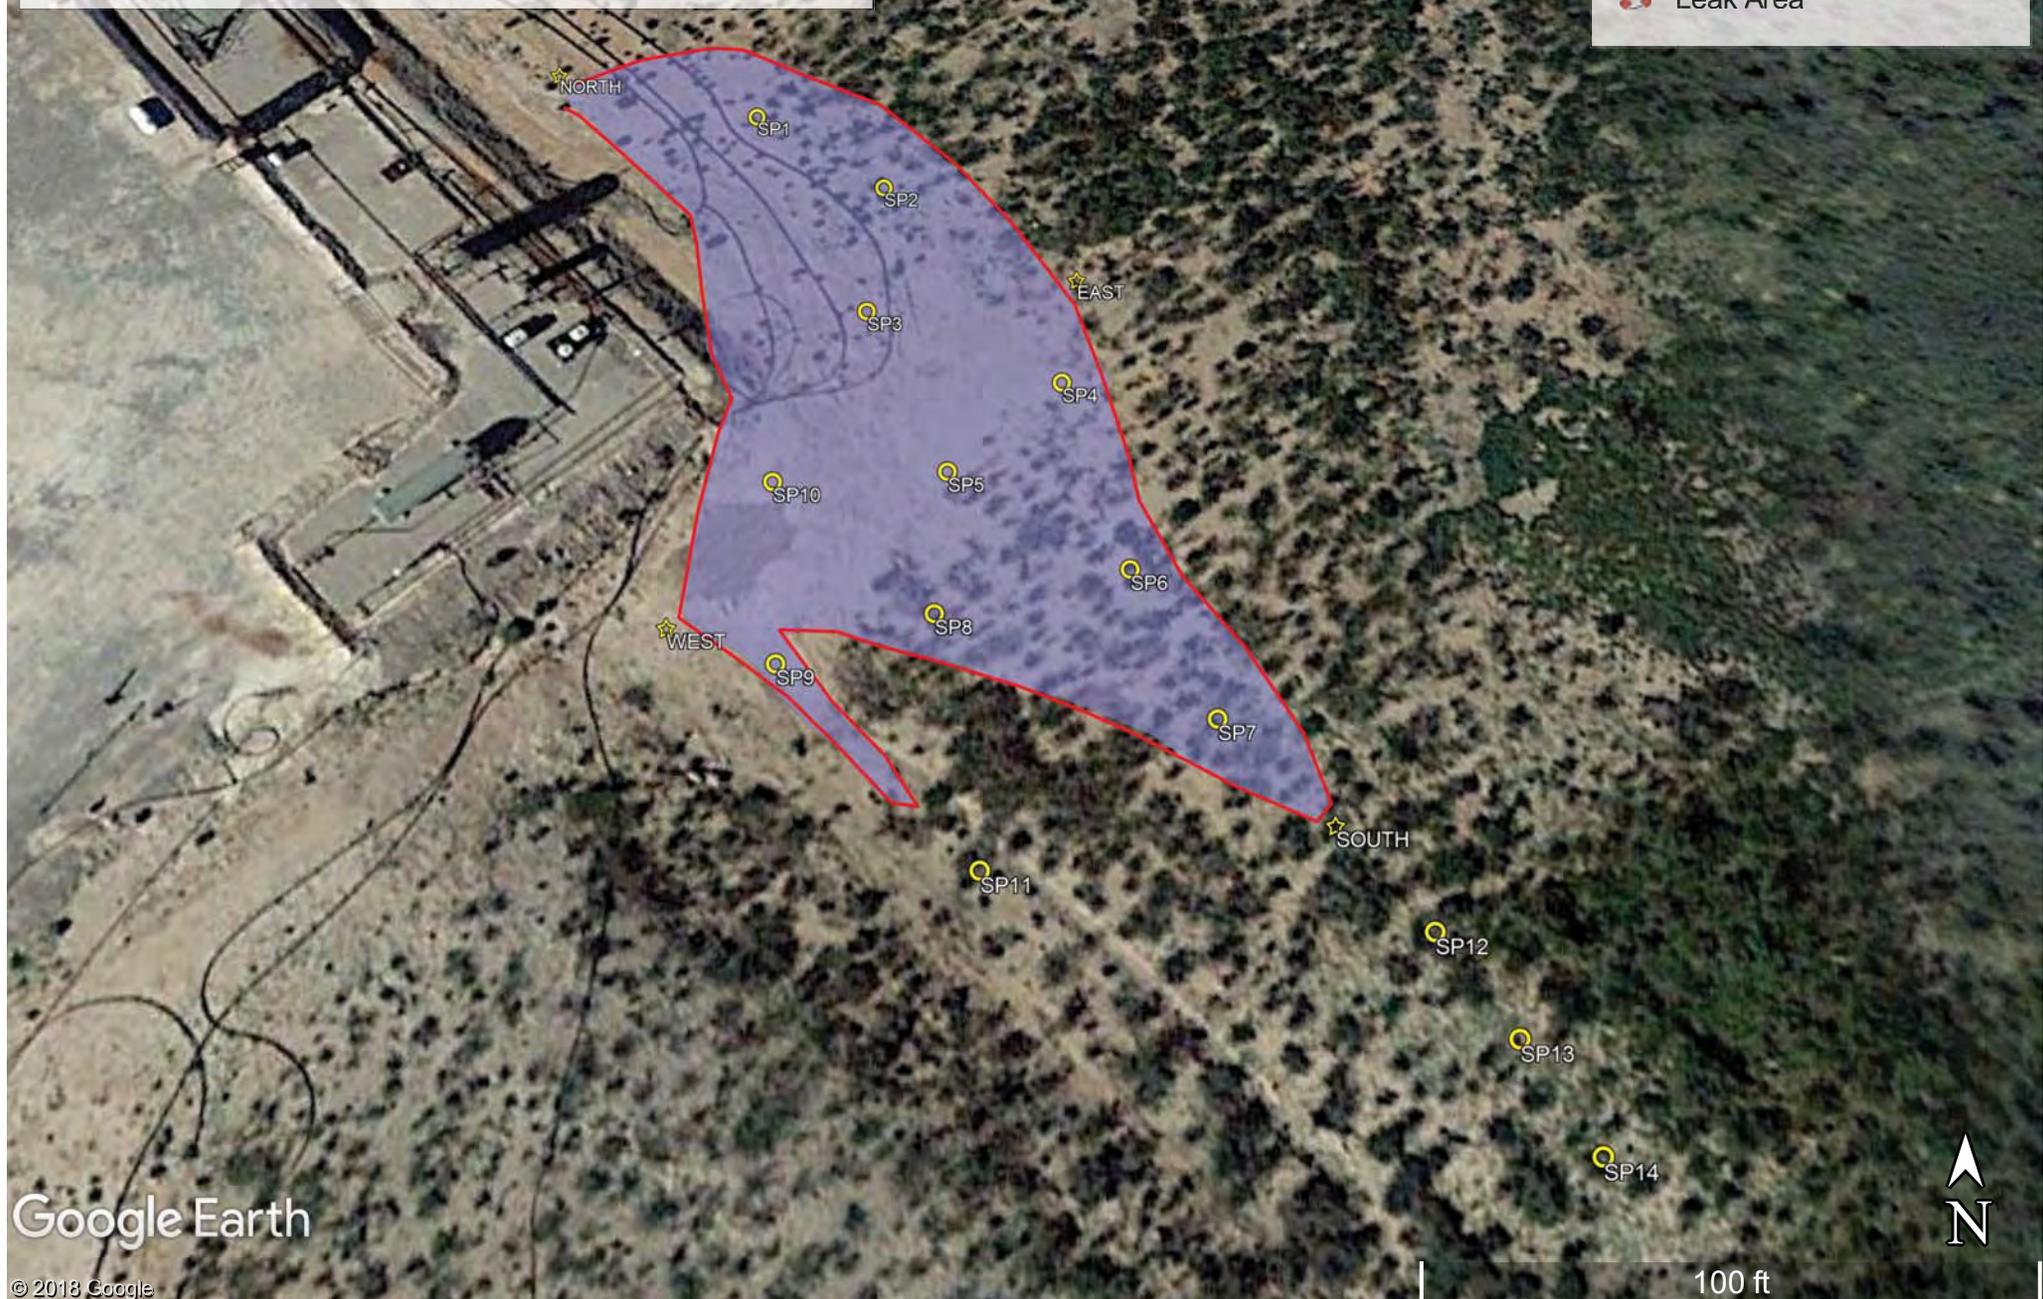
Leak Area

COG will excavate the spill area as depicted on the following site diagram. The entire leak area will be excavated to a depth of 4 feet with an impermeable liner placed in the bottom of the excavation.

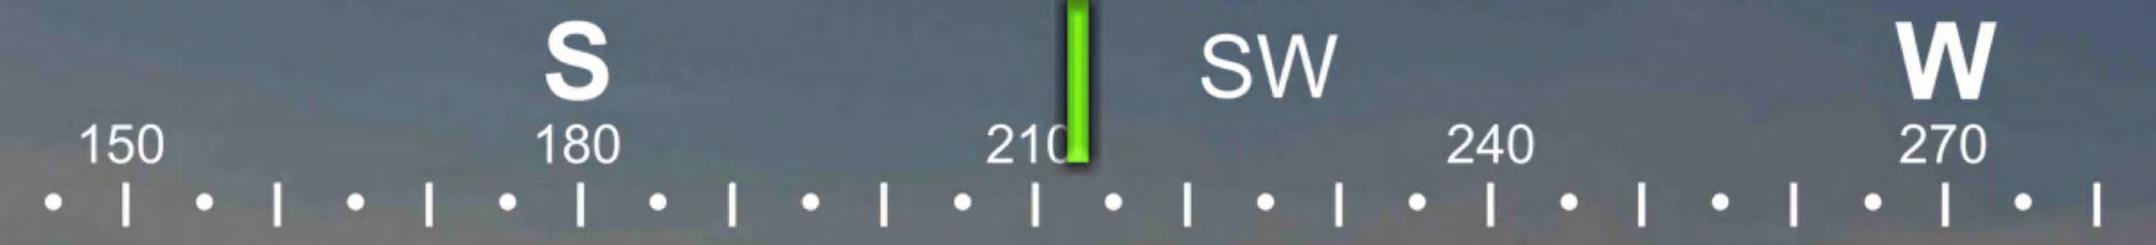
☉ 165°S (T) ● 32°0.103', -104°0.999' ±32ft ▲ 2894ft

COG OPERATING LLC
COPPERHEAD 31 FED COM #1H
UNIT L, H LOT 7 SEC.31-T26S-R29E
480' FSL & 480' FEL
EDDY COUNTY, NM
API #30-015-38532
NMNM121474

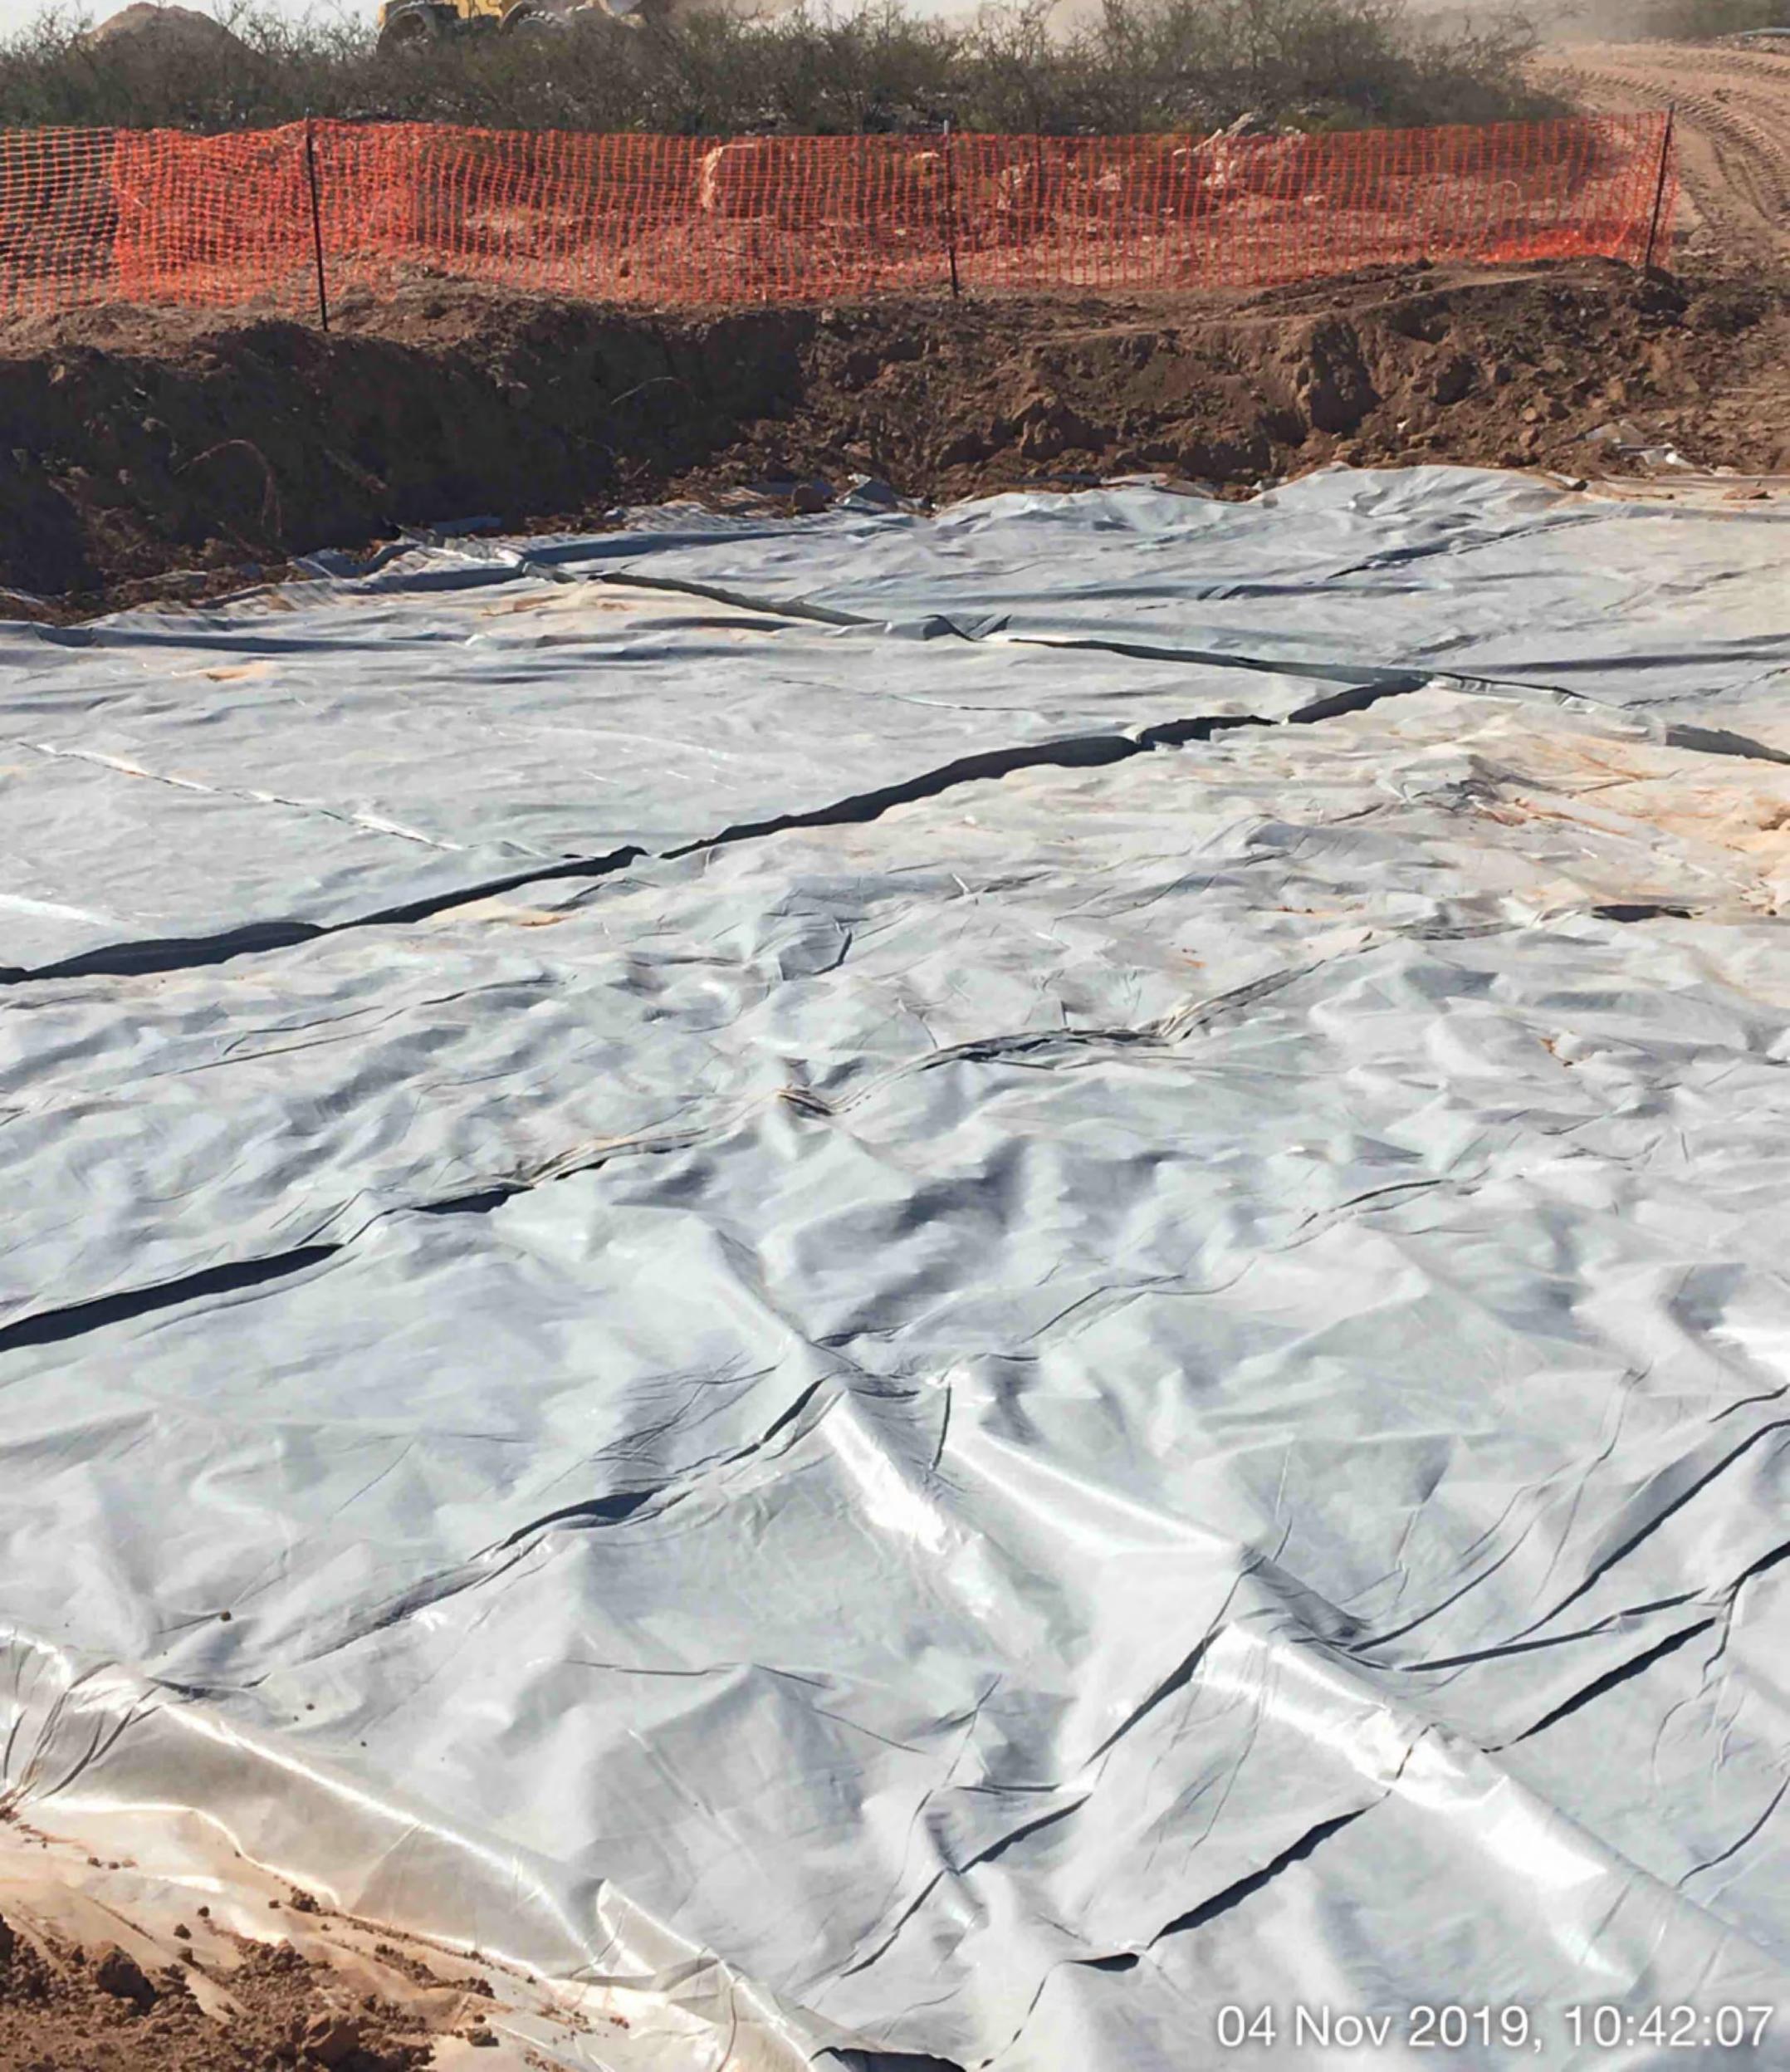
☉ 213°SW (T) ● 32.001416°, -104.015871° ±16ft ▲ 2892ft

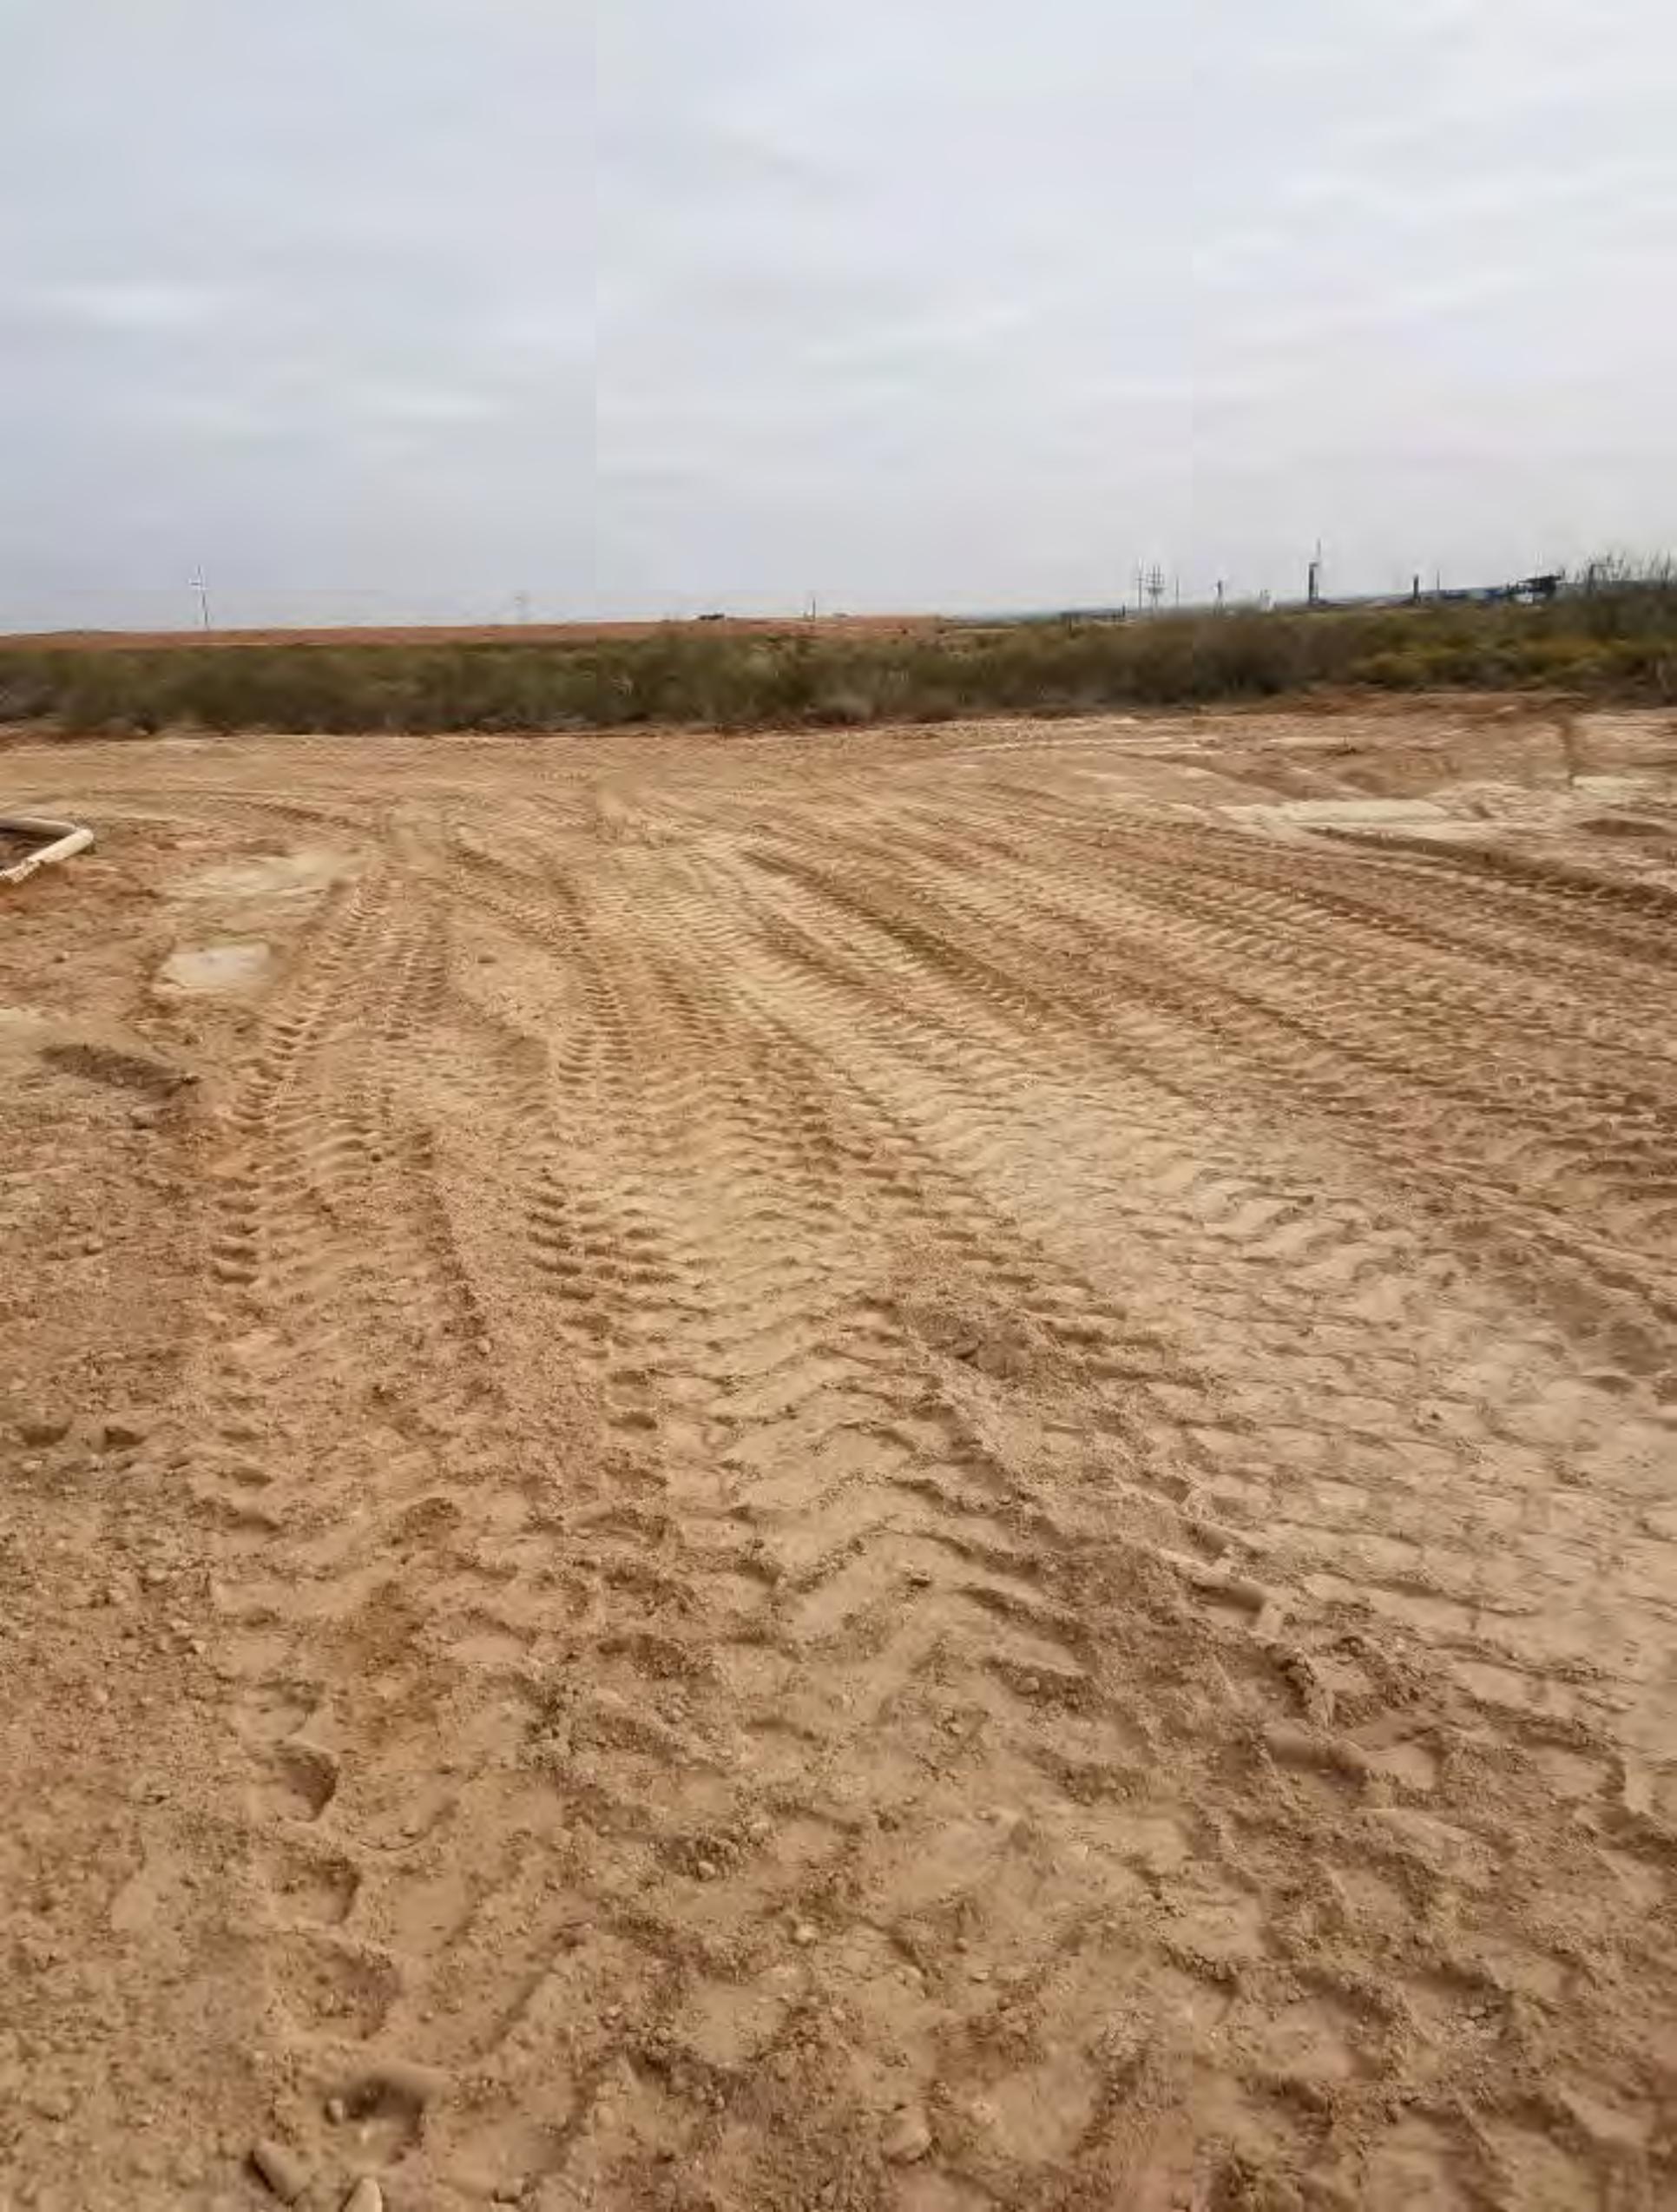
04 Nov 2019, 10:42:07
