Release Notification CGHSS-190822-C-1410

Site Name SWD riser near Poker Lake Unit #158 CTB	Site Type Salt Water Disposal Pipeline
Date Release Discovered 8/7/2019	API# (if applicable) 30-015-31690 (Poker Lake Unit #158)

LT Environmental, Inc.

Project: 012919179	XTO Energy, Inc. Salt Water Disposal Pipeline Riser near Poker Lake Unit #128 CTB

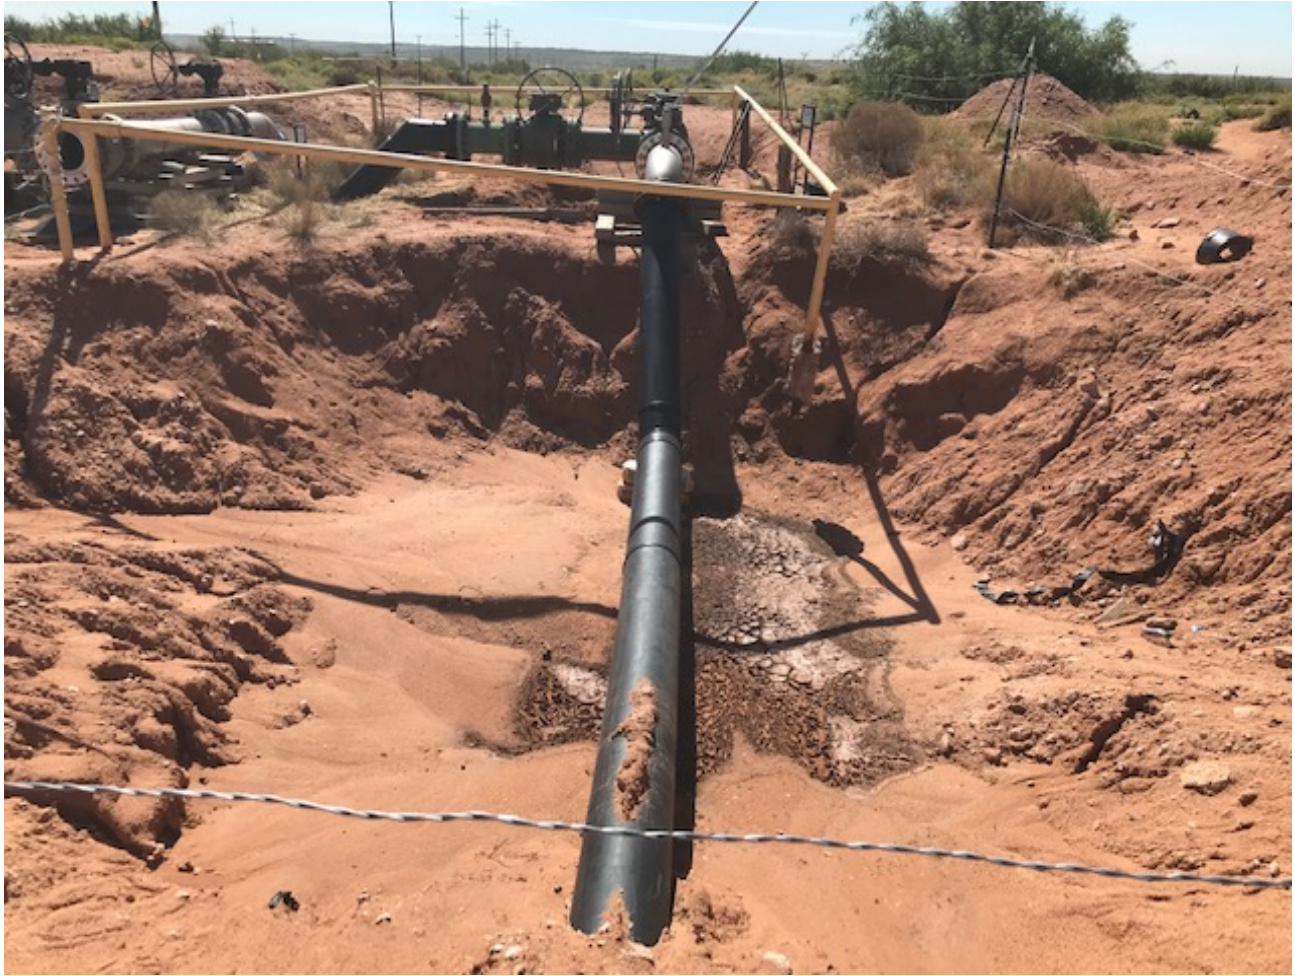
Existing excavation from recently exposing the riser and release facing east during Site assessment activities.

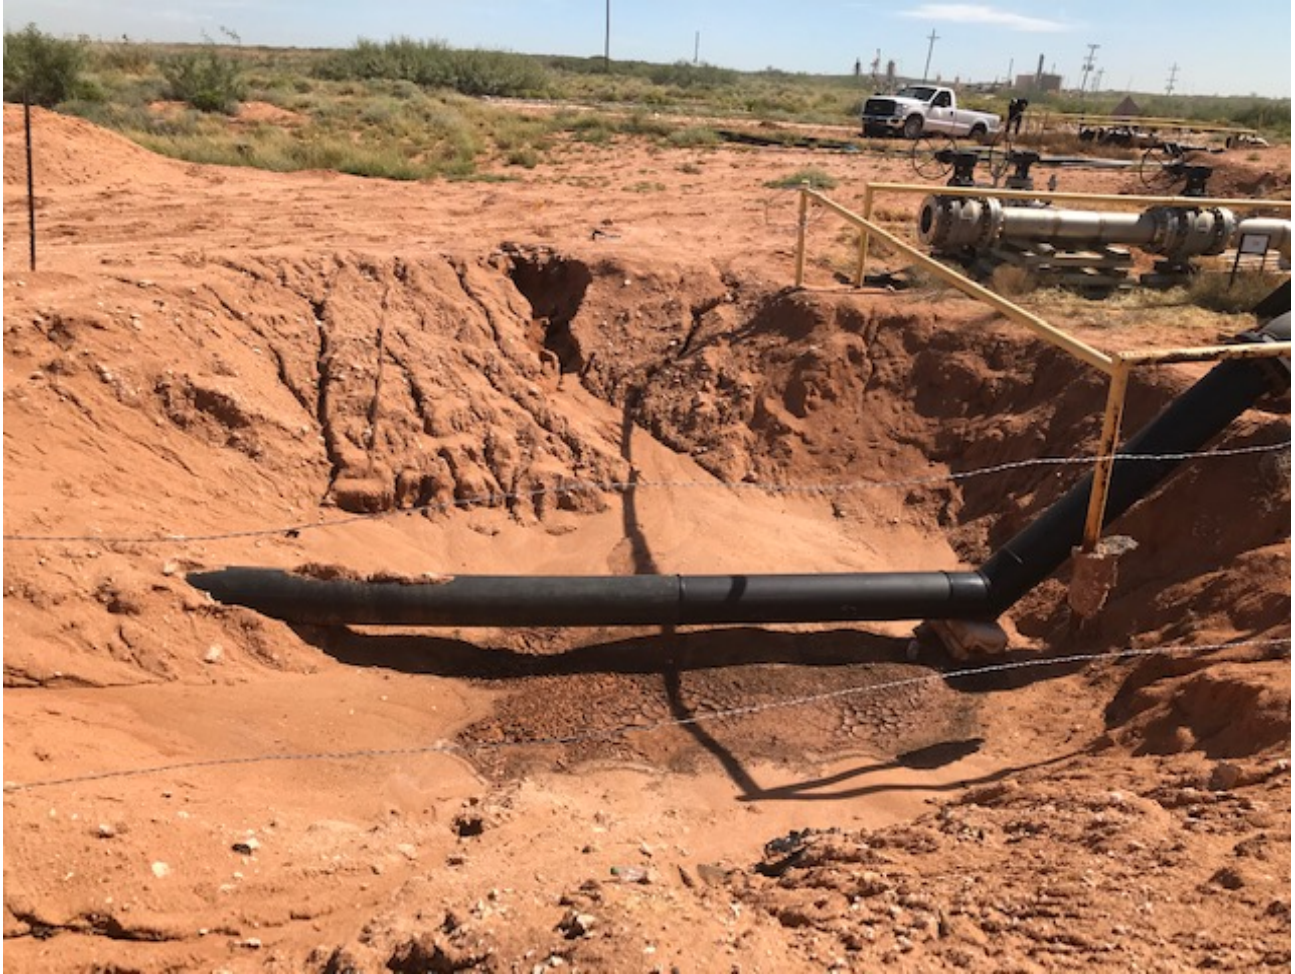
Existing excavation from recently exposing the riser and release facing north during Site assessment activities.
