Release Notification UTL32-190827-C-1410**Responsible Party**

Site Name Poker Lake Unit 330H flow line	Site Type Production Well Facility flow line
Date Release Discovered 8/13/2019	API# (if applicable) 30-015-39253 N/A AB

Project: 012919191	XTO Energy, Inc. Poker Lake Unit 330H Flow Line

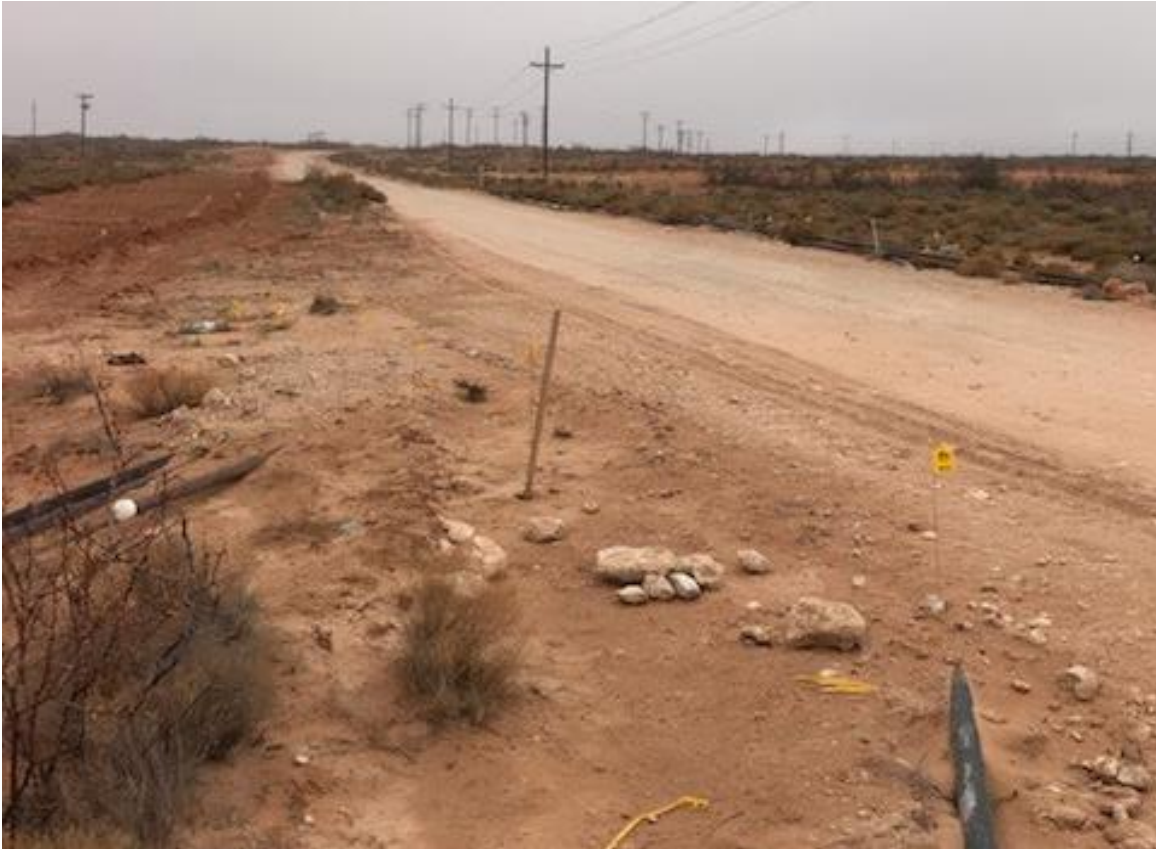
Northern view of release area after excavation activities.

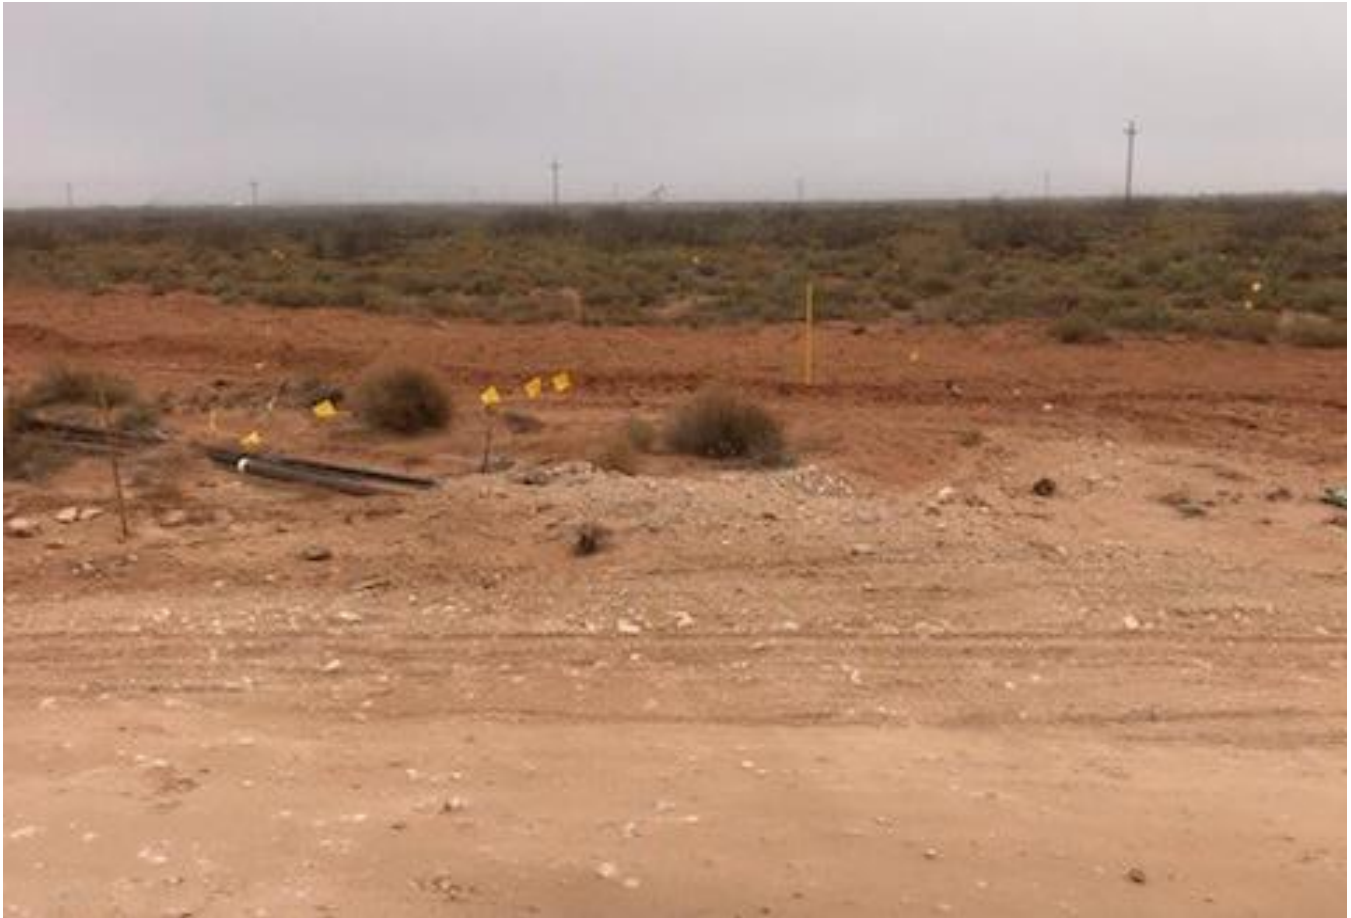
Eastern view of release area after excavation activities.
