Closure Report

Site Name:	Cedar Canyon 15 1 WTF South
Company:	Oxy USA Inc.
Legal Description:	U/L K, Section 15, T24S, R29E
County:	Eddy County, NM
GPS Coordinates:	N 32.21560 W-103.97514

Date of Release:	8/15/18
Type of Release:	Produced water
Source of Release:	Transfer pump seal caused leak between AST Cluster
Volume of Release:	25 bbls
Volume Recovered:	20 bbls

Oxy, Cedar Canyon 15 1 WTF South

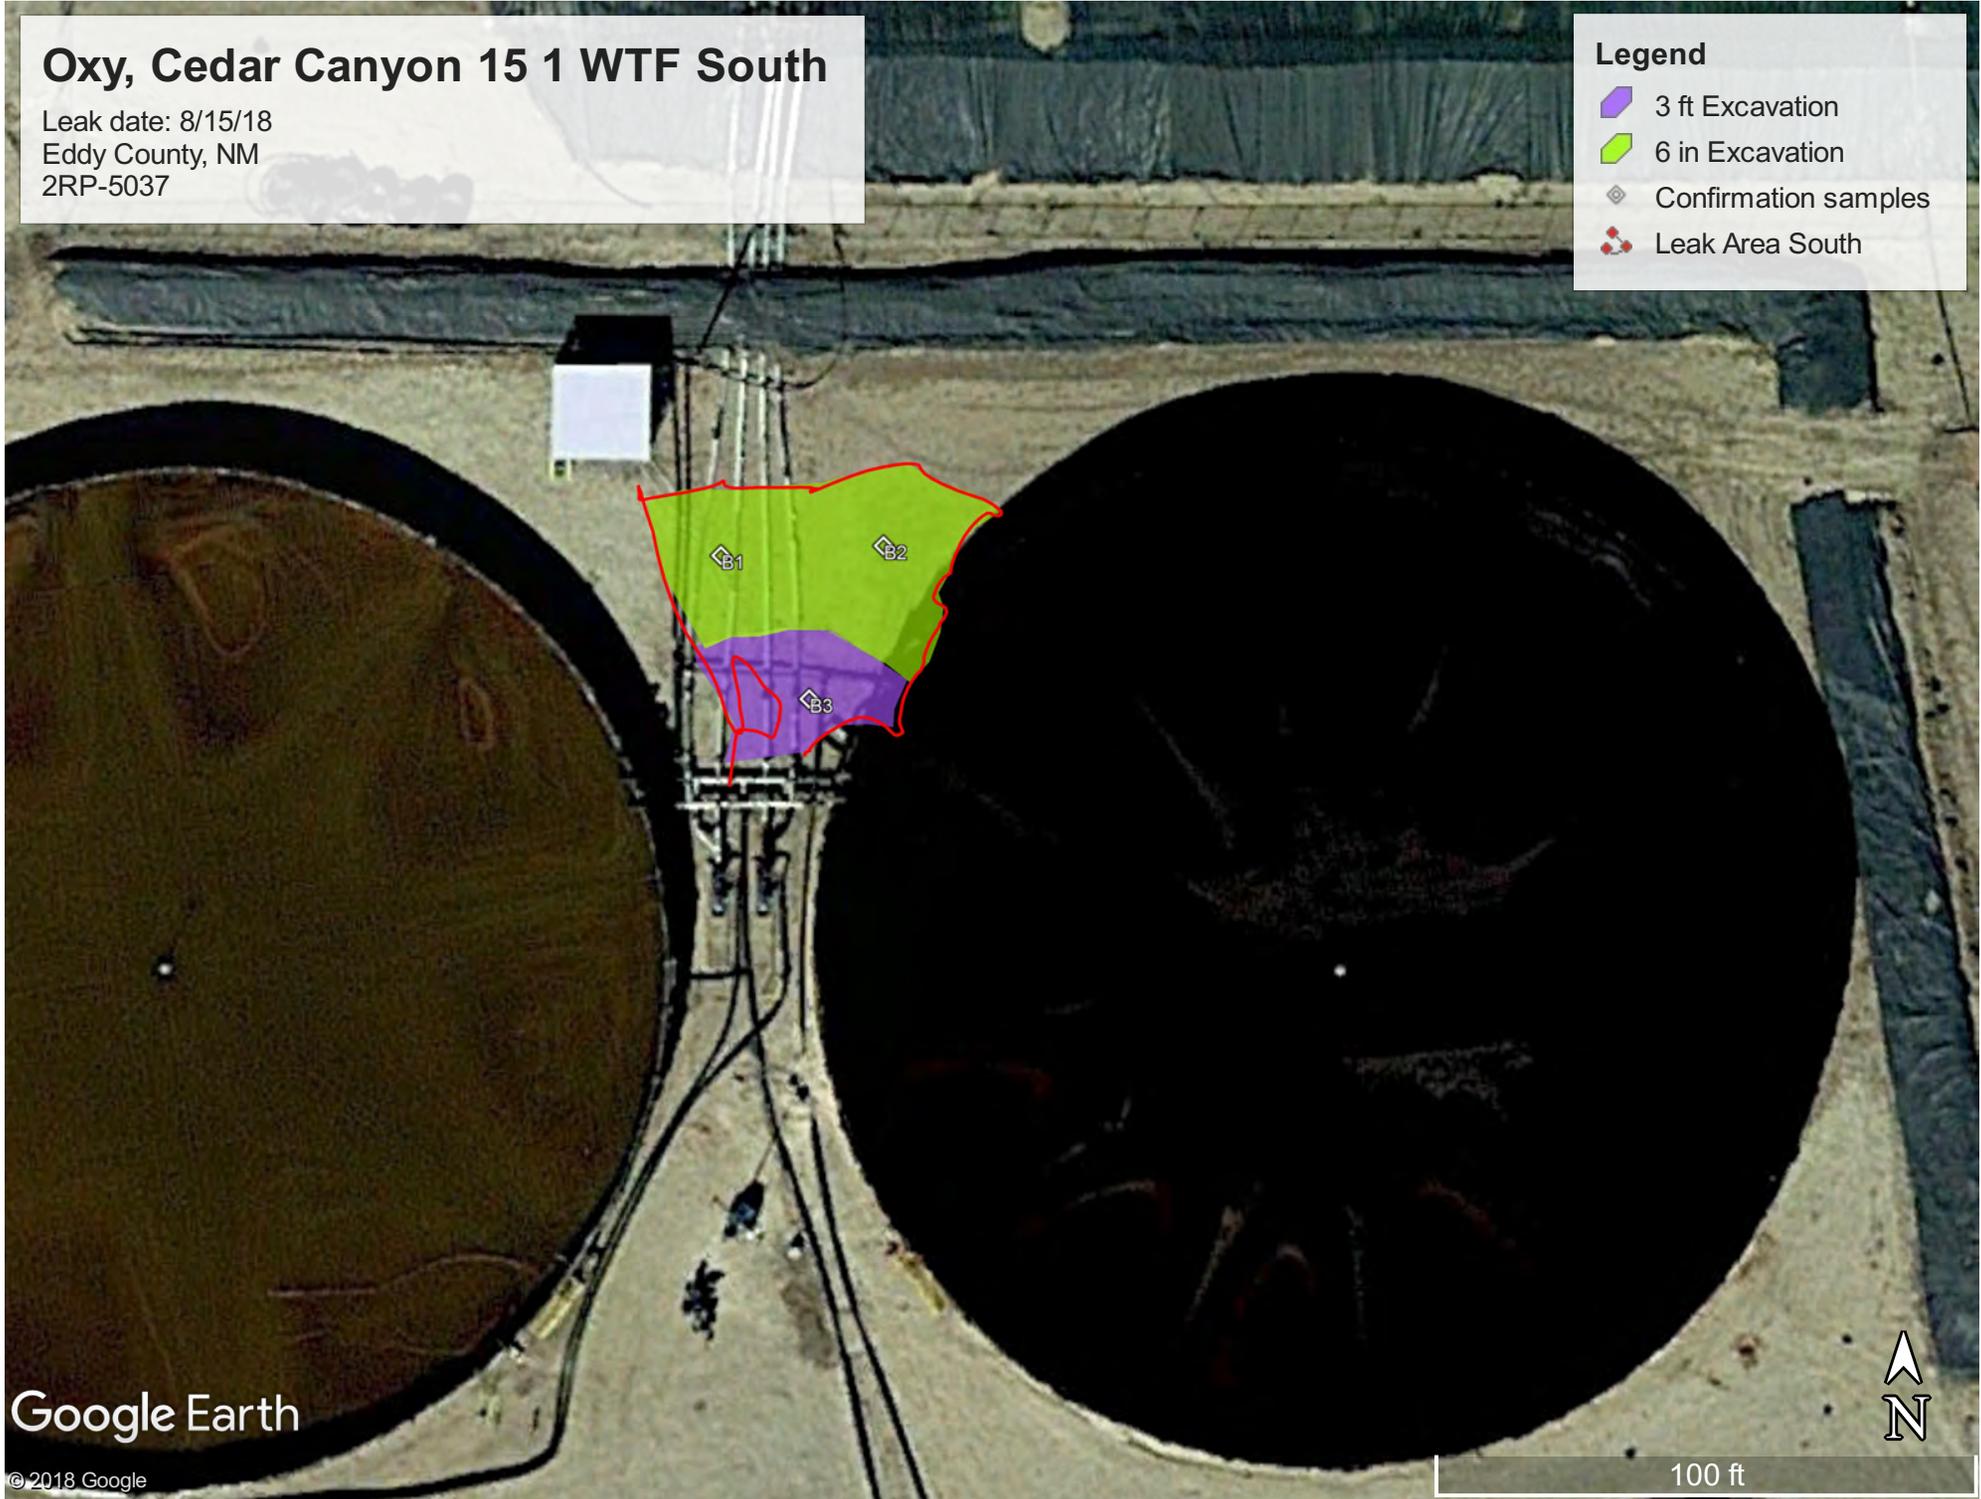
Leak Area South

Legend

3 ft Excavation
-

6 in Excavation
-

Confirmation samples
-

Remediation Parameters:	Excavate the areas of SP1 & SP2 to a depth of 1 foot. Excavate the area of SP3 to a depth of 4 feet. Obtain bottom confirmation samples. Backfill the site with clean soil.	
Remediation Activities:	10/1/19 to 10/21/19	
Plan Sent to OCD:	6/28/19	Email from Cliff Brunson to NMOCD
OCD Approval of Plan:	7/2/19	Email from Robert Hamlet to Cliff Brunson
Plan Sent to BLM:	n/a	n/a
BLM Approval of Plan:	n/a	n/a

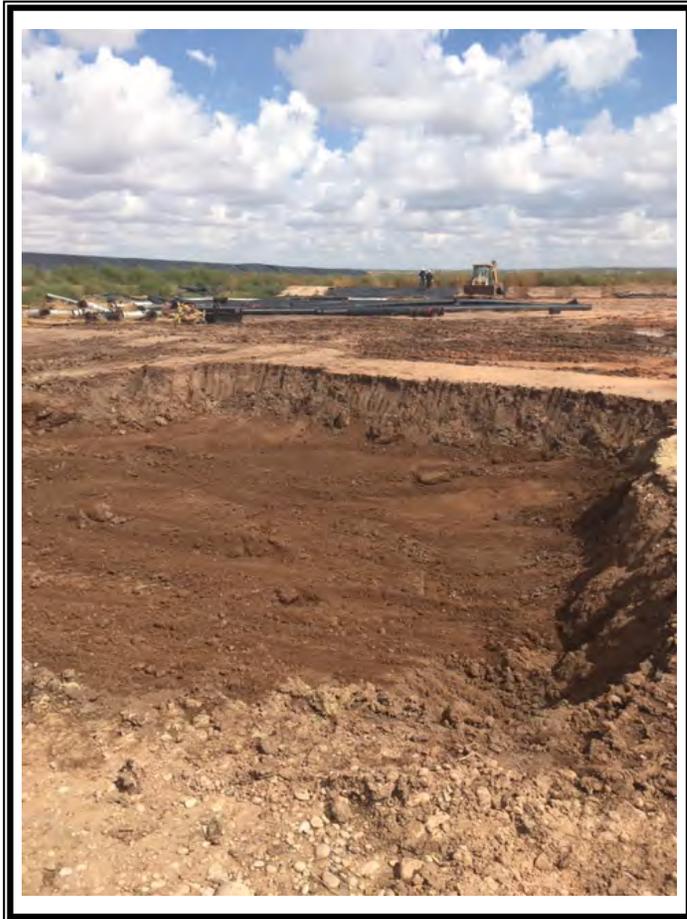
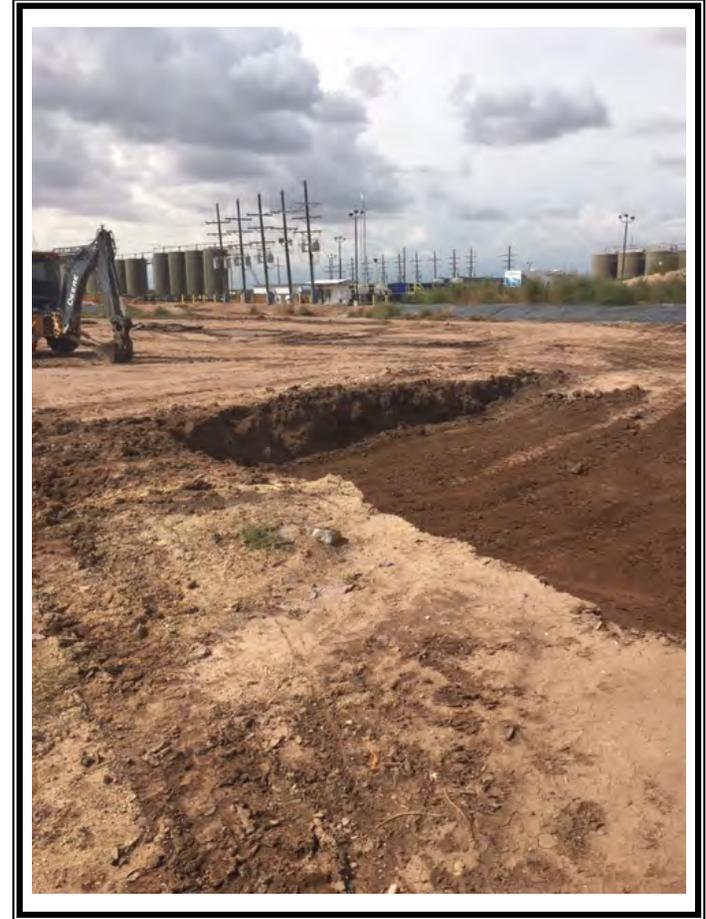
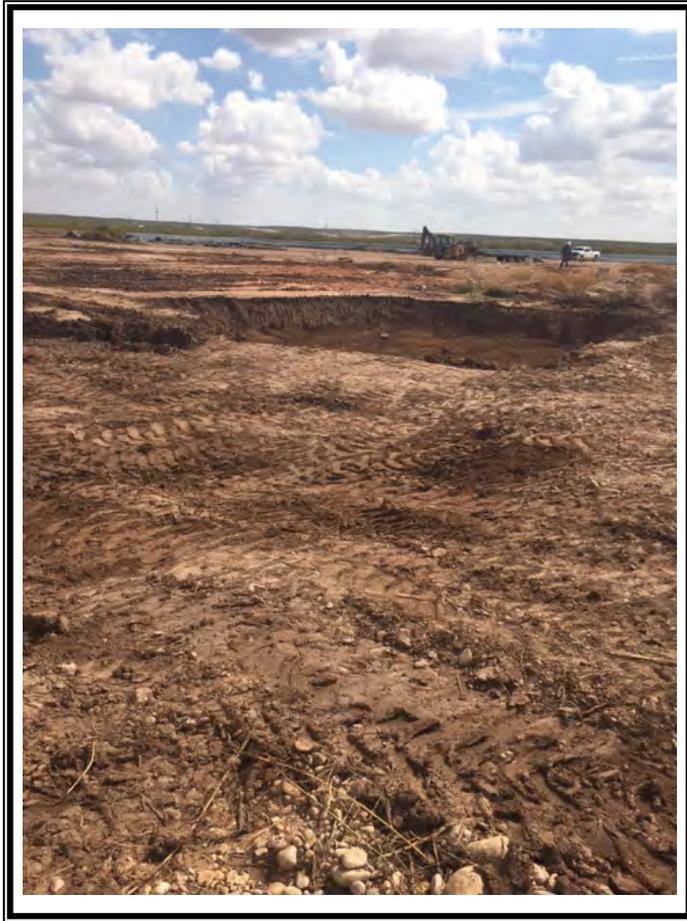
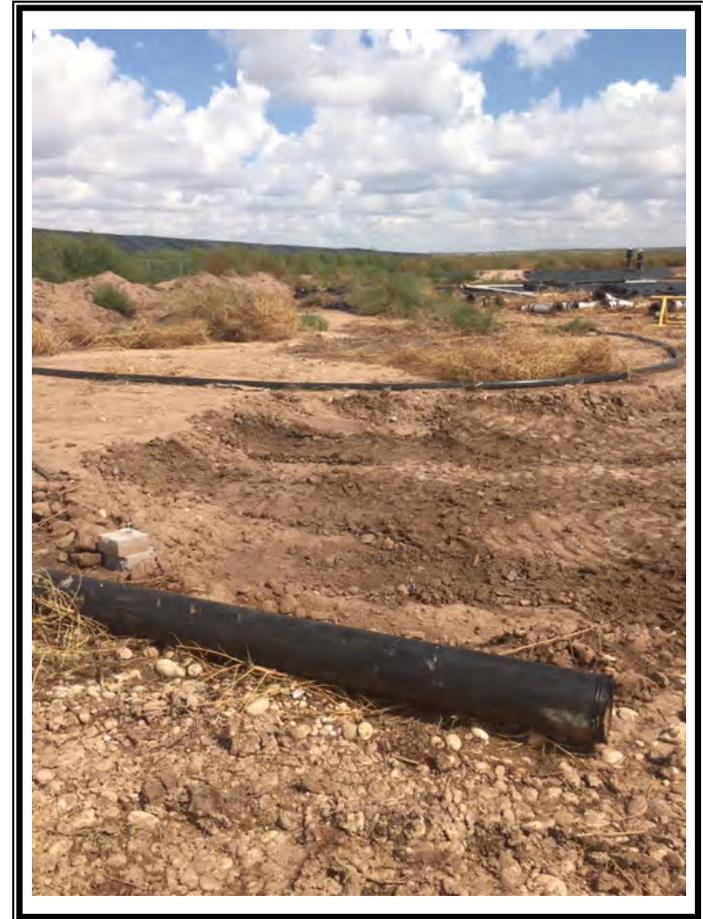
Initial C-141	Signed 11/2/18
C-141, page 6	Signed and included
Site Diagram	September 2018
Pictures	Remediation photos prior to backfill
