**EOG Resources, Inc.**

**Nix GP Battery**

**Remediation Plan**

**O-22-18S-26E**

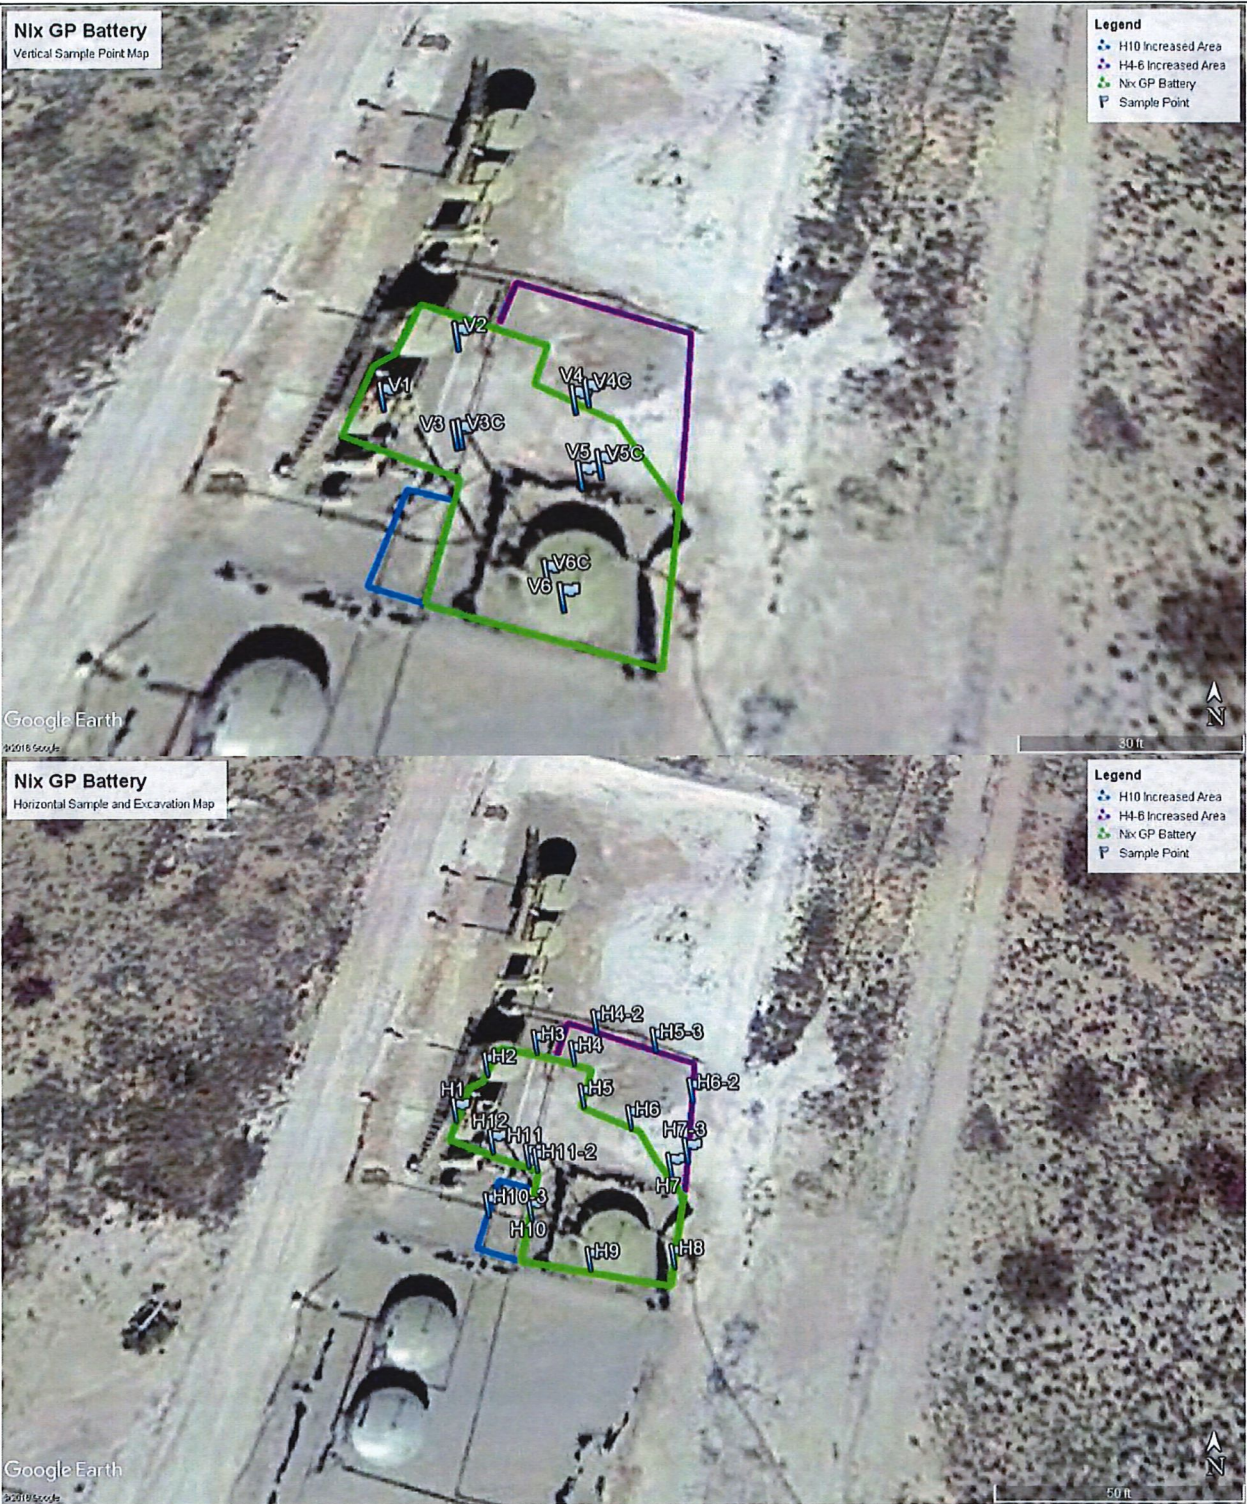
# Figure 1

## Site Map with Sample Points

Due to the completion of bioremediation of the V3 area and excavation complete to the horizontal extents required, EOG Resources, Inc. proposes to backfill the V1, V2, and V3 areas with caliche in order to reinstall production tanks and place the battery back into service. Once this is complete, the remaining island supporting the gas meter at the H11 sidewall, will be completely excavated to four (4) feet bgs. This will effectively make the H10 and H12 horizontal areas continuous and address the impacted H11 area. As soon as that excavation is complete, a confirmation sample will be collected at four (4) feet bgs and at the sidewall that will be exposed between H10 and H12, these samples will be sent to a third party laboratory and if confirmation of Table 1 standards and 19.15.29.13 guidelines are met, the area will backfilled with caliche for reinstallation of the gas meter.

With the reduction in contaminate concentration between initial soil sampling on May 16, 2019, and the confirmation samples collected August 27, 2019, EOG again treated the V4, V5, and V6 vertical areas with Liquid Remediate on September 12, 2019. The treatment on September 12 followed the protocol used for the June 11 treatment, 16 gallons of Liquid Remediate was mixed in with 160 gallons of fresh water and the mixture was applied to the soils as it was stirred with an excavator. EOG Resources, Inc. proposes to allow the bioremediation product to work on the impacted soils for 90 days from the treatment date of September 12. This would put the confirmation sampling date at December 12, 2019. EOG would perform confirmation sampling the same as previously completed, taking a sample every two (2) feet within the treatment areas, with sampling to extend four (4) feet past the known impaction depth. If all samples are below Table 1 standards, then the site will be backfilled with caliche to grade and a Closure Report will be submitted with confirmation soil data. If the confirmation samples are not below Table 1 standards, the site will be reevaluated for the appropriate method to complete remediation of the 3 remaining areas.

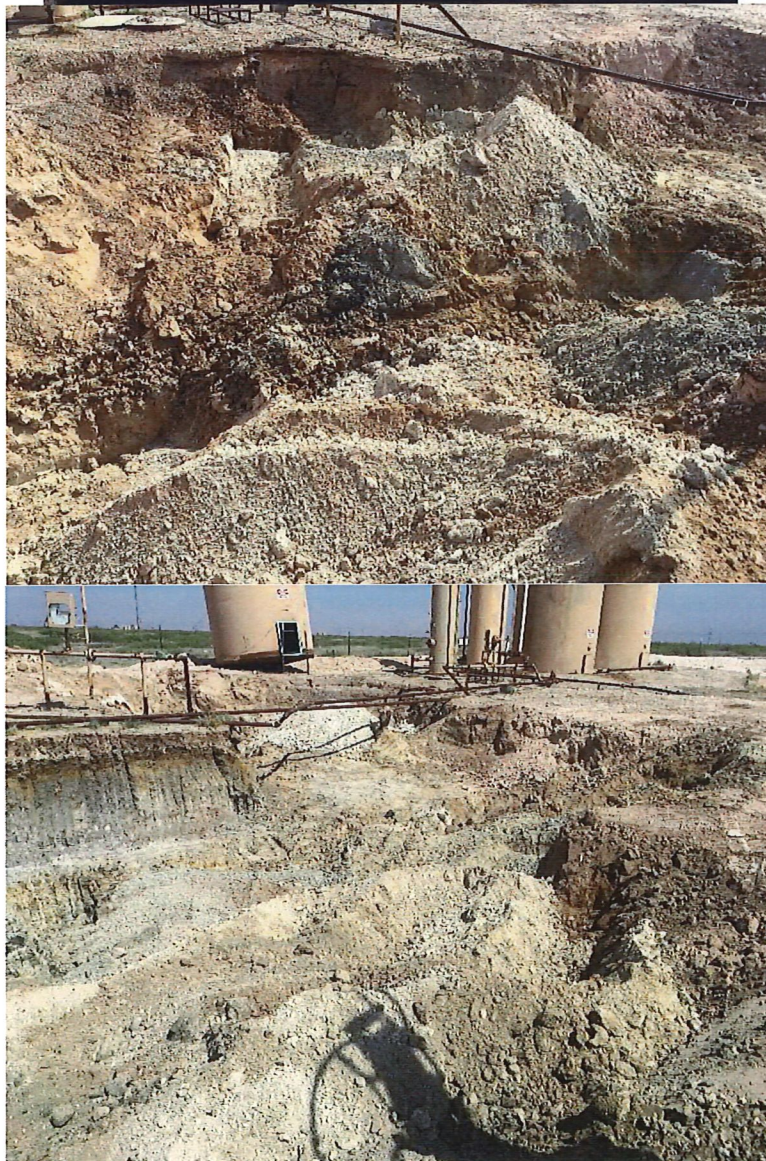
NIX "GP"  
BATTERY

SW 1/4 - SE 1/4 - Unit  
Sec. 22 - T 18 S - R 26 E  
Eddy Co. New Mexico

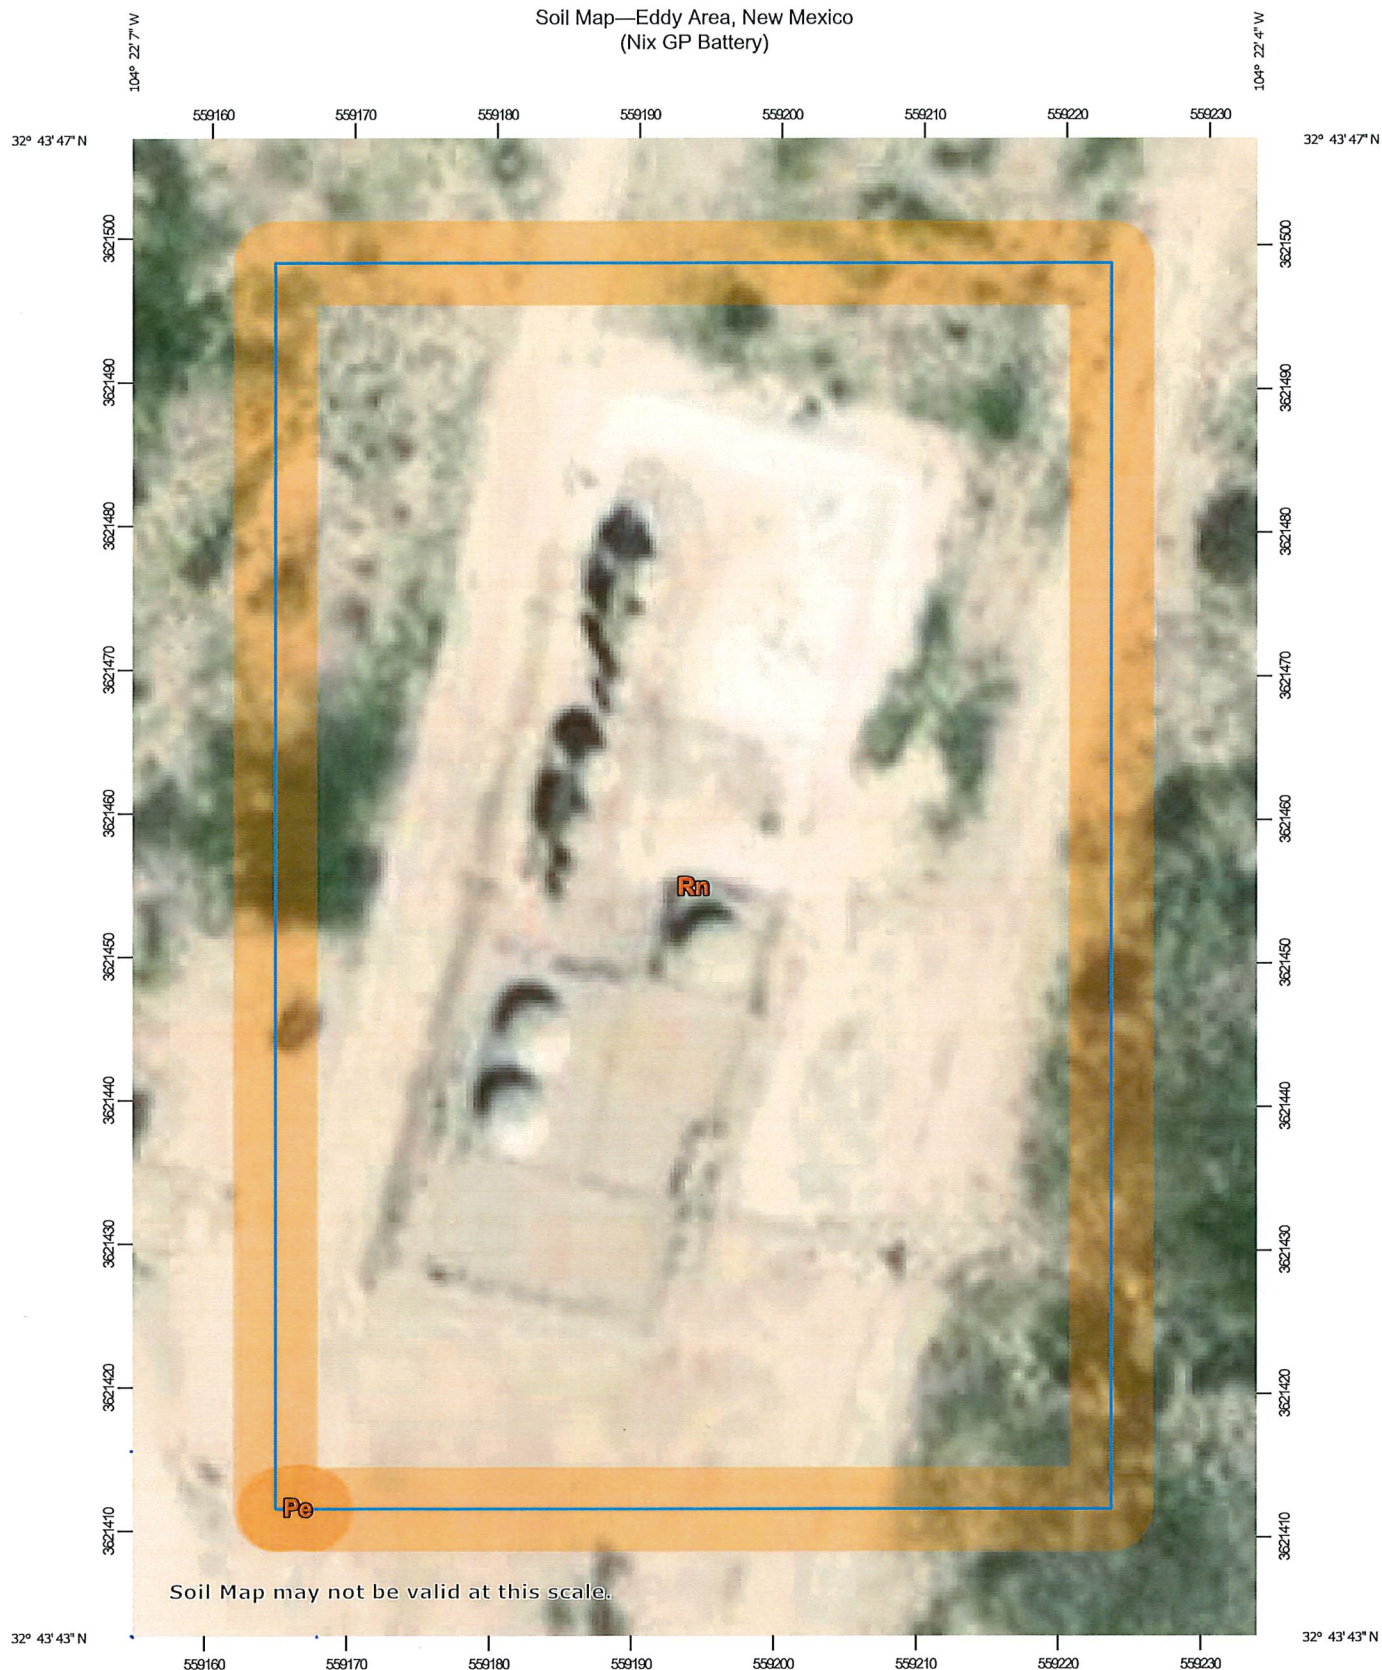
# Soil Map—Eddy Area, New Mexico (Nix GP Battery)

Map Unit Symbol	Map Unit Name	Acres in AOI	Percent of AOI
Pe	Pima silt loam, 0 to 1 percent slopes	0.0	0.0%
Rn	Reeves loam, 1 to 3 percent slopes	1.3	100.0%
Totals for Area of Interest		1.3	100.0%

USDA Natural Resources Conservation Service (NRCS) classifies soil at the site as Reeves loam, with 1-3% slopes.
