December 30, 2019

Vertex Project #: 19E-00614-013

Spill Closure Report: El Presidente State 24 27 2 WA #005H
Unit P, Section 02, Township 24 South, Range 27 East
County: Eddy
API: 30-015-44483
Tracking Number: NRM1935232619

2019 Spill Assessment and Closure
December 2019

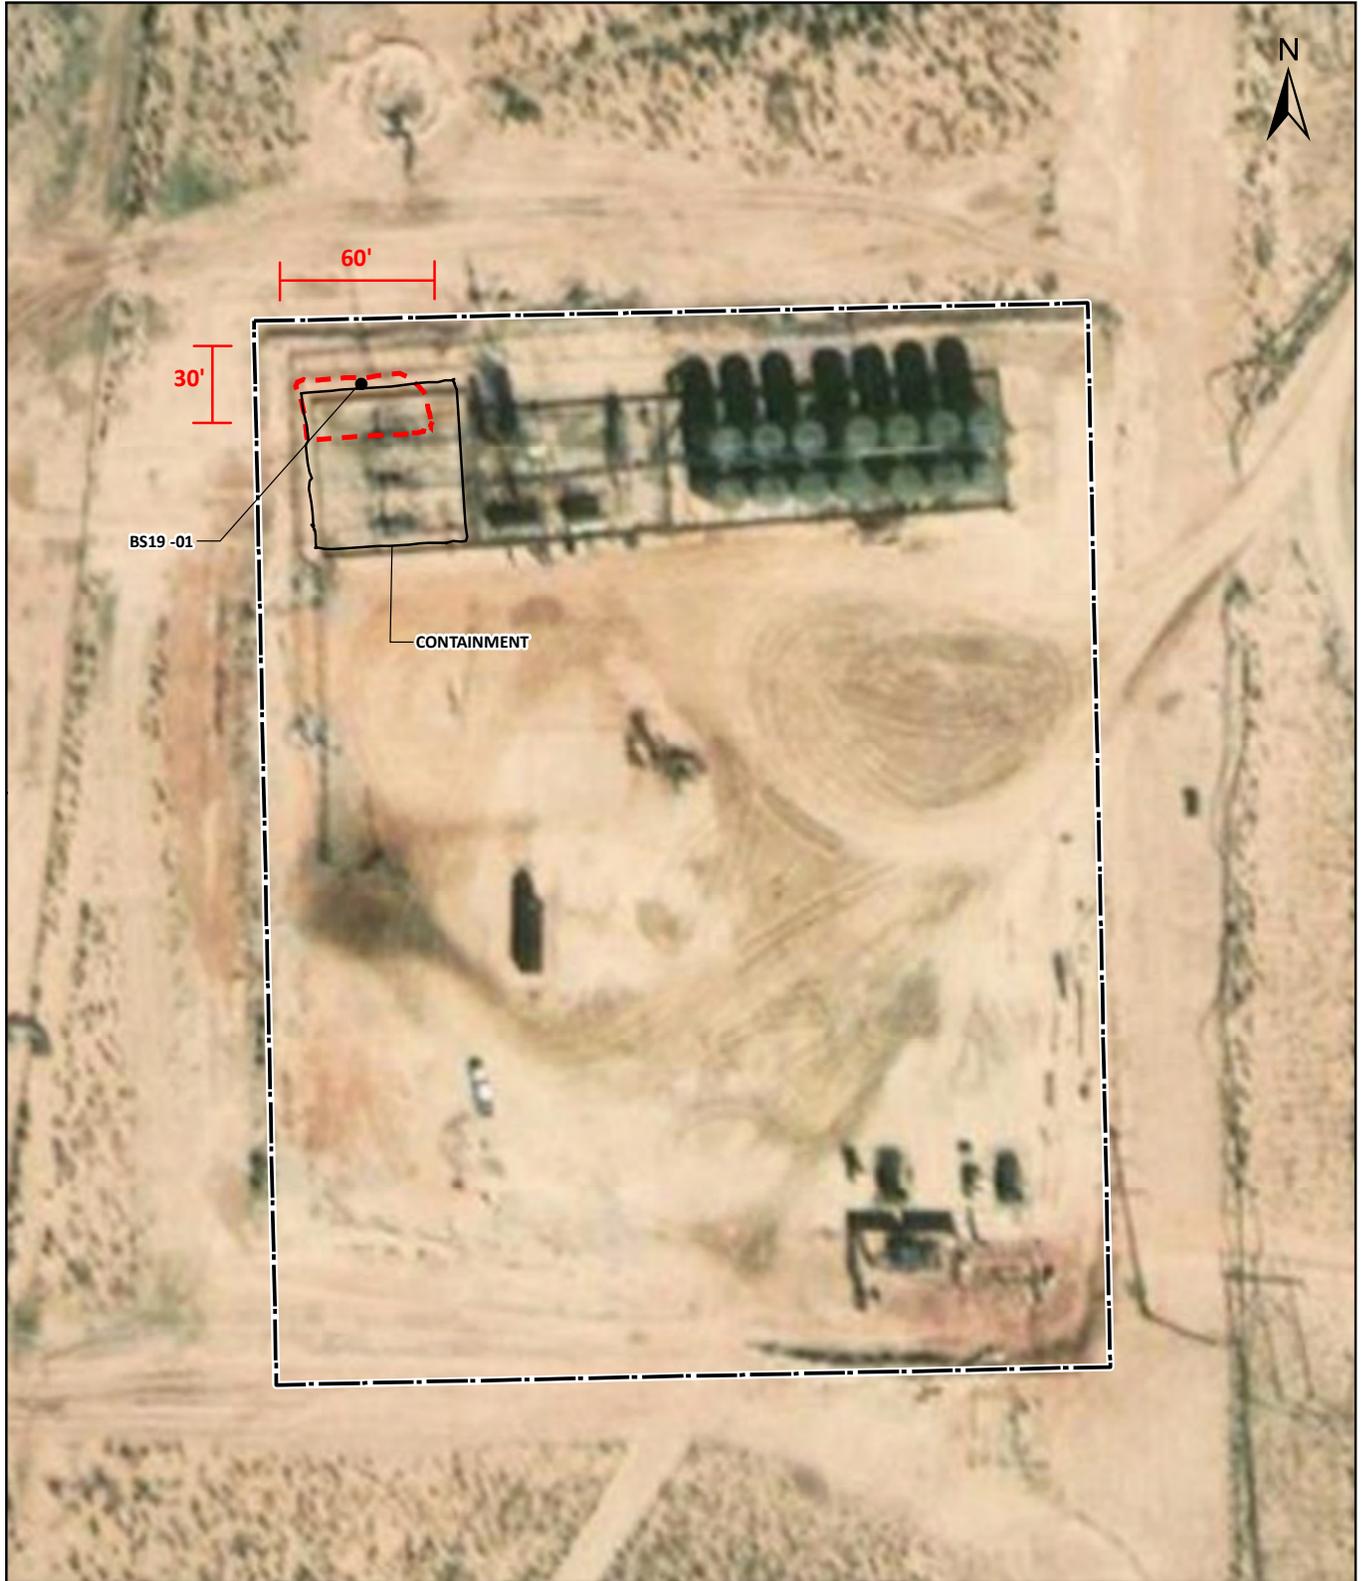
A GeoExplorer 7000 Series Trimble global positioning system (GPS) unit was used to map the approximate center of the five-point composite sample. The confirmation sampling location is presented on Figure 1 (Attachment 2). Relevant equipment and prominent features/reference points at the site are mapped as well.

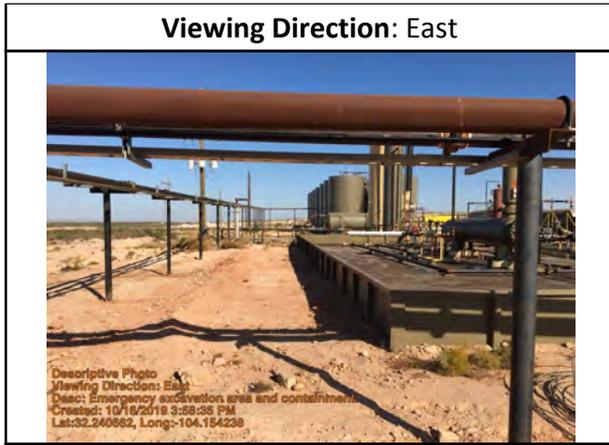
Emergency excavation area and containment.

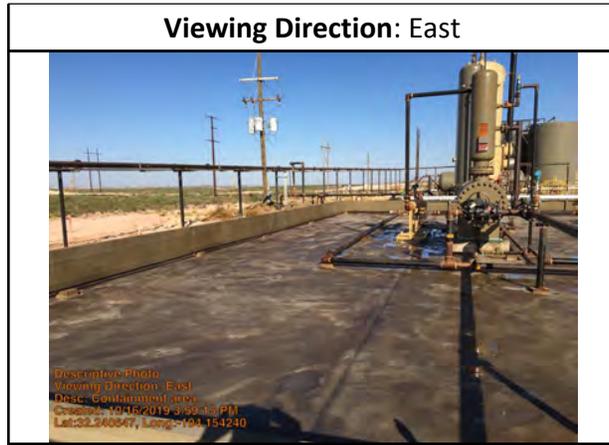
Containment area.

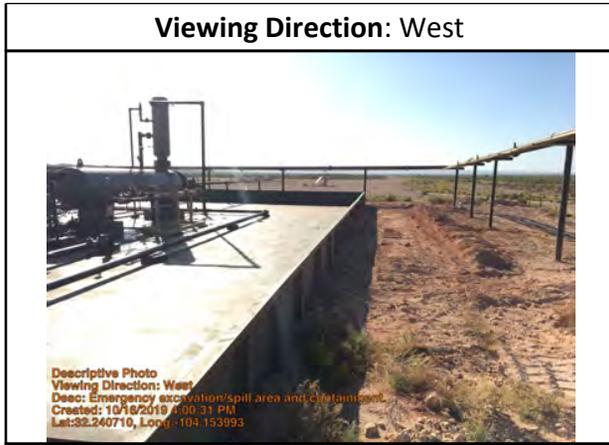
Emergency excavation/spill area and containment.

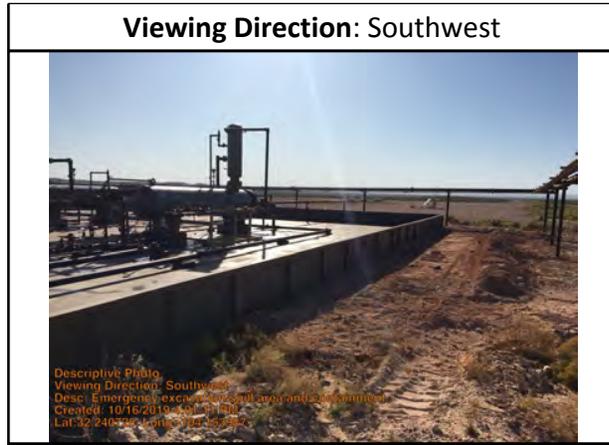
Emergency excavation/spill area and containment.

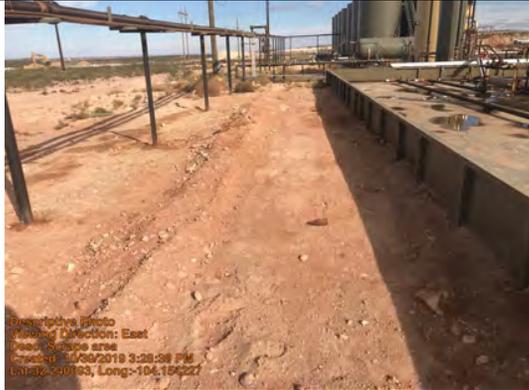
Viewing Direction: East

Scrape area

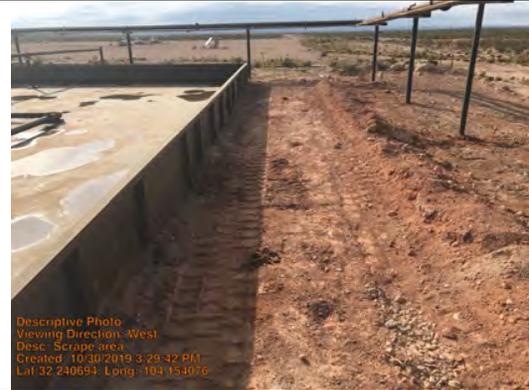
Viewing Direction: West

Scrape area

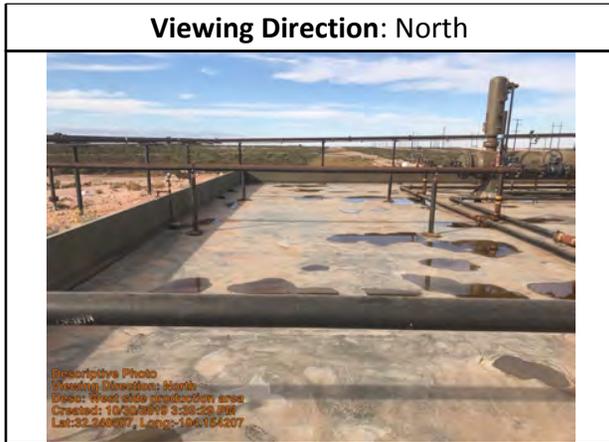
West side production area

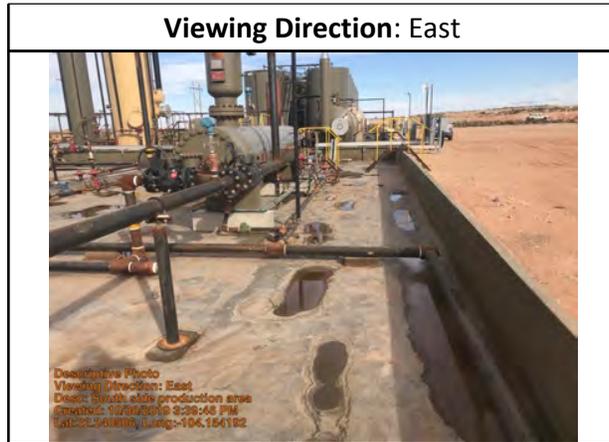
South side production area

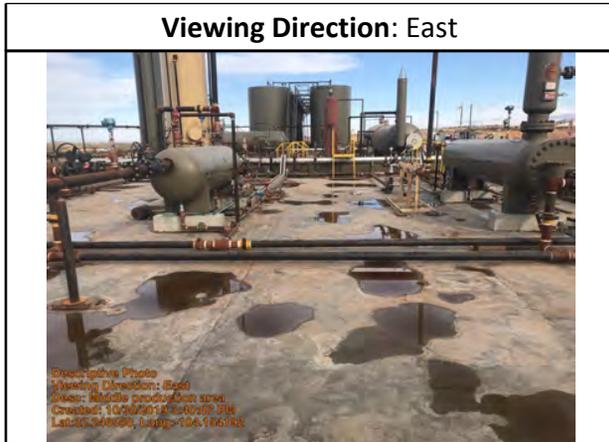
Middle production area

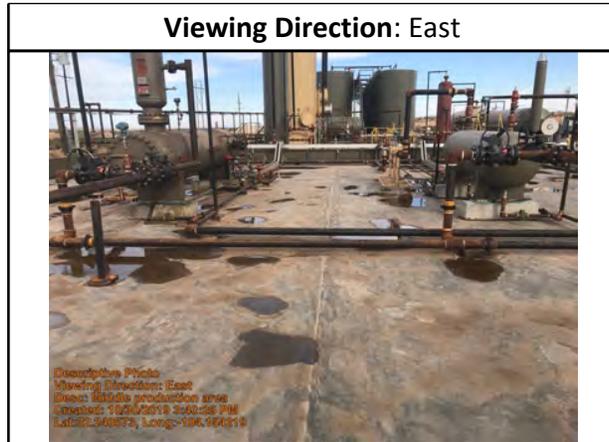
Middle production area

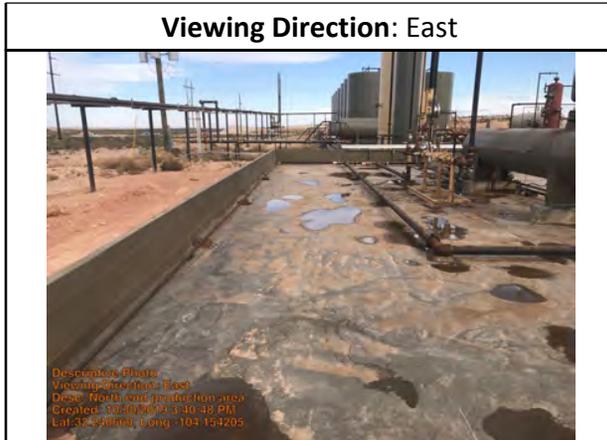
North end production area

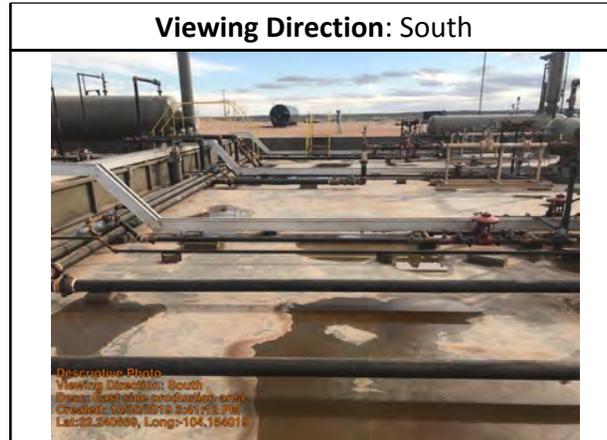
East side production area

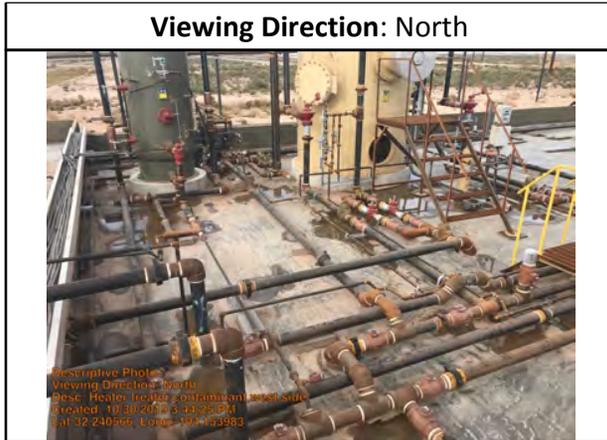
Heater treater contaminant west side

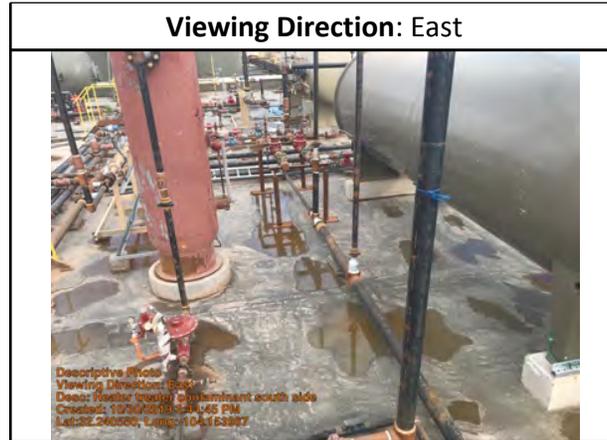
Heater treater contaminant south side

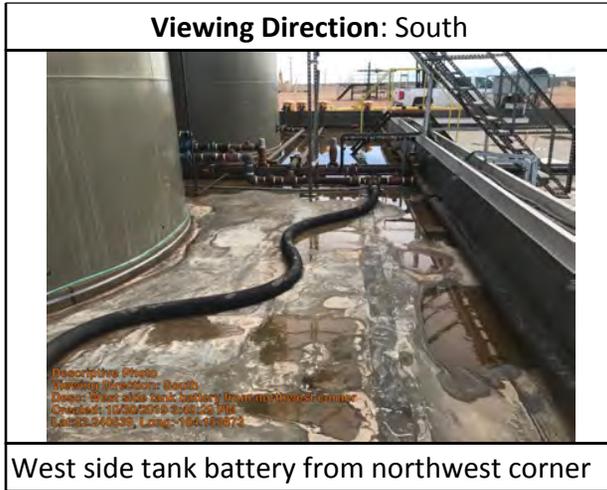
West side tank battery from northwest corner

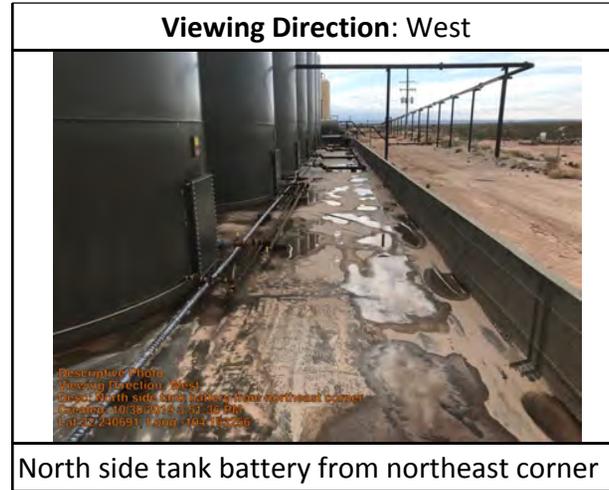
North side tank battery from northeast corner

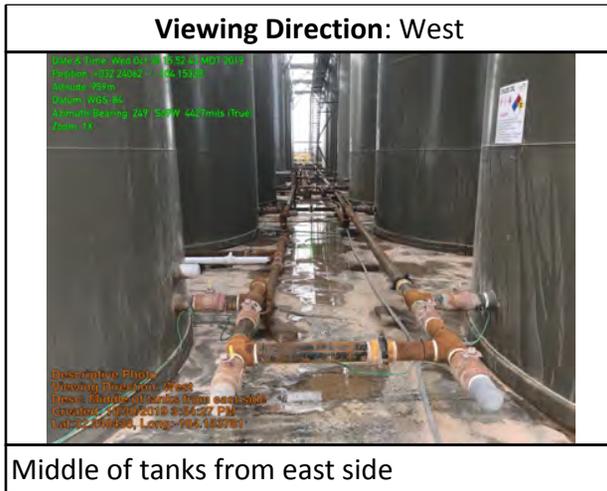
Middle of tanks from east side

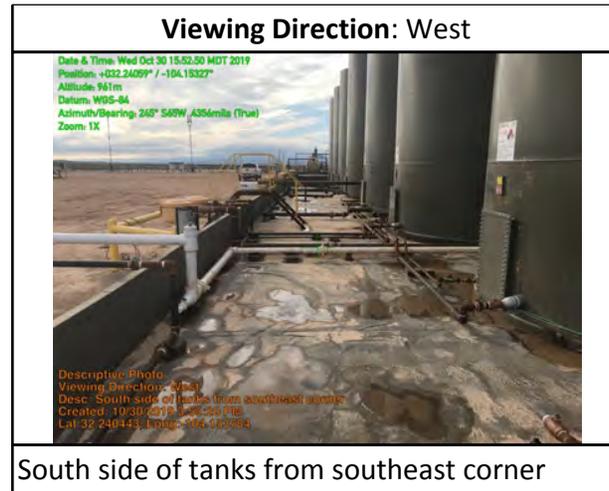
South side of tanks from southeast corner
