## Release Notification

Site Name MARINER FEE 23 28 20 WXY #011H	Site Type Oil and gas drilling facility
Date Release Discovered 10/21/19	API# (if applicable) 30-015-44567

Liner Integrity Inspection (Photos Attached)

Facility: Mariner Fee 23-28-20 #11H, #14H, #18H CTB.

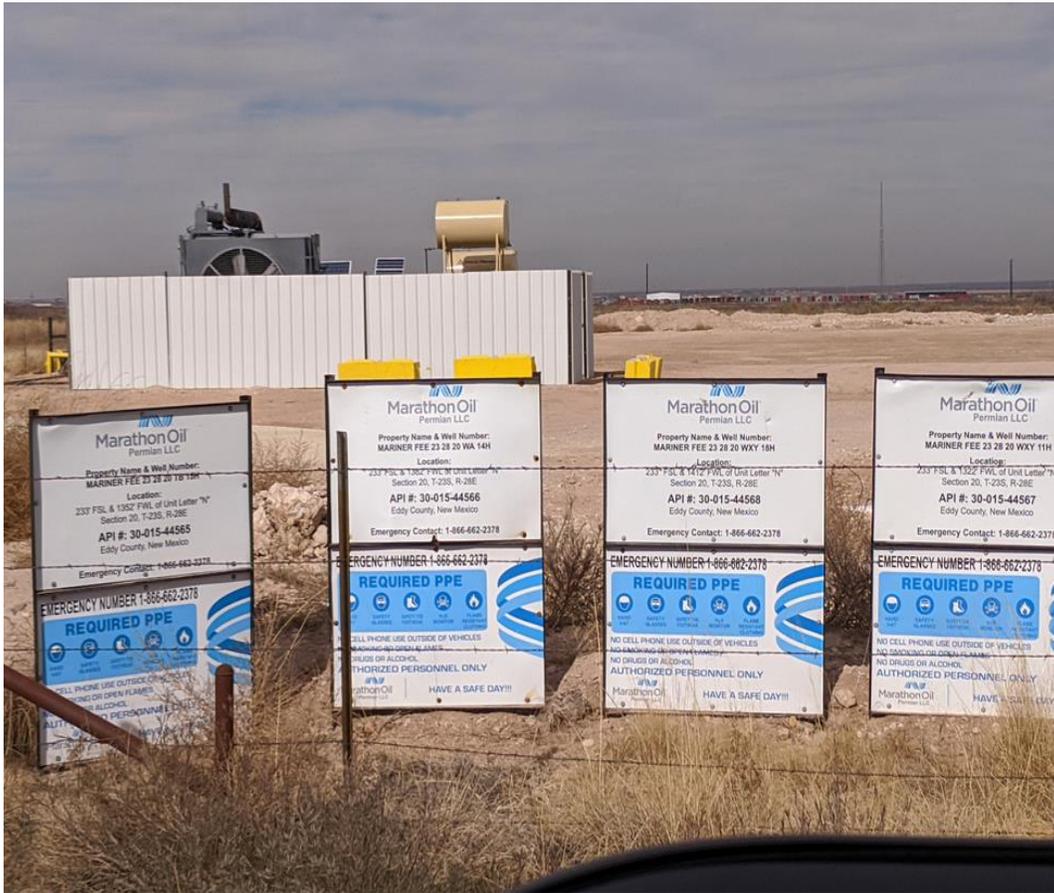
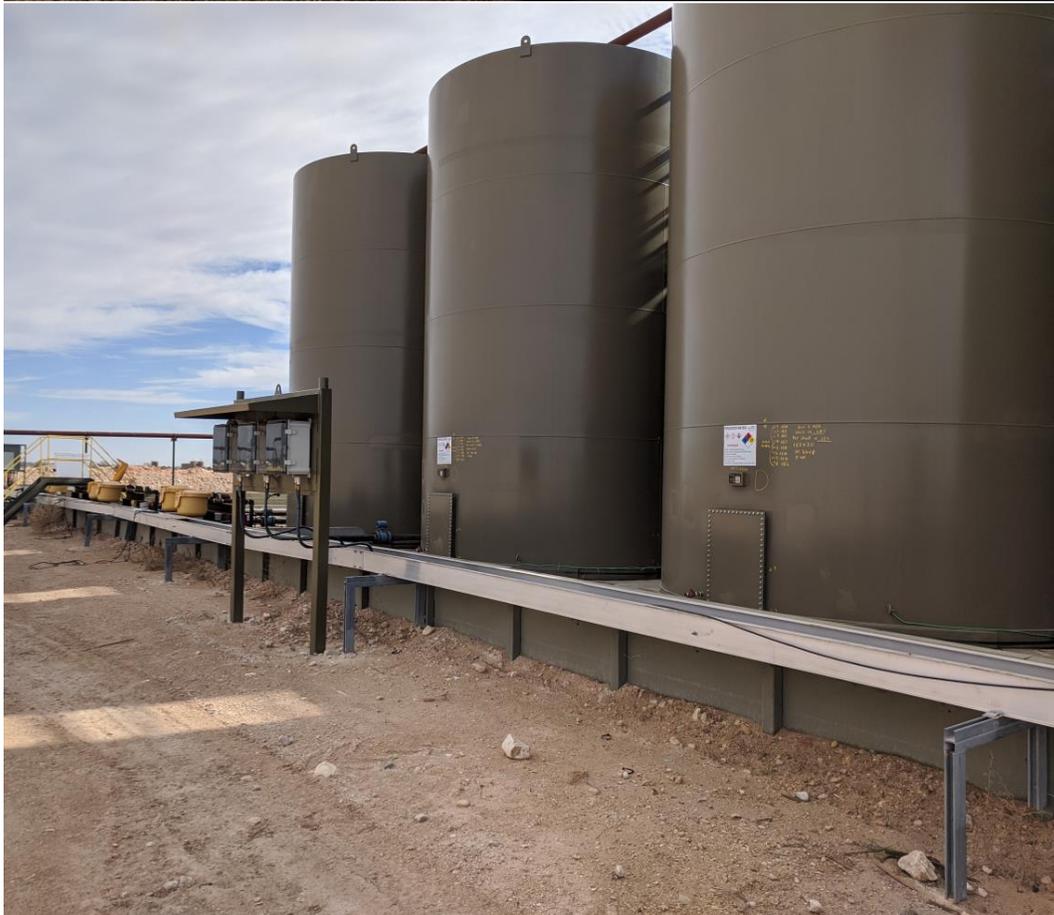
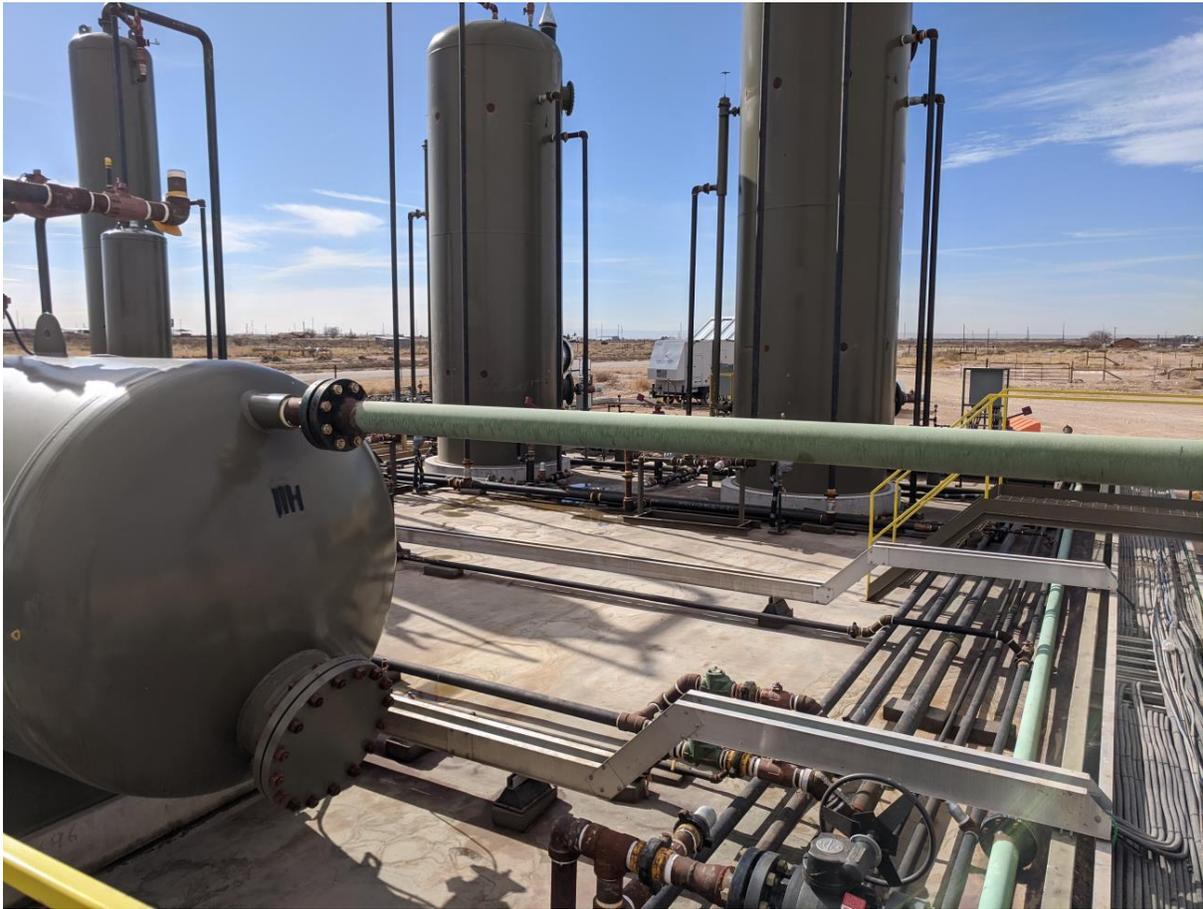
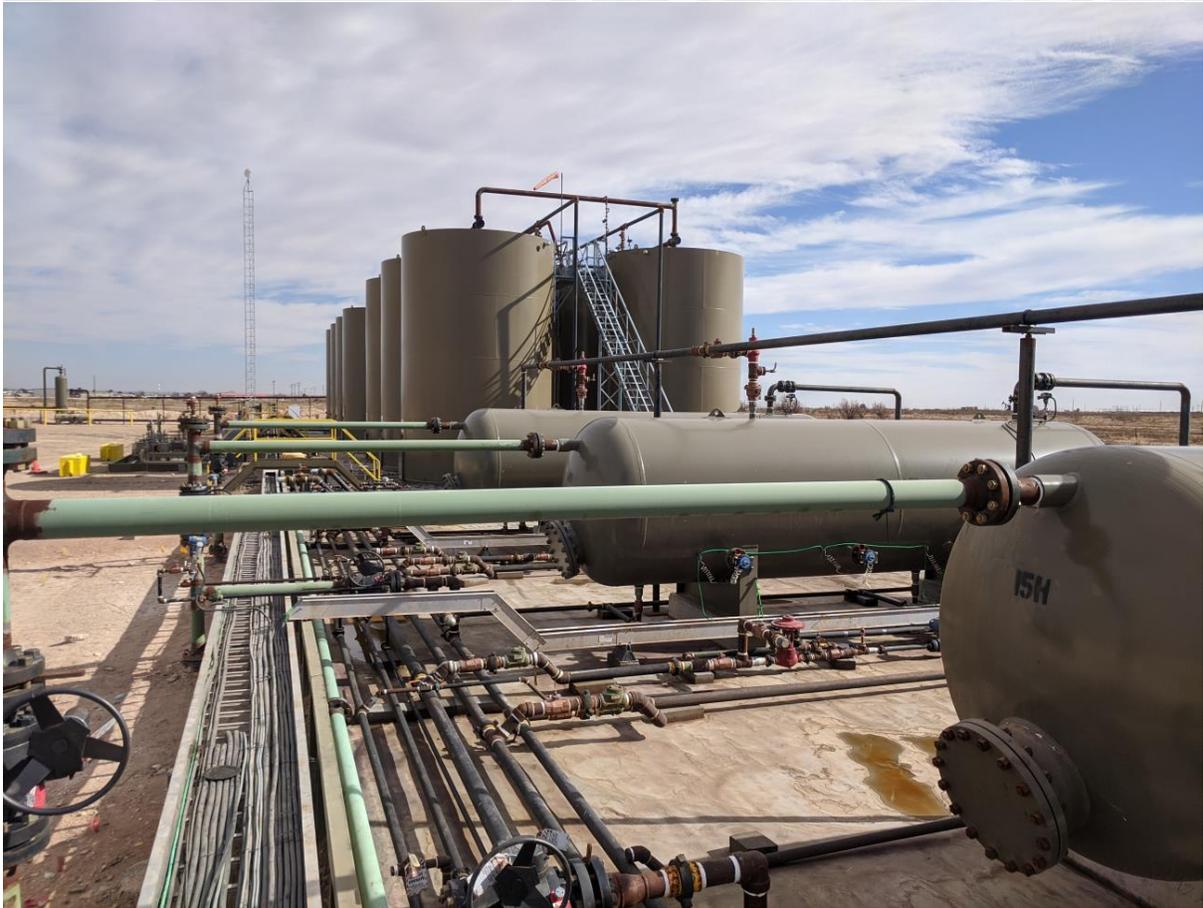
Responsible party has visually inspected the liner (Y)N

Liner remains intact (Y)N

Liner had the ability to contain the leak in question: (Y)N

- . No stains outside containment
  - . no failures in liner or containment
  - . freshly powerwashed - puddles in photo
  - . clean loadouts
- 
- 
- 
- 
- 
- 
- 
-
